TEST EXCAVATION OF *S.S. DICKY*

17th APRIL 2015

S.S. Dicky

Cosmos Archaeology Job Number J14/18

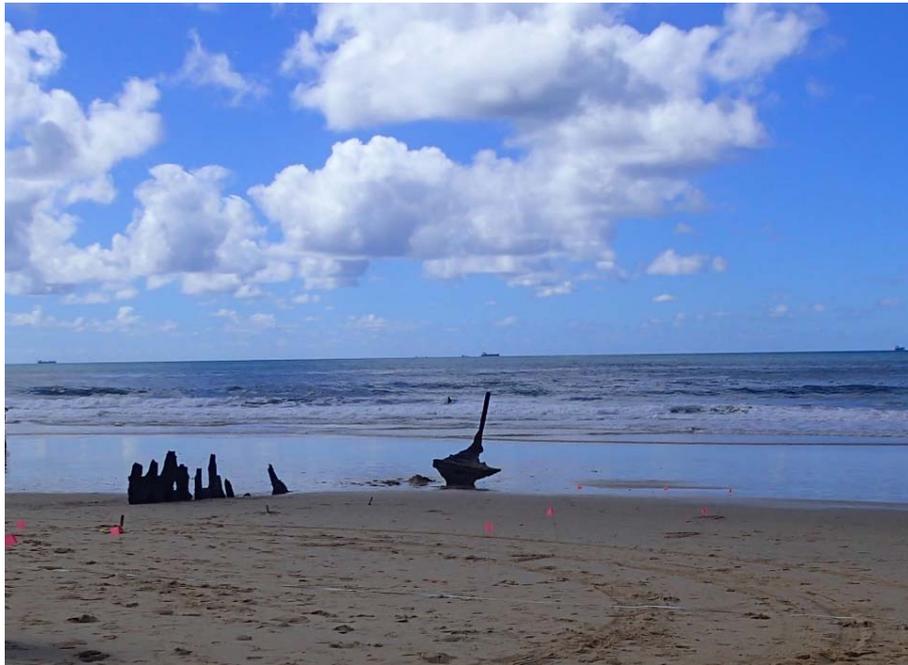
Upon arriving on site in the morning conditions were sunny and still. There was a significant amount of sand accretion on site, amounting to approximately 1 m additional depth of sand surrounding the stanchion to previous observations in mid-March 2015. As a result of the increased sand level, the water line was already beyond the stern section of the wreck enabling immediate access for surveying (Figure 1). There was no rainfall on the day of excavation and only light winds from the east to south-east (

Figure 1. View of S.S. *Dicky* upon arriving on site, showing the water level. (Cosmos Archaeology, 17th April, 2015).

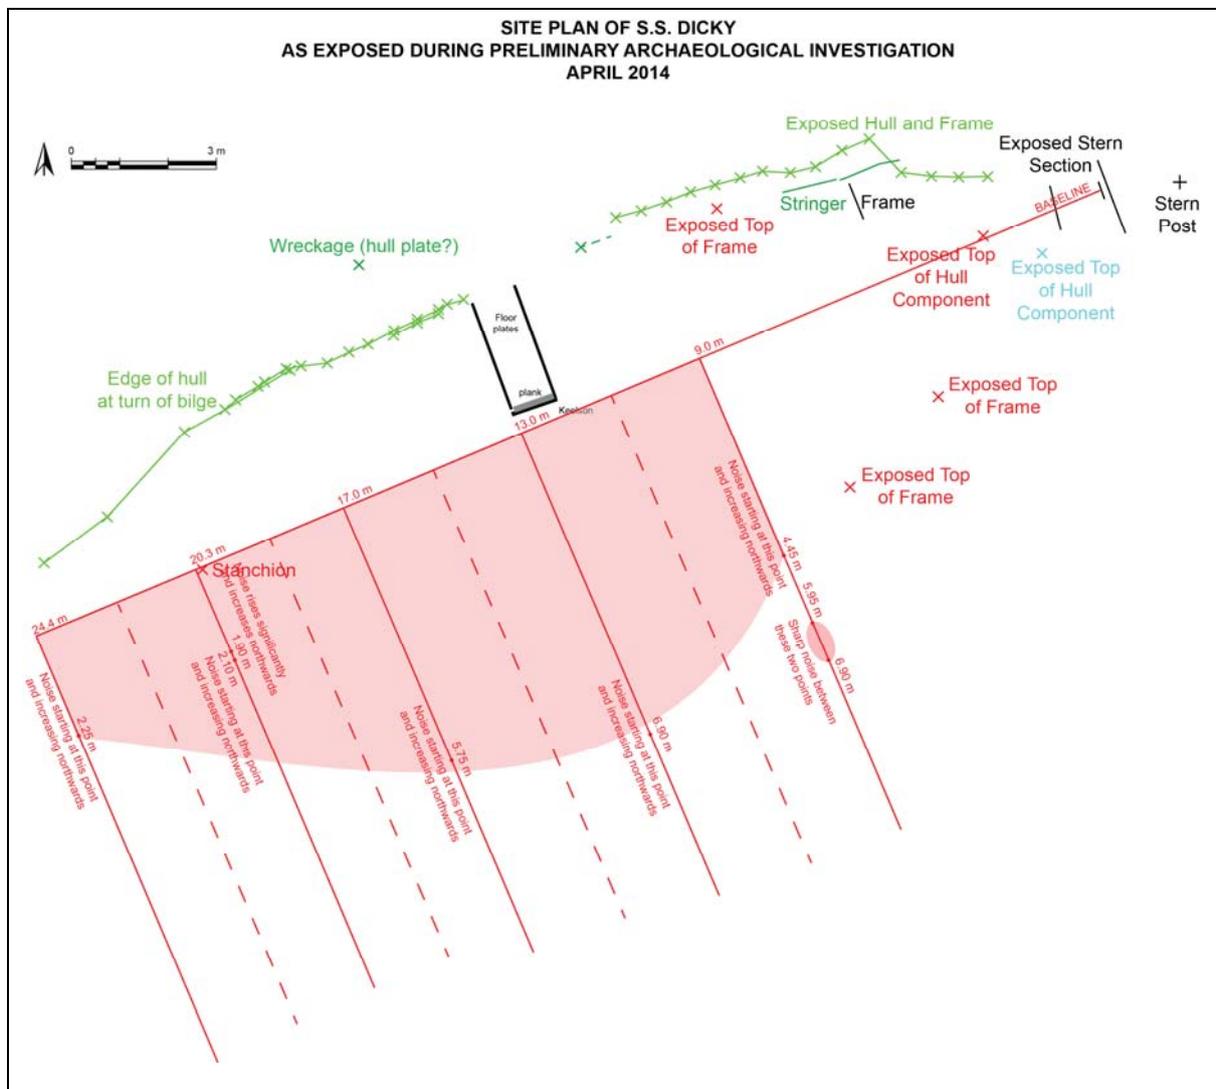
The metal detector survey was conducted between approximately 11:00 am and 12:30 pm. The results are presented in Figure 3. Transects identified a general pattern of signals beginning approximately 4 to 6 m to the south of the baseline and increasing in volume as the transect progressed to the north and closer to the wreck. The only exceptions to this were the western two transects, closest to the bow, in which no noise was heard until about 2 m from the baseline. On the other transects, the volume of noise increased dramatically from about 2 m from the baseline. It was concluded that the noise at 4 to 6 m indicated fallen remains on the exterior port side of the wreck and the noise at 2 m indicated the port side hull. One exception was on the eastern most transect in which a relatively loud isolated signal was detected between 5.95 and 6.9 m from the baseline before silence and then the recommencement of the signal increasing closer to the wreck. This anomaly was interpreted to be a piece of isolated wreckage on the exterior port side of the hull that was relatively close to the surface. Because of the relatively deep sand cover over the site it cannot be stated with certainty that all substantial loose wreckage beyond the remaining intact section of wreck was detected.

Figure 3. Site plan of the S.S. Dicky with metal detector transects and results.

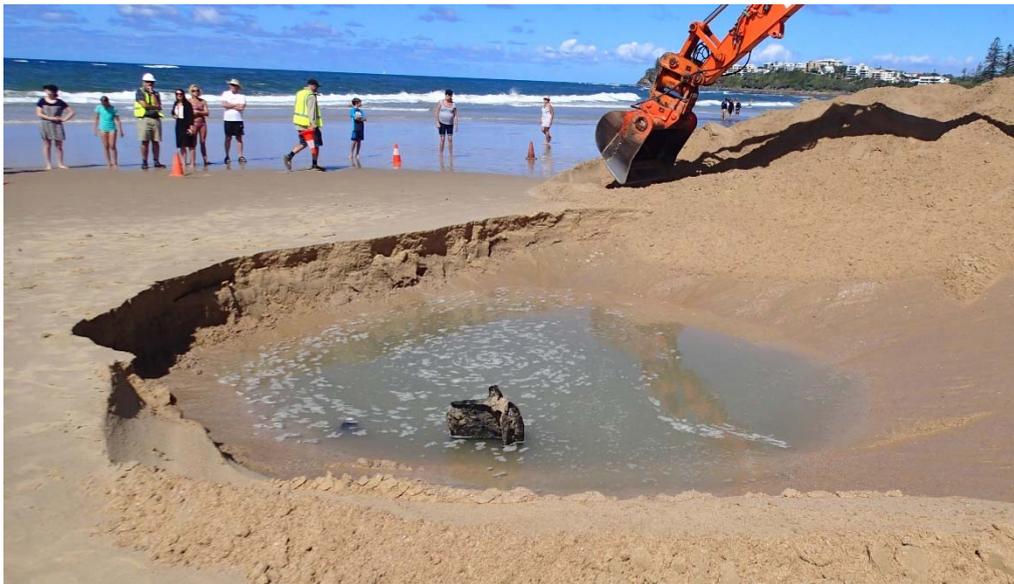
The first test pit was mechanically excavated on the exterior of the port side just toward the stern side of midships, starting approximately 8 m from the baseline and working inward towards the wreck (northward). The intent of this test pit was to uncover wreck remains on the port side to gauge a depth and any limitations to access. Excavation began at approximately 12:40 and identified wreck remains approximately 0.6 m below sand level (Figure 4). As these remains were two intact hull frames and a detached section of frame and hull plating – fulfilling the objective of exposing intact remains below LAT, no further searching for the wreck was conducted. In addition access to the wreck itself was considered too difficult in the present conditions considering the largely increased sand level so it was deemed appropriate to test the cutting methodology on these remains instead attempting to uncover more frames on the port side of the midships area. As a consequence these remains were further exposed to maximise access in order to test cutting with a thermal lance below the water line.

Figure 4. Test pit one, facing SE. (Cosmos Archaeology, 17th April, 2015).

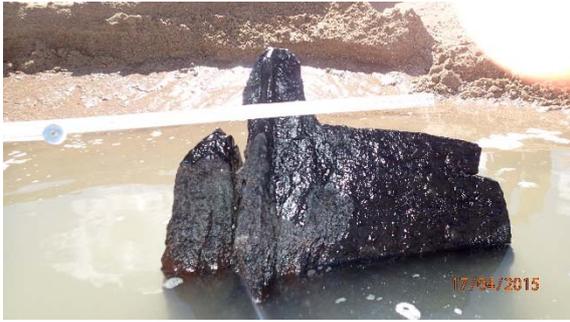
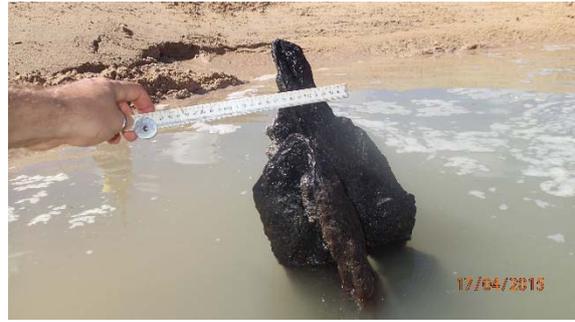
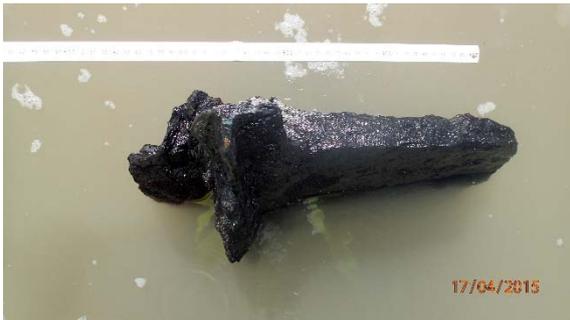
FR001 was the larger and most exposed frame (Figure 5 to Figure 7). It measured approximately 250 mm in length and 200 mm in width with a depth larger than 500 mm in maximum dimensions. It appeared to consist of two attached components including an upright angle iron frame, with a larger angle frame attached to plating immediately adjacent to the east. This frame appears to have been bent over to the port side, with the frame and hull plating now facing outwards and angled downwards.

Figure 5. FR001, facing N. Shows intact angle frame to left and bent over section of hull plating and attached frame to the right. (Cosmos Archaeology, 17th April, 2015).

Figure 6. FR001, facing W. Cosmos Archaeology, 17th April, 2015).

Figure 7. FR001, plan view. Shows intact angle frame to left and bent over section of hull plating and attached frame to the right. (Cosmos Archaeology, 17th April, 2015).

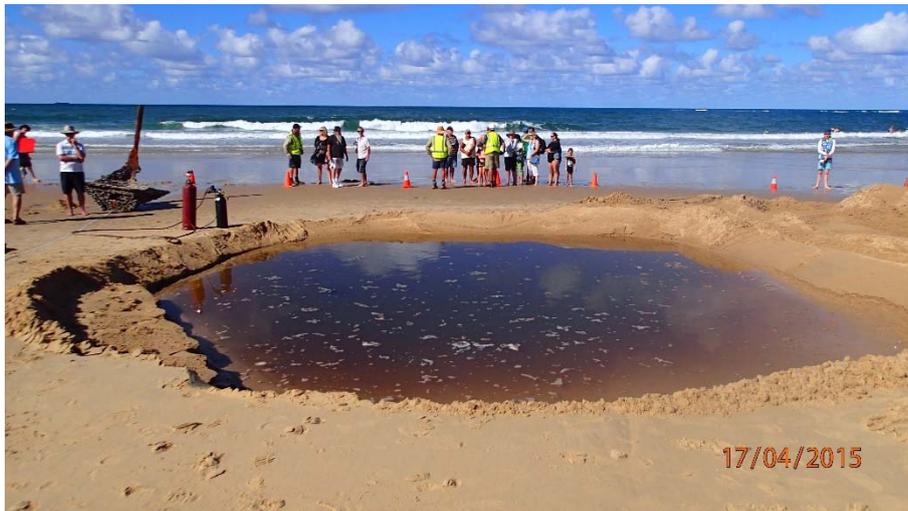
After the completion of cutting, the water level had risen to completely cover the frames. The cutting procedure also changed the colour of the water to a much darker hue (Figure 11). Together these changes completely prevented any form of recording of the remaining frames after cutting.

Figure 11. Test Pit One after the cutting procedure, facing E. (Cosmos Archaeology, 17th April, 2015).

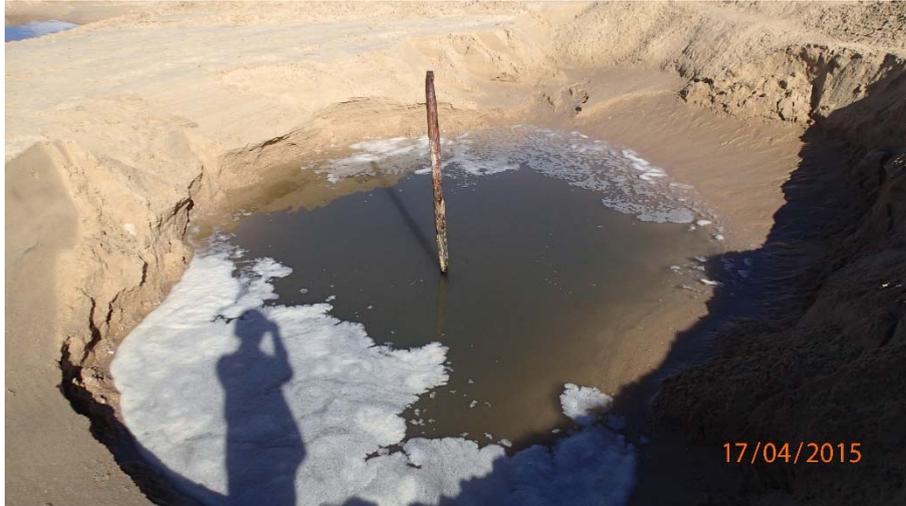
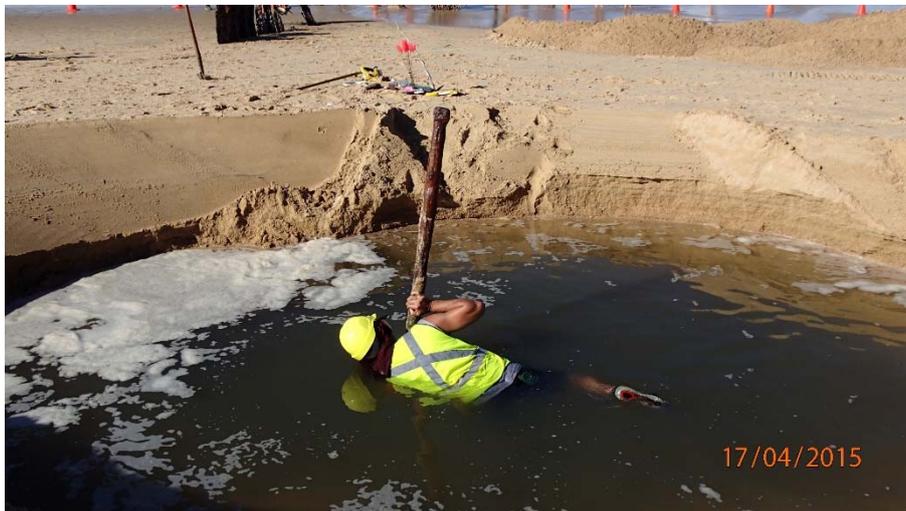
2.13 m of the length of the stanchion was exposed, however, a cause for its instability was not located. Despite this, the stanchion was relatively stable at this level of exposure which indicated that the weakness is much deeper and that the stanchion should remain quite stable without reinforcement.

The second test pit began adjacent to the stanchion in approximately the location of the port side of the wreck. Excavation continued downwards but no remains were encountered. The test pit also encroached on the stanchion and there was first mechanical and manual excavation around it in order to attempt to uncover the source of the instability of the stanchion. 2.13 m of the stanchion was exposed (1.25 m of which was exposed above the water at 3:20 pm) without reaching the attachment point and as a result the reason for its apparent instability was not located (Figure 12 and Figure 13). Gravels and cobbles, of various types including quartz, up to 100 mm across, were encountered towards the base of the stanchion. It is believed that these rocks have accumulated within the hull since the

Figure 12. Exposure of the stanchion in Test Pit Two, facing SE.
(Cosmos Archaeology, 17th April, 2015).

Figure 13. Exposure of stanchion with rising water level, facing E.
(Cosmos Archaeology, 17th April, 2015).

The test excavation was unsuccessful at identifying the cause of instability associated with the stanchion. It was suggested by Paddy Waterson that the weakness may be between the stanchion and the keelson, however, a repeat excavation would need to dig deeper in order to substantiate this claim. Despite not finding the source of the instability, it was observed

- The stanchion should remain *in situ* in the beach with no additional supports or reinforcements until it becomes too unstable to remain in this position. The CMP should be amended likewise;

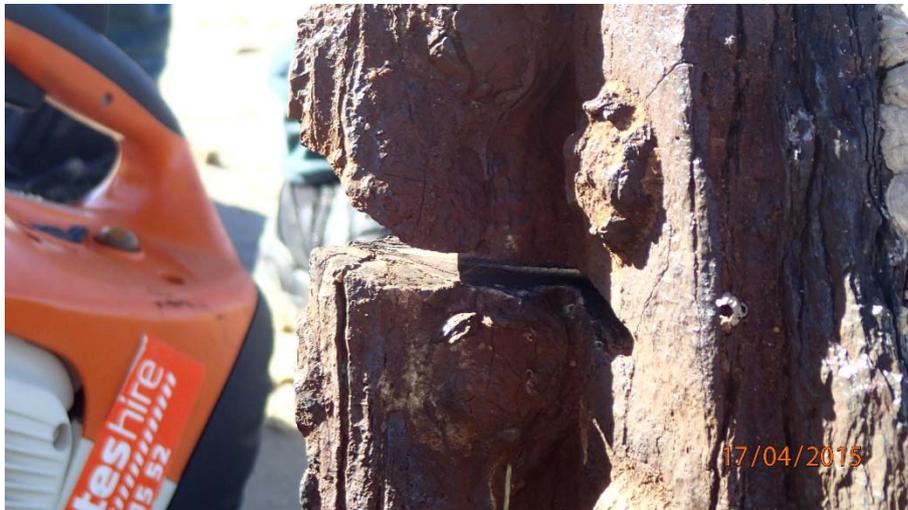
It was intended to test above water cutting equipment on the port side but, because no suitable wreck element was exposed in Test Pit Two, an exposed frame on the starboard side was used for testing instead. A hand held circular saw with a diamond blade was used and this was tested on frame FR002 on the starboard side (Figure 14). The initial cut with the circular saw took approximately two minutes and made significant progress through the western edge of the frame. The internal remains of the frame could be seen through this cut and it was obvious that a significant portion of metal remained, with a large amount of rust and concretion encasing it (Figure 15).

Figure 15. First cut with the circular saw, with the shiny surfaces in the interior indicating metal, facing N. (Cosmos Archaeology, 17th April, 2015).

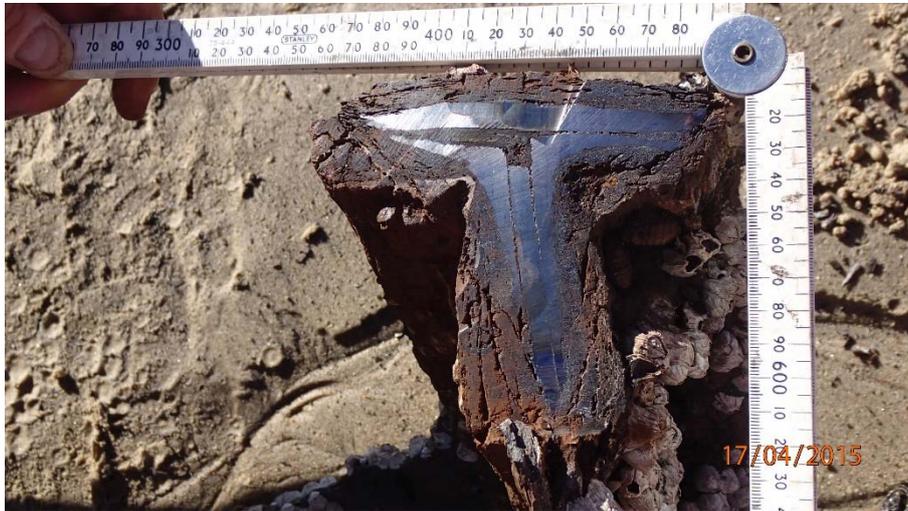
It took approximately another four minutes to cut through the remainder of the frame (Figure 16). The piece of frame that was removed is artefact FR002-001. The cross section of the frame as seen at the top of the remaining frame and base of the artefact clearly shows the frame structure and the amount of metal that survives within the concretion (Figure 17). The frame is shaped as a 'T' with two angle frames back to back and a spacer between as well as hull plating across the top of the 'T'. The thickest part of the surviving metal occurs at the inside corners of the angle frames and the centre of the hull plating, both being approximately 10 mm thick. The surviving metal then tapers down to points towards the edges of the frame.

Figure 17. Cross section of the remaining frame FR002 showing the internal metal and outer concretion and rust product, profile view.
(Cosmos Archaeology, 17th April, 2014).

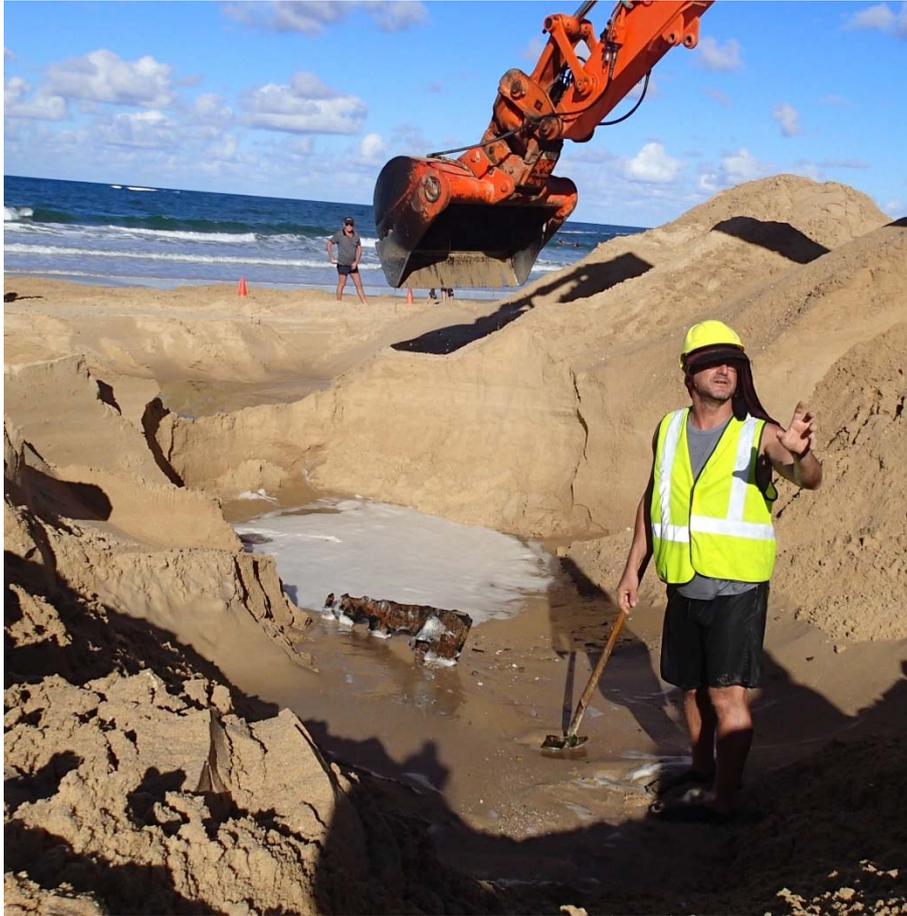
The third test pit was excavated further west, almost adjoining Test Pit Two, and was intended to expose a portion of the bow end of the wreck (Figure 18). This was successful, revealing plating and the remains of the stem post at the end limit of the bow (Figure 19 and Figure 20). The plating on the port side was in good condition, while that on the starboard side had been ripped and twisted to the side. There was relatively little concretion product visible, although this may have recently exfoliated and come off. A number of bolts were still visible. The western end of the bow is positioned 7.86 m from the top of the stanchion at a bearing of 235° (Annex B – Figure 22). The bow in plan appears to be off the centre alignment of the wreck. This could be because the measurement was taken off the top of the stanchion which is leaning and therefore is also off the centreline. It is also possible that the surrounding iron was sufficient to interfere with the compass.

The bow was exposed at between 2 to 3 hours after spring low tide (1:00 pm) and was almost underwater. The water level was unexpected. It was anticipated that the bow area would be mostly 'dry' even on a rising tide, as can be seen in numerous photographs of the site available on the internet. It is speculated that increased sand levels over the bow leads to the retention of fresh water which is run-off from the dune system. This water remains

Figure 18. Test Pit Three at the bow, only marginally separated from Test Pit Two. Note the depth of sand over the bow. Apparently the bow was exposed in early April 2015. (Cosmos Archaeology, 17th April, 2015).

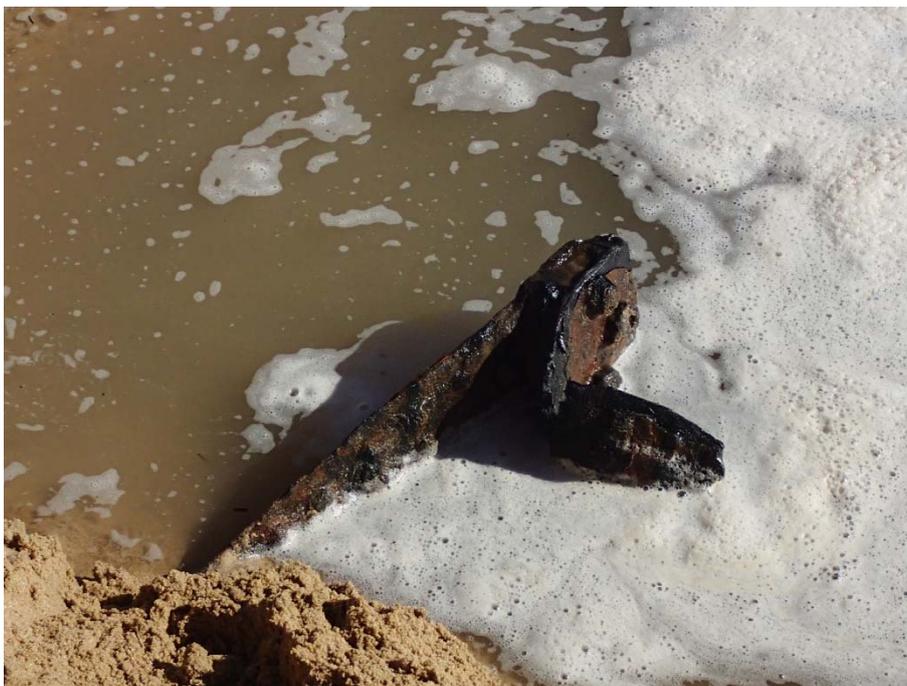
Figure 19. End of the bow in Test Pit Three above the water line, facing SSW. (Cosmos Archaeology, 17th April, 2015).

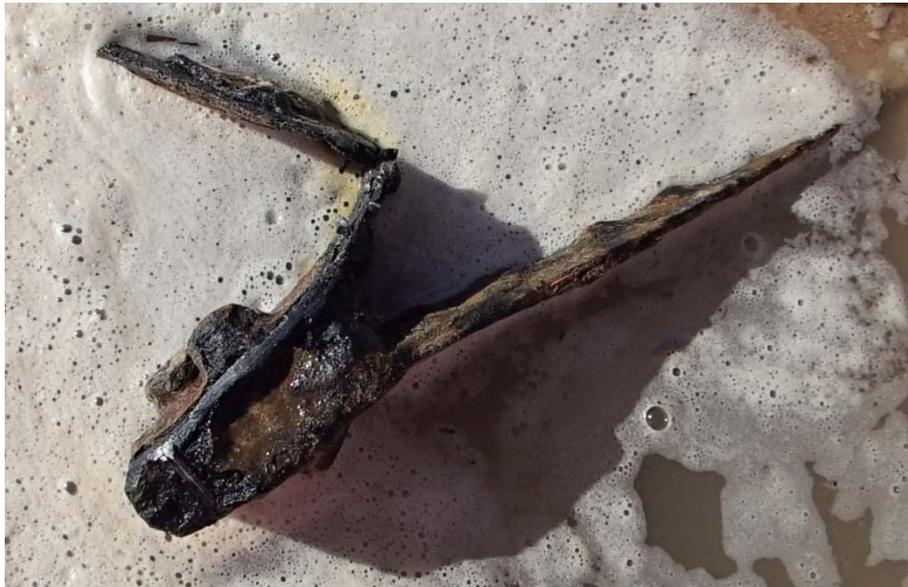
Figure 20. Profile view of the remains of the bow uncovered in Test Pit Three. (Cosmos Archaeology, 17th April, 2015).
