# *S.S. Dicky* Inspection Report

20 and 30 May 2013

Prepared by: Heritage Branch, Environmental Policy and Planning Division, Department of Environment and Heritage Protection

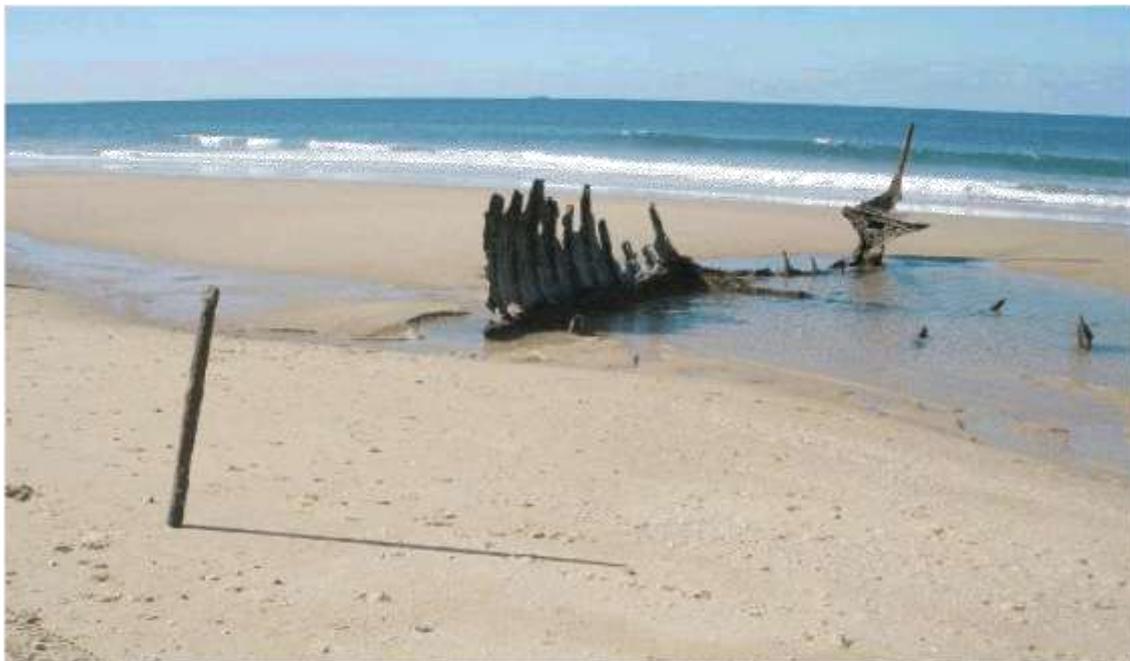
Image 1—A view of the *S.S. Dicky* looking north-east from near the bow toward the stern. While much of the lower hull remains buried in sand, this is the only section clearly visible (SCRC 25/07/2013).

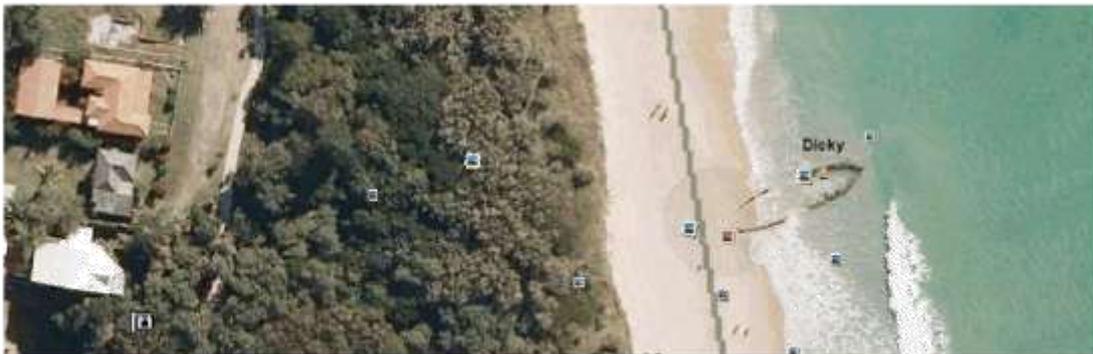
Image 5—This Google Earth Image shows the outline of the wreck in 2011. The missing section of the hull plating about amidships is clearly evident. This feature was possibly created in the late 1960's to allow vehicle access along the beach and would have had a negative impact on the hull's integrity.

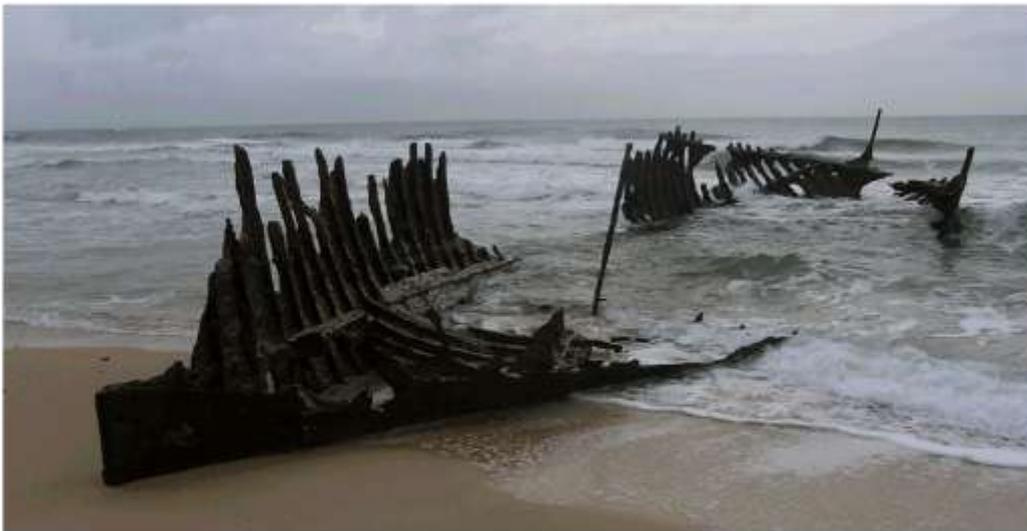
Image 8—The -exposed remains of the S.S. *Dicky* in June 2012 (Courtesy of SCRC).

Although the stern is still extant, the majority of the hull plating has collapsed due to the loss of sand associated with a series of extreme weather events since 2008. As illustrated by images 8 and 9, these events have generated large seas and caused heavy scouring. This triggered catastrophic failure of much of the exposed wreck that was already critically weakened by a combination of historic human intervention, electro-chemical corrosion and over a century of wave action. The port side hull plating appears to have collapsed first, followed by the forward starboard section.

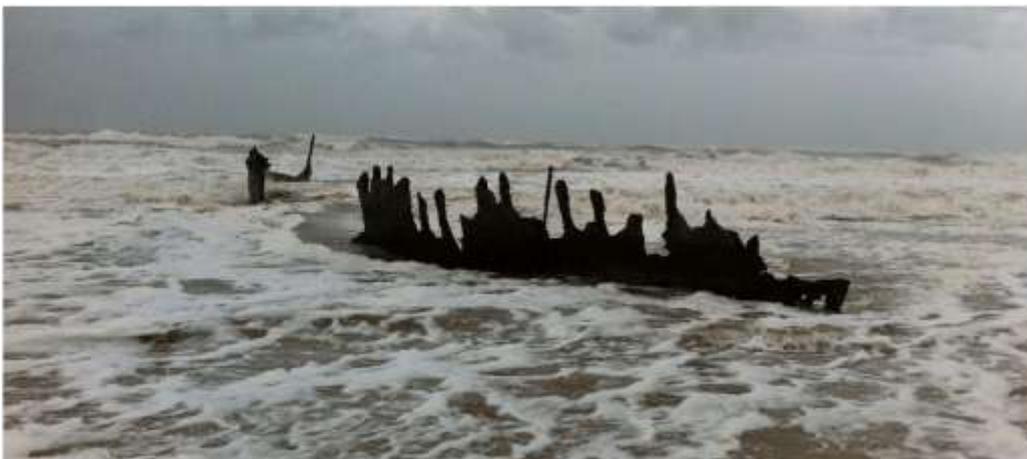
Image 9—The S.S. *Dicky* during heavy seas caused by ex-Cyclone Oswald in 2013. SCRC advised that the forward starboard hull plates collapsed soon after (Courtesy of SCRC).

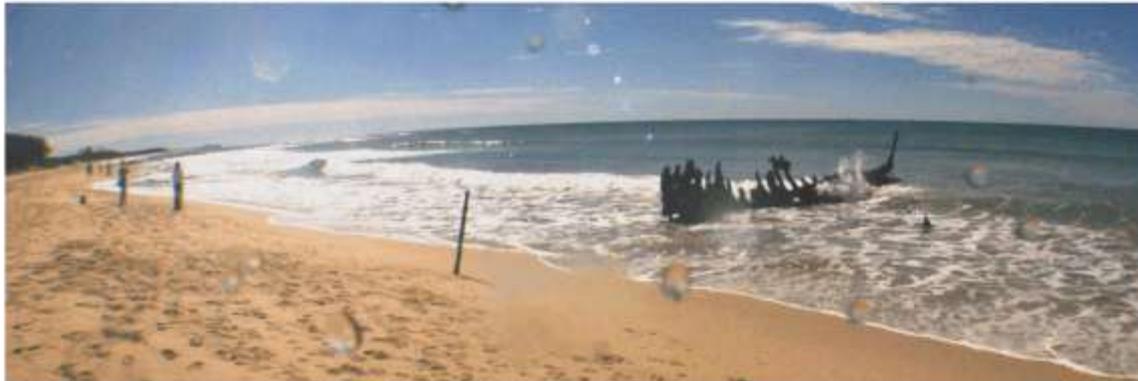
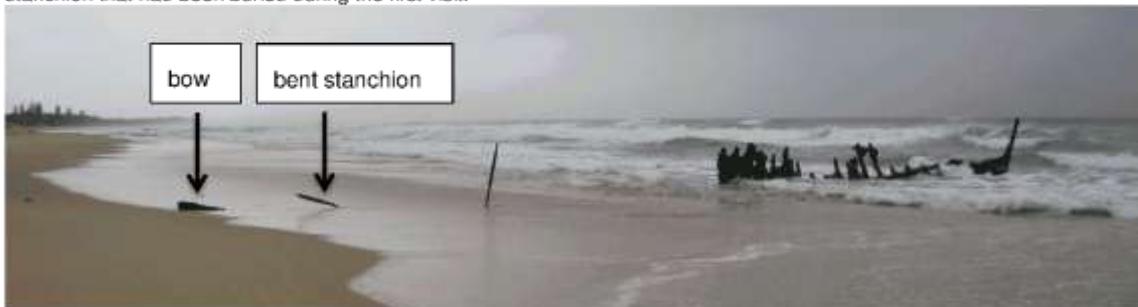
Heavy weather and sea conditions between the 20 and 30 May 2013 did cause a noticeable degree of beach erosion between visits. Based on the height of freshly exposed features of the wreck (bow and forward deck stanchion) it is estimated that erosion was in excess of 0.3m.

Images 10 (above) and 11 (below)—These images were taken on the 20 and 30 May respectively. Poor weather during the intervening period had removed over a 0.3m of sand from the beach, exposing the bow and the bent over forward deck stanchion that had been buried during the first visit.

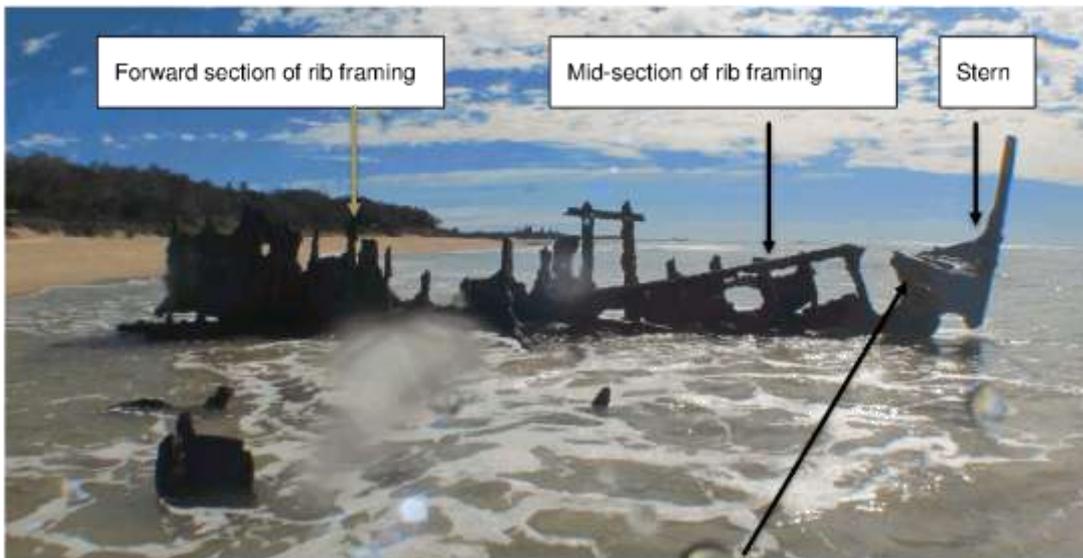
The midsection of rib framing has been visibly weakened by the collapse of the upper stringer near the stern. Judging from available images the break appears to have occurred as late as early 2013. This was probably facilitated by the prior loss of the hull plating that was helping to provide structural support (refer to images 16 and 17). The separation of the stern and bow from the main body of the wreck is a common feature in iron hulled wrecks as, by their nature, both terminal ends of the ship are more heavily built than the sides (McCarthy:2000).

Image 12—The remnant starboard side looking north. Note the break in the stringer near the stern and the missing stern post.

Reinforcement of the stern post to provide added structural support was recommended in the management plan and it is still potentially viable in the short-term. The stern post has a section missing, which was probably cut during the removal of the propeller in 1963. As the stern post, keel and bow post form the principal structural spine of the ship, maintaining these sections is the key to preventing the wreck from completely 'unzipping'. The loss of the upper portion of the bow post would have structurally weakened the hull and placed added emphasis on the hull plating to retain the outline of the ship forward of amidships. The turbid conditions and safety precautions prevented the stern from being closely examined, but it generally appears quite solid and its usual submersion would help create a more stable preservation environment compared to those sections that are more regularly exposed to the air.

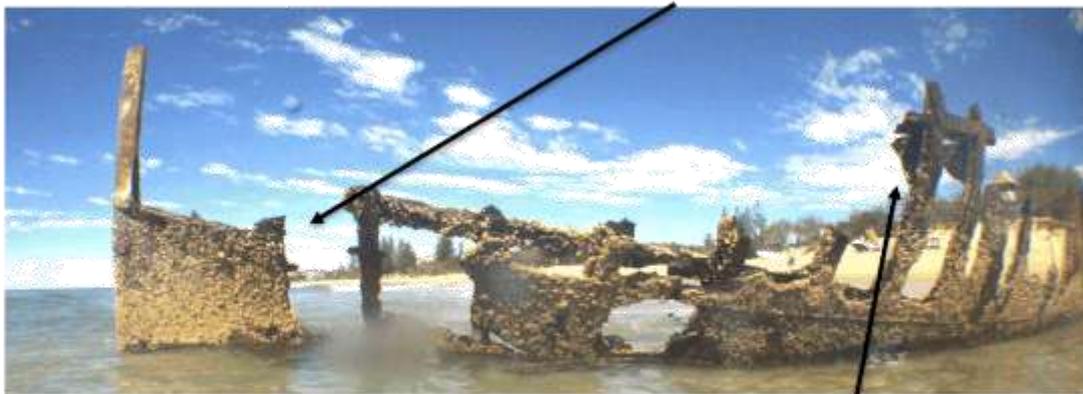
Image 13—The remnant starboard side looking south.

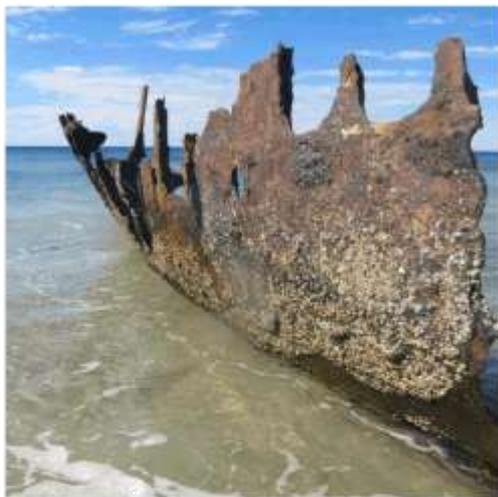
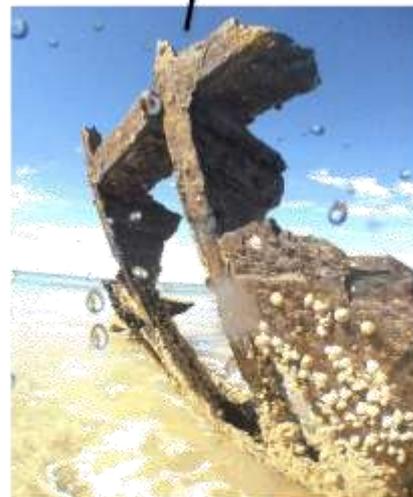
Images 14 and 15—The misaligned sections of rib framing. Note the orange colour and lack of protective concretion layers. The section of frame jutting out of alignment visibly flexes, even in gentle surf.

It was beyond the capacity of the inspection to undertake detailed analysis to determine the condition of the metal near the break. However, a visual assessment indicated the remaining section is relatively weak and flexes in even gentle surf. The extant frames are visibly narrowed or tapered and show signs of cracks near the base.

The break in the stringer in the mid-section of the extant rib framing is a serious concern. As stated previously this section is misaligned and flexes easily in light swell. The section of framing is therefore very fragile and could collapse during the next major weather event. The extant lower stringer was never directly attached to the stern, but rather to the upper stringer, which has since collapsed. There is quite advanced decay on the surviving metal terminals on both the extant stringer and stern and it is unclear how much viable metal is left. This inspection was unable to directly assess the condition of the extant metal under the corrosion product, but there are concerns there may not be enough viable metal left to make an effective attachment. If viable metal remains, it may be possible to brace the mid-section by welding in a short piece of iron to reconnect the stringer to the stern. The introduced metal would soon be covered in corrosion product and marine growth and blend in. The dimensions or shape of the introduced metal could deliberately differ in a minor way from the original fabric so that on close inspection it was readily distinguishable from the original (thereby complying with the provisions of the Burra Charter).

The materials used in repairs would need to be carefully considered and monitored to avoid galvanic corrosion of the historic metal and/or cause more serious damage to the reattached sections, should the mid-section still collapse.

The concern is that the whole mid-section is now misaligned and that the above bracing will do little to stabilise the lower rib-frames, which are obviously damaged through repeated flexing and exposure. It may be possible to further stabilise these areas as well. But if the level of decay is too advanced, this section is unlikely to survive in the short-term and the viability of attaching reinforcing material is slim.

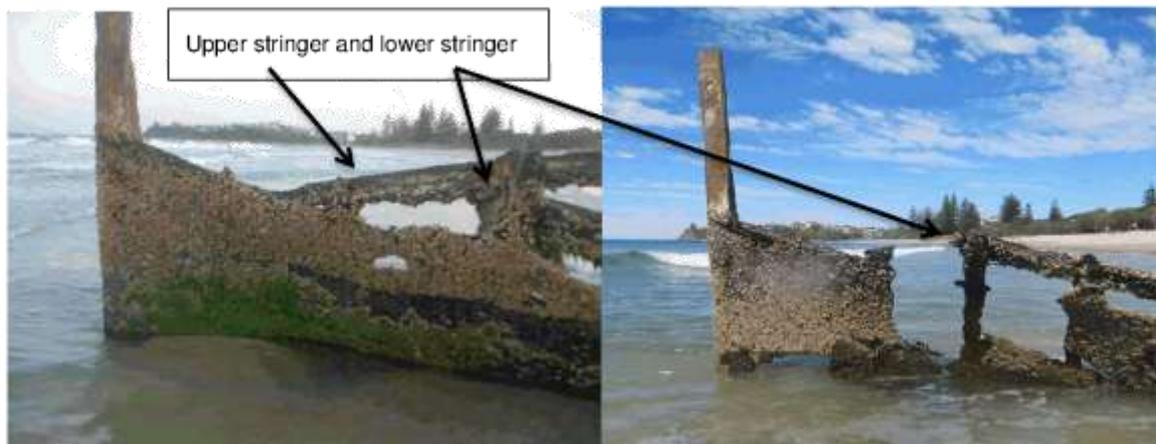
Images 16 and 17—The starboard side of the stern in 2008 and the same view in May 2013. Note the accelerated loss of hull plating near the break site.

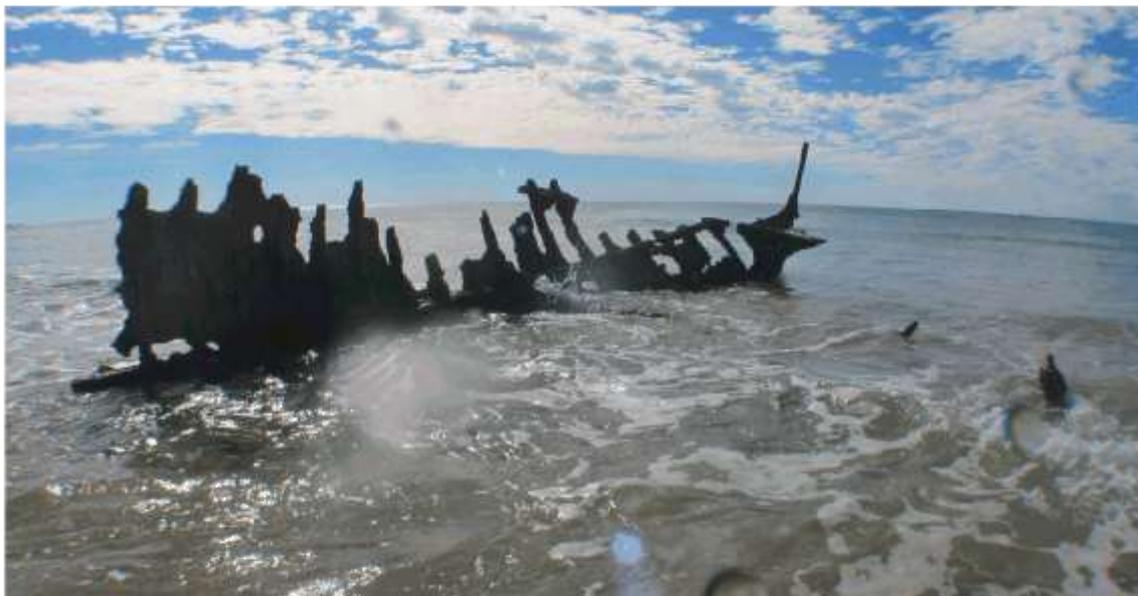
The missing sections from the port side have collapsed both into the wreck itself and onto the adjacent ocean floor—often in large sections. Some of the broken port side frames are still quite proud of the ocean floor and are corroding in the water column to a classic 'point' shape (refer to image 18).

Image 18—The remnant exposed section and the protruding abraded ends of the collapsed port side right of centre.

In the short term, it may be feasible for highly dangerous elements, such as the partially-exposed and pointed ribs on the port side, to be collected (if loose) and placed with other materials held by SCRC, or be cut off below sand level and coated with retardant before being reburied. This could reduce (but not completely remove) the risk of a bather or visitor being impaled or cut.

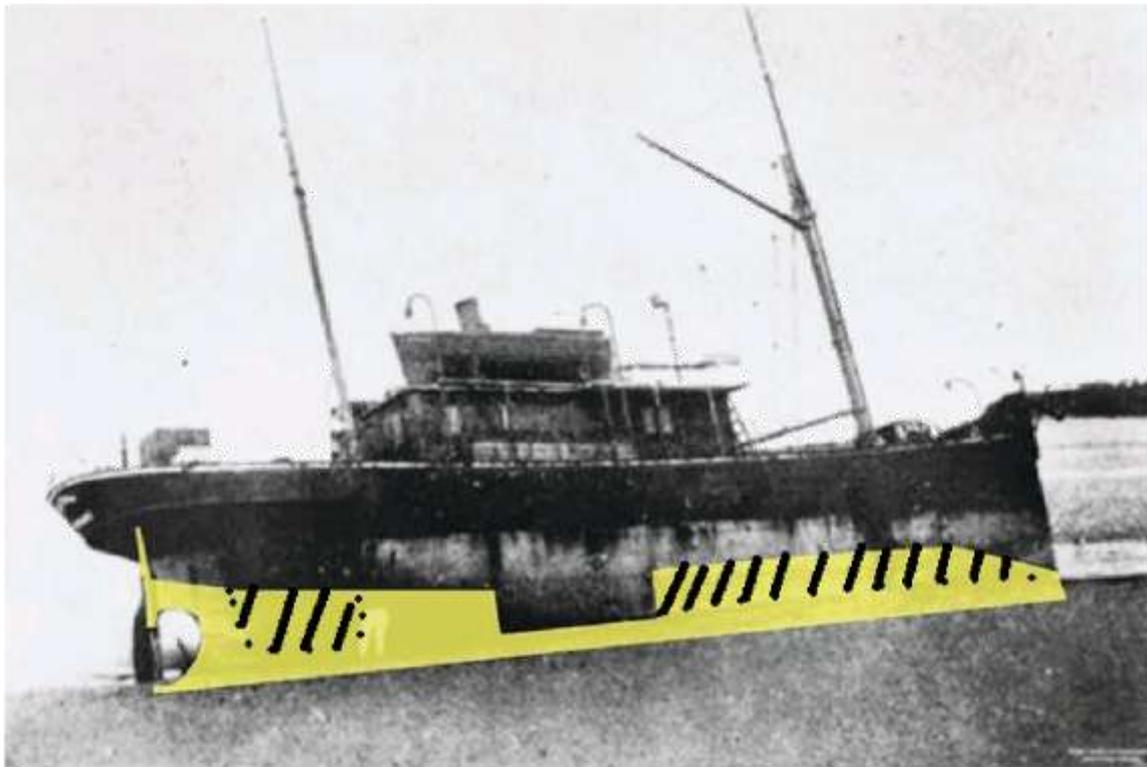
Image 19—The 2008 management plan (Cosmos Archaeology 2008:36) illustrated the decay of the wreck by shading an historic image with yellow to represent the extent of the then surviving fabric. This image has been updated to reflect the subsequent loss of fabric by marking the recently collapsed sections with black hatching. Only the areas in solid yellow are now extant.

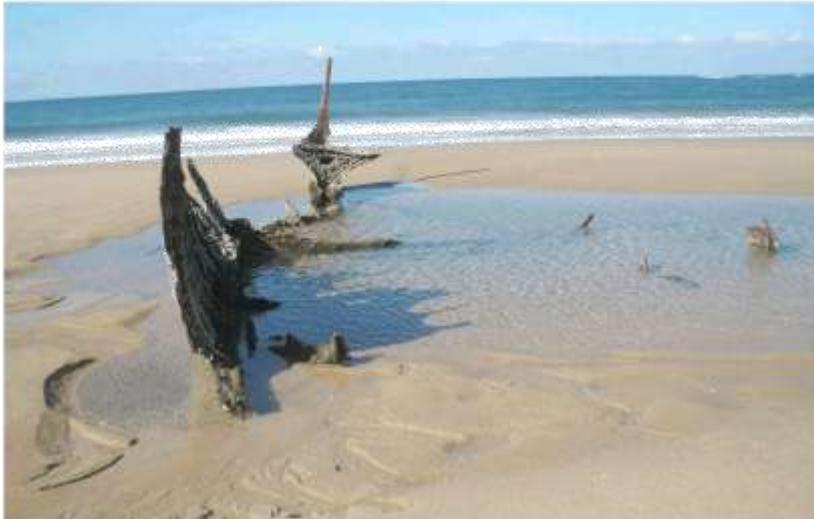
On the 25 July 2013, Mr Denis Shaw, Coast and Canals Manager at SCRC informed EHP that the wreck of the *S.S. Dicky* had deteriorated further. The mid-section of rib framing had collapsed, and although the stern remained upright, it was no longer supported by any vertical hull structure. The instability of the mid-section of rib framing was recognised during the inspection and it appears that concerns about its stability and viability for conservation were warranted. With the continued deterioration of the wreck and the resultant impact upon its established heritage significance, the case for complete or partial removal is heightened. The preferred management option will need to be agreed by SCRC and a proposal put to EHP for approval by the Director of Heritage Branch.

Image 21—The remaining exposed sections of the *S.S. Dicky* after the collapse of the mid-section of rib framing in July 2013.
