The Kings Beach Surf Life Saving Club building is a brick and hardiplank two storey structure approximately 25 years old on the beach front at Kings Beach, Caloundra. It is currently actively used as a life guard look out, lifeguard equipment storage facility and Nippers club house.

Following the request from Darren Lee from Sunshine Coast Regional Council, GHD were engaged to undertake a dilapidation review of the Kings Beach Surf Life Saving building located on the beach at Kings Beach, Caloundra. The 25 year old building is situated in a severe corrosive environment, which has had an obvious effect on the structure.

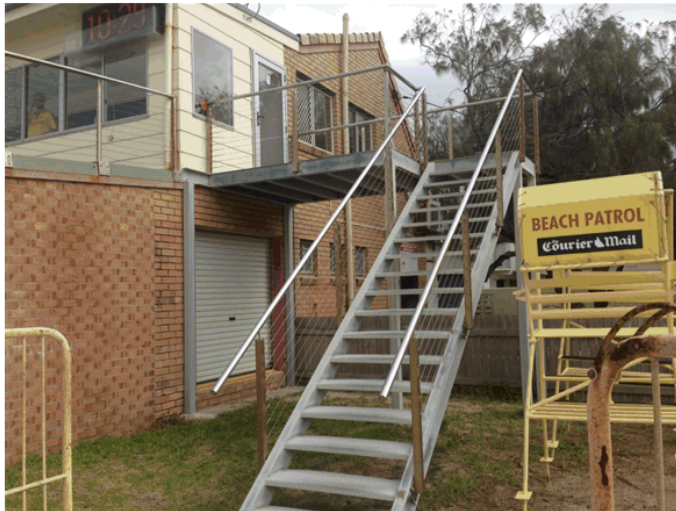
Figure 2 North Elevation

The main area within the building that requires the most work is the kitchen area, which appears to be an ad hoc addition. While it would appear to serve a worthy and needed community purpose, it does require some additional work to make its structural amenity conform to acceptable building standards. The additional work includes floor toppings to make water tight and changing the roof layout of the casualty room to eliminate the internal box gutter. This area is likely to also require some architectural fit out work including skirting tiles, new benches, and electrical ELCB and bench tops, to make it compliant as a commercial food serving area.

The ad hoc kitchen area is illustrated in Figure 2, positioned on the left-hand side underneath the roof vents.

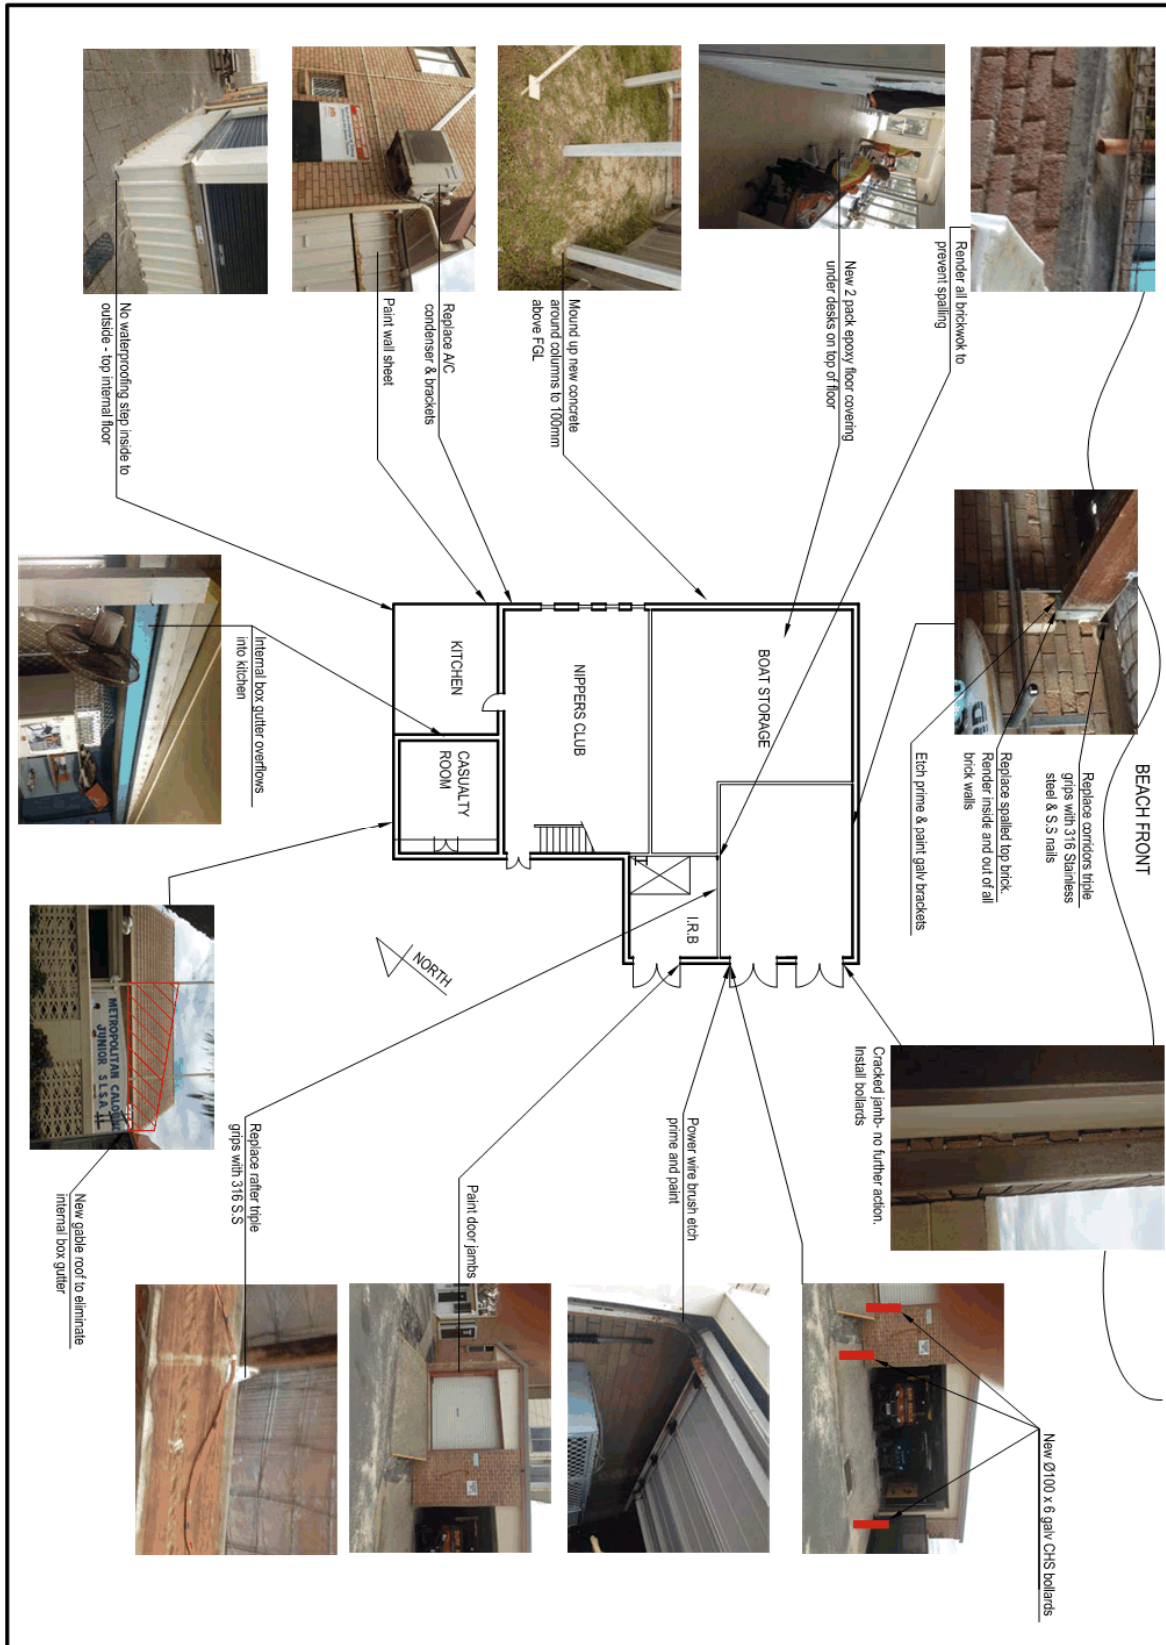
Appendix A – Pictorial Record of Required Maintenance

It is apparent that routine upkeep of this building has been lacking for some time. In particular spalling is evident in the brickwork, corrosion of triple grips and garage door tracks, bringing the kitchen up to a compliant standard and installing protective bollards in front of the boat storage doors. All areas of concern have been summarized as a pictorial record in Appendix A.

The particular area of concern is the spalling of the inside face of the beachside brick walls. Spalling can be described as severe deterioration of the brick face due to erosion and harsh environment of the beach. The mechanism causing this is considered to be recrystallising of airborne dissolved salt from the breaking surf. The salt is carried through the material from moisture and crystallizes inside the material under the surface as the water evaporates. The expanding salt crystals build up stresses on the surface of the brick; breaking away spall from the surface.
