**Sunshine Coast Regional Council**  
**Noosa Waters Revetment Walls**  
**Condition Assessment & Concept Report**

May 2013

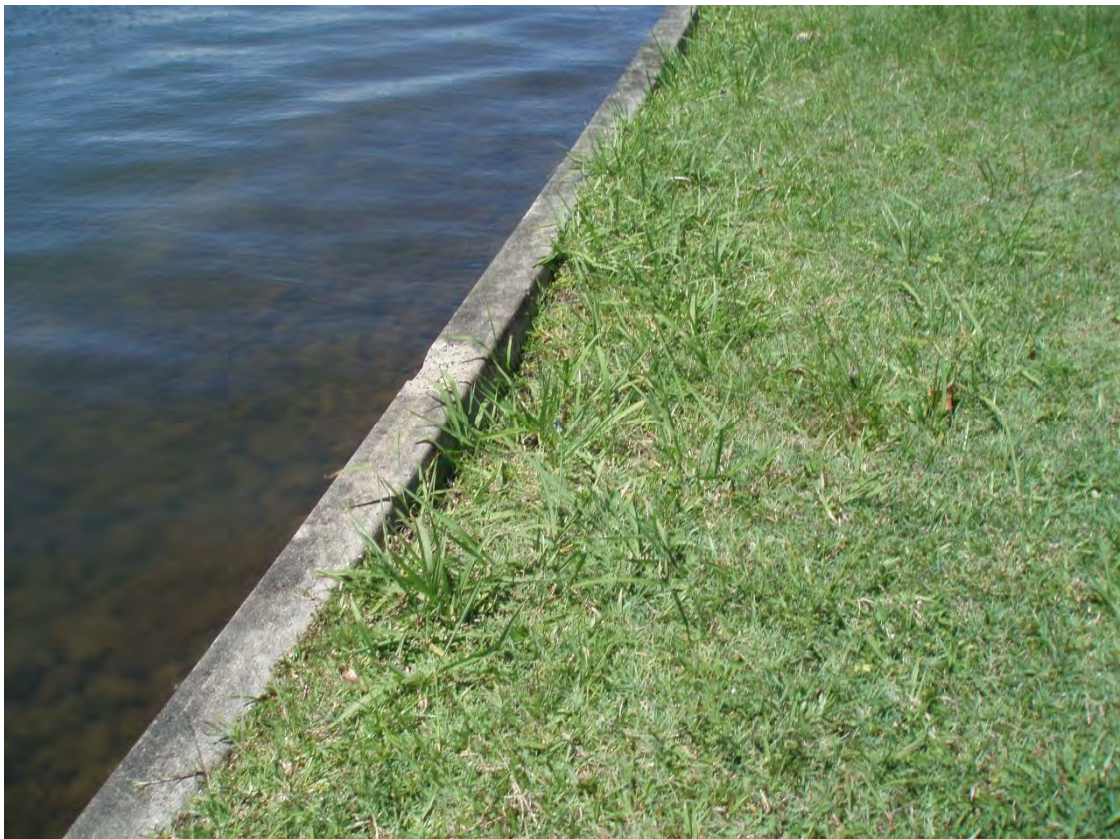
Figure 2-1 Potholing at drainage hole.

Minor potholing is occurring at a number of sites adjacent to the drainage holes and revetment wall joints. This should be monitored for any sites where this potholing has reached a level where the ground surface is noticeably lower as it is likely sediment is being lost. It is not considered critical at this stage but should this potholing increase it is recommended at these drainage holes/joints a geotextile should be installed to prevent any further loss of material and the potholes topped up with a free draining sand/gravel.

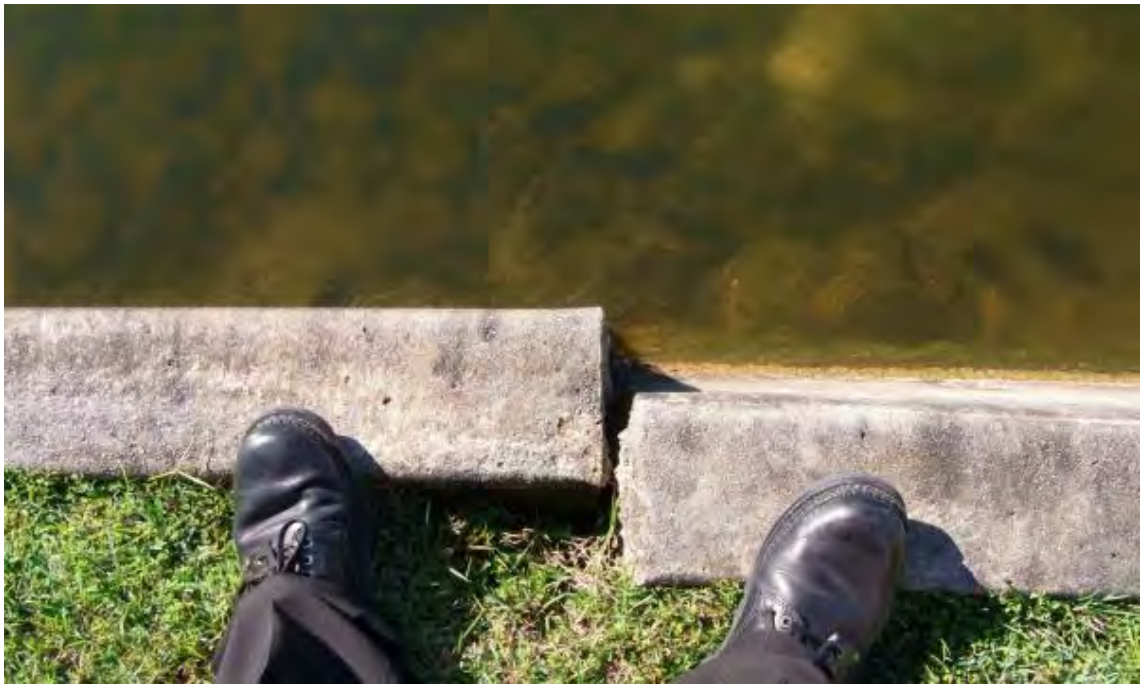
Figure 2-2 Revetment wall tilting forward at 37 Masthead Quay (SCRC 2012).

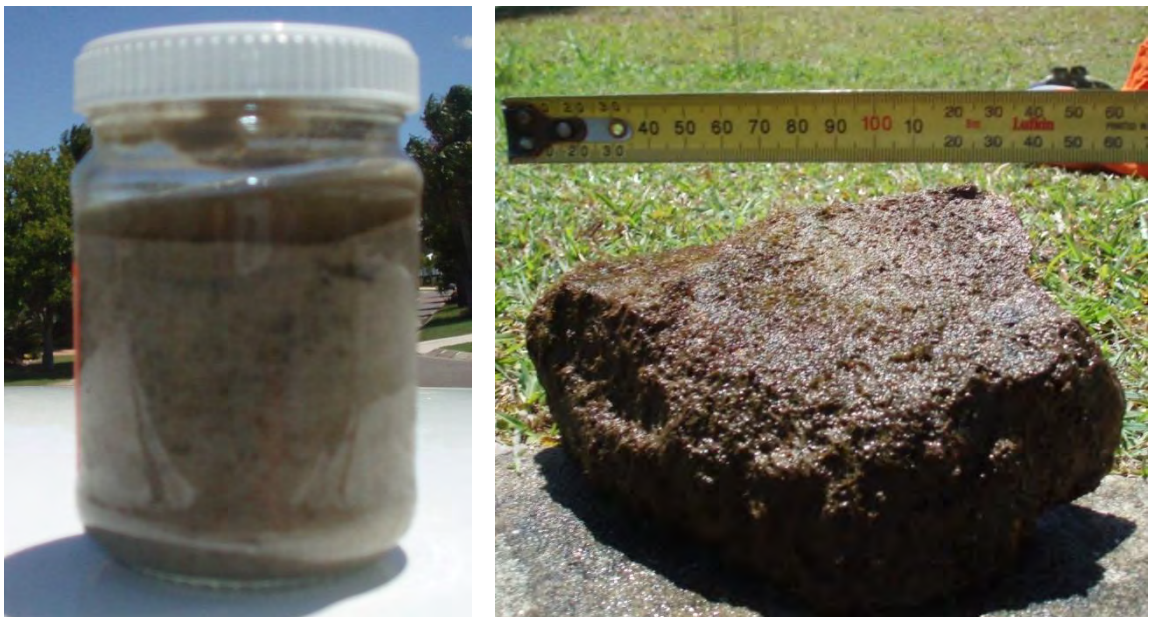
Figure 2-3 Sand with minor fines & Rock protection greater than 75mm .

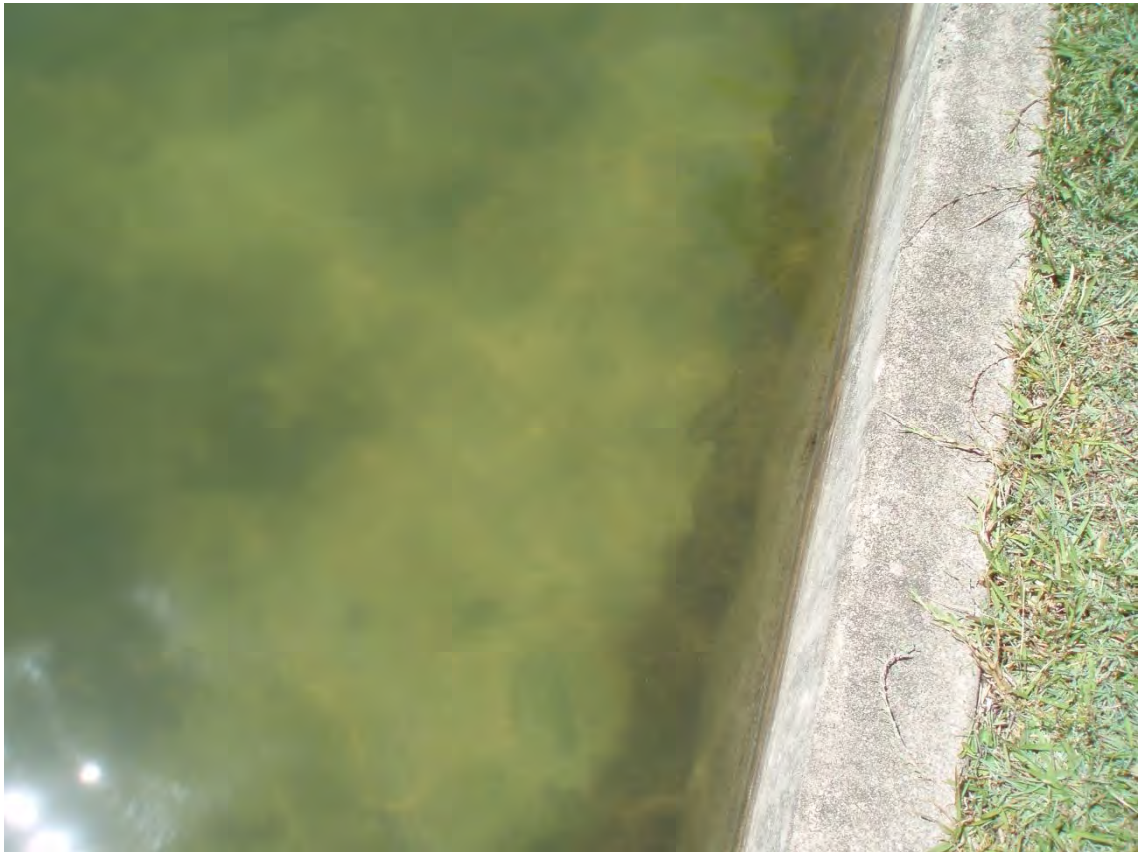
Currently 38 Saltwater Av is a vacant block so provided good access for the inspection of the revetment wall. The inspection identified that very little of the rock protection remained in front of the wall in the middle of the block with only a few scattered rocks remaining (Figure 2-4). Digging down into the sand at the toe of the wall no rock could be found to have settled through the sand and there was no presence of geotextile. Going further across the bank into deeper water none of the original rock protection could be found either. The batter material was mostly sand with some minor fines. The properties at 36 and 40 Saltwater Av both have added additional rock protection placed at the toe of their walls (Figure 2-5 & Figure 2-6).

Figure 2-4 No rock scour protection at toe of wall 38 Saltwater Av

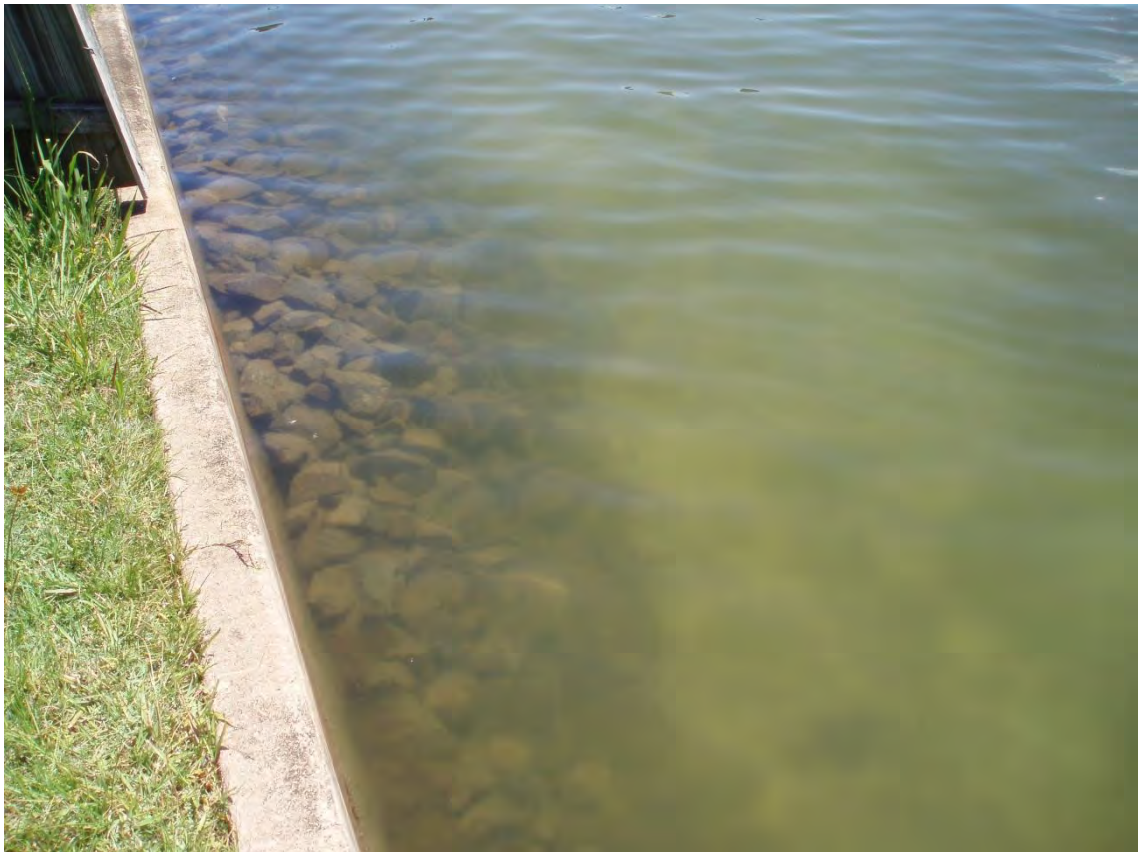
Figure 2-5 Additional Rock Scour Protection 40 Saltwater Av.

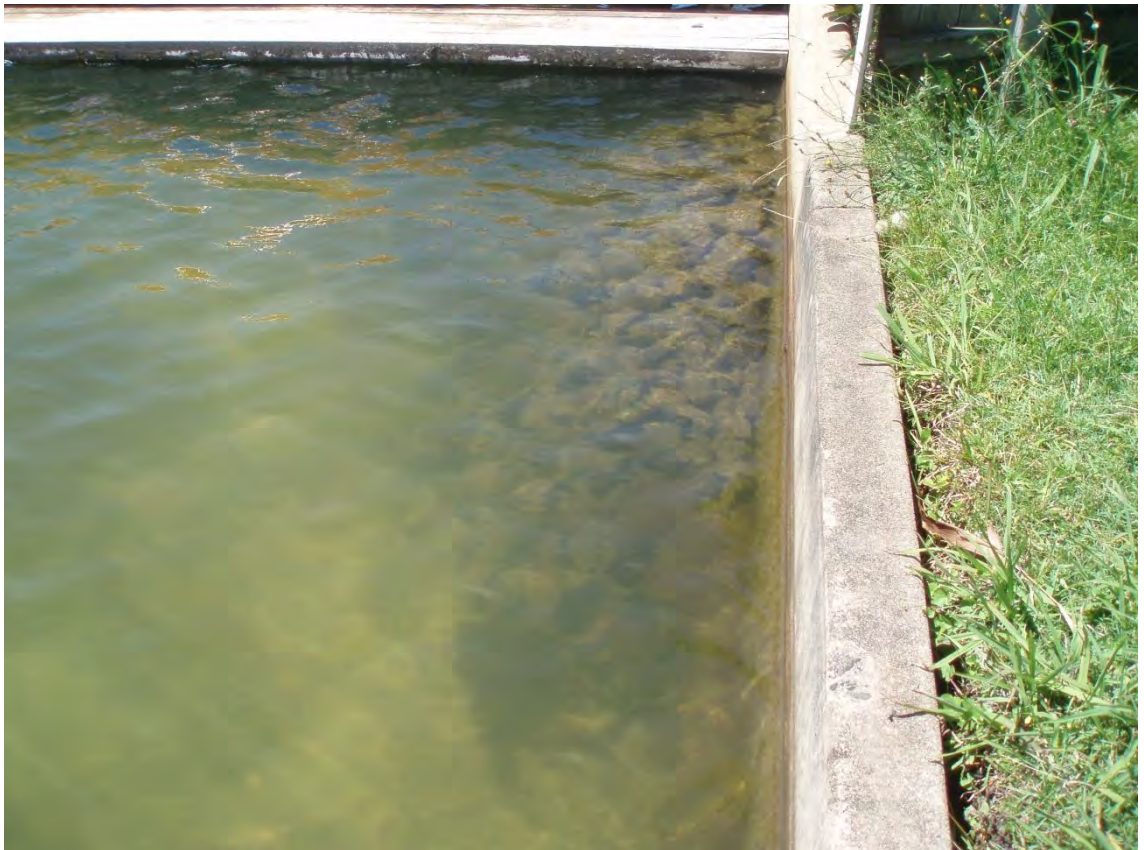
Figure 2-6 Additional Rock Scour Protection 36 Saltwater Av.

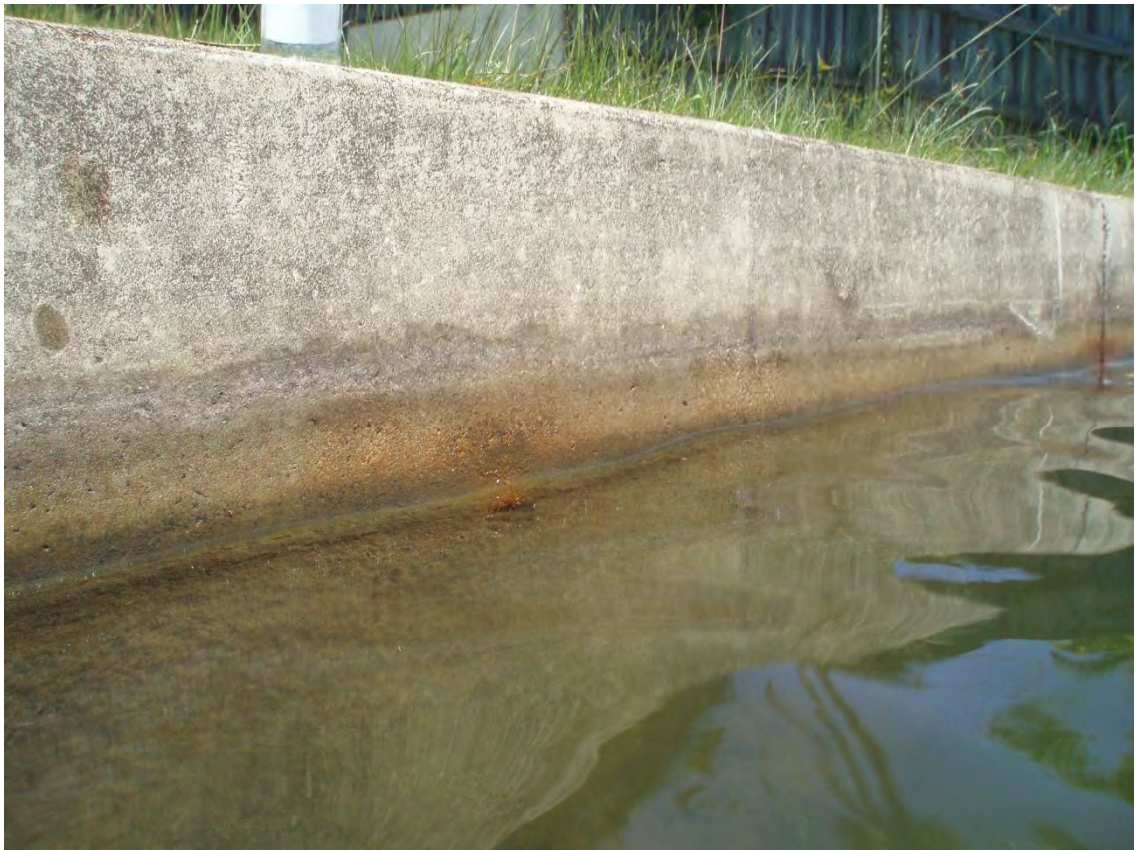
The entire wall in front of 38 has settled around 100 mm and the drainage holes are now just below the water surface. The toe level in front of the wall is approximately 300 mm below the design level but 150 mm or more of this could be accounted for due to the loss of the two layers of rock protection. Without rock protection at the toe of the wall, the toe of the wall is highly susceptible to scour and a couple of large scour holes have formed under the toe of the wall. With the drainage holes now below the water surface and no toe protection to protect against scour, the wall has begun to tilt forward slightly and potholes are forming at joins and drainage holes where material could be lost.

Figure 2-7 Wall sunken at 38 Saltwater Av, drainage holes are below water surface.

At 38 Saltwater Av the entire wall has settled approximately 100 mm such that the drainage holes are just below the water's surface and the wall is beginning to tilt forward slightly. The drainage holes are important to the stability of the structure as they allow water to drain from behind the wall. For this section of wall it would be recommended to install new drainage holes at the joints in the wall. Soil Surveys is currently undertaking further investigation as to the stability of this section of wall and will propose a site specific remediation option.

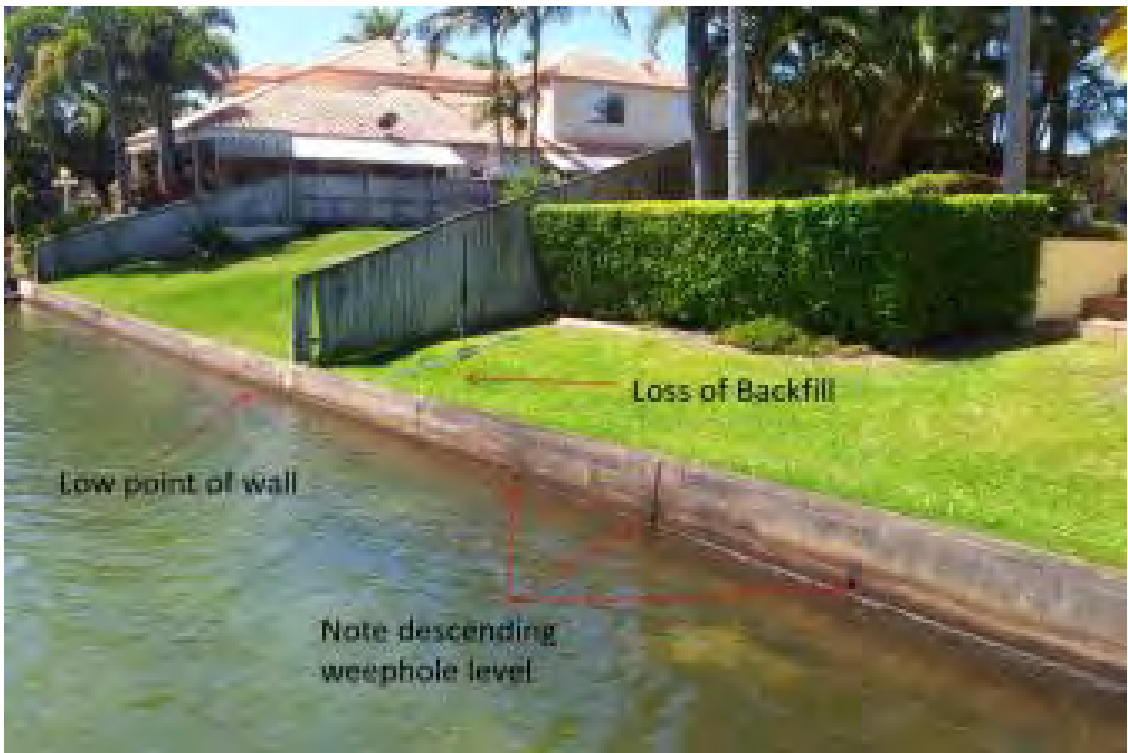
Figure 2-8 Sunken wall at 40 Saltwater Ave (Hall 2012).

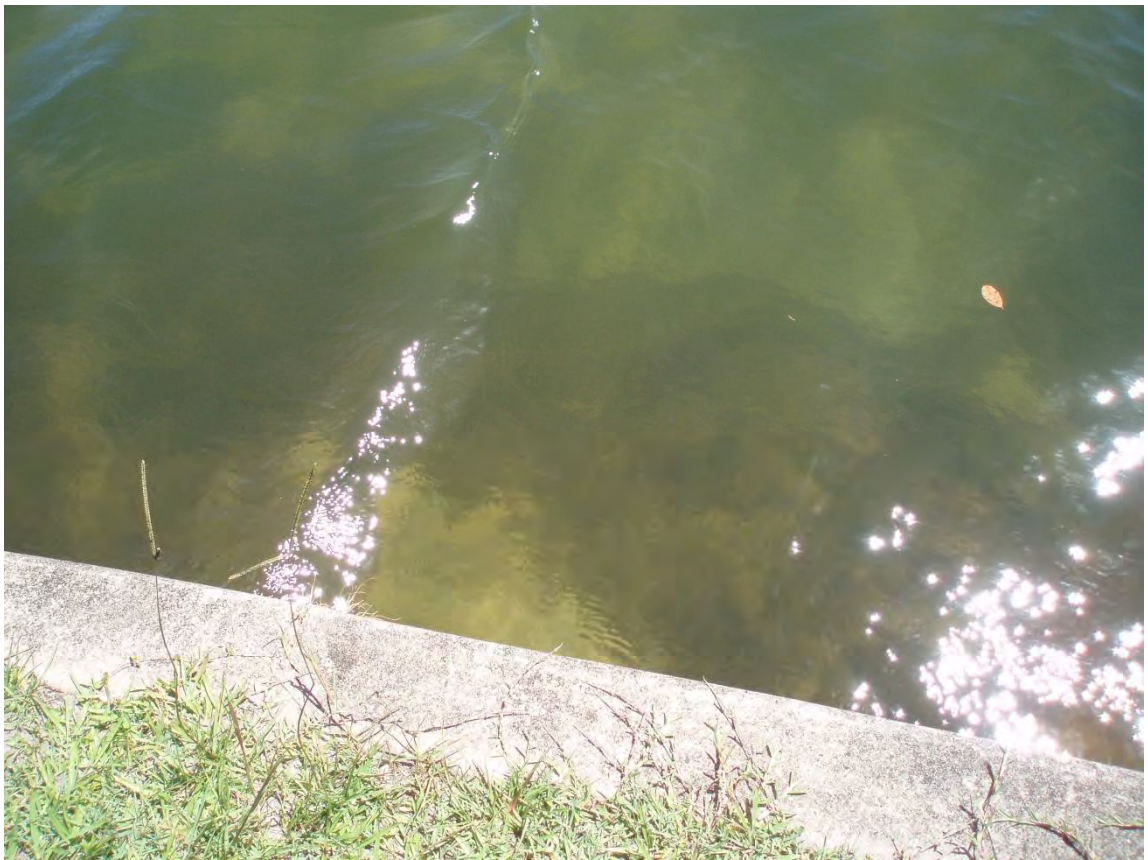
Figure 2-9 Section of scour protection moved slightly down toe.

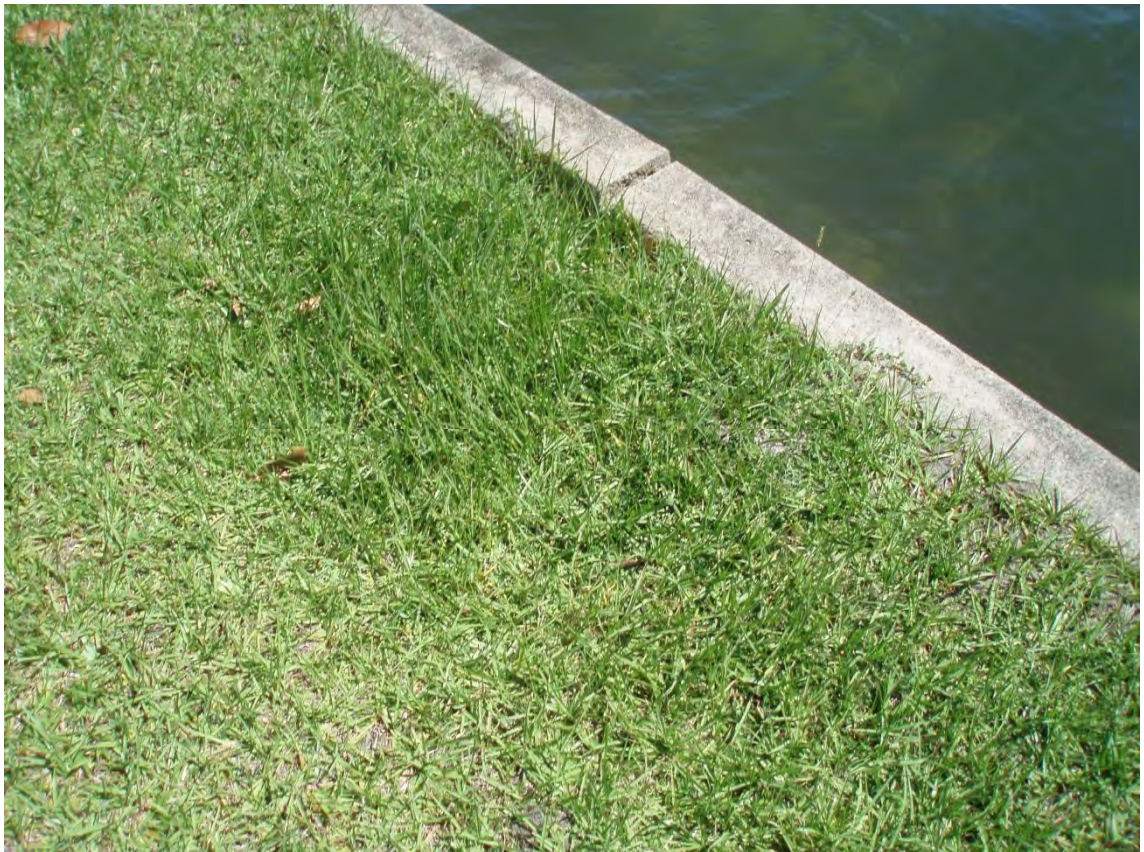
Figure 2-10 Potholing at drainage hole.

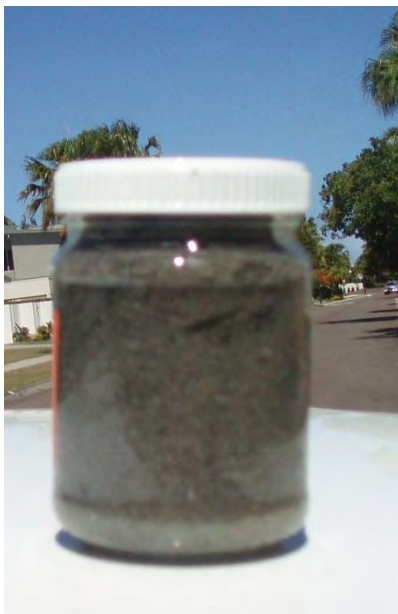
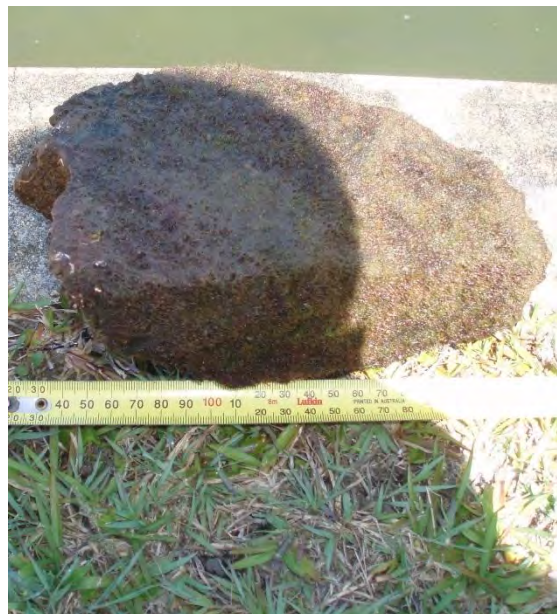
Figure 2-11 Sand with fines & Rock protection greater than 75mm .

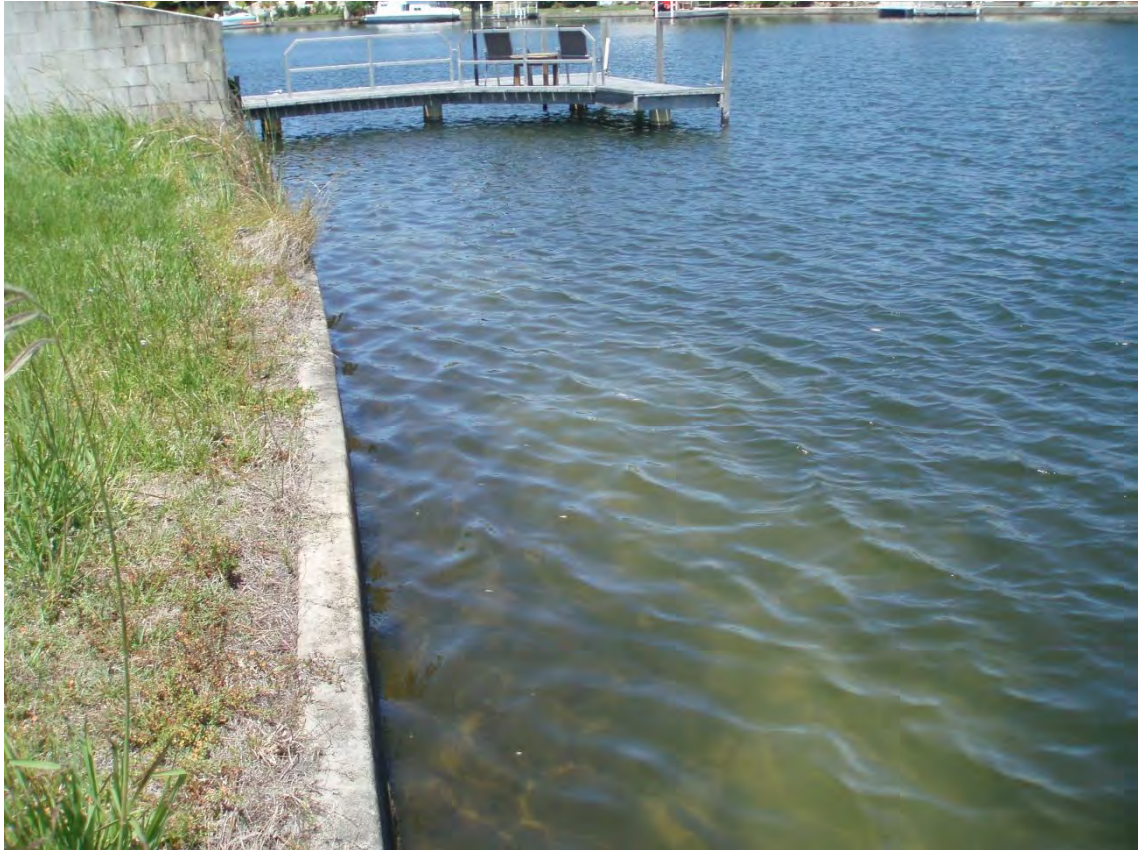
Figure 2-12 Topsail Place

Topsail Place was inspected at a couple of vacant blocks that existed. As with the three main sites, some sections of the toe are up to 300 mm below the original design levels. The rock scour protection was in place with a 1m strip from the toe of the wall (Figure 2-12). Only very minor potholing was occurring at the joints and it was not determined whether geotextile existed.

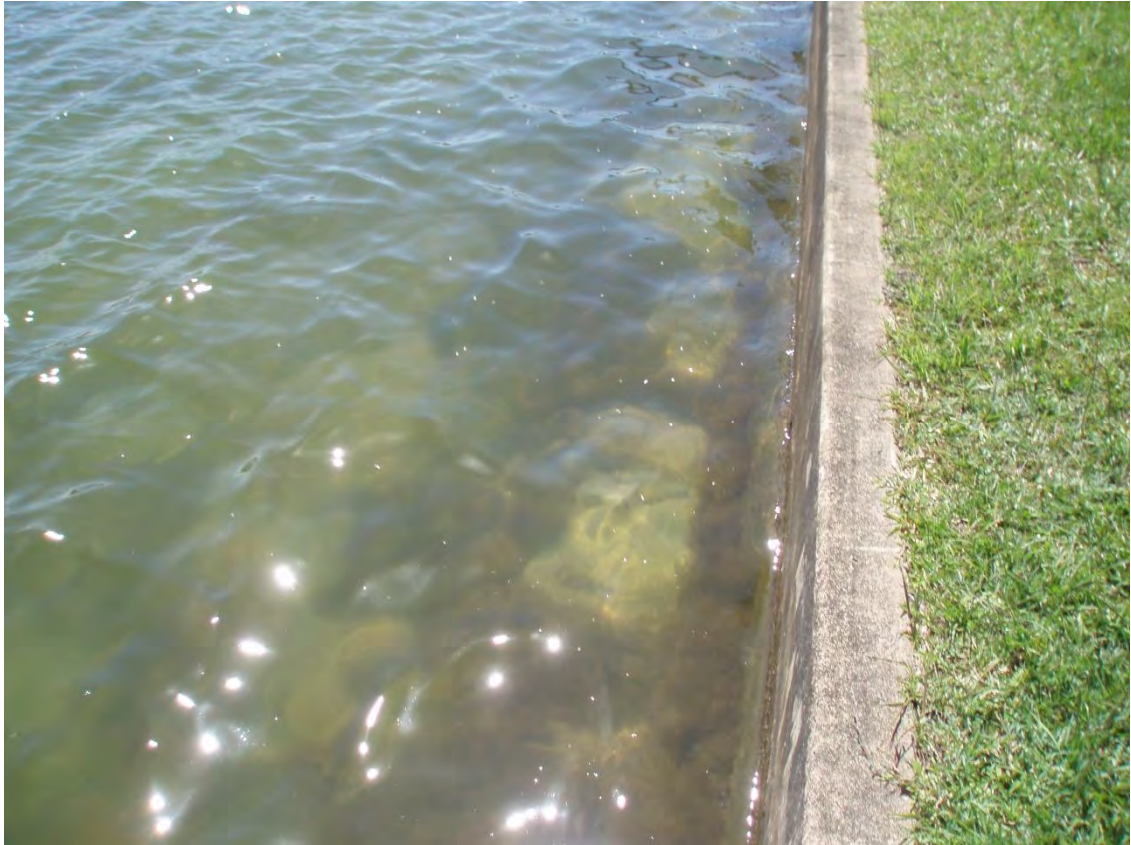
Figure 2-13 Seahorse Place.

Seahorse Place was inspected at a vacant block at 13 Seahorse Place. In some locations the toe is approximately 100 mm below the original design level. Some of the scour protection had been displaced in front of the wall (Figure 2-13). Only very minor potholing was occurring at the joints and it was not determined whether geotextile existed.

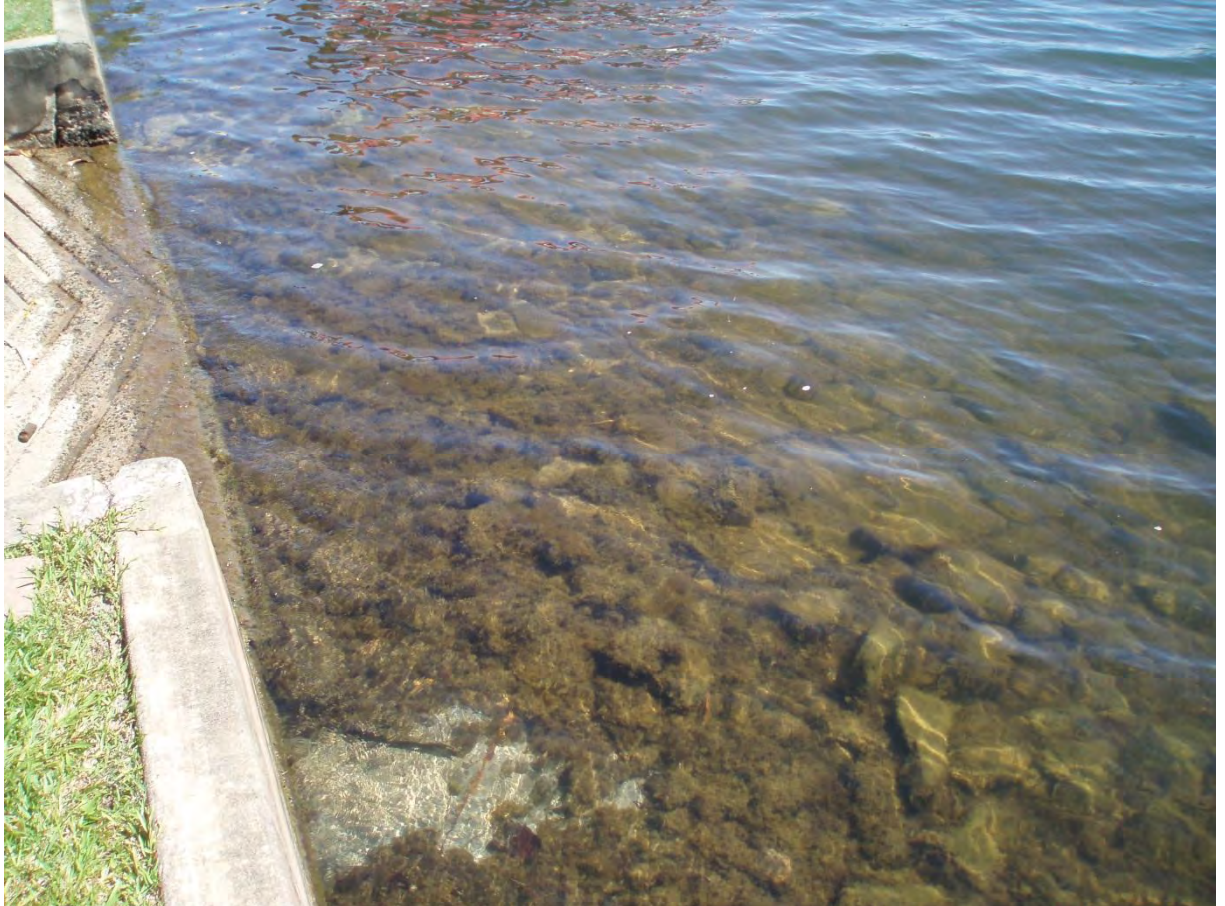
The wall at Waterside Court was inspected from a park. At this location a flexible concrete mat boatramp had been constructed extending into the water. There was 3+m of rock scour protection at the toe of the ramp and no measureable settlement of the wall (Figure 2-14). There appeared to be no geotextile extending out from under the boat ramp and it was not determined whether there was geotextile under the scour protection. This section of wall generally is in good condition and does not require any maintenance work.

Figure 2-14 Waterside Court flexible concrete mat boat ramp
