161059/1-B ku:PS
29 November 2016

**RE: PROPOSED INTEGRATED TOURIST FACILITY - 24 & 25 BOX STREET BUDERIM
PEER REVIEW OF REPORT BY CORE CONSULTANTS PTY LTD**

161059/1-C ps:ps
16 May 2017

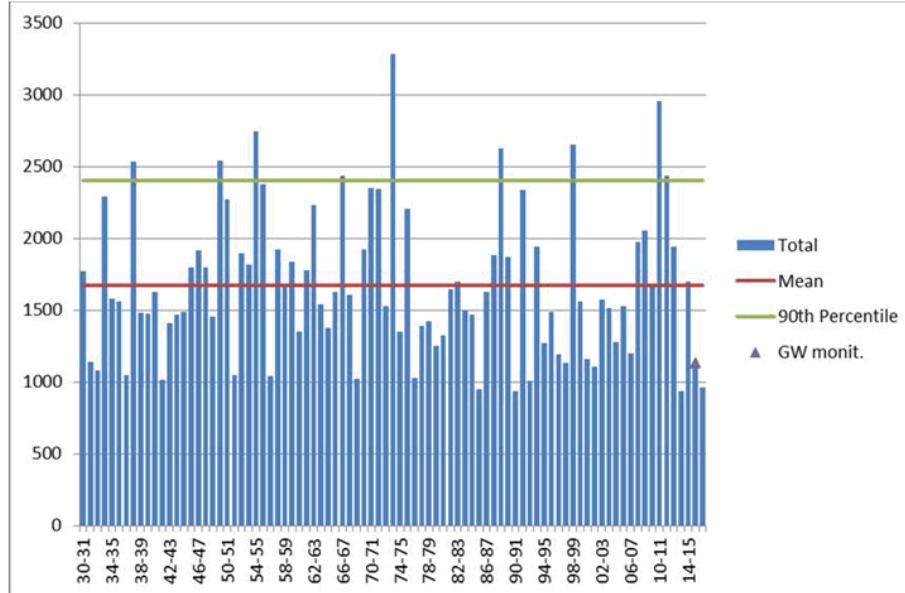
Figure 2 – Annual Rainfall (Palmwoods)

- The assumed groundwater conditions appear to be based largely on groundwater monitoring in September 2015, which Core Consultants indicate (p13) is after 80% of the annual rainfall (at Sunshine Coast Airport). However, referring to rainfall records over a much longer period from Palmwoods (refer Figure 2 below, plotted with rainfall as July-June so that summer rainfall is reported in the same year), the investigation and groundwater monitoring has occurred in a series of years of average or well below average rainfalls. As highlighted in the previous Coffey & Partners reports, because of the fissuring in the Tertiary clays the groundwater levels can rise rapidly in response to rainfall. It is likely that the groundwater levels are highly responsive to rainfall, and undertaking one or two discrete readings is prone to underestimate the likely reasonable extreme case condition that might be experienced.

With this in mind, whilst it would be preferable to obtain groundwater levels over a much longer period including at least one summer of above average rainfall, there should preferably at least be continuous groundwater level monitoring (using in borehole data loggers) in selected key locations with close examination following significant rainfall events.

At the current preliminary phase, it would be at least prudent to adopt more elevated groundwater conditions to be more representative of the 90th percentile case rainfall events (which last occurred in 2010/2011 and 2011/2012 years) to understand the magnitude (and economic viability) of works required to deal with likely extreme rainfall conditions. It is expected that it will be necessary to give detailed consideration to a groundwater control system (and proposed discharge options/approaches) for the project which may be required to cope with significant flows during and after significant rainfall events.

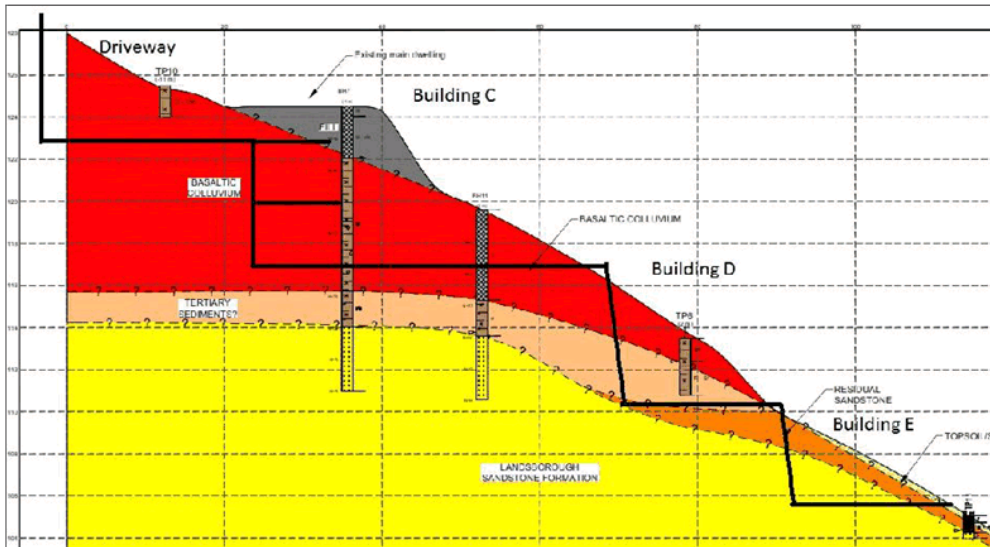
Figure 3 – Building C Excavation Ground Profile

Sediments around RL 116 and Sandstone around RL 114. It is reasonably likely that Building C will require a grid of bored pile foundations into the Sandstone, and these measure will provide a significant stabilising influence for this part of the slope. The Building C basement wall will provide a significant engineering structure to support the slope in that location. The Building D retaining walls will likely require quite extensive engineering measures with continuous positive support (eg soldier pile bored pile wall) because of the presence of the Tertiary Sediments in that location. Given the above, it seems it should be reasonably practical in this part of the site to provide measures that will provide a safety factor of 1.5 for stability.
