S.S. *Dicky* Archaeological Management Planning Documentation

Heritage Impact Assessment

S.S. Dicky

May 2015

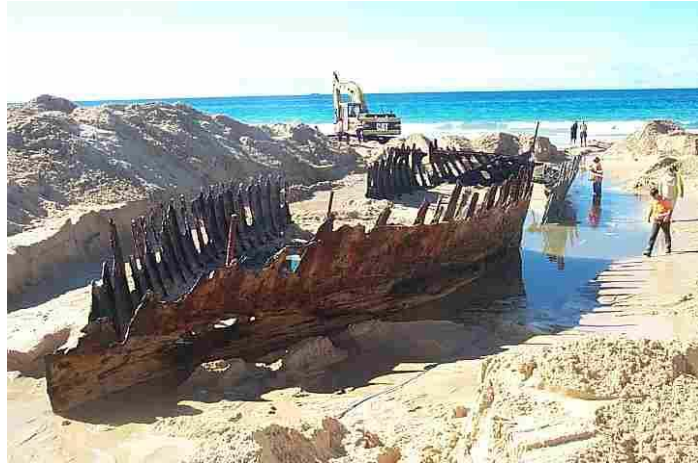
Figure 2. The S.S. Dicky excavated for the purpose of applying fish oil for conservation, July 2006. (Source: John Waldron)

In 2006 SCC exposed the wreck down to the turn of the bilge and applied a fish oil treatment to the exposed hull of the S.S. *Dicky* (Figure 2). This treatment followed advice from conservators at the Western Australian Museum in an attempt to slow down corrosion.

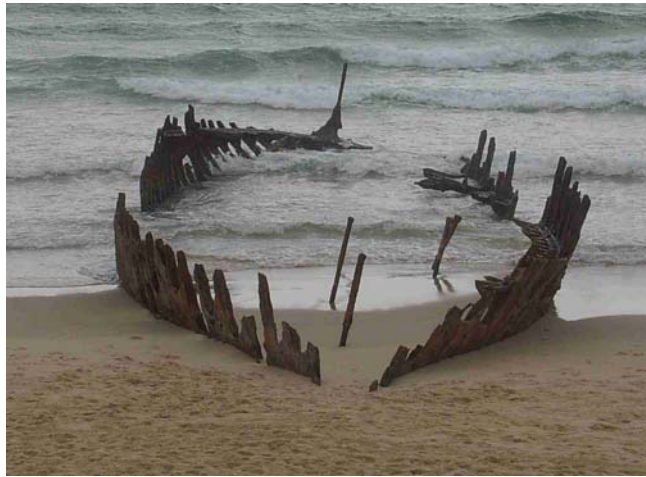
Figure 3. S.S. Dicky, early morning on 17th October 2007 during wreck inspection. (Source: Cosmos Archaeology)

Cosmos Archaeology was asked to undertake and prepare a Management and Interpretation Plan for the S.S. *Dicky* shipwreck in 2007 by the SCC (then the Caloundra City Council) (Figure 3).⁴ This was in response to the desire for remains of the wreck to persist as an important social element and landmark for Caloundra. The management plan suggested a preferred option of applying fish oil and cathodic protection to the wreck as well as supporting the rudder post at the stern.

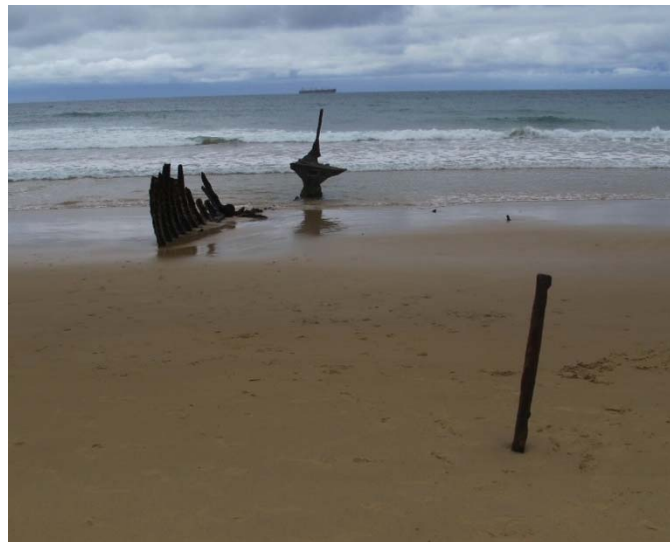
Figure 10. Exposed elements of S.S. Dicky at 11:00am, before excavation; facing NE towards stern.
(Cosmos Archaeology 28th April, 2014)

Most recent observations during the 2014 test excavation observed that only a portion of the starboard of the stern end of the wreck were exposed above sand level, similar to 2013. Exposed sections of the wreck included the sternpost to below the turn of the bilge, a section of the hull along the starboard side towards the stern, one stanchion, the tops of two frames at sand level along the port side and the tops of three other frames (Figure 10 and Figure 11).²⁴ The rudder post was still the most prominent and highest point of the wreck. The base of the rudder post had been cut away, likely during the removal of the propeller in 1963, and the weight of the post is taken by a connection with the keel.

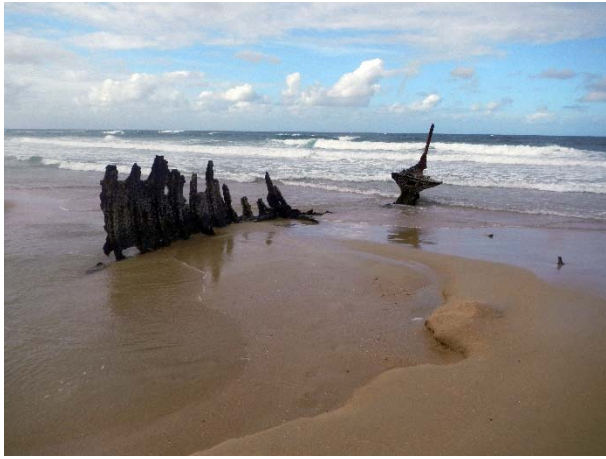
Figure 12. Exposed hull and stern section of the wreck; facing NE towards stern. (Cosmos Archaeology 28th April, 2014)

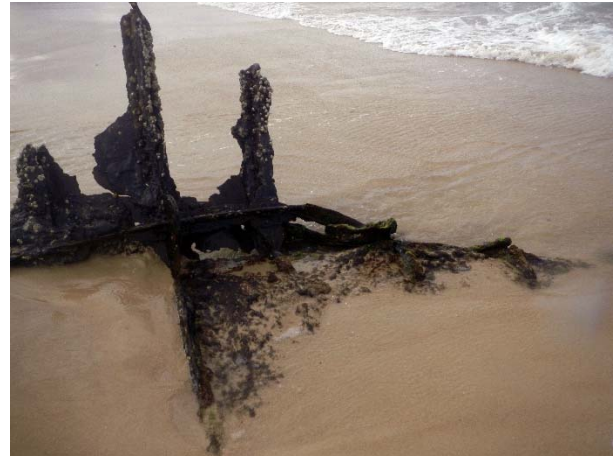
Figure 13. Stringer and perpendicular frame in the section of exposed hull; facing N. The stringer shows evidence of a bend towards the stern side (right side). (Cosmos Archaeology 28th April, 2014)

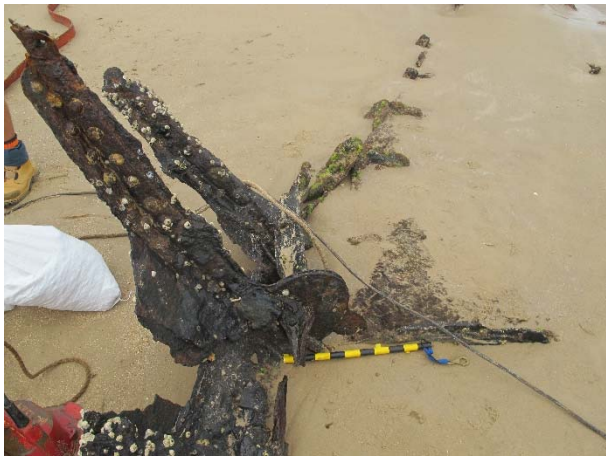
Figure 14. Looking along the only visible stringer, showing a break where it has weathered away and a perpendicular frame (parallel to the scale, 50 mm increments) extending from a frame; facing E. (Cosmos Archaeology 28th April, 2014)

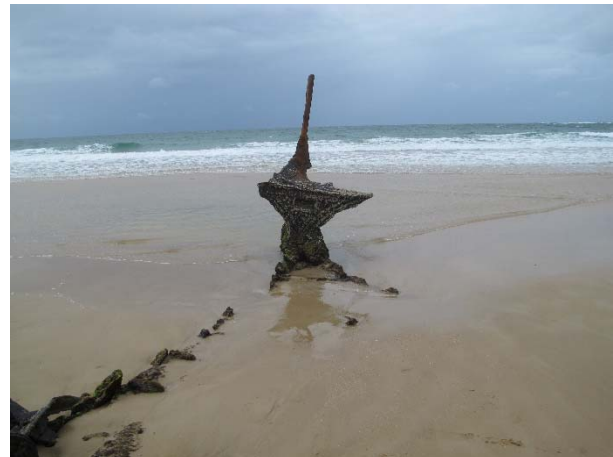
Figure 15. Stern section of the wreck with the tops of four broken frames where a section of hull has been removed (left of the stern section); facing NE. (Cosmos Archaeology 28th April, 2014)

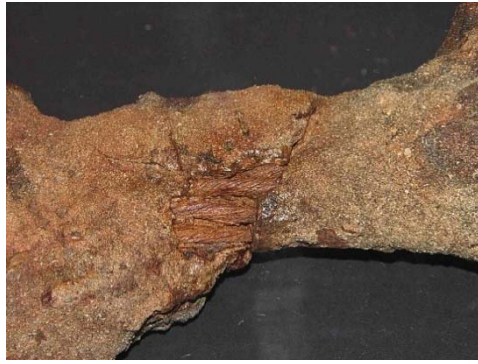
Figure 20. Close up of the steel cable under glass at the Dicky Beach Surf Club (Cosmos Archaeology, October 2007).

A concreted coil of steel cable is displayed, untreated, under glass in the Dicky Beach Surf Club (Figure 20). This item was donated to the Club by the Wilson family, who had recovered it from the wreck after a cyclone in the mid-1970s. Also at the Club is a scale model of the S.S. *Dicky* on display in a glass cabinet (Figure 21). The model, constructed by Neil Dowsett in 1984, is made of timber and fibreglass with the hand railings made from grass.⁵¹ The model is 10 kg in weight, 640 mm long and 140 mm wide. It was built using information from photographs, records held by the Harbours and Marine Department and the State Archives.⁵²

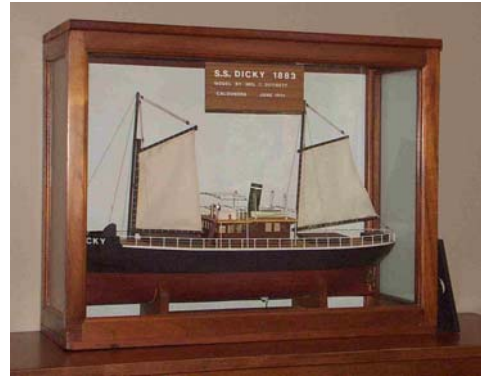
Figure 21. Neil Dowsett's model of the S.S. Dicky on display in the Dicky Beach Surf Club (Cosmos Archaeology, October 2007).

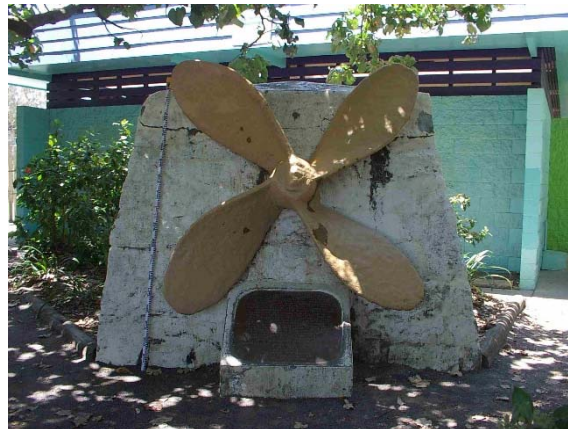
Figure 22. The propeller mounted onto a monument for the S.S. Dicky at Dicky Beach Carpark. (Cosmos Archaeology, October 2007).

The propeller of the S.S. Dicky, recovered in 1963, is mounted on a stone cairn in the Dicky Beach Carpark (Figure 22). The monument is located adjacent to the car park toilets and is shaded by a large fig tree for most of the morning and early afternoon. The cairn, and the block under the propeller upon which a plaque is mounted, are painted white. The propeller itself measures approximately 1.5 m across and is coated with two layers of fibreglass (Figure 23). Signs of rust weeping from the cracks in the fibreglass show that the propeller is made of iron, the pitting in the surface of the object point to it being cast iron (Figure 24). It is unlikely that the propeller underwent any conservation treatment prior to being coated – initially it is assumed with paint – and then with fibreglass.⁵³

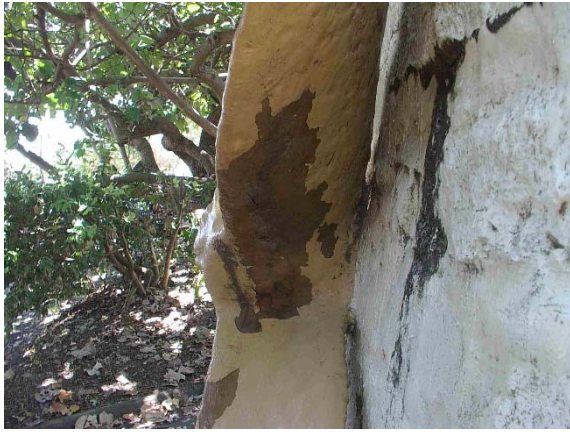
Figure 23. Detail of the layers of fibreglass coating for the propeller at Dicky Beach Carpark. (Cosmos Archaeology, October 2007)

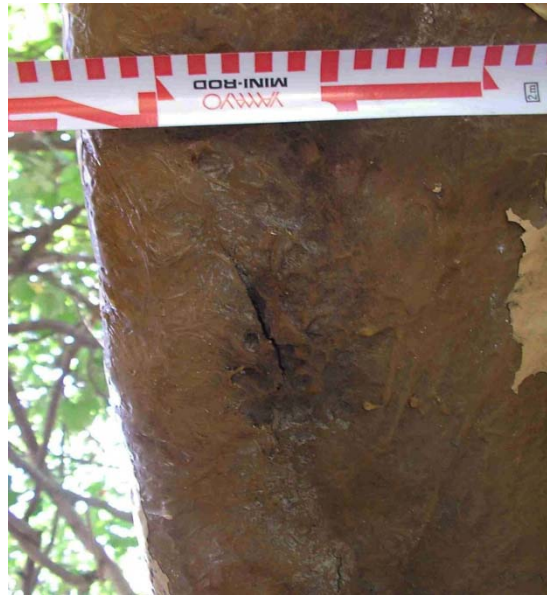
Figure 24. Crack in the fibreglass coating for the propeller at Dicky Beach Carpark. (Cosmos Archaeology, October 2007)

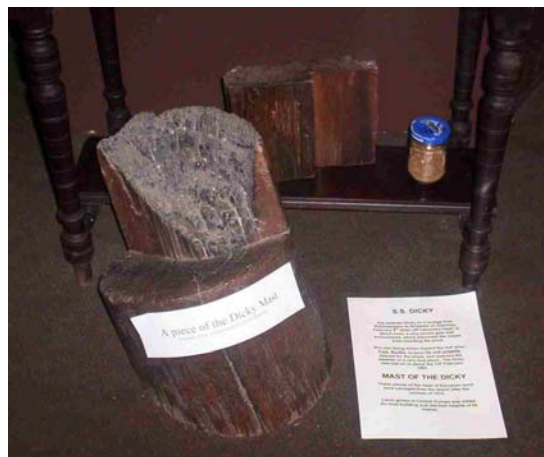
Figure 25. Sawn off fragment of mast from the S.S. *Dicky*, Landsborough Historical Society. (Cosmos Archaeology, October 2007).

The Landsborough Historical Society Museum displays a sawn off section of what has been identified as a mast from the S.S. *Dicky*. This piece was recovered from the wreck after the 1974 cyclones.⁵⁴

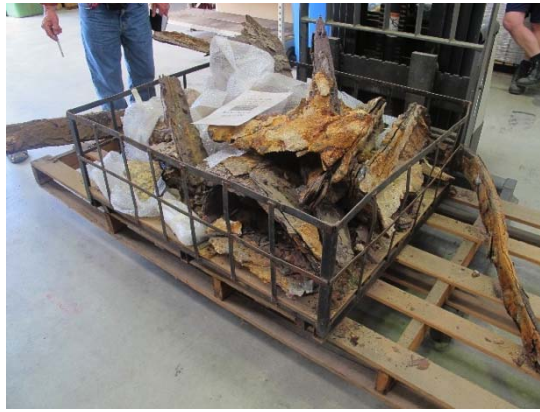
Figure 26. Artefacts in storage at the SCC Depot.
(Cosmos Archaeology, 26 September, 2014)

Iron hull components of the S.S. *Dicky* are also stored in the SCC Depot (Figure 26). This includes a pallet of objects recovered from the site during and after the application of fish oil on the wreck in mid-2006. It appears that these artefacts have not undergone any conservation treatment and are actively rusting.⁵⁵

Most of the objects appear to be from the bow area; the longest piece, approximately 3.7 m in length, being the stem post. The stem bar is approximately 130 mm wide with a surviving core of 30 mm thickness, or 50 mm thickness if the remains of possible hull plating are included. Rivets in a zigzag configuration and approximately 27 mm in diameter at the head. One end of the stem bar has a heavily concreted bolt through it. No measurements possible. The approximate length of the stem bar piece is 3.5 m. A loose piece of stem bar, broken off, has rivet head thickness of 10 mm, although this may actually be exposed shaft of the rivet. This piece tapers to a rounded point at one end, similar to one end of the longer piece, suggesting that they were connected at this point but it was worn down by wave/wind action and snapped (Figure 27). The small piece of stem bar is approximately 1.5 m long, giving a total of approximately 5 m. The stem bar appears to taper in other areas, although this may be an effect of corrosion. Other measurements of width include 150 mm and 120 mm.

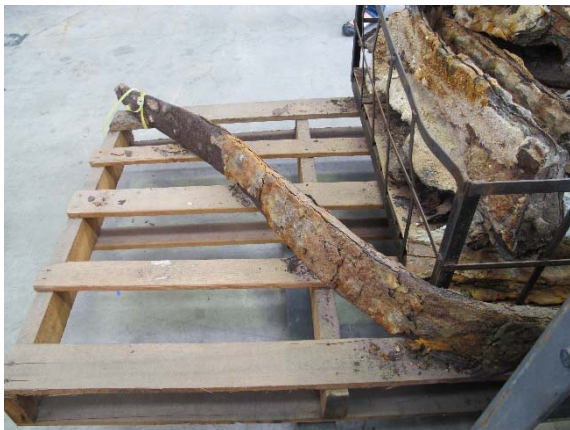
Figure 27. Corroded tapered end of the stem post at the SCC Depot. (Cosmos Archaeology, 26 September, 2014)

The remains of the hull plating riveted to the stem post are present. There are also segments of hull frames and built knees which were reportedly knocked off the wreck from the port stern area during the process of sand removal (Figure 28).

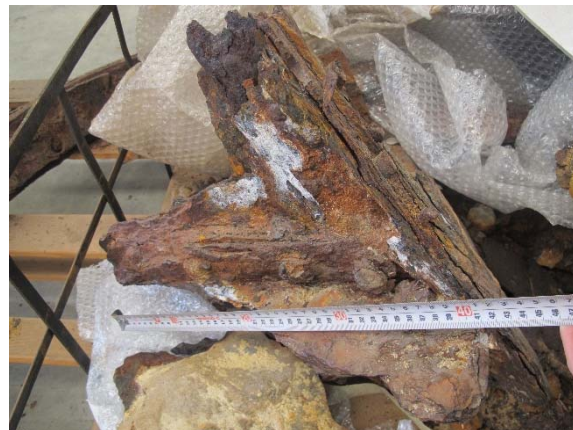
Figure 28. One of the knees at the SCC Depot. (Cosmos Archaeology, 26 September, 2014).

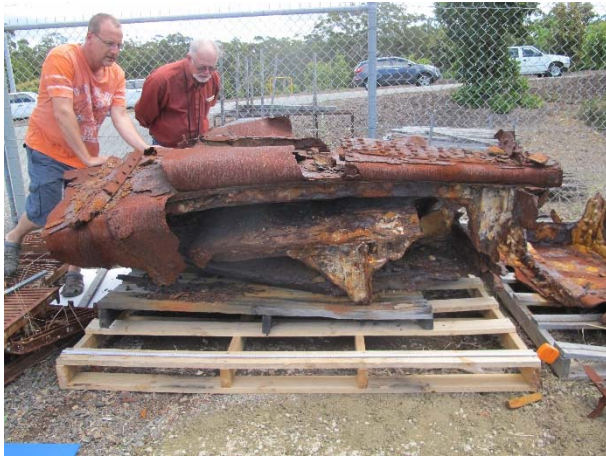
Figure 29. First hull piece, folded over, with five frames inside. (Cosmos Archaeology, 26 September, 2014)

The Depot also houses two large hull pieces that were found buried and loose near the wreck. These are in surprisingly good condition. The largest piece is approximately 1.8 m x 1 m x 0.8 m in size and appears to be a higher piece of hull – unknown side – which has been folded in half (Figure 29). This first piece contains five frames on inside surrounded by hull, with more hull bent over the top. The inside frames also have knees and a deck frame (Figure 30).

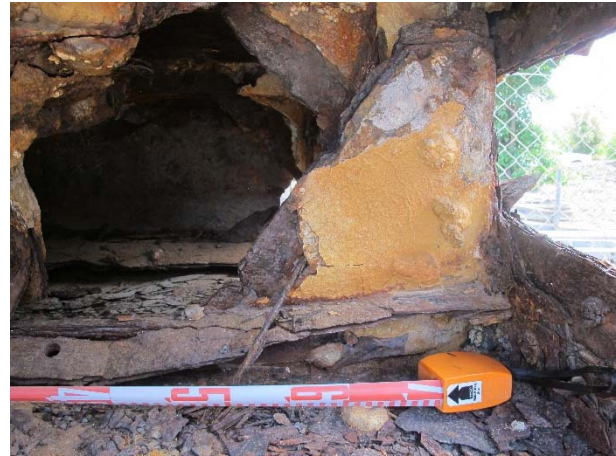
Figure 30. Close up view of one of the knees and frames inside the first hull piece. (Cosmos Archaeology, 26 September, 2014)

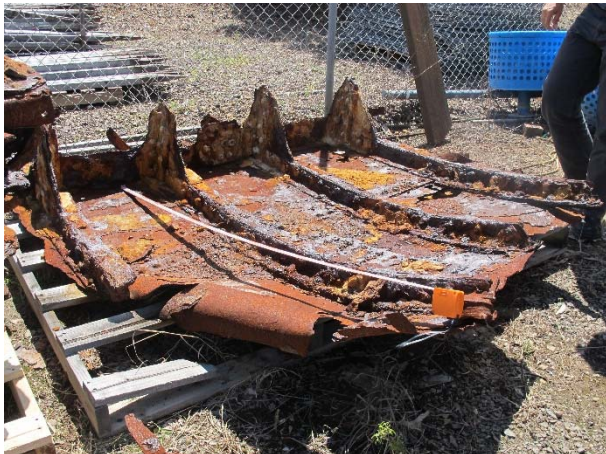
Figure 31. Second hull piece with four frames and knees. (Cosmos Archaeology, 26 September, 2014)

The second piece is a 'flat' piece with hull measuring approximately 1.8 m by 1.7 m with four frames, deck knees and deck planking (Figure 31). There is also a butt strap between two frames. Overlap and riveting of hull plating is obvious. The hull piece is of quite good condition. A slight curve was observed to the piece suggesting that the curve is towards the turn of the bilge and that the knees are hanging knees (Figure 32 and Figure 33).

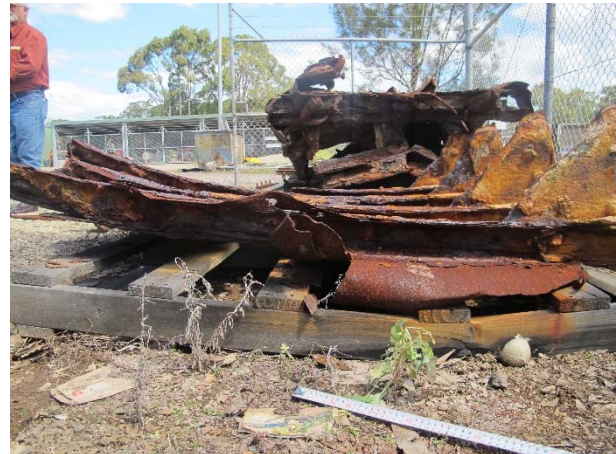
Figure 32. Second hull piece, showing a slight curve. (Cosmos Archaeology, 26 September, 2014)

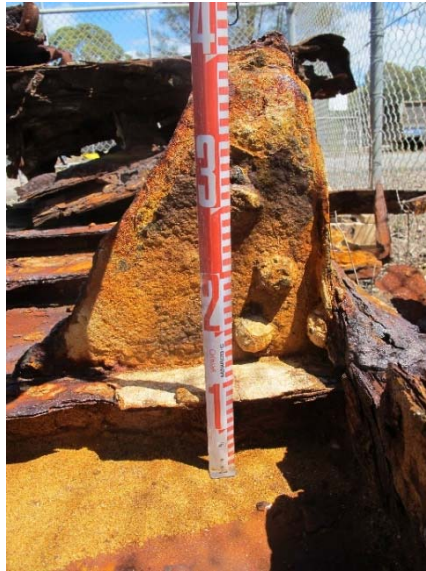
Figure 33. Close up of one of the hanging deck knees. (Cosmos Archaeology, 26 September, 2014)

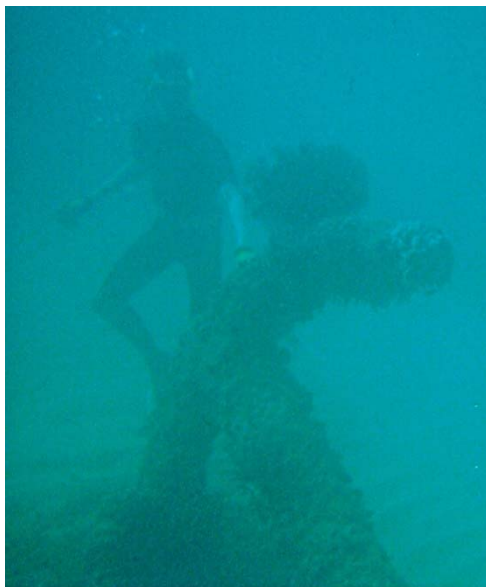
**Figure 35. Admiralty Pattern anchor
150 m offshore from the S.S. *Dicky*.**
(Source: Tristan Muir)

An anchor, reportedly associated with the S.S. *Dicky* is located approximately 150 m directly offshore from the wreck of the S.S. *Dicky* and is what appears to be a large Admiralty Pattern anchor with an iron stock (Figure 35). It is reported to be the kedge anchor used in the attempts to refloat the vessel.⁵⁶ This appears likely as there is no report of the master of the S.S. *Dicky* dropping his anchor in order to prevent the vessel from coming ashore.

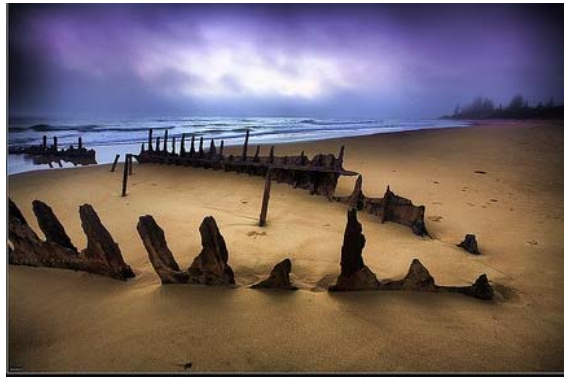
Figure 36. The wreck of the S.S. *Dicky* late October or early November 2007. (Source: Garry' – uploaded onto *Flickr* on November 2, 2007)

In 2008, the wreck of the S.S. *Dicky* was a shipwreck archetype. The twin rows of frames with the upright rudder post protruding from golden sand just beyond the crashing waves on a long sweep of beach, combined to form an image that is universally recognisable and iconic. The contrasts between light and dark, the transient and the seemingly immovable, straight lines and curves, the tensions between culture and nature were what attract the photographer (Figure 36).

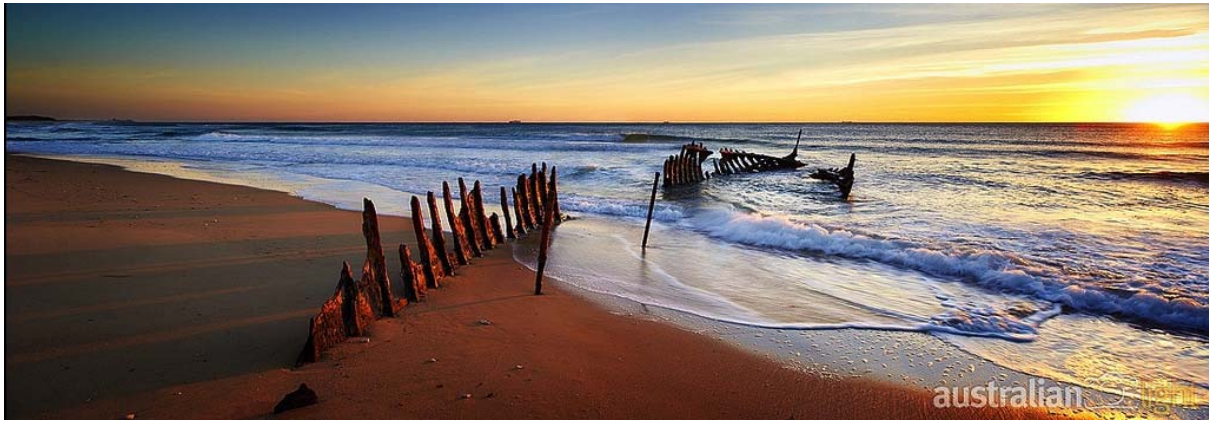
Figure 38. S.S. Dicky at sunrise, showing approximately the most degraded state the wreck appears in the Flickr results. (Source: Bernie Zajac – uploaded onto Flickr on 24 March, 2012).

The aesthetic qualities of the wreck of the S.S. *Dicky* are best demonstrated by a search of the Internet. On one web site alone, *Flickr*, there are approximately 90 images of the site posted between 2006 to November 2007 and over 250 images by October 2014, showing the wreck in a number of stages of deterioration but the majority taken when both port and starboard side hull was exposed (Figure 38). Another site features the *Dicky* in on-line computer art (Figure 39).

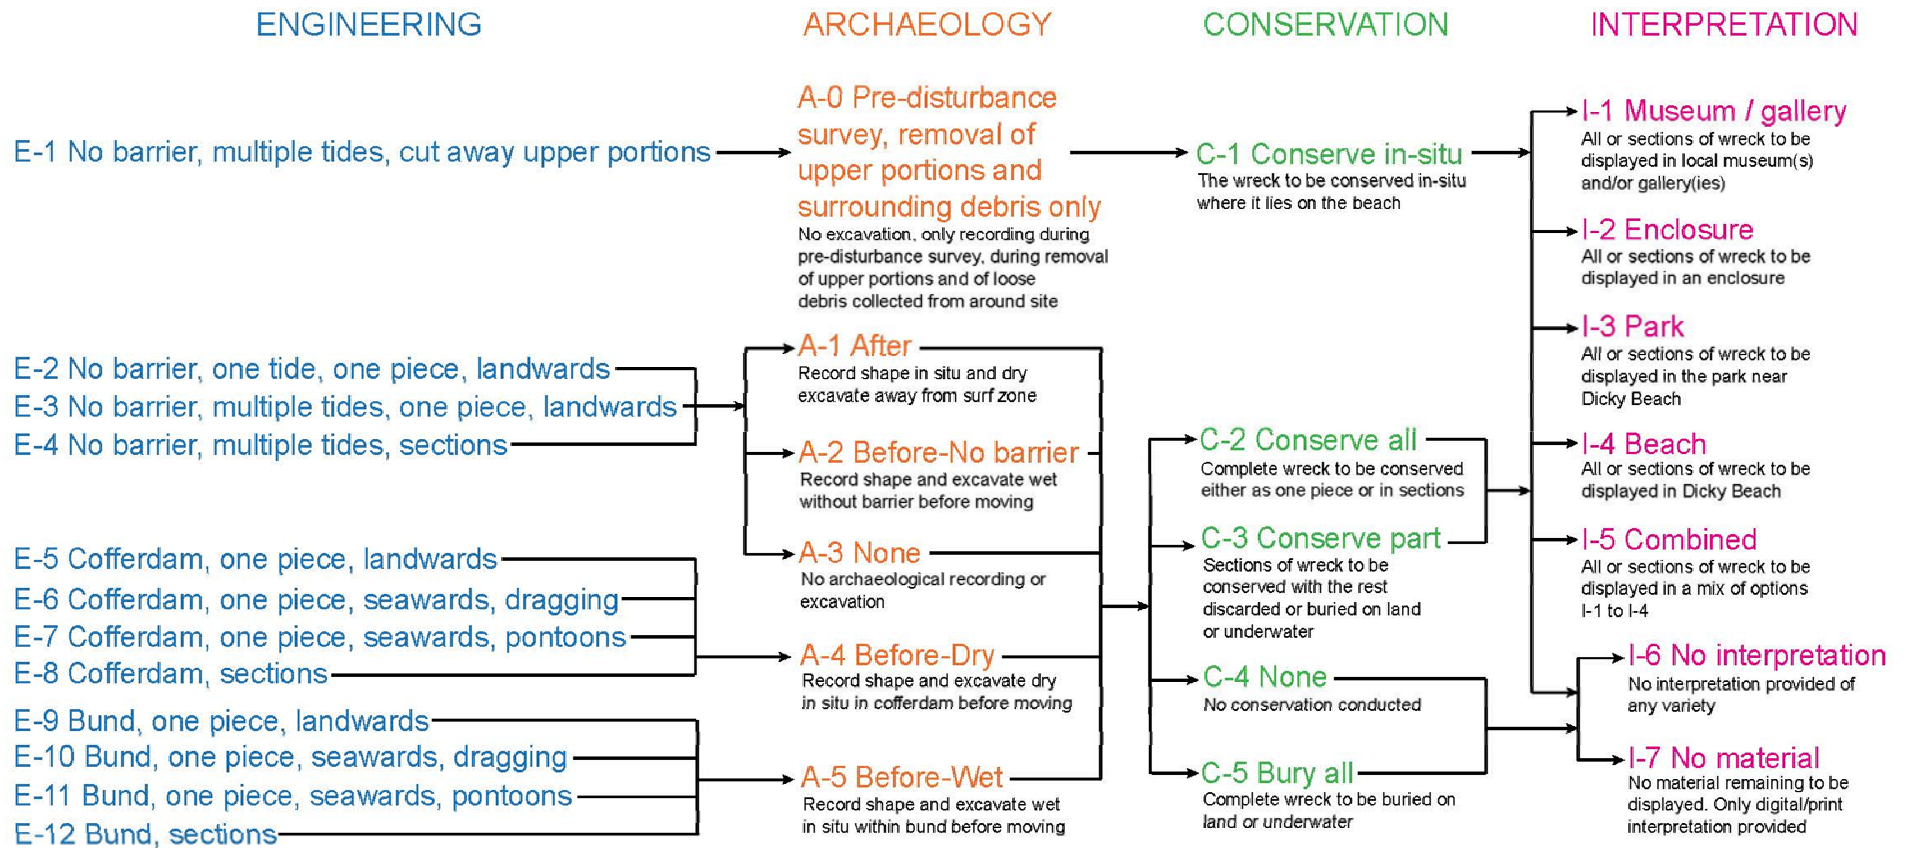
Figure 42. Flow chart of viable option combinations.

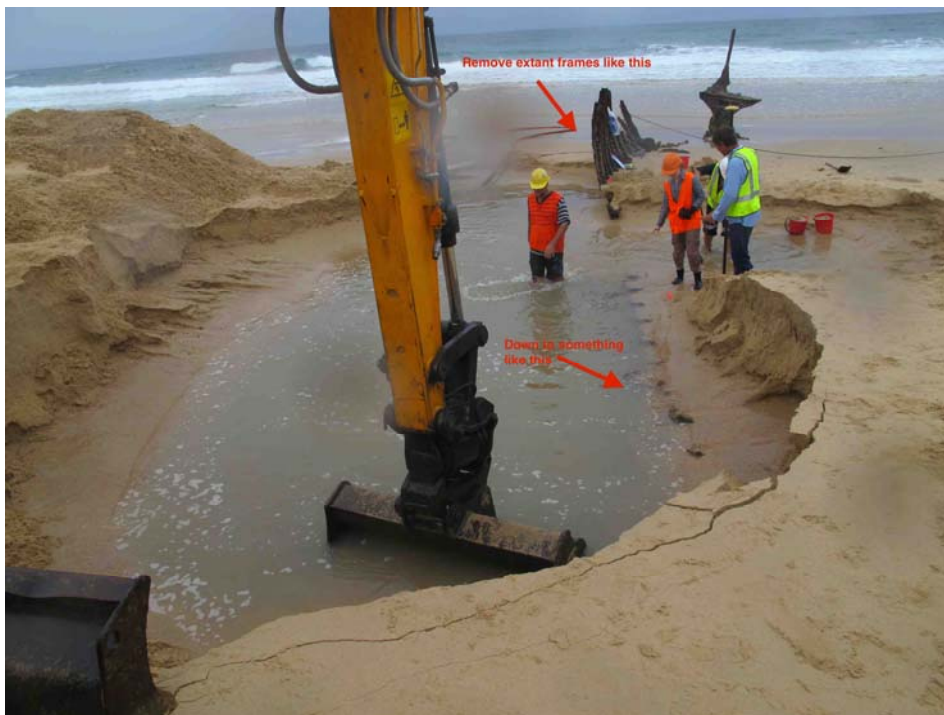
Figure 43. Example of where frames are to be cut down to on starboard side. The stubs in the foreground are the tips of the floors, the frames having been removed by recent storm surges. (Cosmos Archaeology, 28 April, 2014)

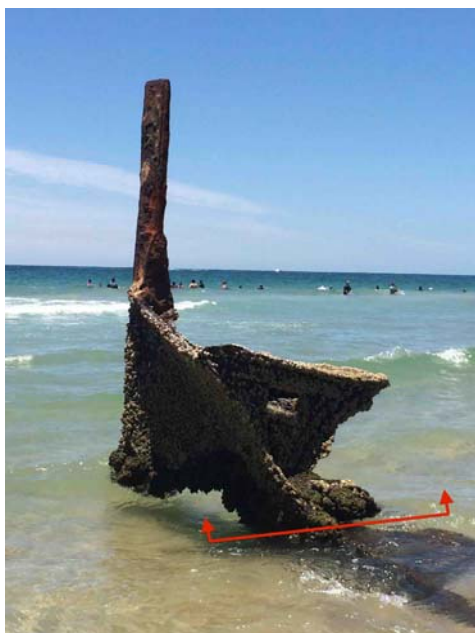
Figure 44. Indicative cut for the removal of the stern assembly. View from the starboard side. (Cosmos Archaeology, 19 December, 2014)

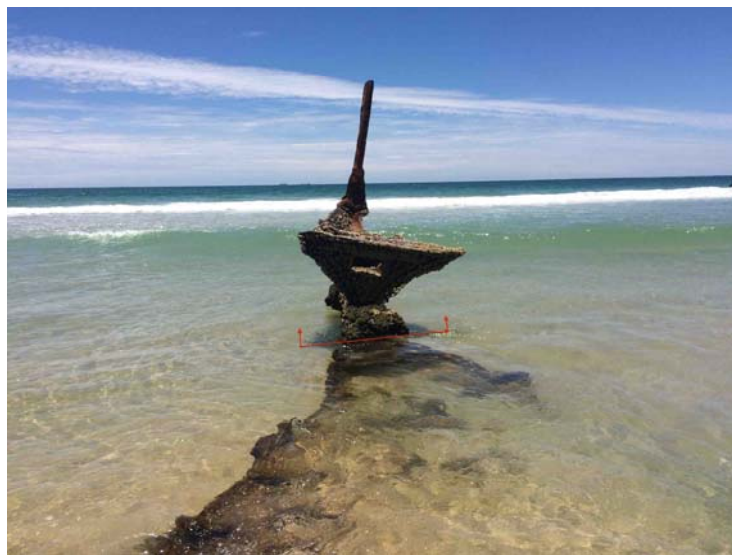
Figure 45. Indicative cut for the removal of the stern assembly. View from inside the wreck. (Cosmos Archaeology, 19 December, 2014)
