Golden Beach and Bribie Island Breakthrough - Options, Design, Approvals and Investment Plan Final Report

January 2015

Golden Beach and Bribie Island Breakthrough - Options, Design, Approvals and Investment Plan

Prepared for: Sunshine Coast Council

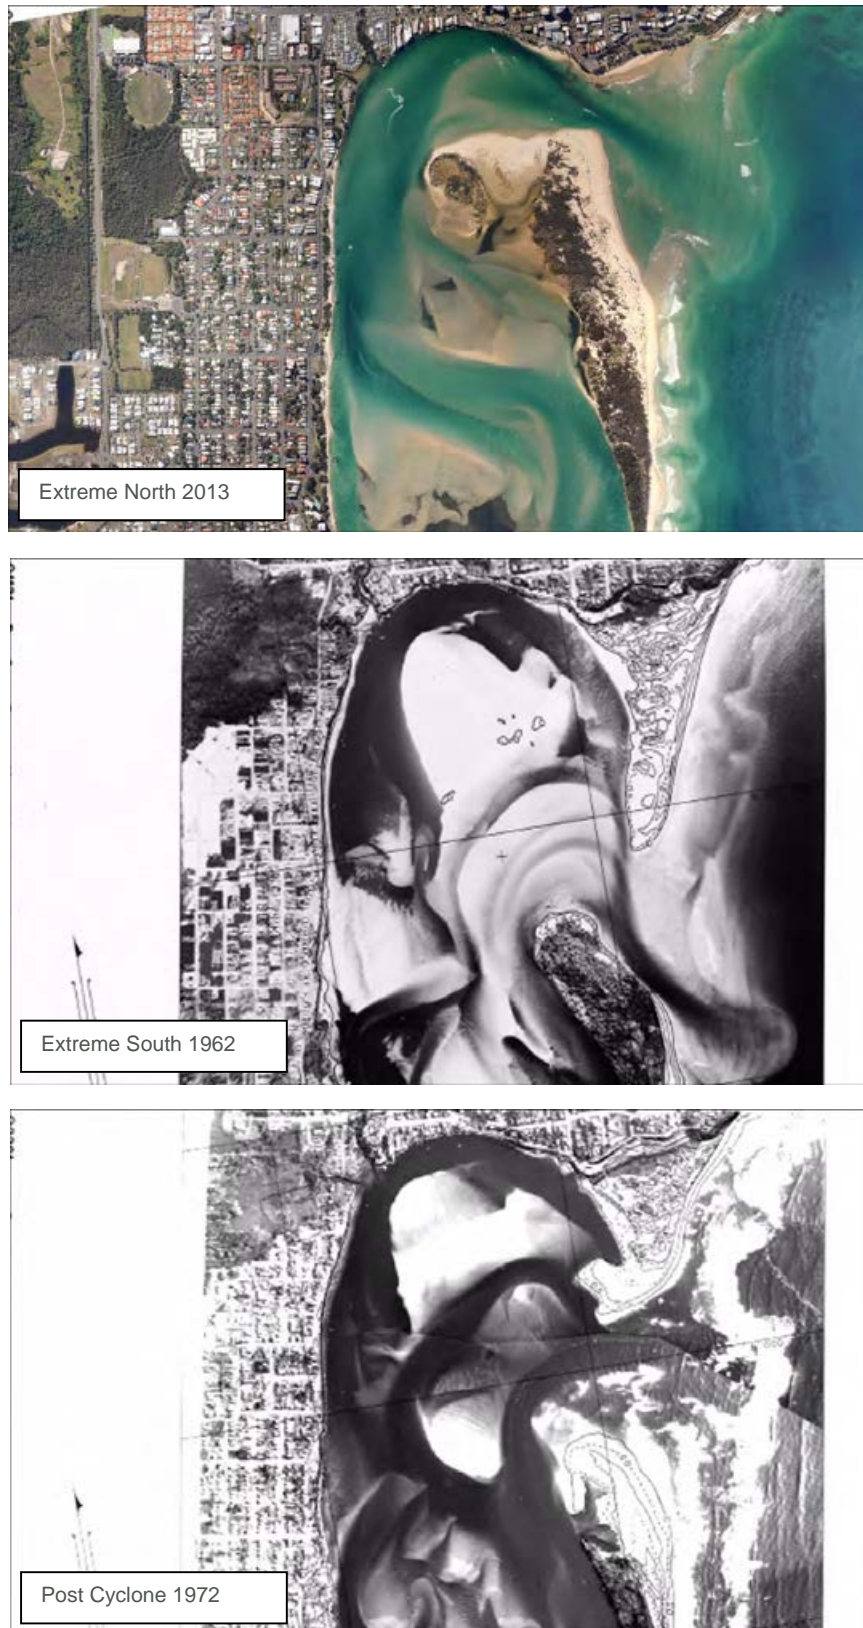
Figure 2-3 Observed Bribe Island Northern Spit and Caloundra Bar Position: Extreme North (top); Extreme South (middle); Post Cyclone (bottom)

Dramatic changes have been observed at the northern end of Bribie Island and Caloundra Bar since the regular capture of aerial photography commenced in 1940. Examples of the Bribie Island northern spit and Caloundra Bar locations are shown in Figure 2-3, showing 'extreme north' and 'extreme south' entrance positions and the condition following a period of significant tropical cyclone activity.

The available historical aerial photos show the entrance position migrating north and south over a range of approximately 1km. It is expected that narrowing and eventual breakthrough of the Bribie Island northern spit was the catalyst for a permanent entrance to form in the more southern position observed in 1962. In the decades that followed, the entrance slowly migrated north and has been in its present 'extreme north' position since the late 1990's. The entrance was observed to widen following a series of flood and severe wave events associated with tropical cyclone activity in the early 1970's. Riedel and Byrne (1979) suggest the temporary widened condition did not destroy the underlying cyclic movement of the entrance, which is primarily controlled by the migration channels within the passage.

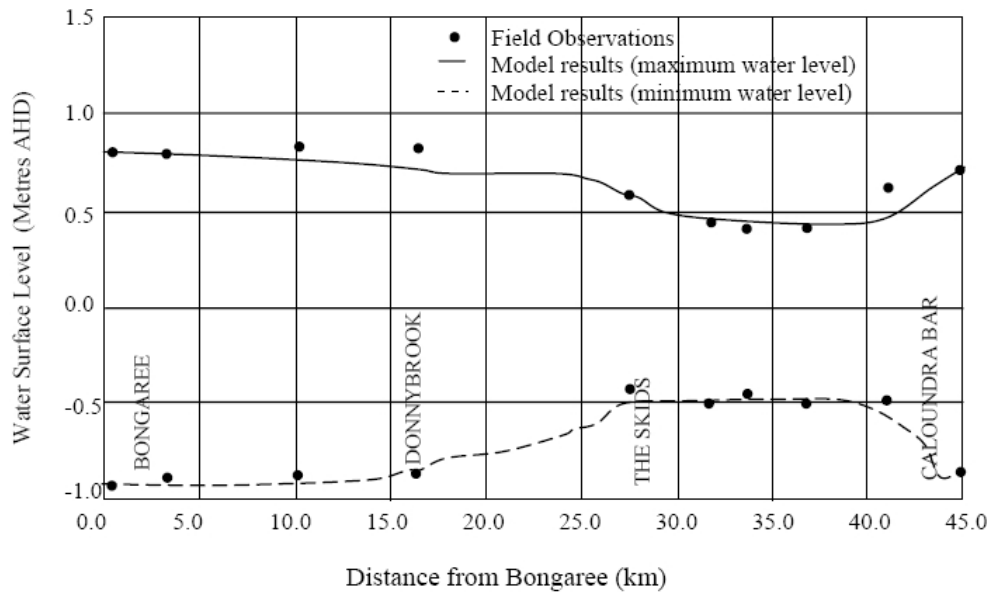
Figure 2-6 Profiles of High and Low Water within Pumicestone Passage in 1978 (Inter-Departmental Committee, 1982; reproduced in Larsen, 2007)

The Inter-Departmental Committee (1982) analysed the variation in tidal range throughout Pumicestone Passage using an extensive data set and numerical modelling tools. The observed and modelled profiles of maximum high and low water (the water level envelope) are shown in Figure 2-6. This assessment shows the tidal attenuation occurring more rapidly from the northern entrance, with peak attenuation within a 5km distance of Caloundra Bar. In comparison, tidal attenuation from the southern entrance (Bongaree) occurs more gradually and over a 25-30km distance.

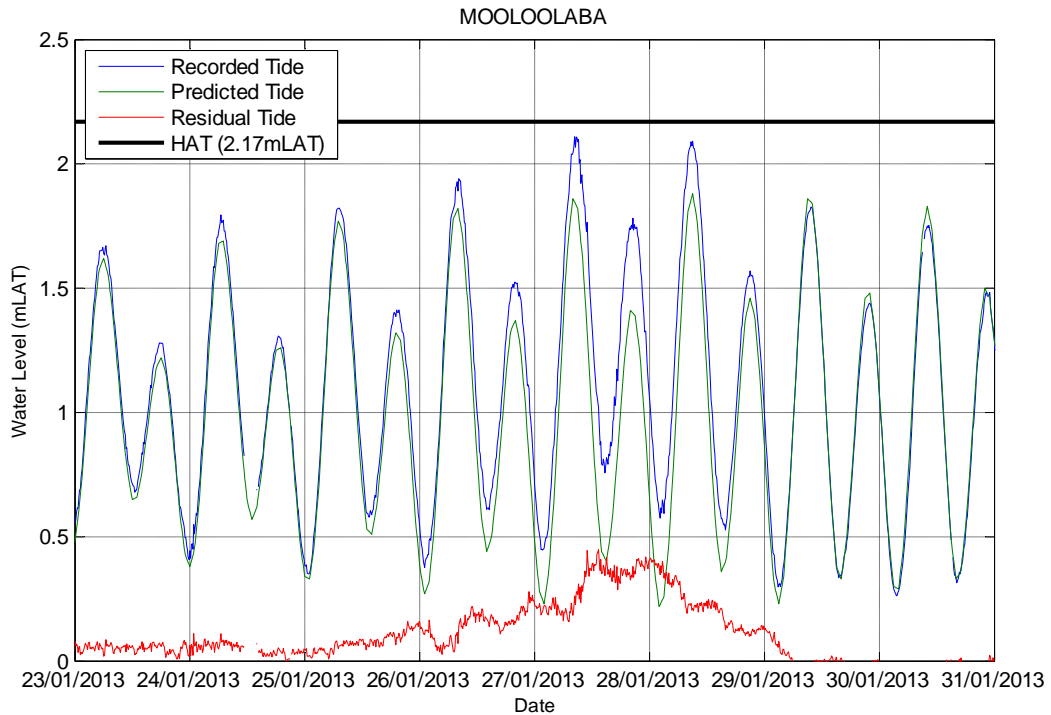
Figure 2-7 Recorded, Predicted and Residual Tide at Mooloolaba Storm Tide Gauge during ex-TC Oswald (data provided by DSITIA)

Water level recordings during ex-TC Oswald (January 2013) are presented in Figure 2-7. The water level data at Mooloolaba suggest a surge (residual tide) peak close to 0.5m and a recorded water level (storm tide) close to HAT was observed. It is assumed that these conditions were also experienced at the northern entrance to Pumicestone Passage. Similar conditions would be expected at the southern entrance to Pumicestone Passage, potentially slightly amplified as the surge wave propagated into Moreton Bay.

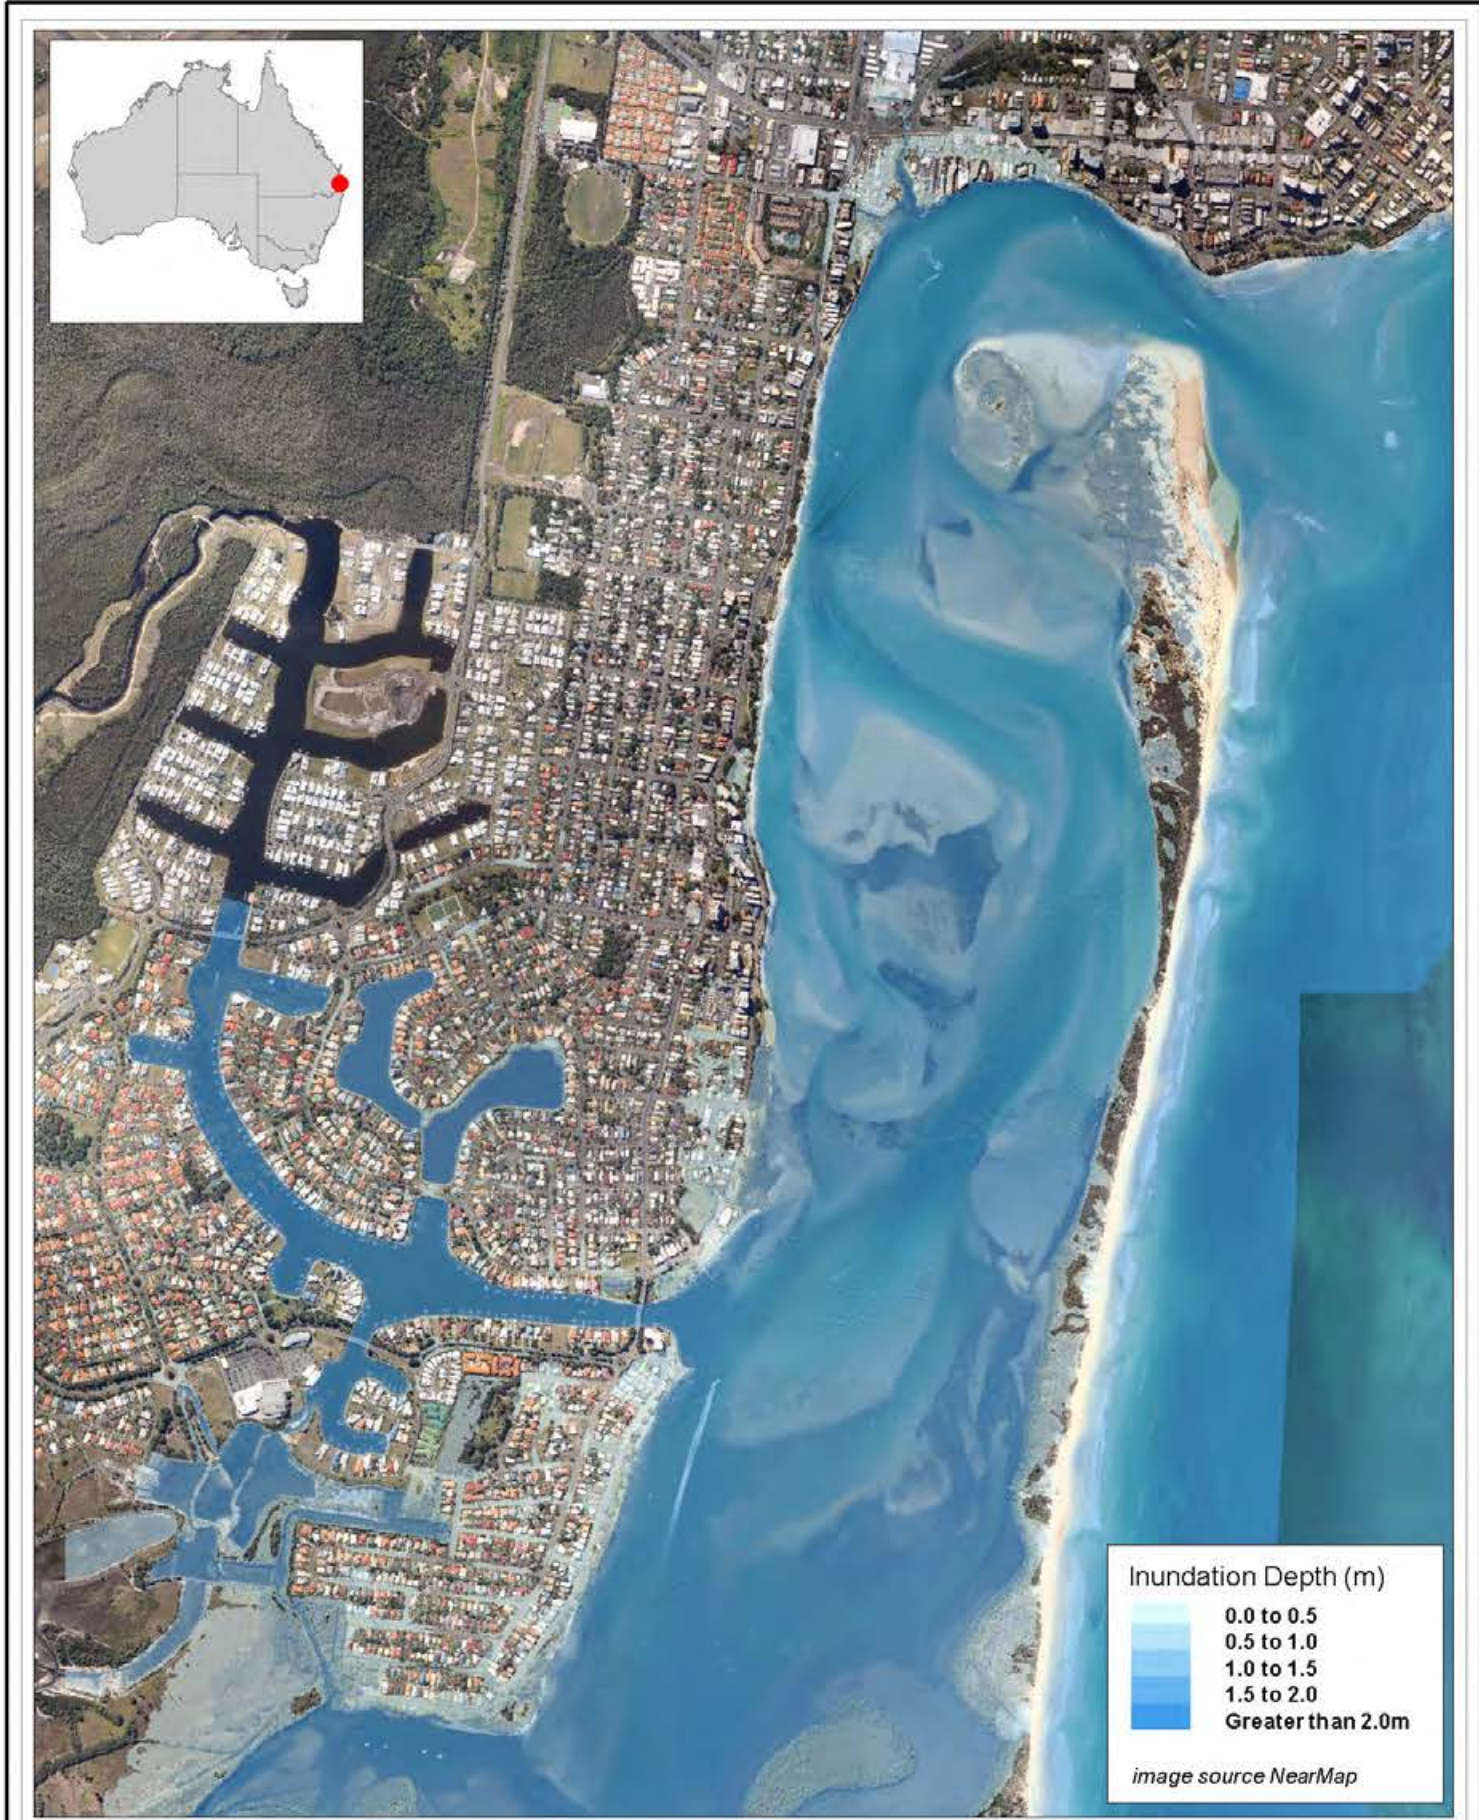
Title:
100yr Storm Tide Inundation with 0.2m increase to Mean Sea Level (bathtub mapping)

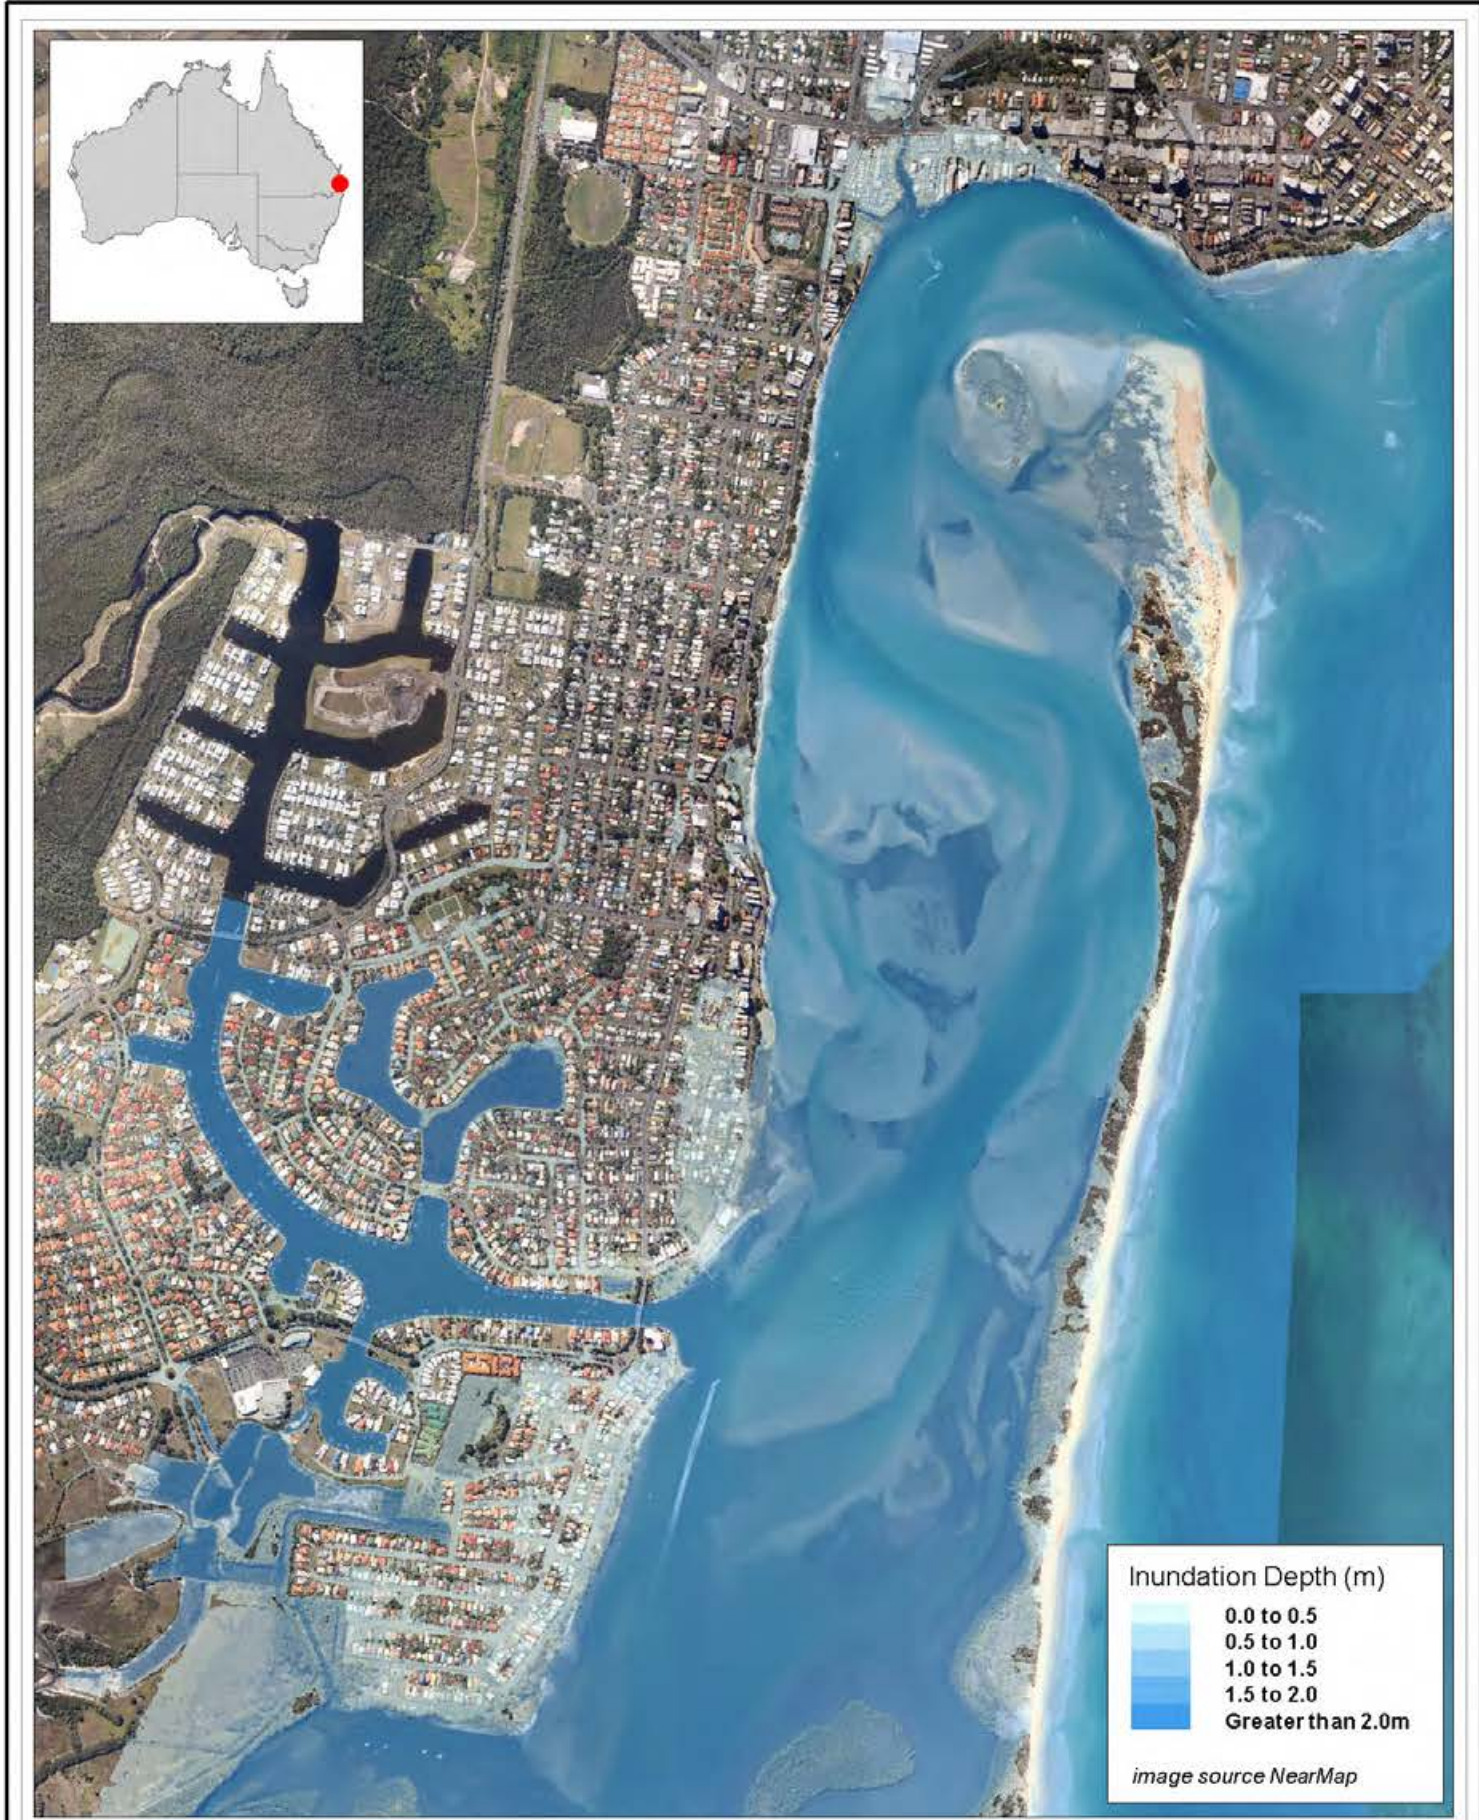
Title:
100yr Storm Tide Inundation with 0.4m increase to Mean Sea Level (bathtub mapping)

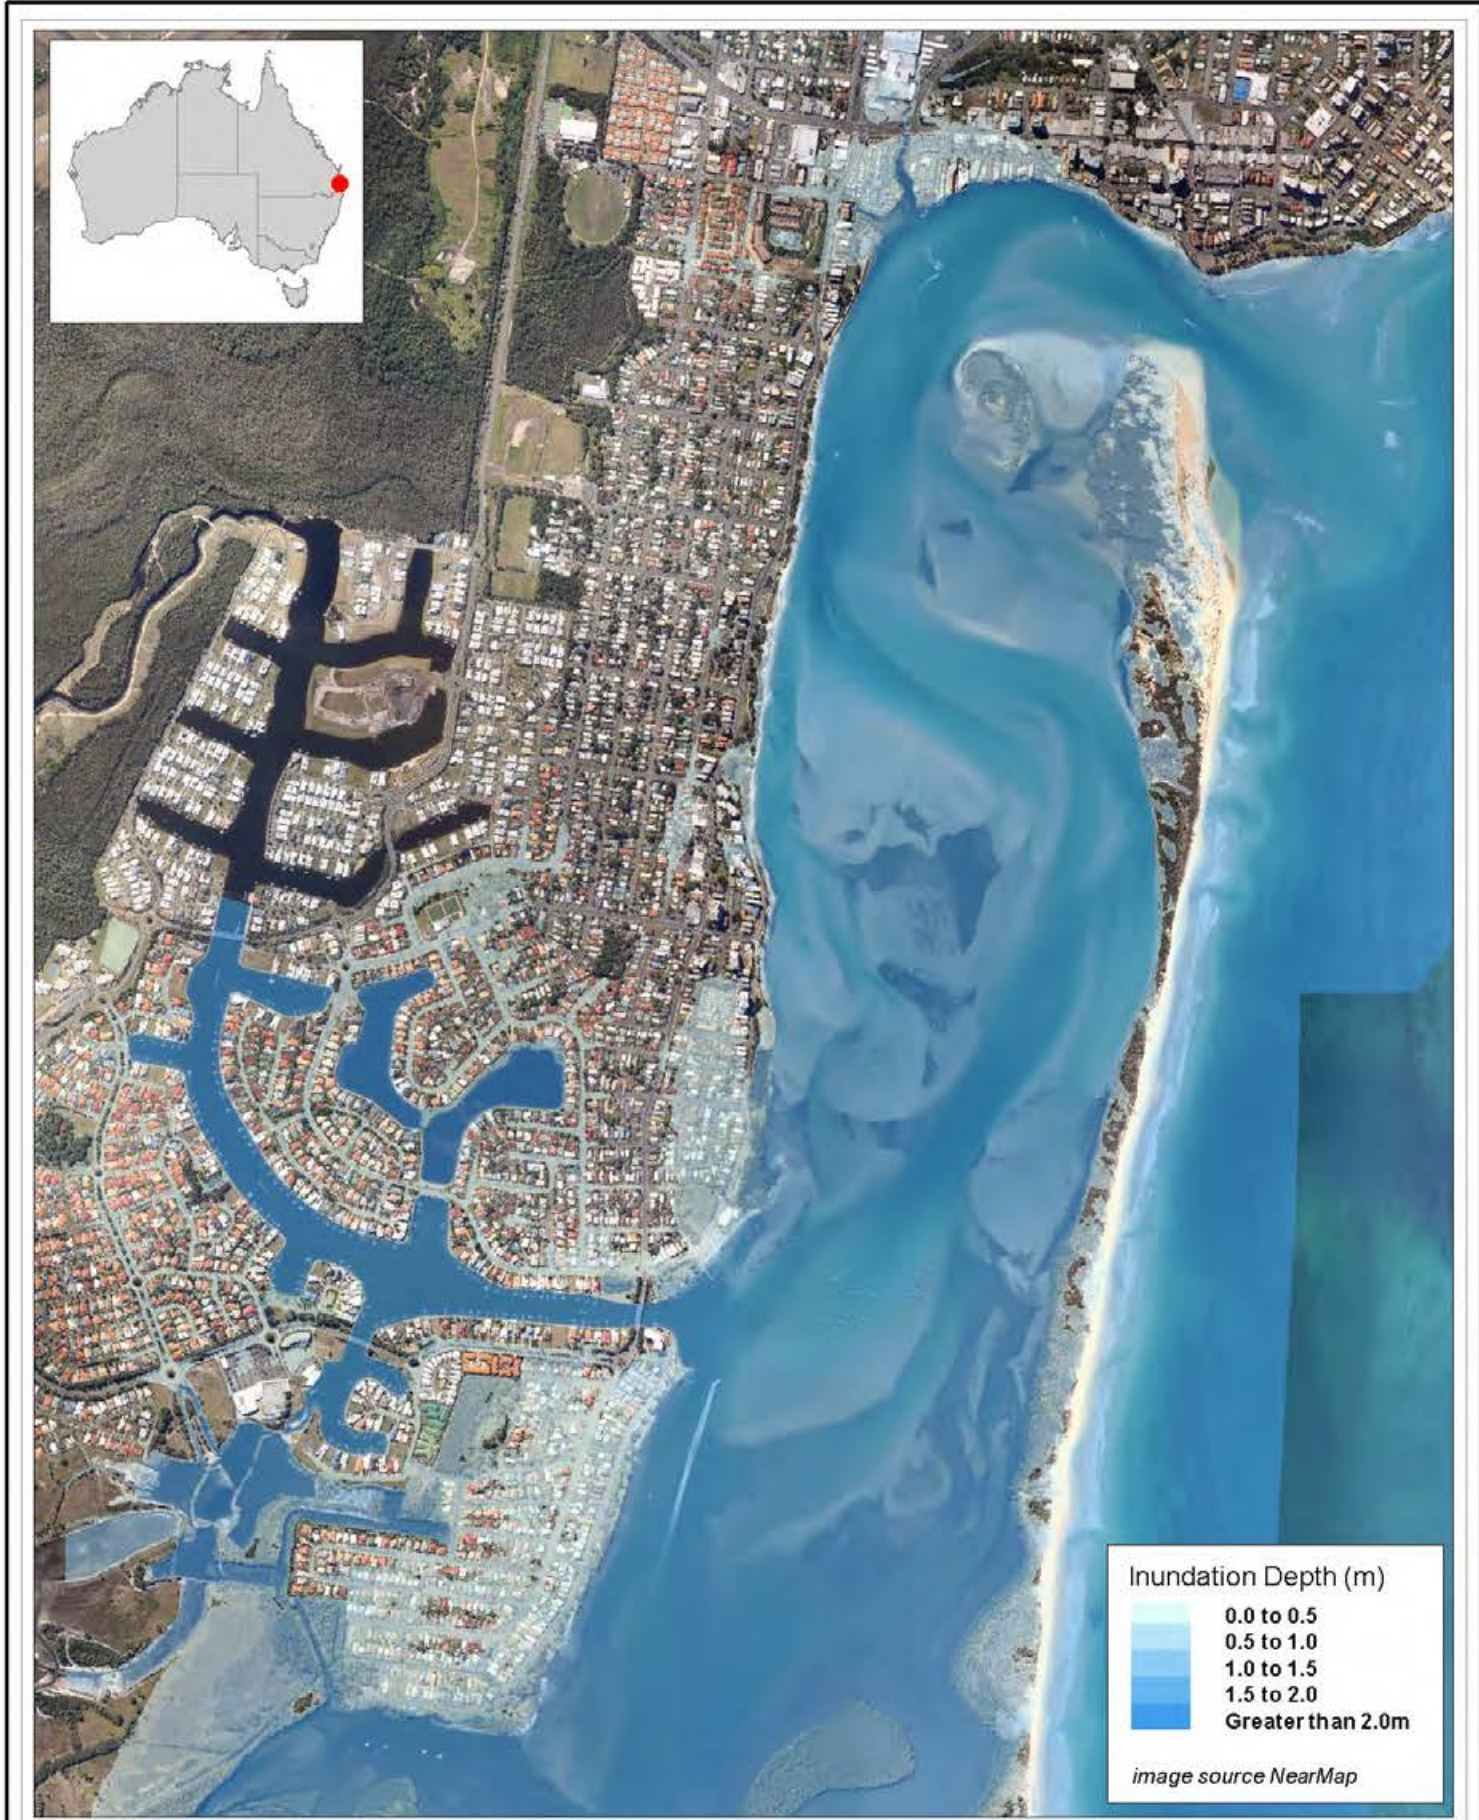
Title:
100yr Storm Tide Inundation with 0.6m increase to Mean Sea Level (bathtub mapping)

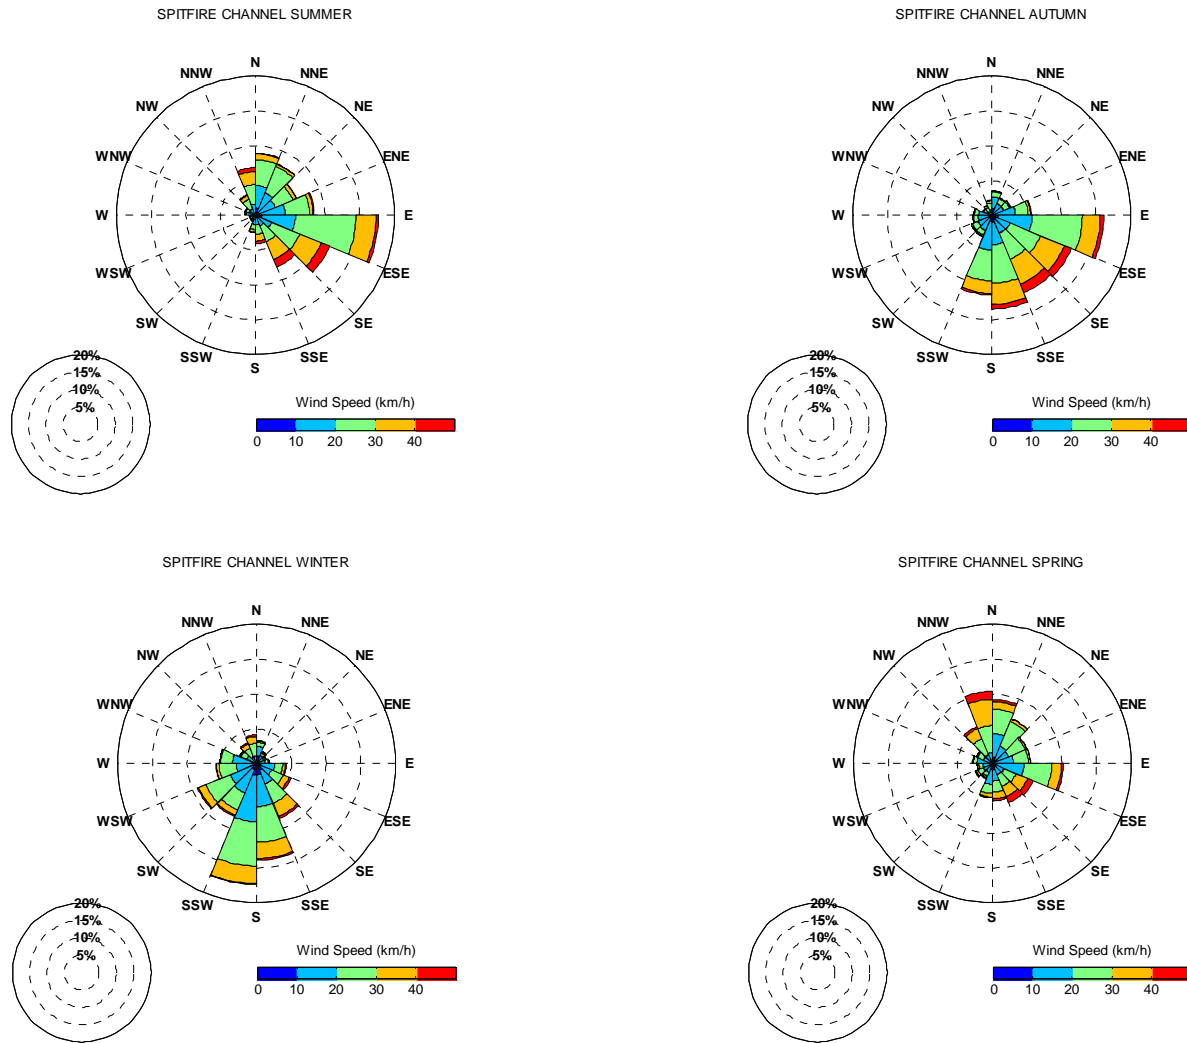
Figure 2-12 Long Term Average (2002 – 2011) Seasonal Wind Roses – Spittfire Channel

A long term average wind rose based on recorded data from Bureau of Meteorology (BOM) Spitfire Channel weather station (station number 40927) is provided in Figure 2-11 and shows the directional spread of wind speed at the northern entrance to Moreton Bay, approximately 25km southeast of the study area. This weather station is positioned on a beacon over water and therefore the wind speeds are expected to be higher than those observed at land based locations. Small changes to wind direction would also be expected as the winds move over the local terrain.

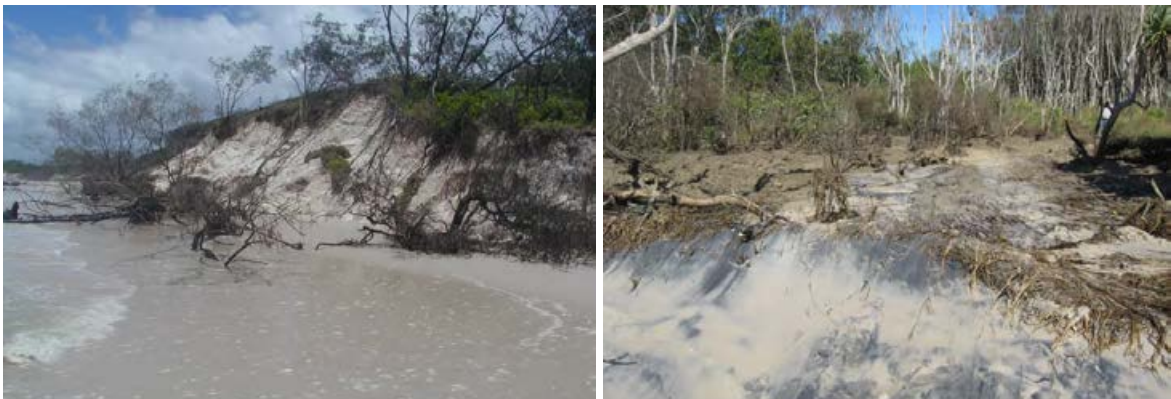
Figure 2-16 Erosion along High Dunes (left) and Mangrove Degradation due to Wave Overtopping (Queensland Government, 2008)

Overwash only occurs at locations where the runup height exceeds (overtops) the dune crest elevation. Figure 2-16 provides examples of erosion along high dunes and evidence of wave overtopping at a low crested dune location.

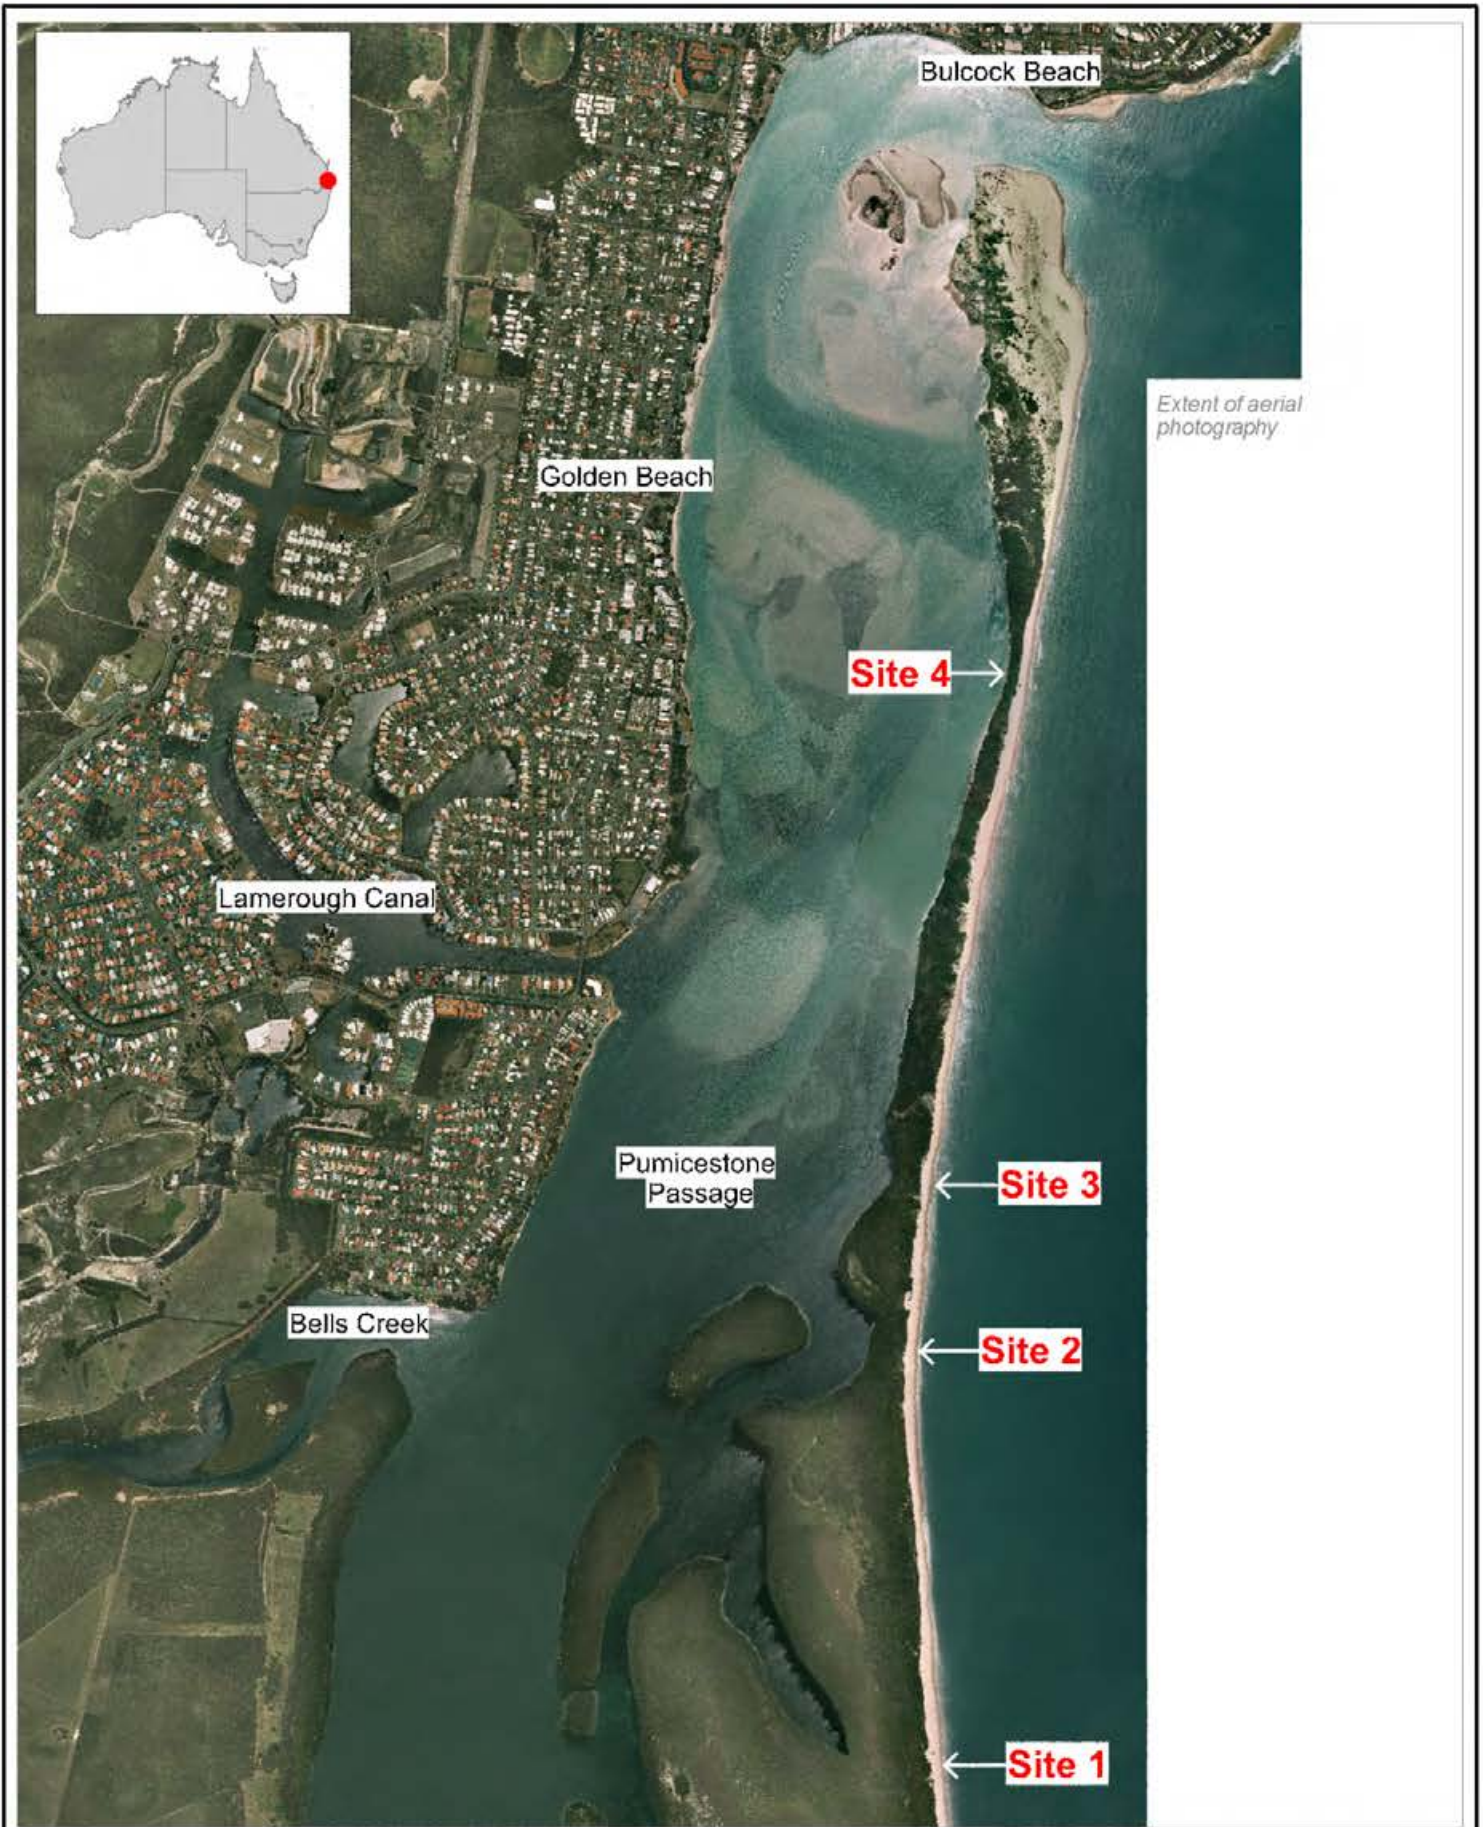
Title:
Bribie Island Northern Spit Narrow Locations

Analysis of recent aerial photography and information gathered during a site visit in early 2014 suggest the pattern of shoreline recession and vegetation loss is ongoing. A vast area of mangrove die back between Site 2 and Site 3 can be seen in Figure 2-21. Sediment laden wave overwash and sedimentation appears to be the primarily cause of mangrove habitat loss. Sand deposition acts to smother the mangrove pneumatophores causing suffocation and eventual death of the plant. Evidence of wave overtopping and mangrove die back are shown in Figure 2-22 and Figure 2-23. The width of the vegetated dune at the narrowest point (Site 4) was approximately 25m in late 2013.

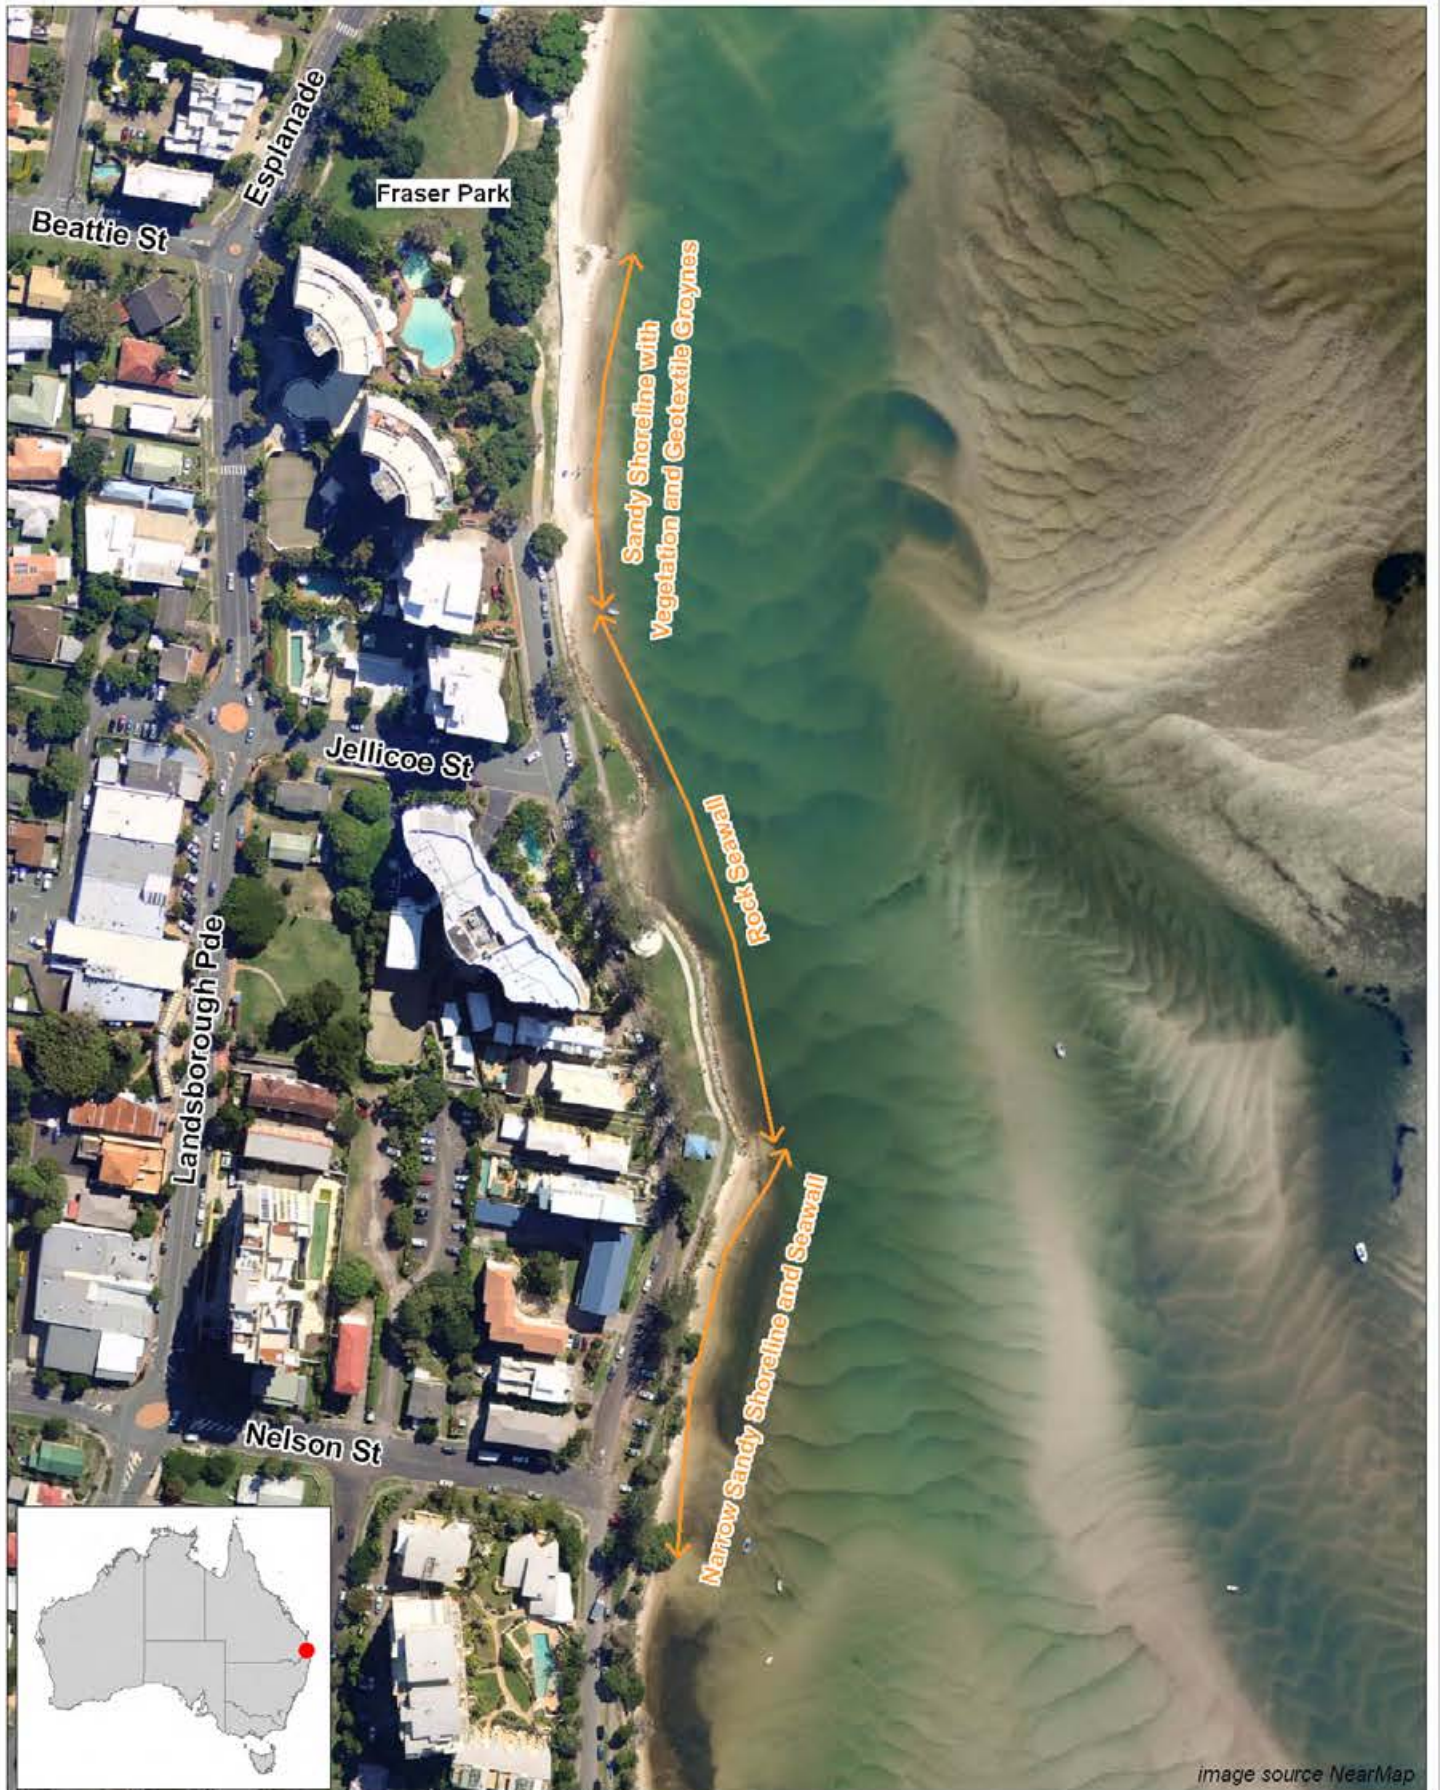
Title:
Nelson Street to Beattie Street Shoreline Types

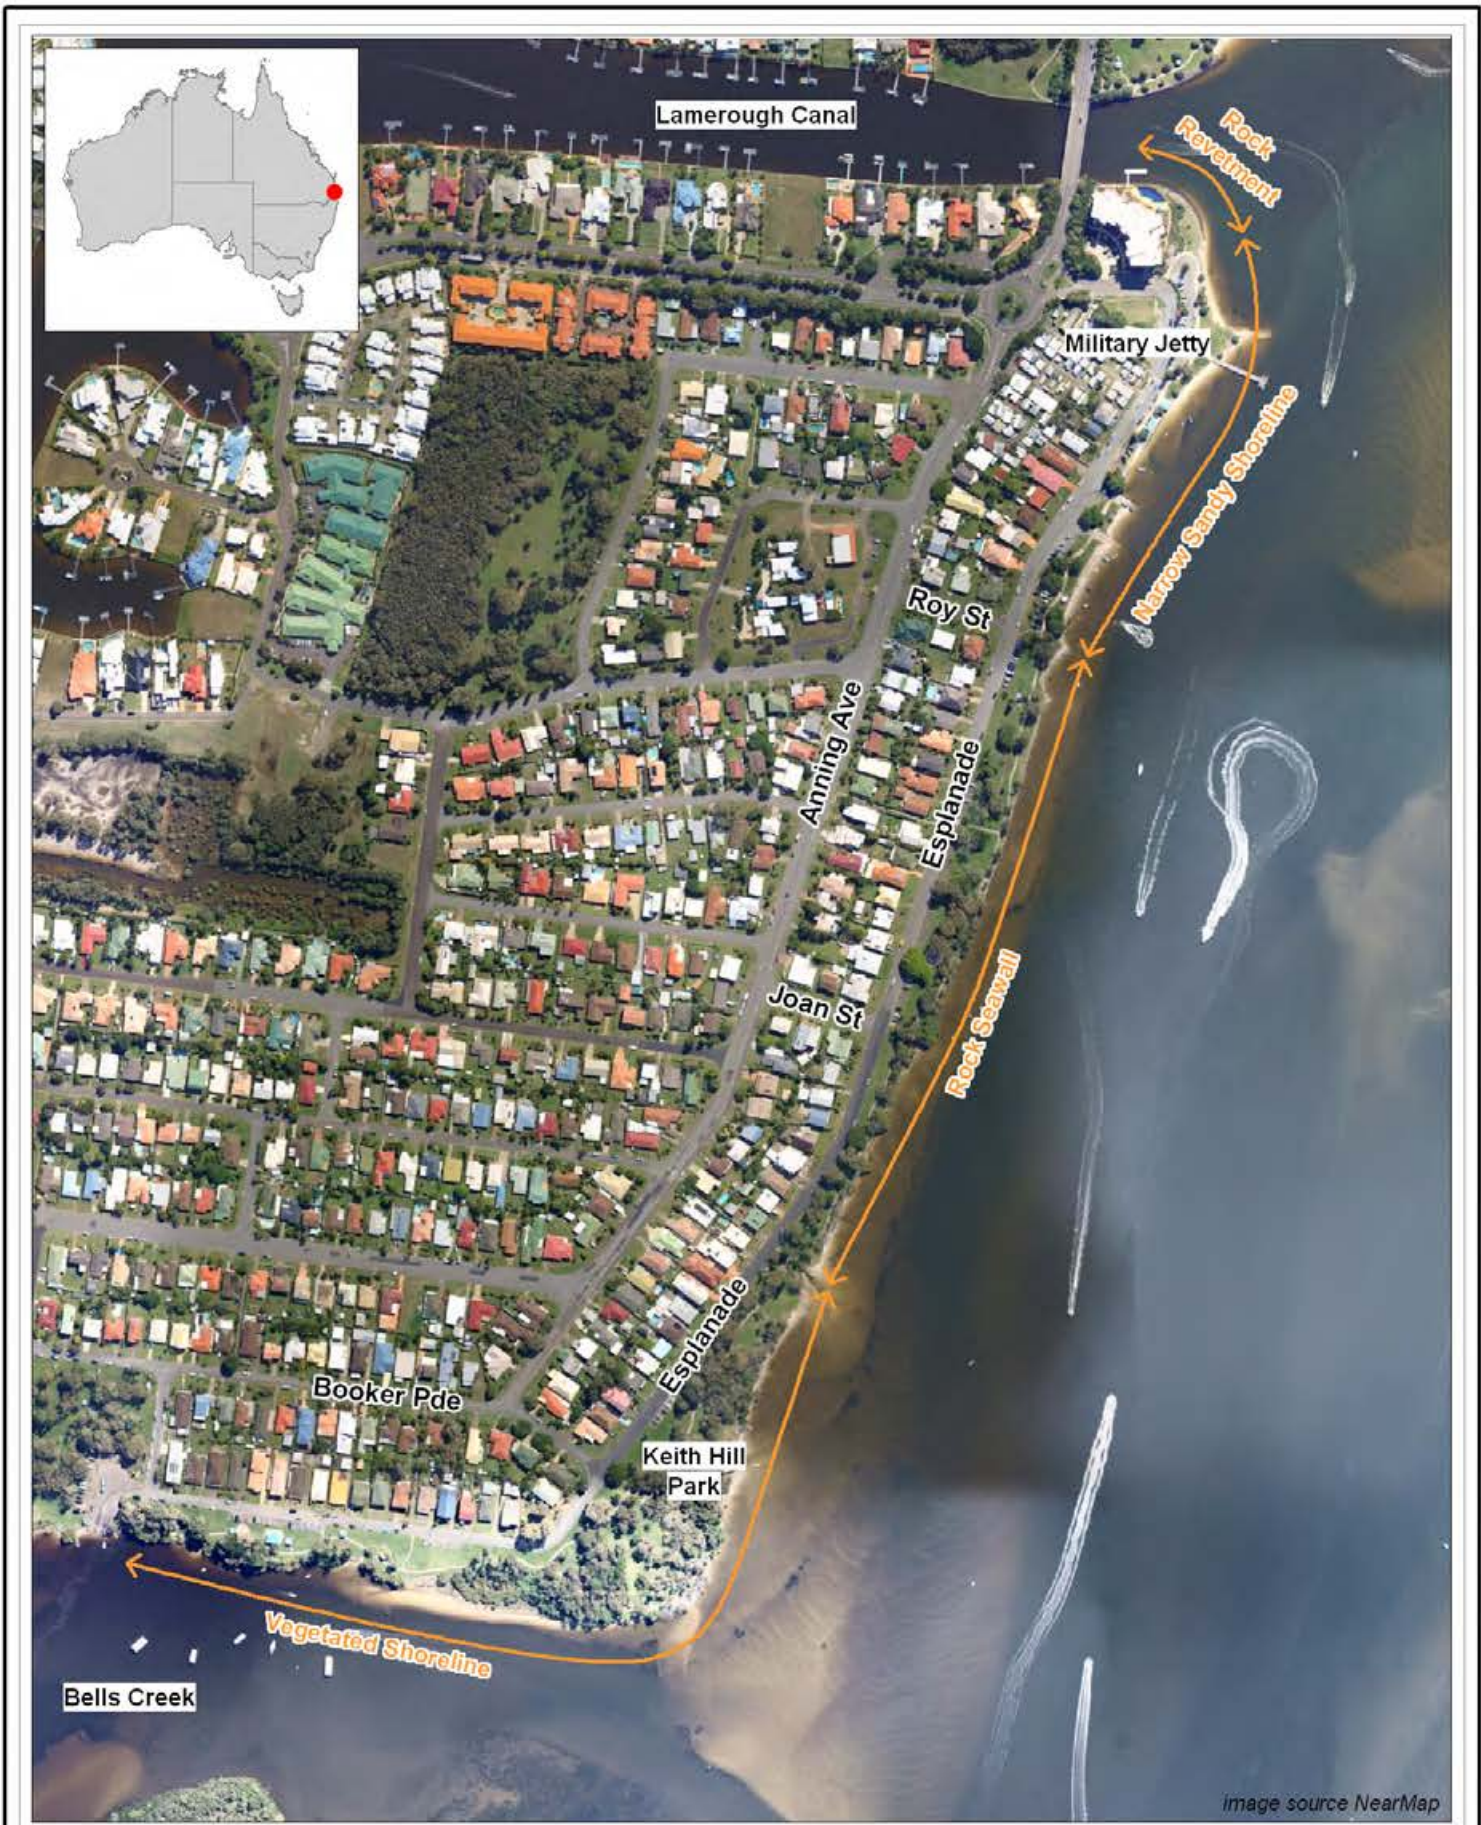
Title:
Bells Creek to Lamerough Canal Shoreline Types

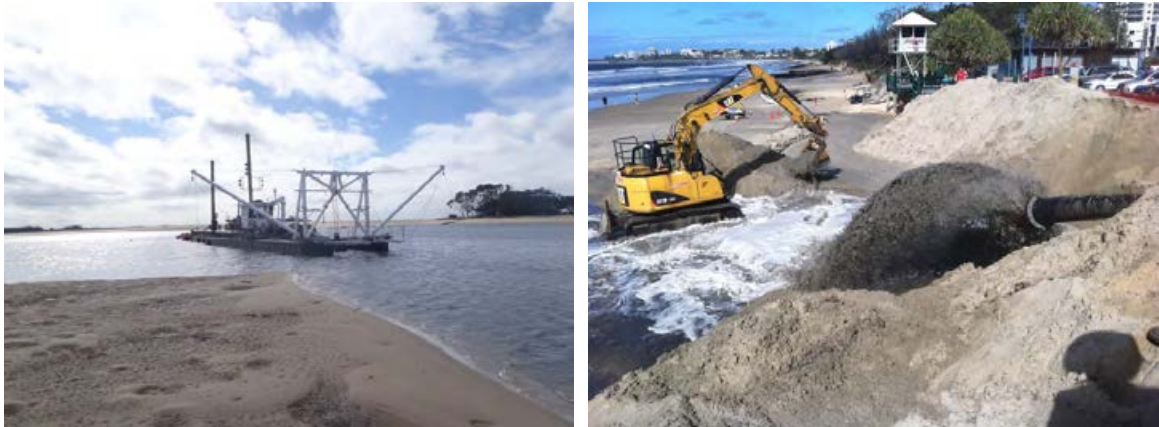
Figure 4-3 Cutter Suction Dredge and Pipeline Sand Delivery to Maroochydore Beach
