Golden Beach and Bribie Island Breakthrough - Options, Design, Approvals and Investment Plan Final Report

January 2015

Golden Beach and Bribie Island Breakthrough - Options, Design, Approvals and Investment Plan

Prepared for: Sunshine Coast Council

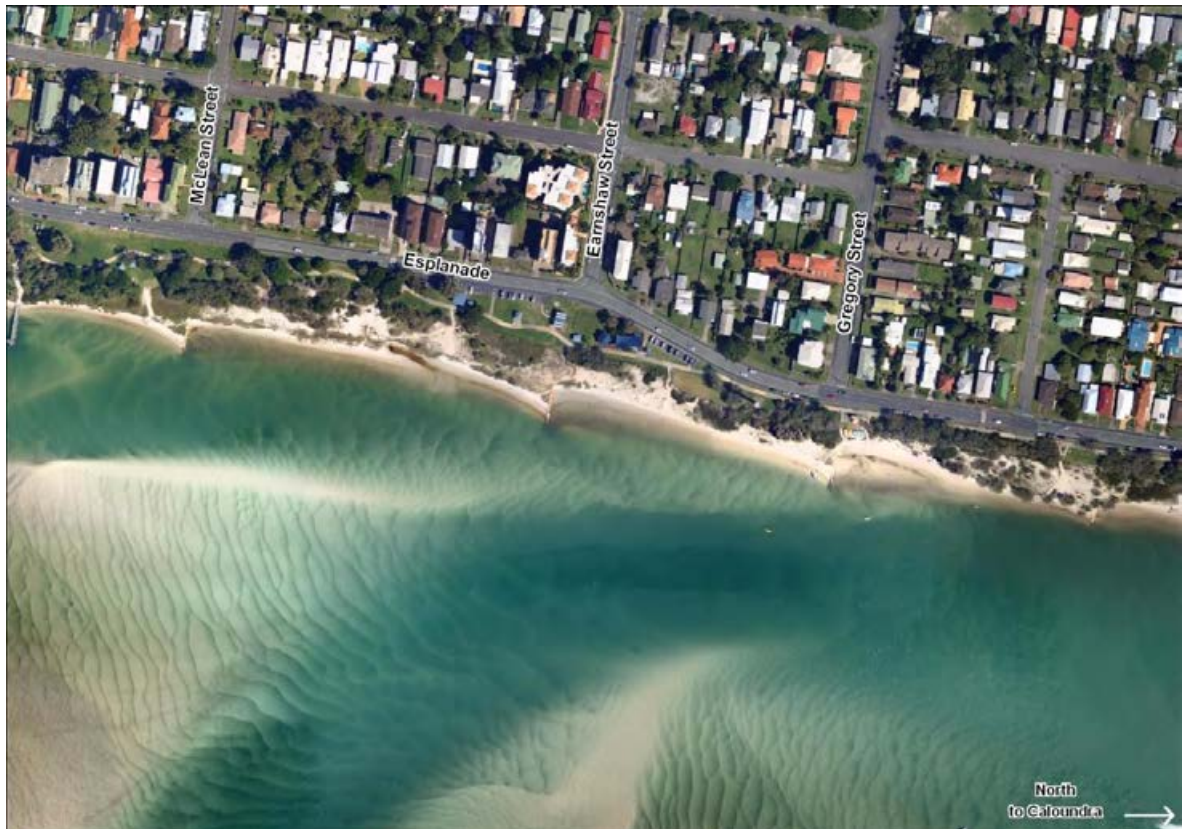
Figure 4-8 A Series of Groynes at Golden Beach (NearMap Pty Ltd, 2013)

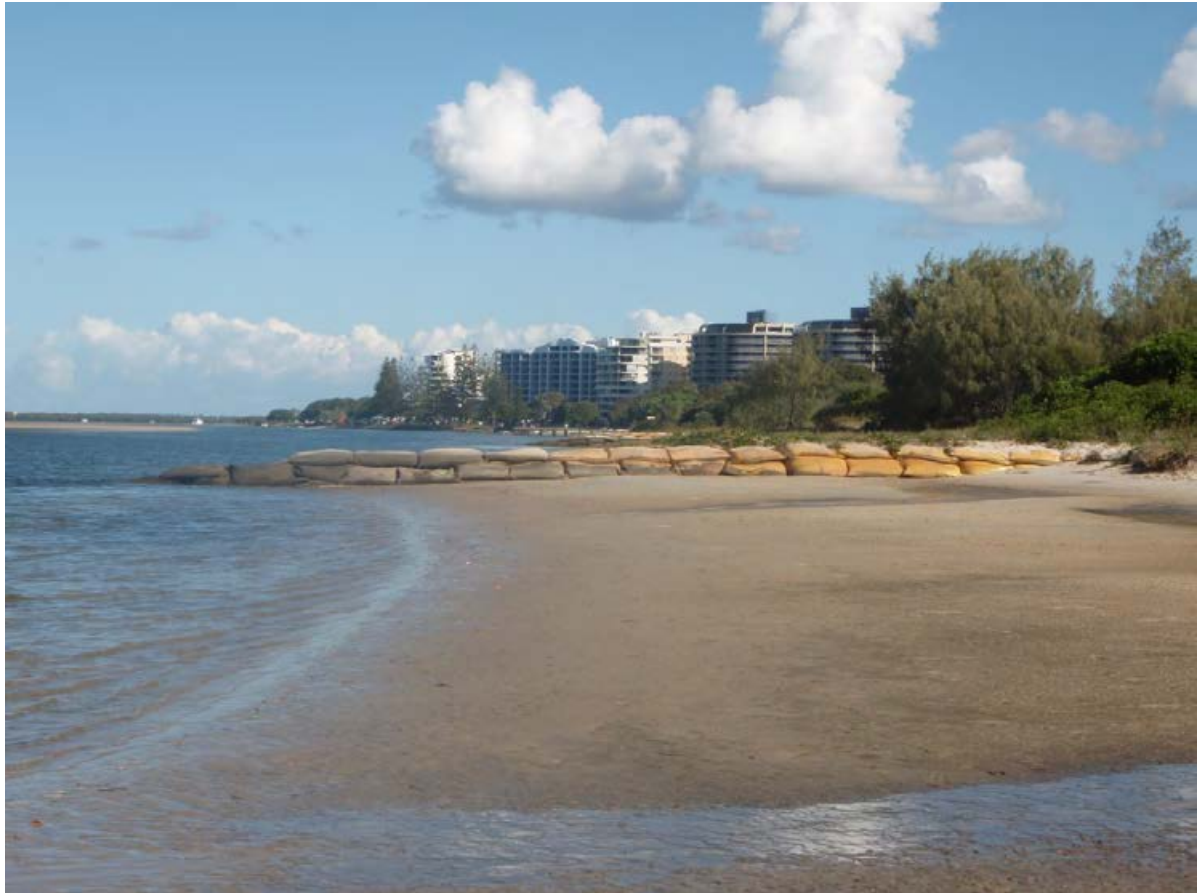
Figure 4-10 Stormwater Outlet Concealed and Protected using Geotextile Sand Containers
