Sunshine Coast Sand Sourcing Study

Reference:
R.B21192.001.02.SandSourcing.docx Date:
February 2016

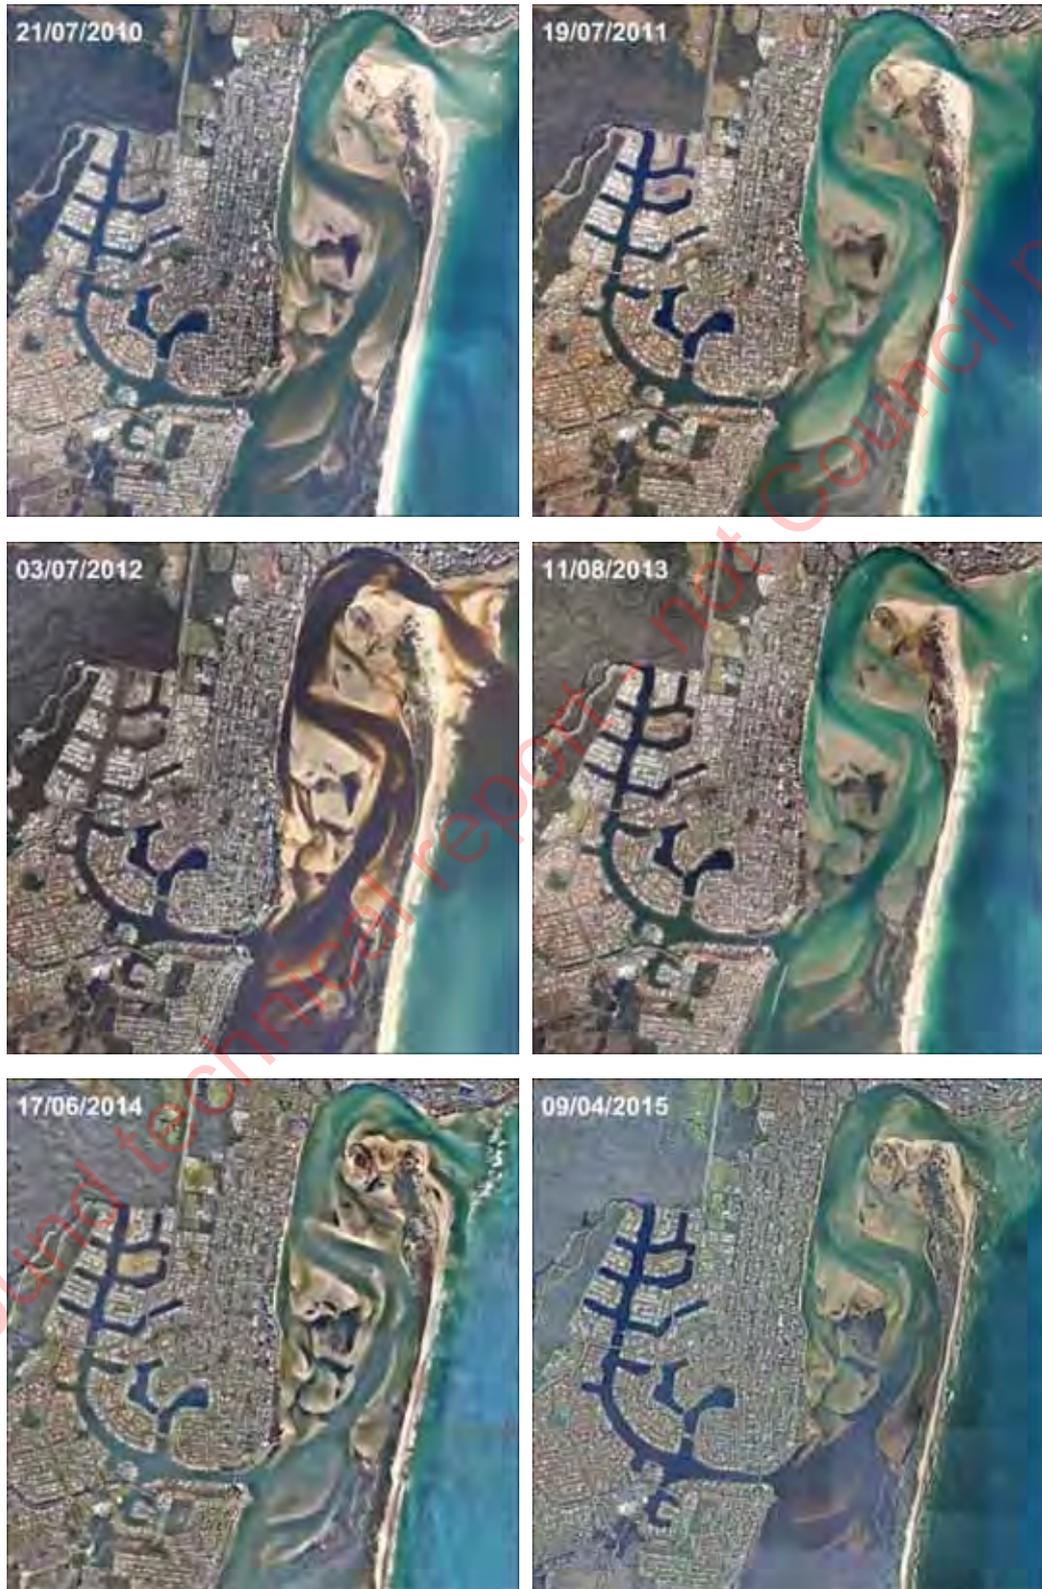
Figure 2-9 Northern Pumicestone Passage Morphology 21/07/2010 to 09/04/2015 (NearMap, 2015)

The sequence of aerial photos in Figure 2-9 suggests a relatively stable physical system within the northern reach of Pumicestone Passage. The key threat to stability of the area is associated with the expected breakthrough of the Bribie Island spit. This may cause a change to the tidal regime within the northern Pumicestone Passage. Reduced tidal attenuation within the passage and therefore greater tidal amplitude will lead to an increased risk of coastal inundation associated with storm tide events. This threat is significantly greater for land assets on low-lying land south of the Caloundra Power Boat Club.

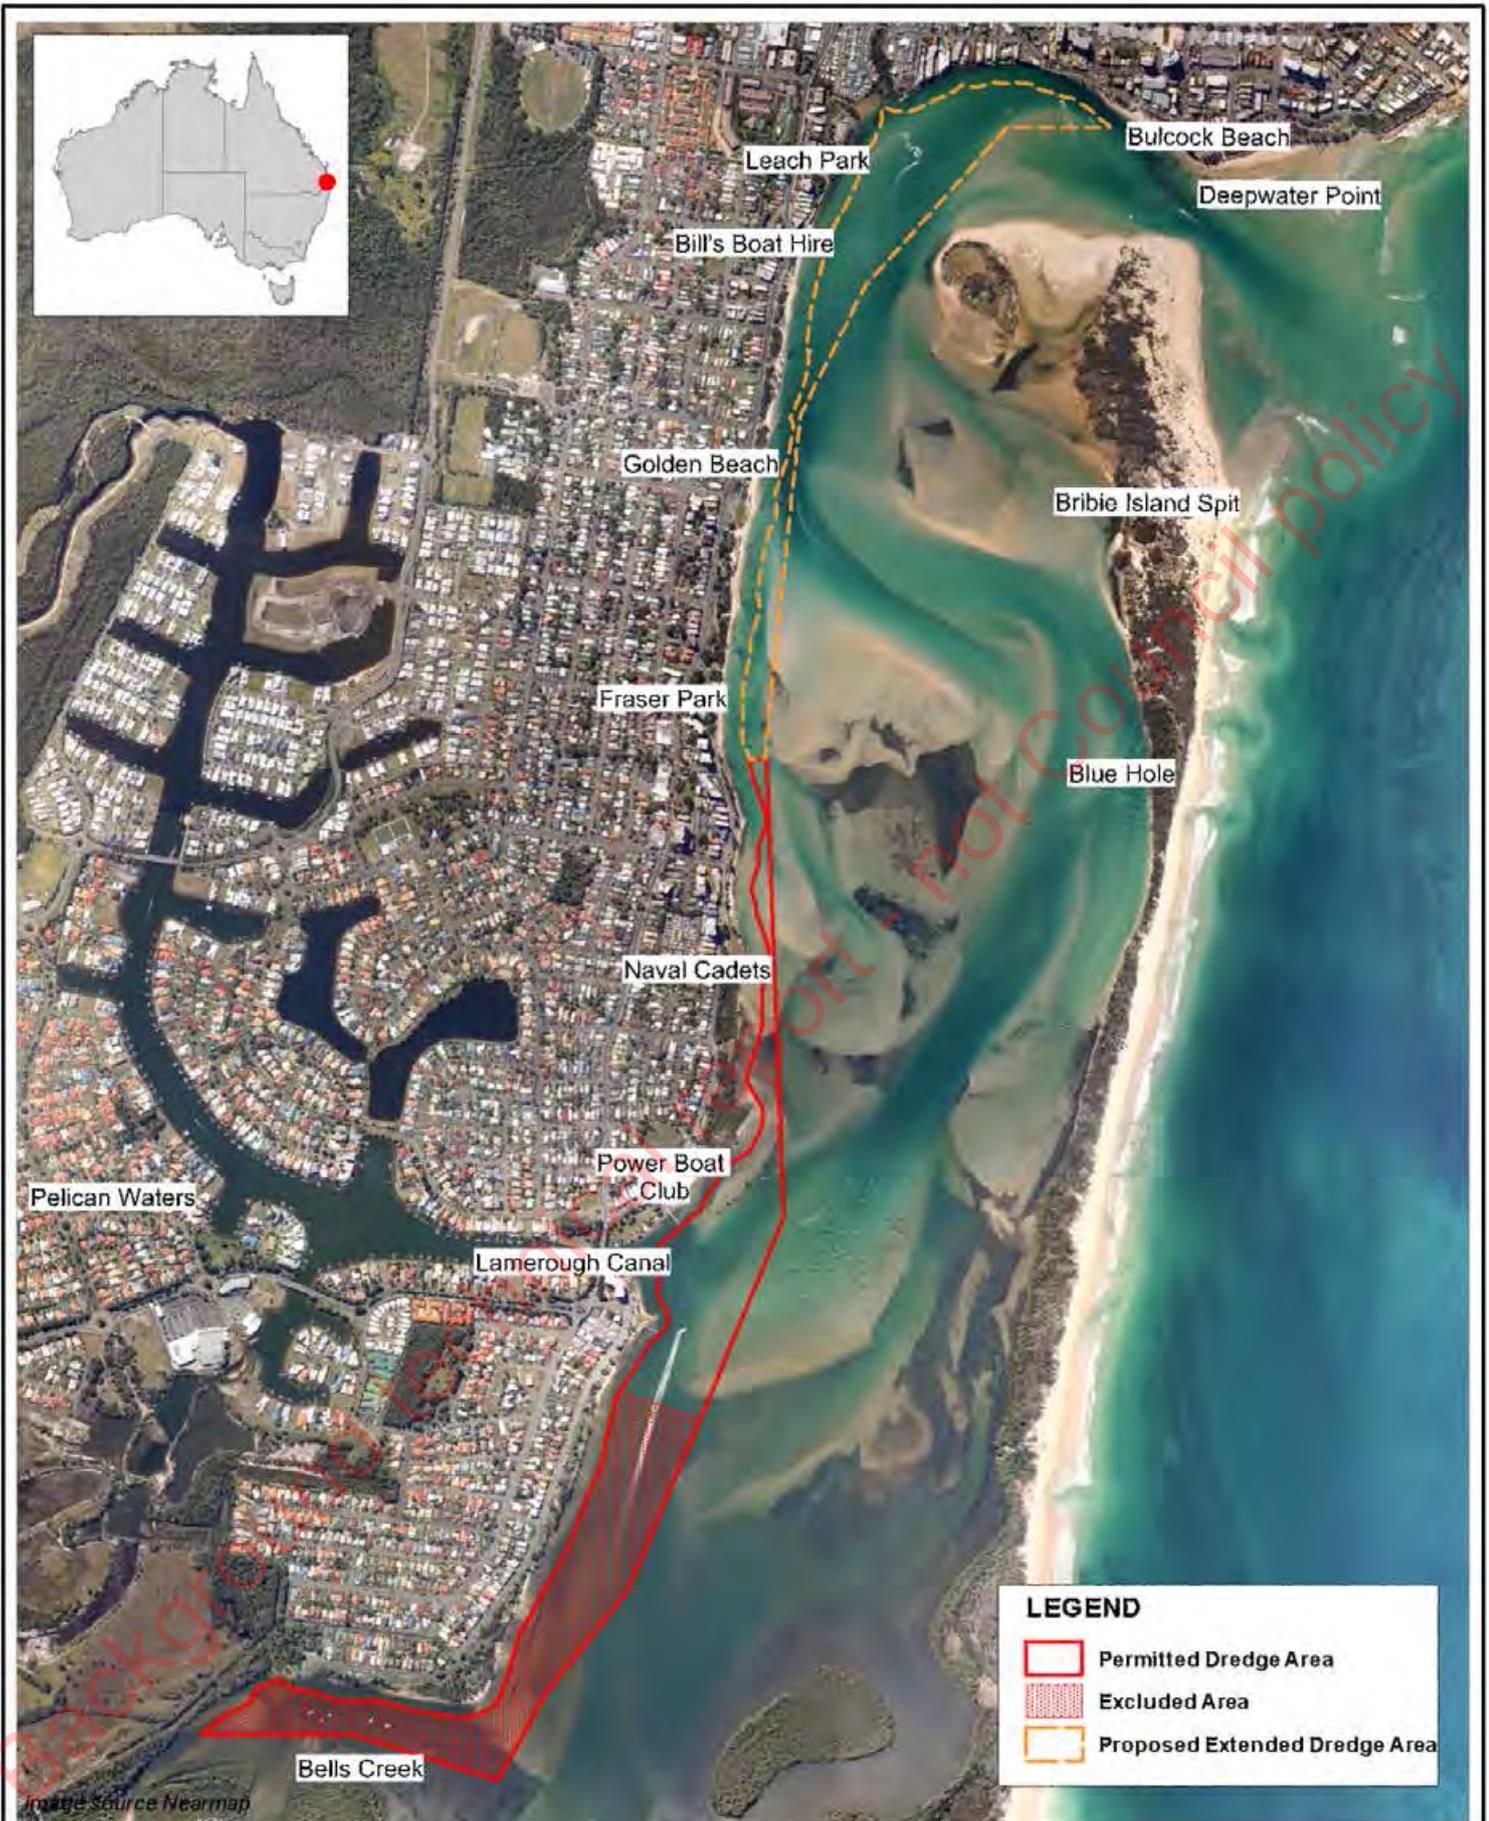
Title:
Permitted and Proposed Dredge Areas within Northern Pumicestone Passage

Sediments within northern Pumicestone Passage are generally expected to be suitable for nourishment of the adjacent mainland beaches. Council holds existing permits that allow the dredging and placement of sand throughout this area. The notional “approved” maintenance dredge area, subject to permit conditions, is shown in Figure 2-11.

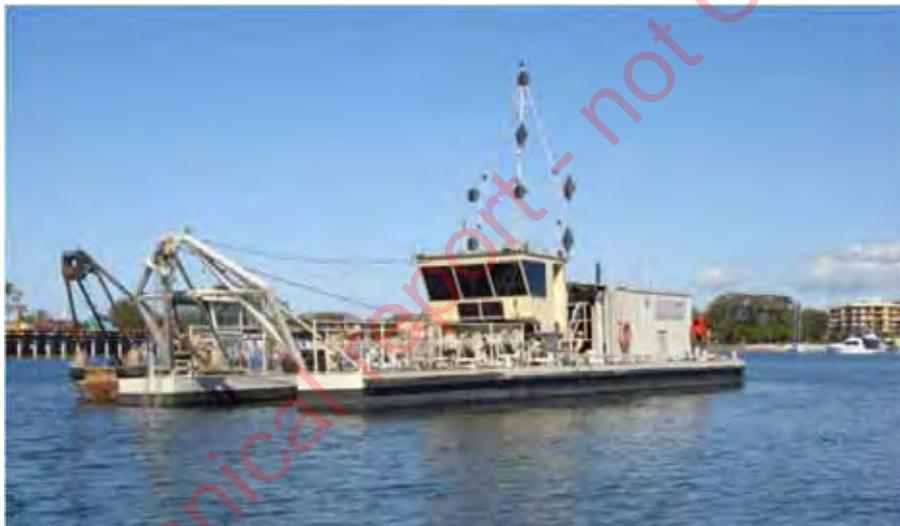
Figure 2-12 400mm Cutter Suction Dredge (Photo Courtesy of Hall Contracting)

It is assumed that a small, shallow draft cutter suction dredge (CSD) similar to that shown in Figure 2-12 could access the target dredge areas with Northern Pumicestone Passage. A CSD works most effectively in loose unconsolidated material which is pumped directly by pipeline to a disposal area. Such operations are an efficient means of delivering sand to a target renourishment location. The maximum distance of pumping depends on the dredge capacity. For the type of dredger that would have sufficient manoeuvrability to operate effectively in Pumicestone Passage a maximum pumping distance of approximately 1 km may apply. If required, delivery of sand beyond this distance would be achieved using booster pumps along the pipeline route. A pipeline would need to be permanently in place over the dredging period, as it cannot be easily dismantled and installed each day. Council had recent experience with this type of dredging and placement method through the Maroochydoore Beach Renourishment Project (discussed further Section 2.4.1.1).

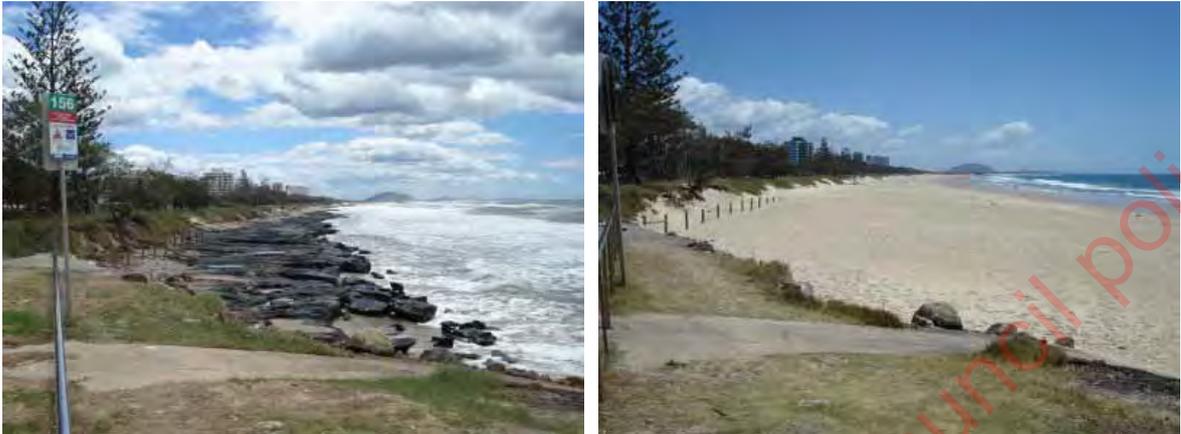
Figure 2-13 Before (left) and After (right) Maroochydhore Beach Renourishment Project Stage One (photos courtesy of Birdon Pty Ltd)

Stage one of the Maroochydoore Renourishment Project was completed in 2013 and involved relocation approximately 125,000 m³ of sand from a permitted area within the lower Maroochy River to Maroochydoore Beach. The sand was relocated via a Cutter Suction Dredge (CSD) and pipeline. The dredge can be seen working within the permitted area in aerial image dated 11/08/2013 in Figure 2-16. Stage one before and after photos are shown in Figure 2-13.

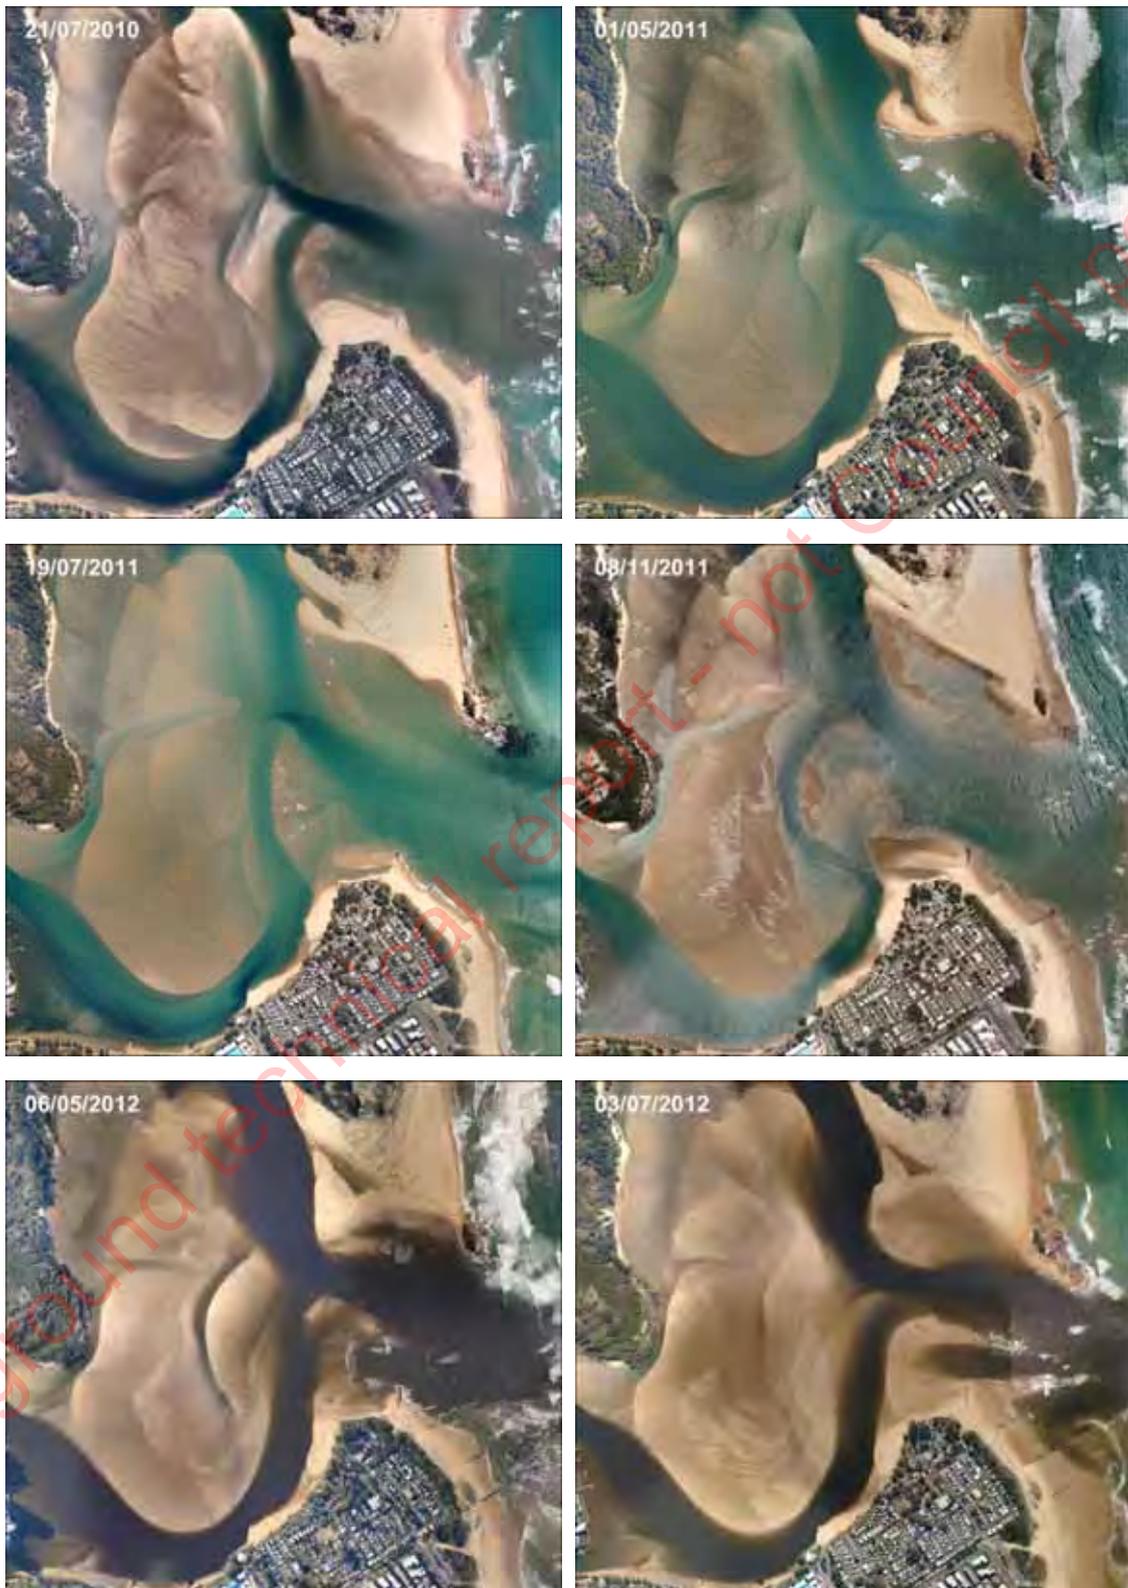
Figure 2-14 Maroochy River Mouth Morphology 21/07/2010 to 03/07/2012 (NearMap, 2015)

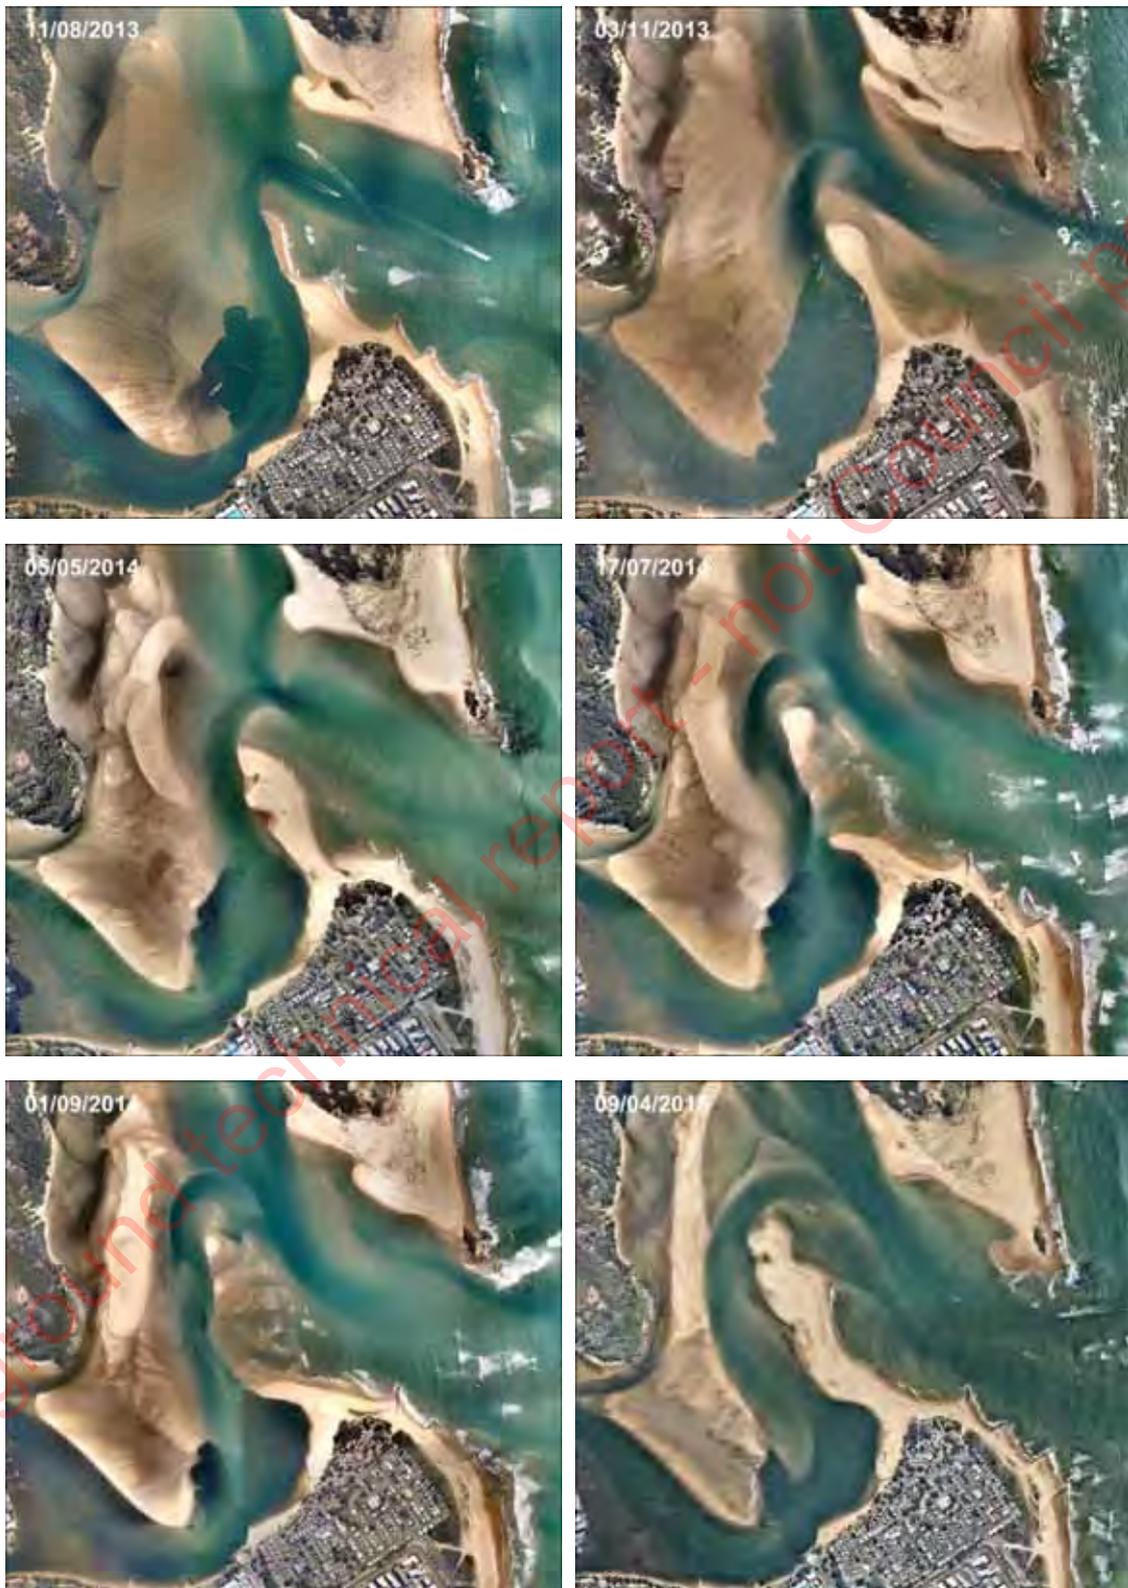
Figure 2-16 Maroochy River Mouth Morphology 11/08/2013 to 09/04/2015 (NearMap, 2015)

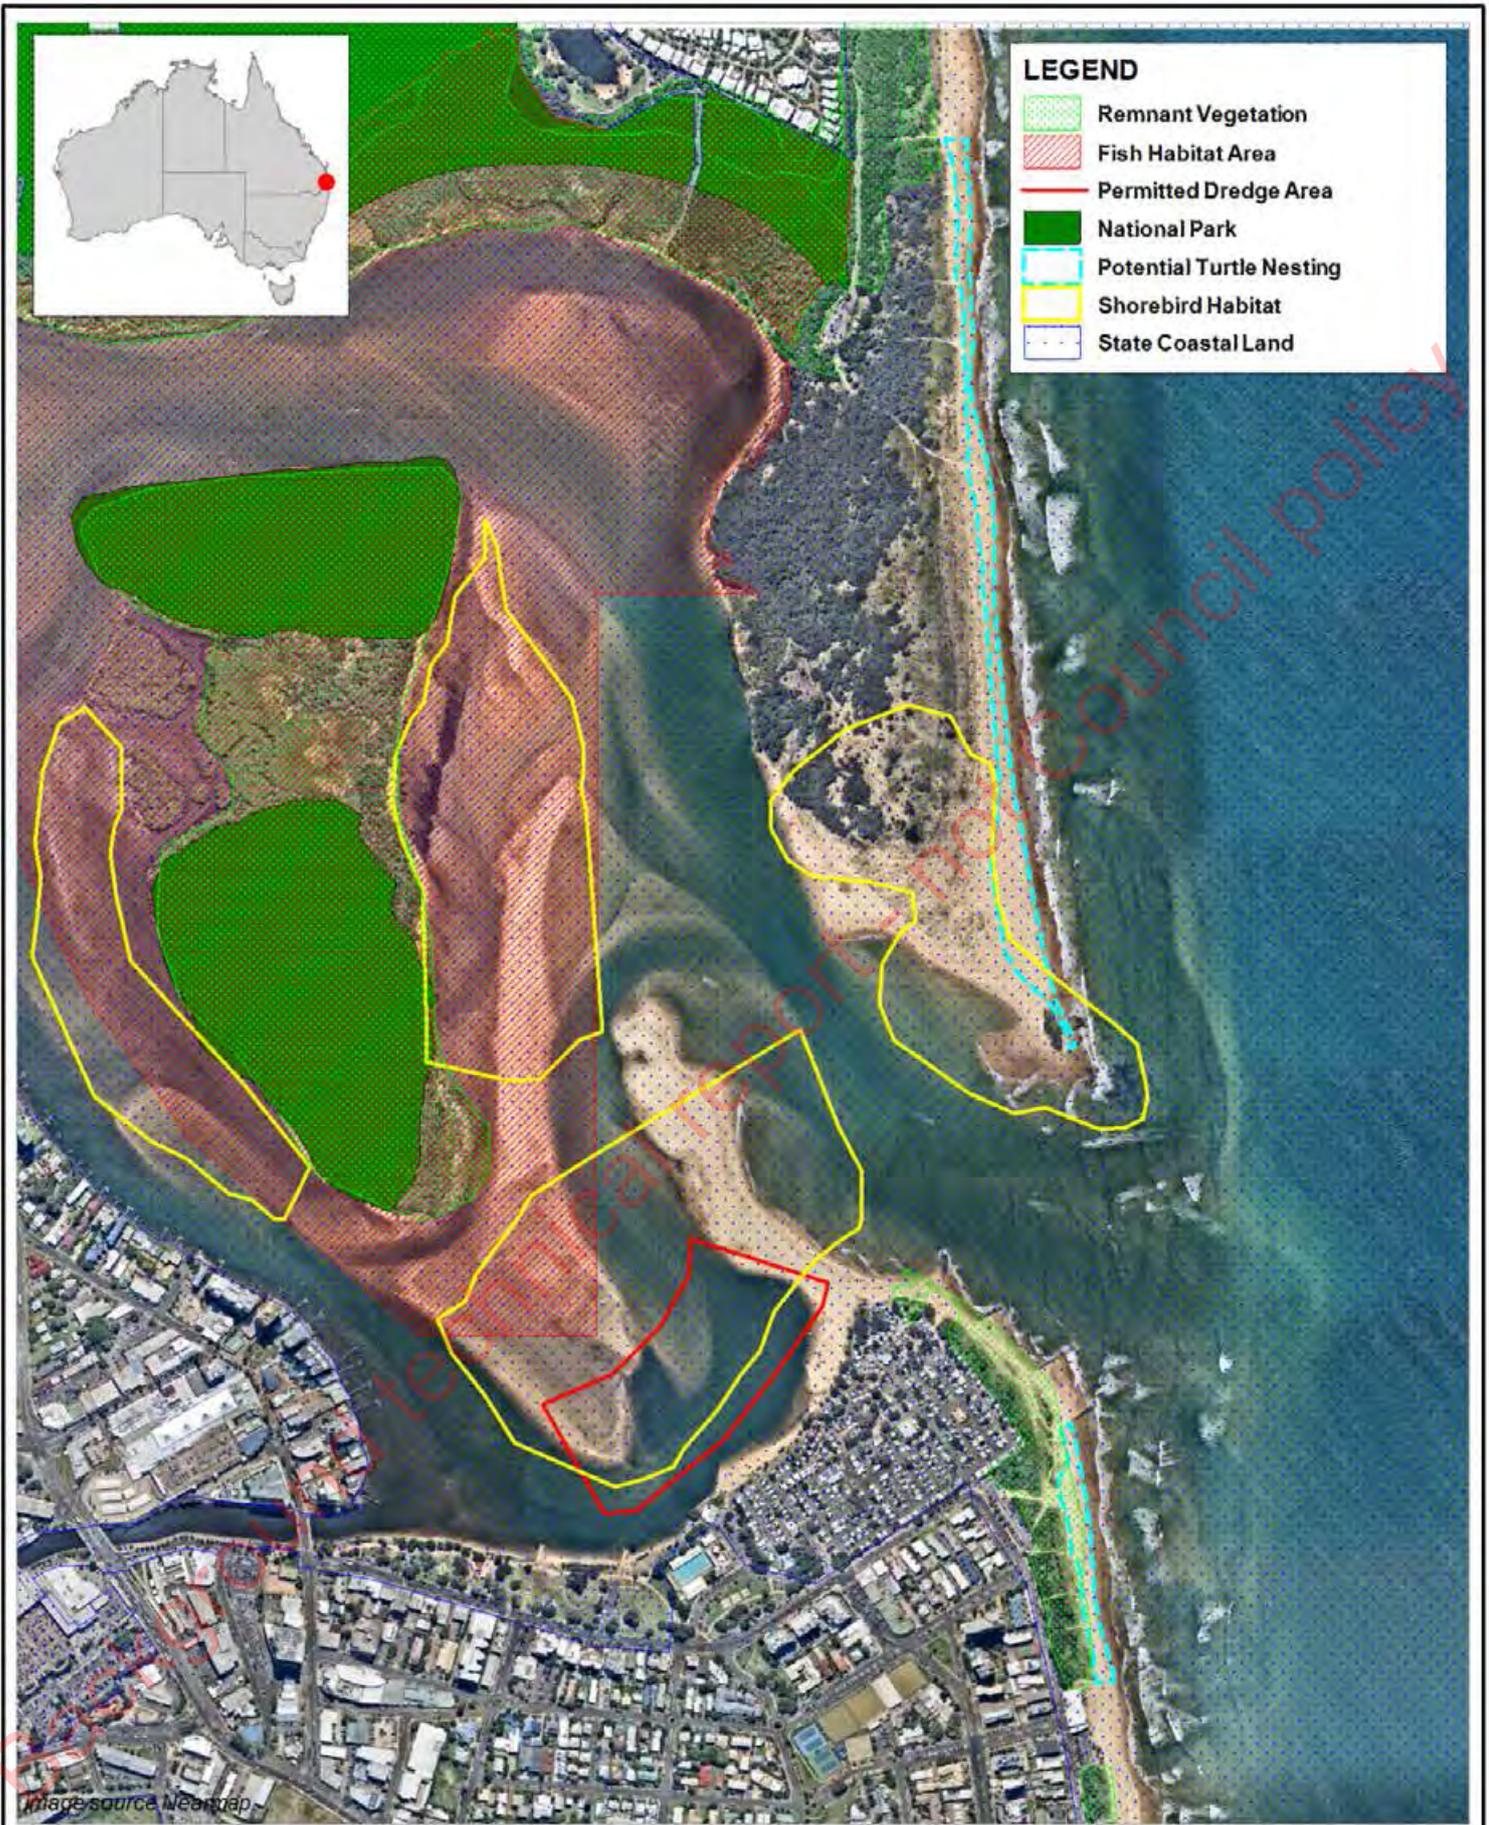
Title:
Environmental Constraints within the Lower Maroochy River

The environmental constraints relevant to the lower Maroochy River sand source are shown in Figure 2-17. The existing permitted and proposed extended dredge areas discussed further in the following sections are also indicated.

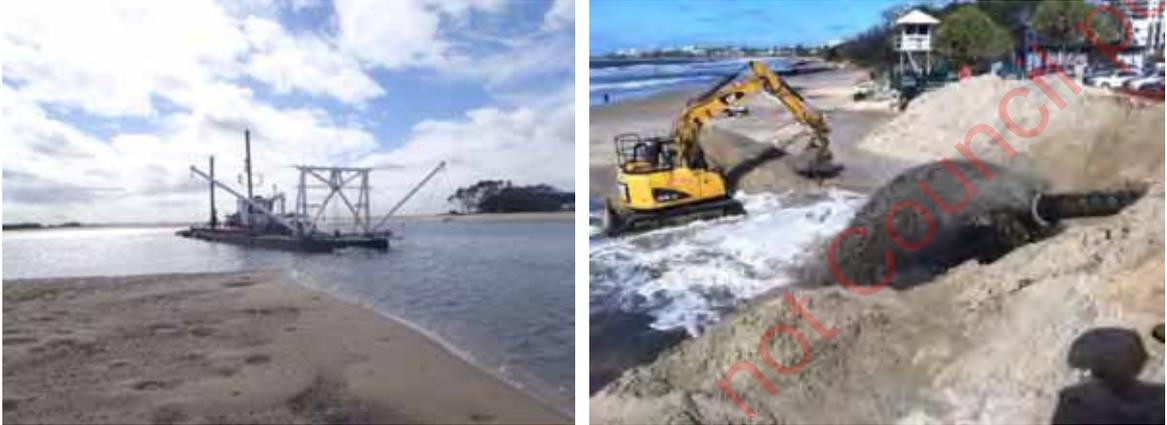
Figure 2-20 Cutter Suction Dredge and Pipeline Sand Delivery to Maroochy Beach

Consistent with recent dredging campaigns in the lower Maroochy River, any ongoing access to this sand resource is likely to be via a CSD and pipeline with profiling of the material using standard earthworks equipment as shown in Figure 2-12. Other general considerations relevant to this renourishment methodology have been previously discussed in Section 2.3.5.

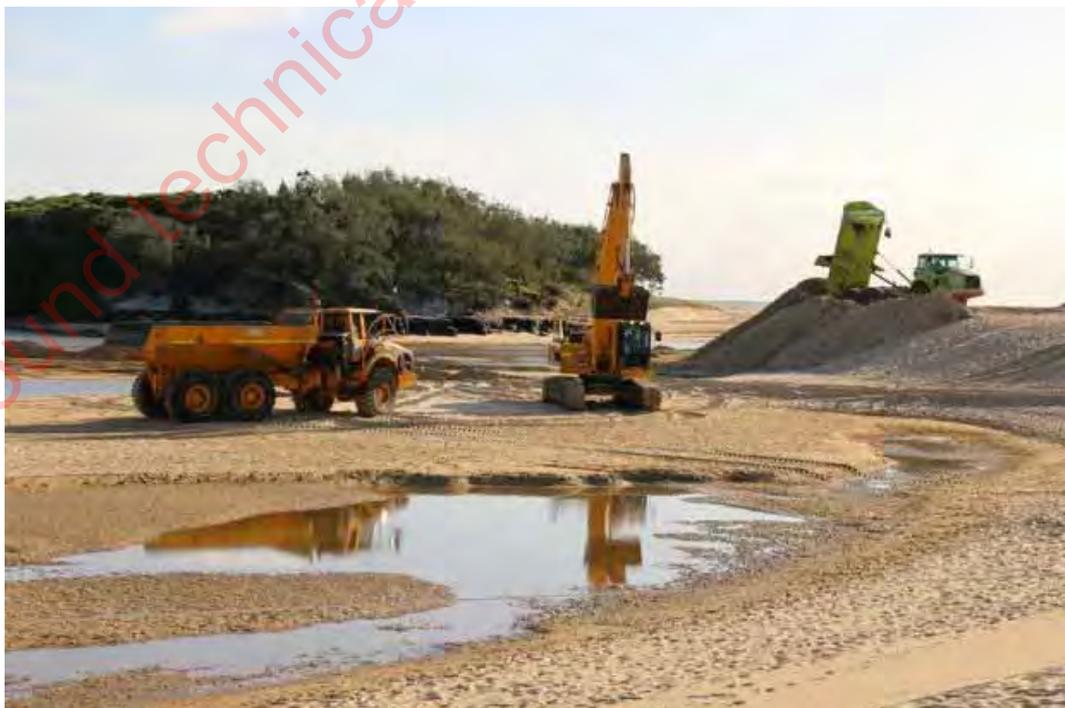
Figure 4-2 Berm Building at Currimundi Lake Entrance (Sunshine Coast Daily, 2015)

- Artificial opening and closing of the entrance in an effort to achieve environmental objectives and manage the upstream flood risk; and
- Maintenance of a berm at height that minimises overtopping (a height approximately equivalent to the Mean High Water Spring level of 0.7mAHD) to stabilise the entrance and limit channel migration (see Figure 4-2).

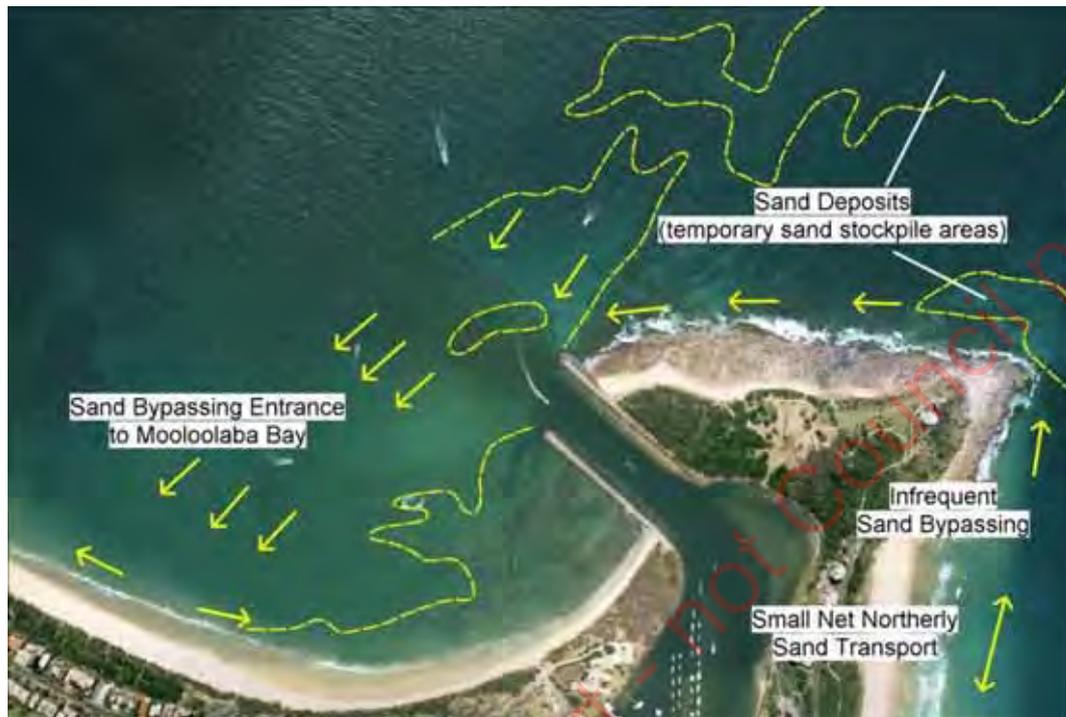
Figure 4-3 Conceptual Model of Sand Bypassing at the Mooloolaba Harbour Entrance (modified from: Department of Harbours and Marine, 1987)

The sequence of coastal processes understood to cause a significant Mooloolah Entrance shoaling event were originally described by the Queensland Department of Harbours and Marine (1987) who suggested sand bypassing mechanisms at Point Cartwright contributed to the “stockpiling” of sand deposits that can then move toward the entrance under certain wave conditions. This conceptual model is illustrated in Figure 4-3 and was generally supported in a subsequent investigation by WBM Oceanics (2004).

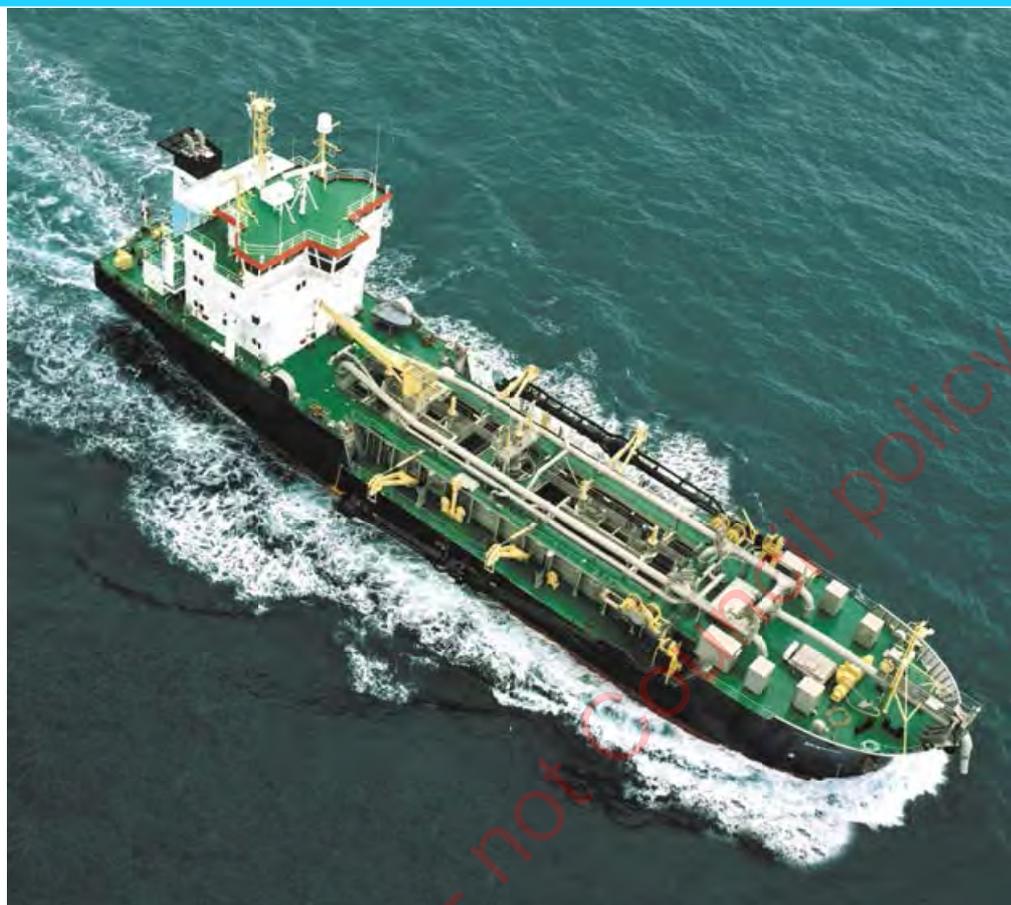
Trailing Suction Hopper Dredger BRISBANE

Principal dimensions

Length overall	84,00	m
Length between perpendiculars	79.90	m
Breadth moulded	16.00	m
Depth moulded	7.00	m
Draught at summer load line	5.50	m
Draught at reduced freeboard	6.25	m

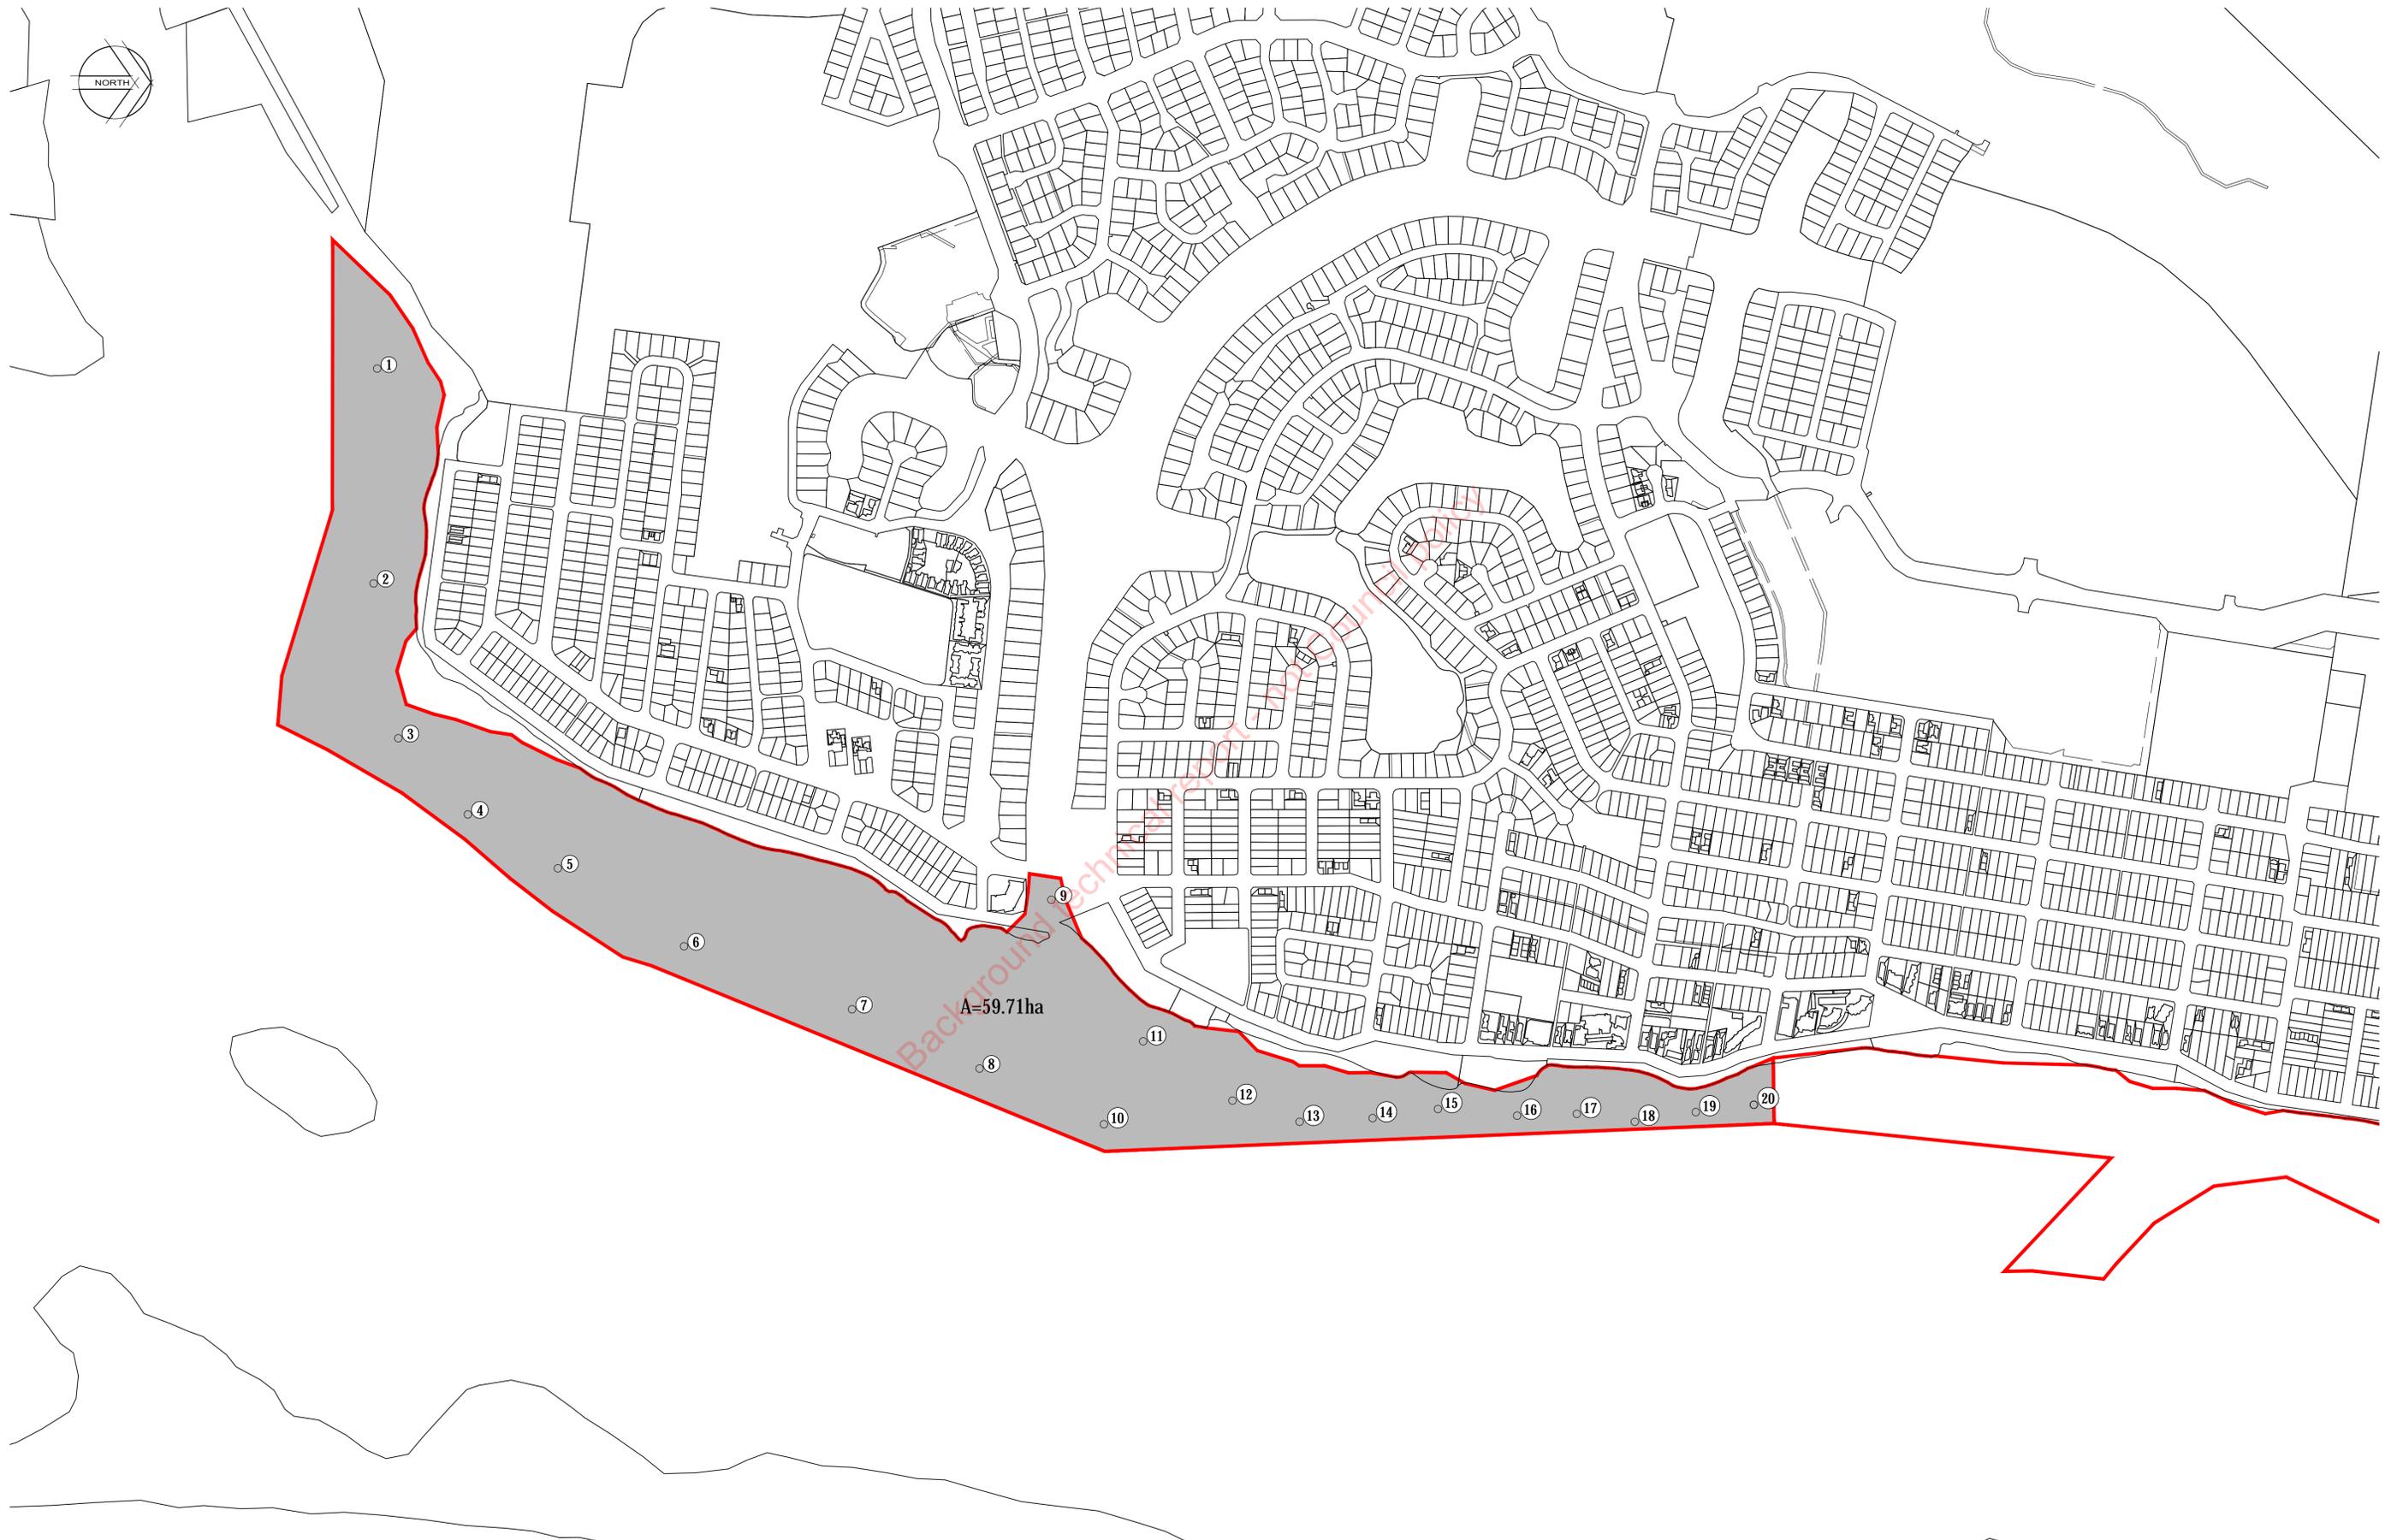
PUMISTONE PASSAGE - MAINTENANCE DREDGING AREA

A=59.71ha

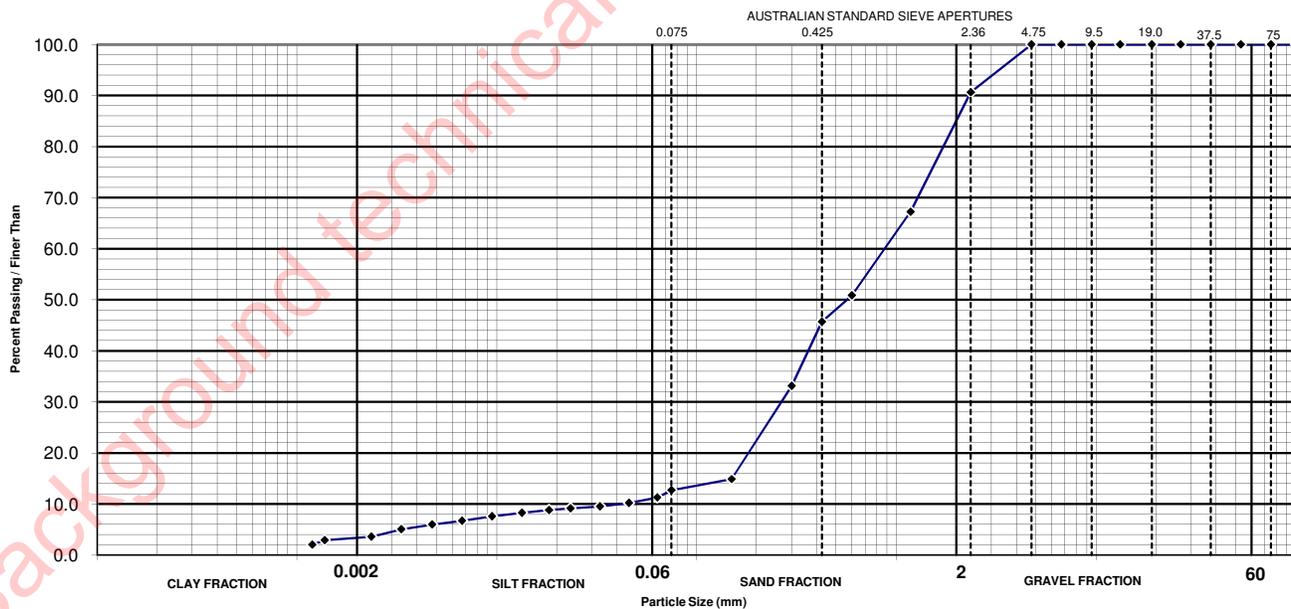
PARTICLE SIZE DISTRIBUTION - HYDROMETER

Particle Size (mm)	Cumulative Percent Passing	Particle Size (mm)	Cumulative Percent Passing	Particle Size (mm)	Cumulative Percent Passing
100		1.180	67	0.0134	8
75		0.600	51	0.0095	8
53		0.425	46	0.0067	7
37.5		0.300	33	0.0048	6
26.5		0.150	15	0.0033	5
19.0		0.075	13	0.0024	4
13.2		0.064	11	0.0014	3
9.5		0.046	10		
6.7		0.033	9		
4.75	100	0.023	9		
2.36	91	0.018	9

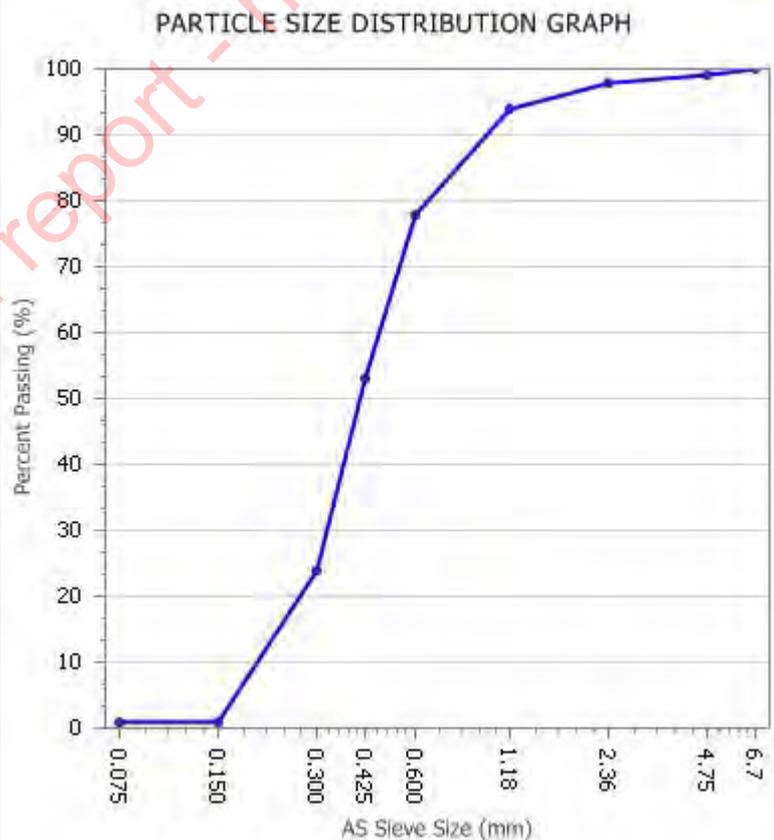
Test Procedures: AS1289.3.6.1	Sample Location
Sample Number 3740/S/42921	Location1 WP36
Sampling Method	Location2 1.5-2.0
Date Sampled 04/05/2015 09:00	Location3
Sampled By Paul Mayes	Location4
Date Tested 12/05/2015	Material Type Suspected ASS
Material Source Insitu

AS Sieve (mm)	Specification Minimum	Percent Passing (%)	Specification Maximum
6.7		100	
4.75		99	
2.36		98	
1.18		94	
0.600		78	
0.425		53	
0.300		24	
0.150		1	
0.075		1

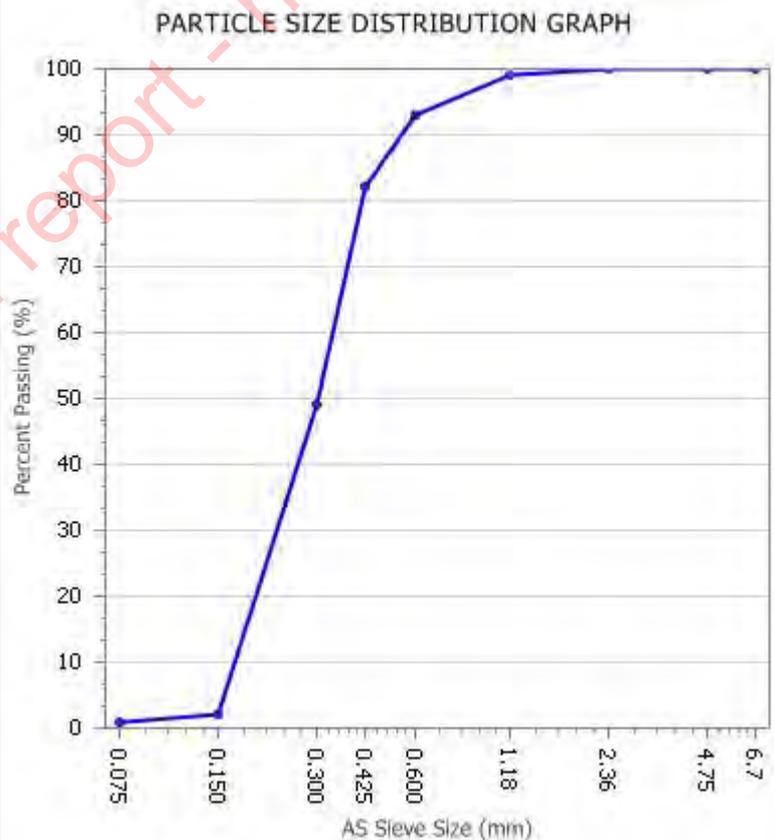
PARTICLE SIZE DISTRIBUTION GRAPH

Test Procedures: AS1289.3.6.1	Sample Location
Sample Number 3740/S/42926	Location1 WP37
Sampling Method	Location2 0.0-0.5
Date Sampled 04/05/2015 09:00	Location3
Sampled By Paul Mayes	Location4
Date Tested 13/05/2015	Material Type Suspected ASS
Material Source Insitu

AS Sieve (mm)	Specification Minimum	Percent Passing (%)	Specification Maximum
6.7		100	
4.75		100	
2.36		100	
1.18		99	
0.600		93	
0.425		82	
0.300		49	
0.150		2	
0.075		1

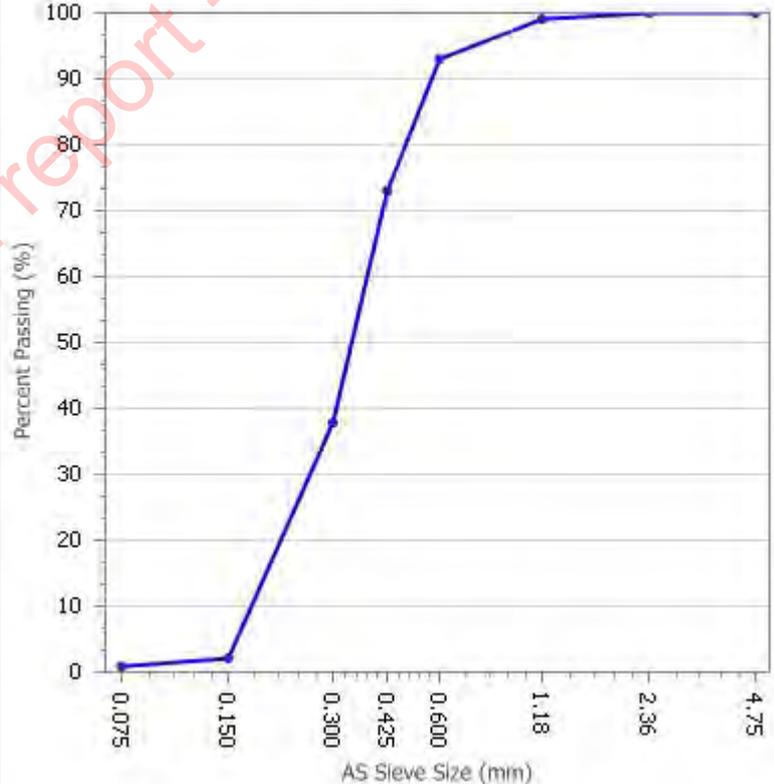
PARTICLE SIZE DISTRIBUTION GRAPH

AS Sieve (mm)	Specification Minimum	Percent Passing (%)	Specification Maximum
4.75		100	
2.36		100	
1.18		99	
0.600		93	
0.425		73	
0.300		38	
0.150		2	
0.075		1
