Final Report for

Performance Monitoring of the Earnshaw Street Stormwater Vegetated Infiltration Basin at Golden Beach

by the Stormwater Research Group
at the University of the Sunshine Coast

June 2018

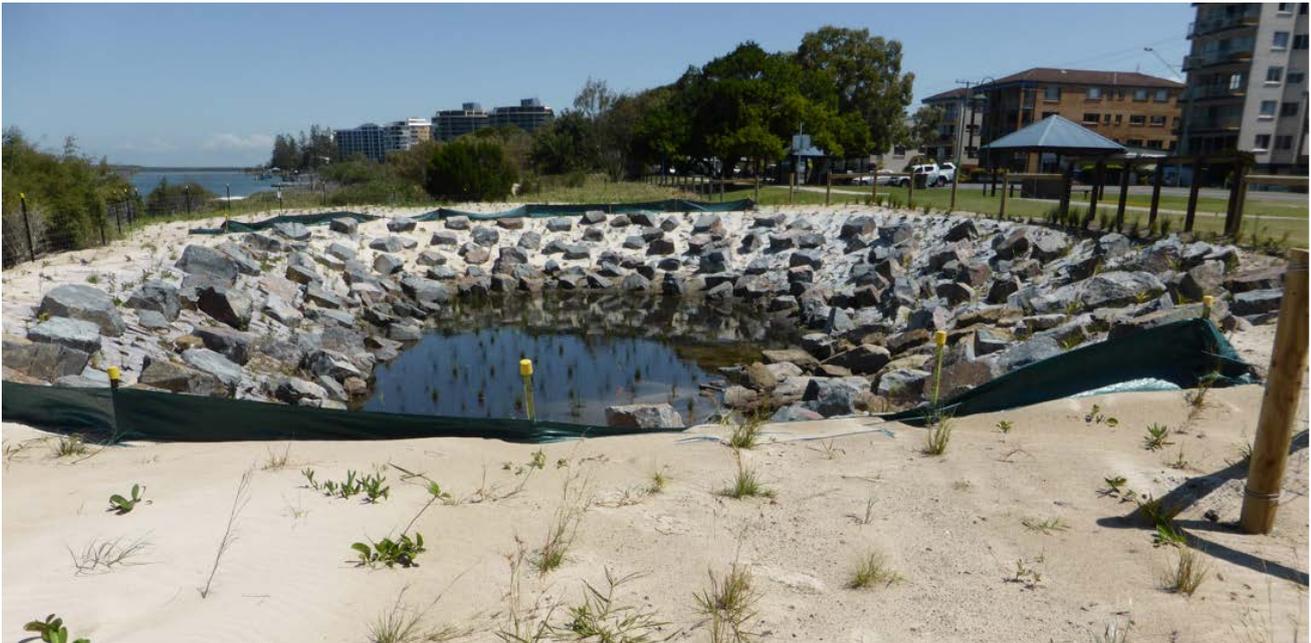
Figure 1 - Earnshaw Street Vegetated Infiltration Basin Installation (27-1-2015)

Sunshine Coast Council (SCC) is committed to implementing water sensitive urban design initiatives across the region to improve the quality of urban stormwater runoff and to improve the overall quality of downstream receiving waters. As part of their commitment to improving urban runoff, SCC installed a new vegetated infiltration basin at the end of Earnshaw Street on the Esplanade at Golden Beach in Caloundra (Figure 1) in 2015.

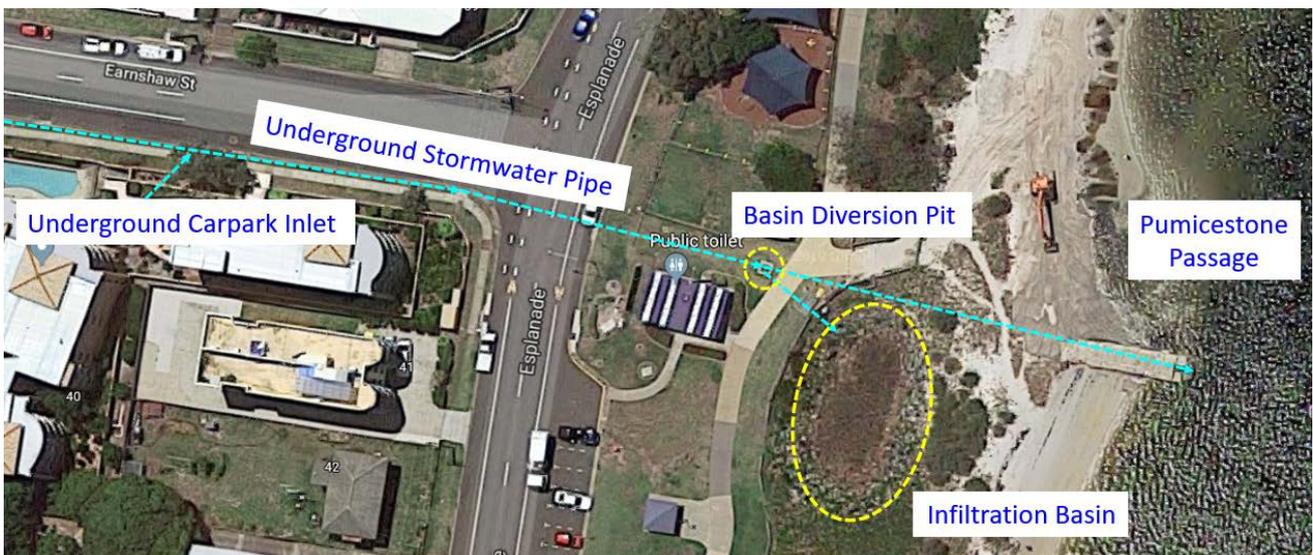
Figure 2 – Aerial View of Earnshaw Street Vegetated Infiltration Basin (Google Maps 2018)

After extensive consultation with leading industry consultants, this site was identified as the most effective location for the installation of the basin in order to remove pollutants from local stormwater runoff before discharging into Pumicestone Passage (Figure 2).

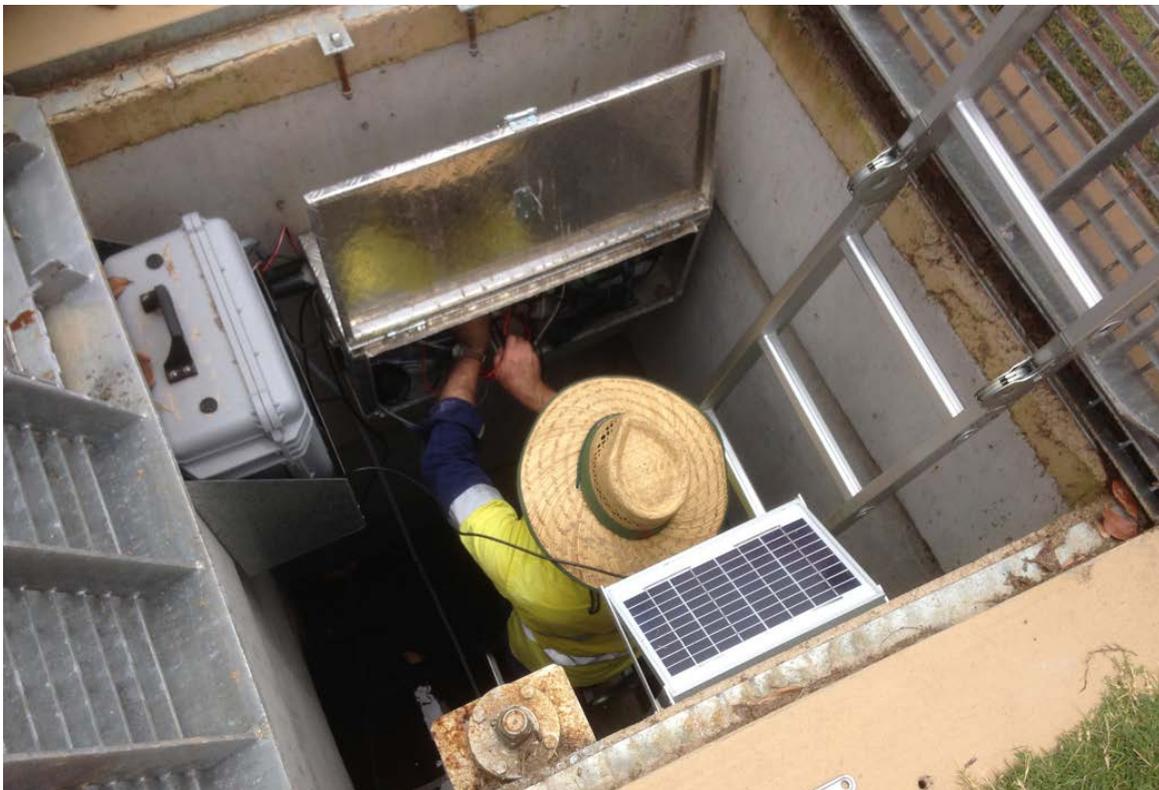
Figure 3 – Installation of Automated Water Sampling Equipment in Diversion Pit

An automated water sampling system was installed inside the basin diversion pit (Figure 3) to measure stormwater flow volumes and to collect water samples during storm events. An automatic water sampler (ISCO GLS) was installed in the pit and the sampler was triggered automatically when the flow meter (Starflow ultrasonic probe) recorded flows of ≥ 5.0 L/s. Samples were collected by the ISCO auto-samplers at 1,000 L intervals thereafter until flow ceased. Sample aliquots (200 mL) were composited within the automatic sampler.

Unfortunately, despite SWRG researchers having had much success in the past with these types of sampling systems, the automated sampling system at Golden Beach was prone to problems and proved to be very unreliable. The system was repaired, and components were replaced numerous times over the course of the project. However, the automated system simply did not seem to be able to cope with being installed inside a stormwater pit and it could not produce reliable storm event flow data. As such, in the interests of completing the project on time, the decision was made to estimate catchment runoff volumes coming into the diversion pit using the catchment area and daily rainfall volumes.

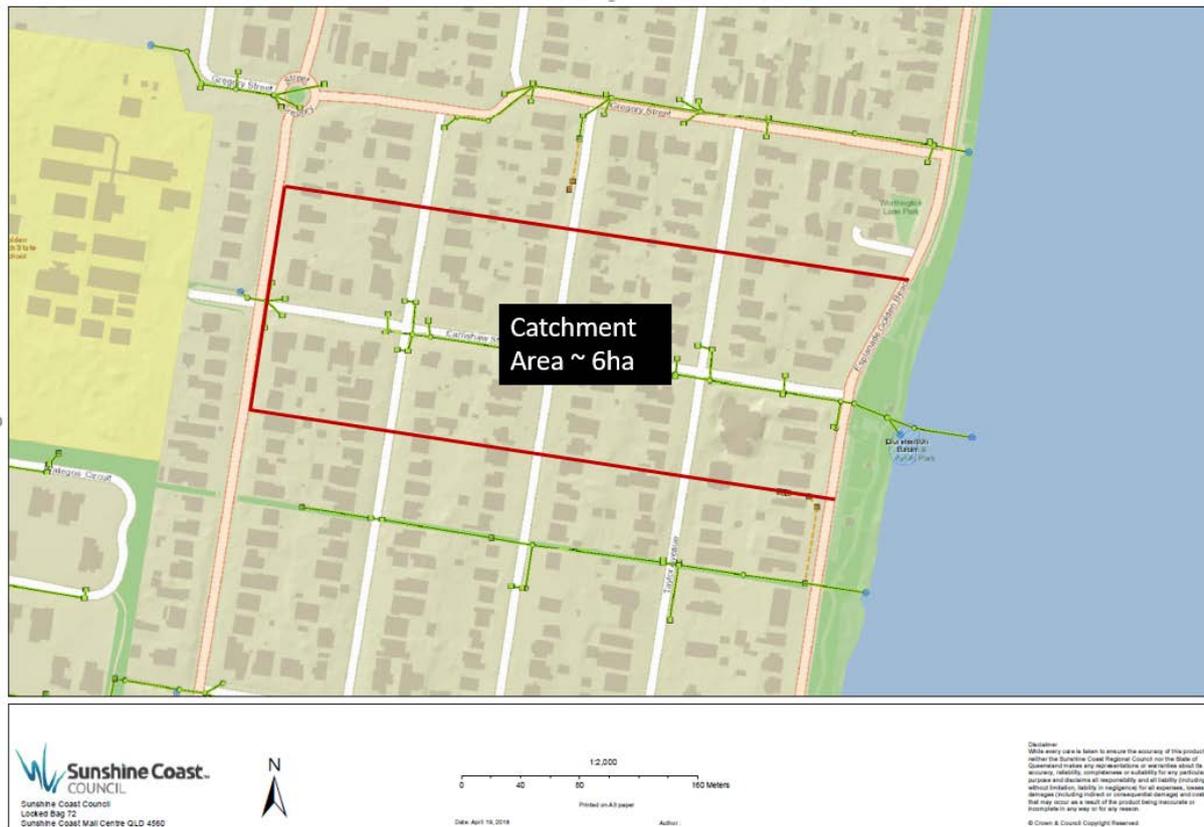
Figure 4 – Catchment area treated by Earnshaw Street Vegetated Infiltration Basin

The total volumes of stormwater being conveyed to the basin diversion pit by the main drainage line during storm events were calculated by multiplying the catchment area by the daily rainfall data from the BOM rain gauge at Caloundra Airport (www.bom.gov.au). A Runoff Coefficient (C) of 0.7 was applied to the volumes to allow for infiltration into the high-density urban residential catchment (QUDM, 2013 - Table 4.5.1). The rainfall catchment area for the Earnshaw Street stormwater outfall was estimated to be approximately 6.0ha (Figure 4 – SSC Stormwater Drainage Infrastructure Plan). Estimated runoff volumes are listed in Table 2.

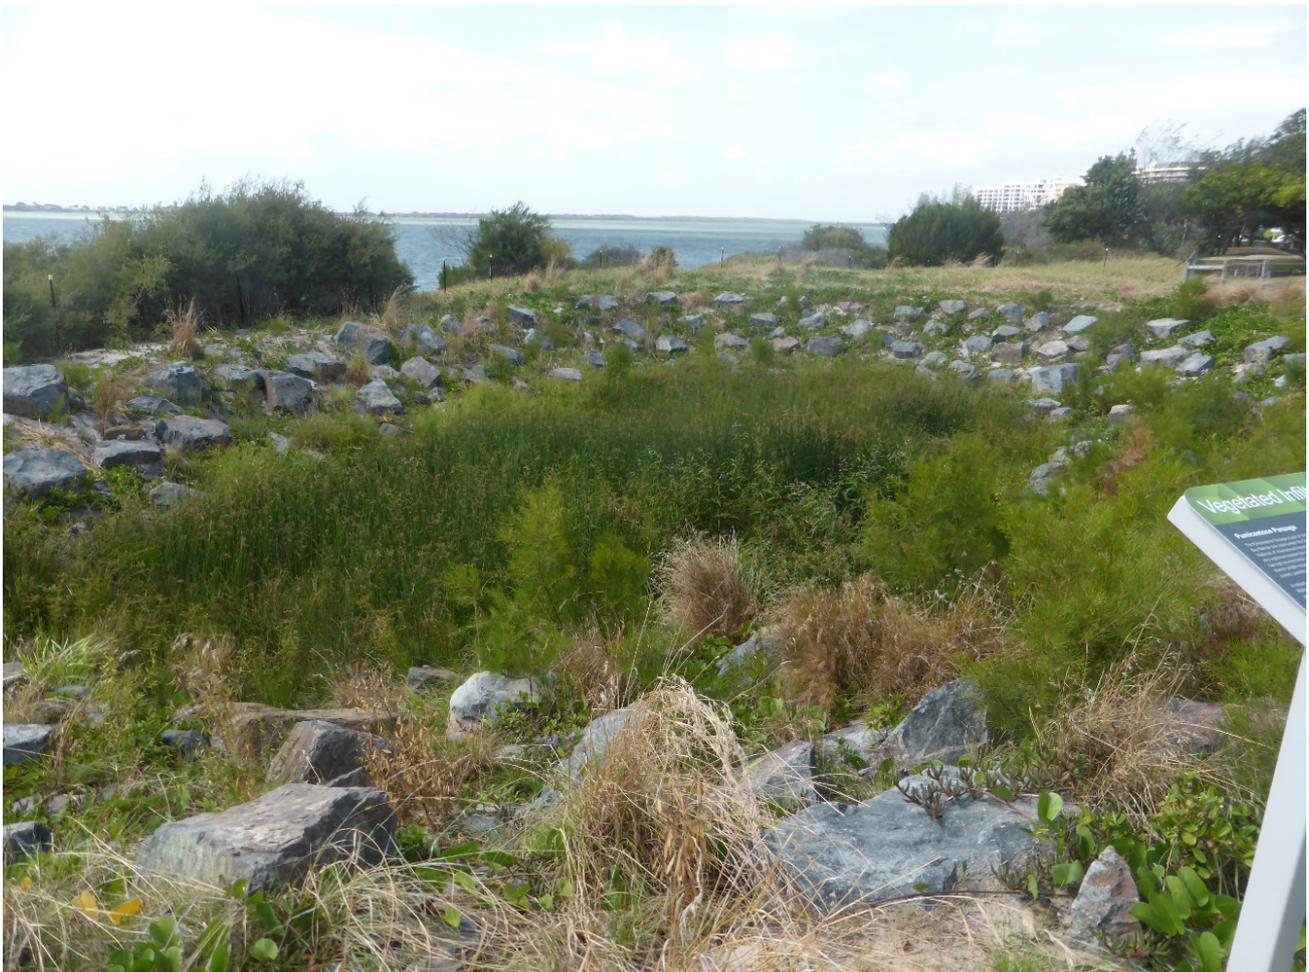
Figure 6 – Fully Established Vegetation in Earnshaw Street Infiltration Basin
