Infiltration Basin Sediment Analysis Earnshaw Street, Golden Beach

Prepared for:
Yolanda Burt
Transport and Infrastructure Policy
Regional Strategy and Planning
Sunshine Coast Council

Report Number: J000196-0018-R-Rev0

July 2017

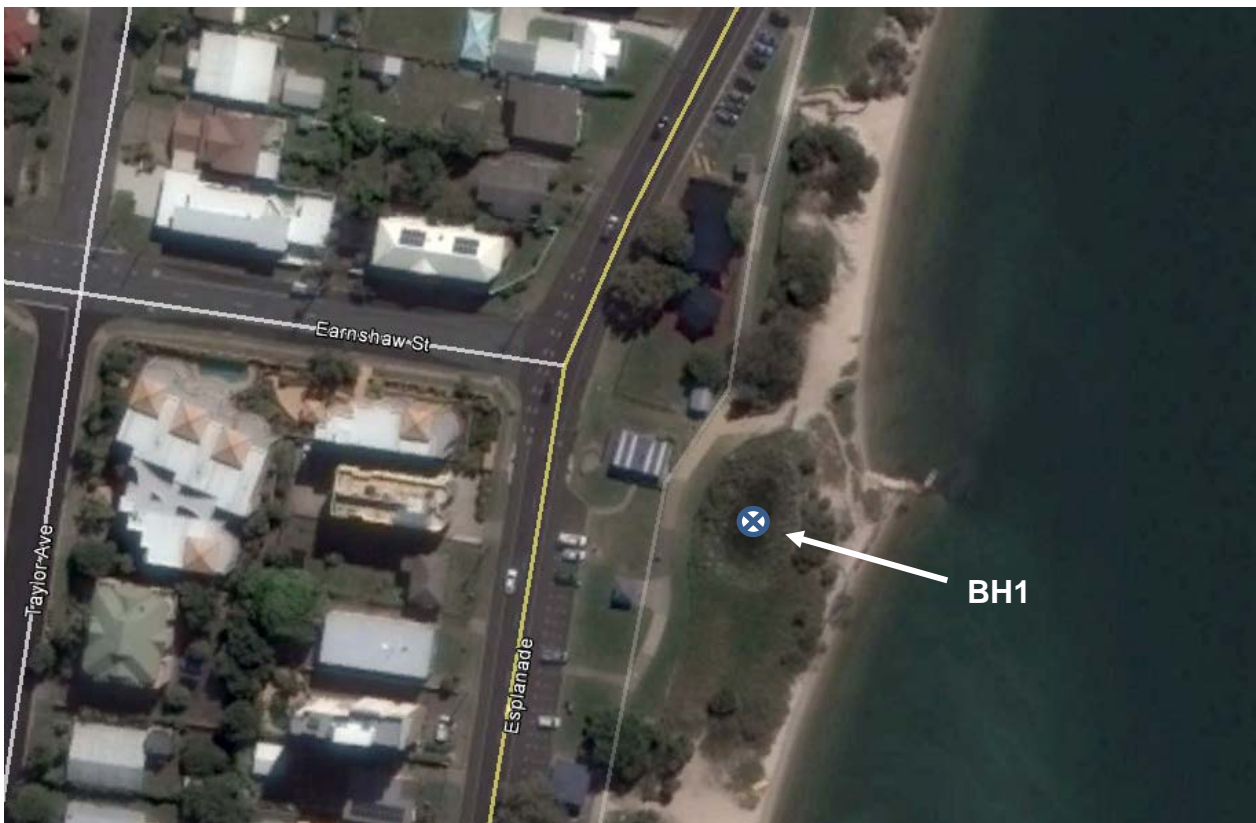
Plate 1: Site locality and Borehole Location.

The infiltration basin is located at the junction of Earnshaw Street and The Esplanade, Golden Beach. The site is owned and maintained by Sunshine Coast Council and is surrounded by parkland and recreational facilities with Pumicestone Passage located approximately 10 metres to the east. The infiltration basin is vegetated with a mixture of typical wetland species both native and introduced grasses and reeds.

For the purpose of this investigation Core undertook one borehole within the infiltration basin to identify subsurface conditions at the site (refer Plate 1).
