# Moffat Beach Seawall Reconstruction Project

Community Focus Group

Meeting 2 October 2024

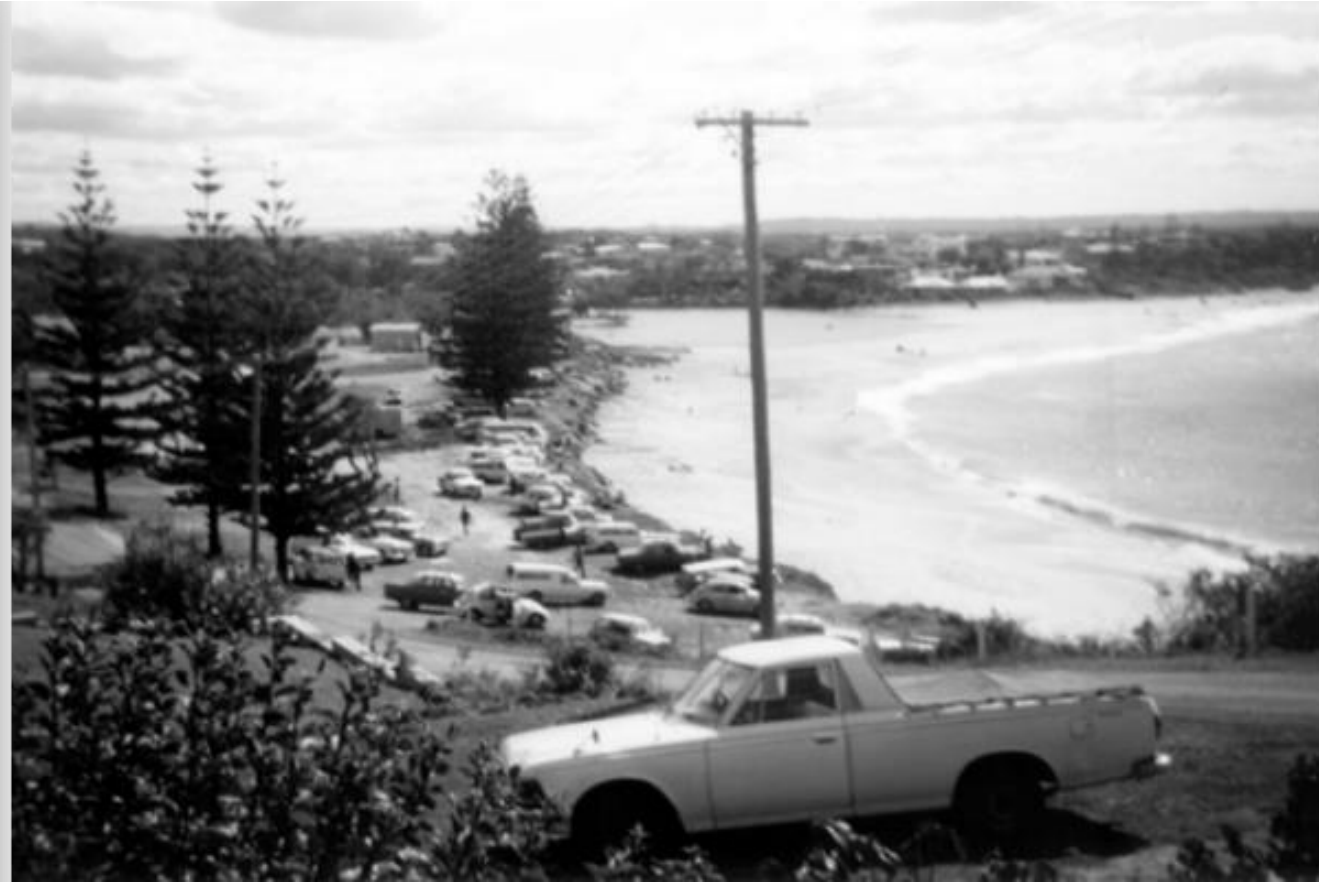
Moffat Beach after dump rock on shoreline, infilling of park (circa 1960)

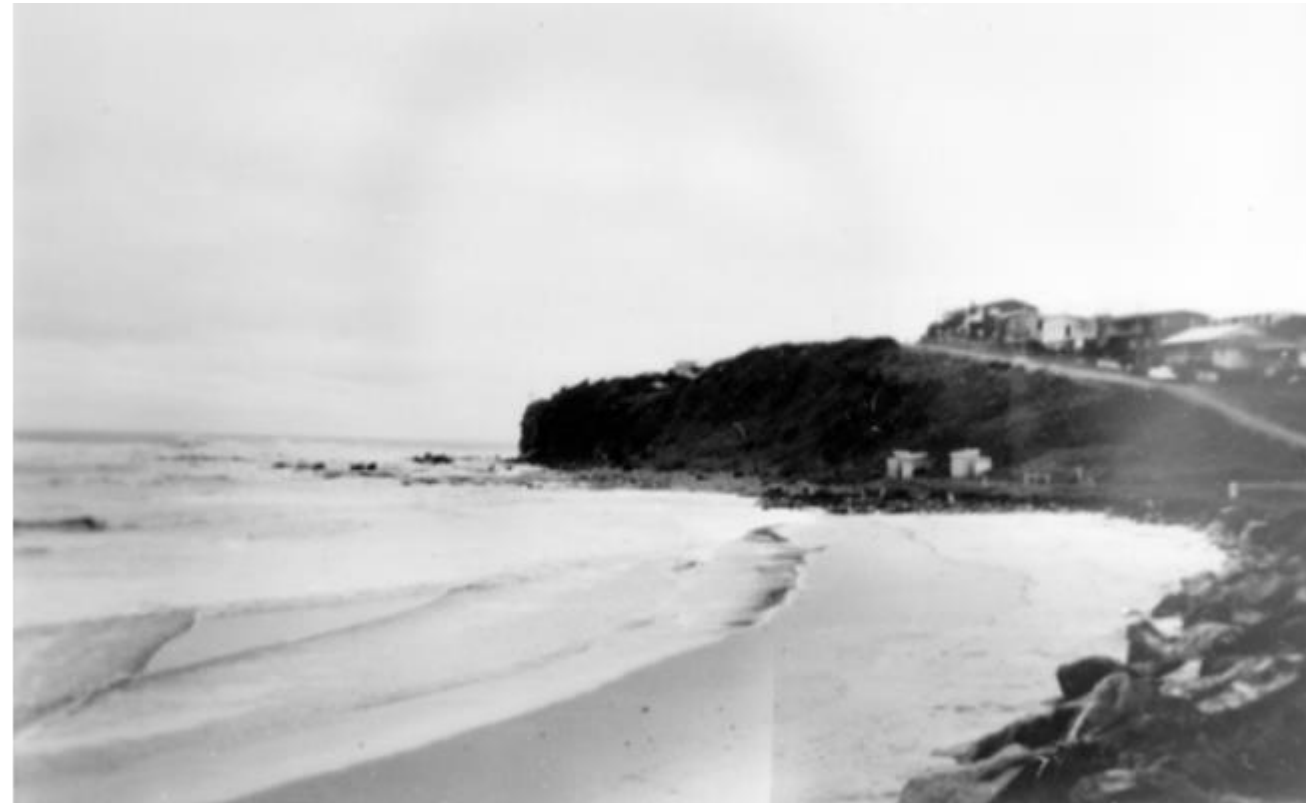
Moffat Beach after cyclones in February 1972

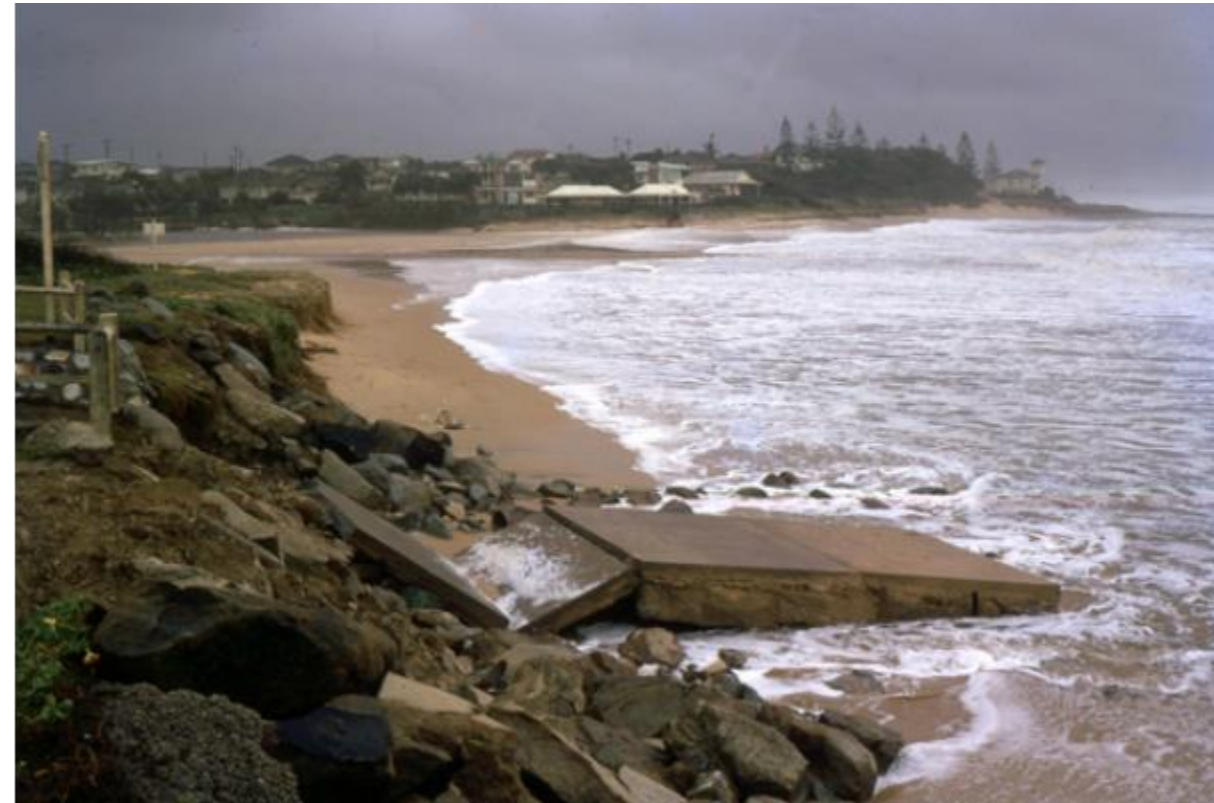
Moffat Beach following Cyclone Daisy, February 1972

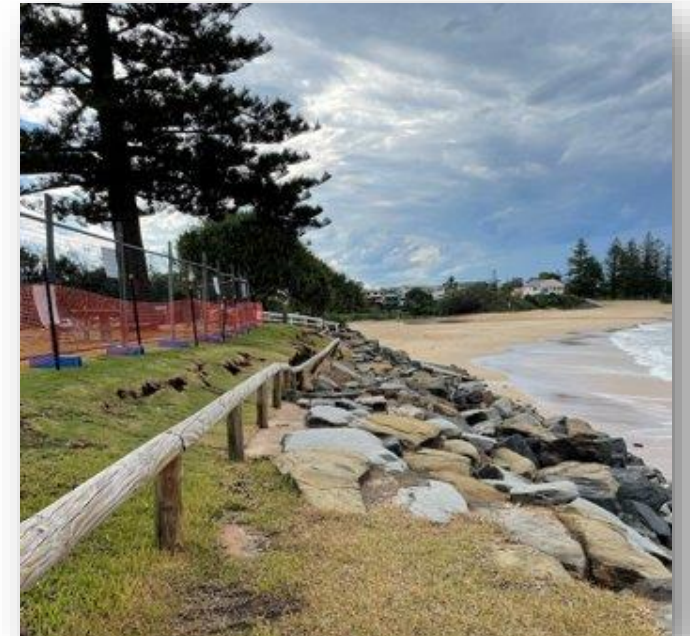
- The Moffat Beach seawall (approx. 260m), and its two timber beach accesses were constructed in 2008 following erosion of the embankment and collapse of the old dumped rock wall.

- The 2008 seawall design footprint was minimised to retain the Norfolk pines and park area whilst also reducing the encroachment onto the beach as much as possible. Because of this, the front face of the wall was constructed too steep - at or beyond 1:1 or 45 degrees (priority not given to function/safety/engineering design).

- Due to the narrow seawall, there was also insufficient drainage material placed at the time of construction.
- During the February 2022 rain event, a 60m section of seawall underwent a rotational failure.

- The main causes of this failure included:
  - Extended period of wave erosion - low sand levels at the base of the wall offer little restoring force.
  - Heavy and consistent rainfall, successive La Nina years – led to high ground water pressure behind the seawall with poor drainage.

- Steep seawall batter, the rock is placed beyond its natural angle of repose and is more prone to failure and wanting to return to this natural angle when stacked up a slope.

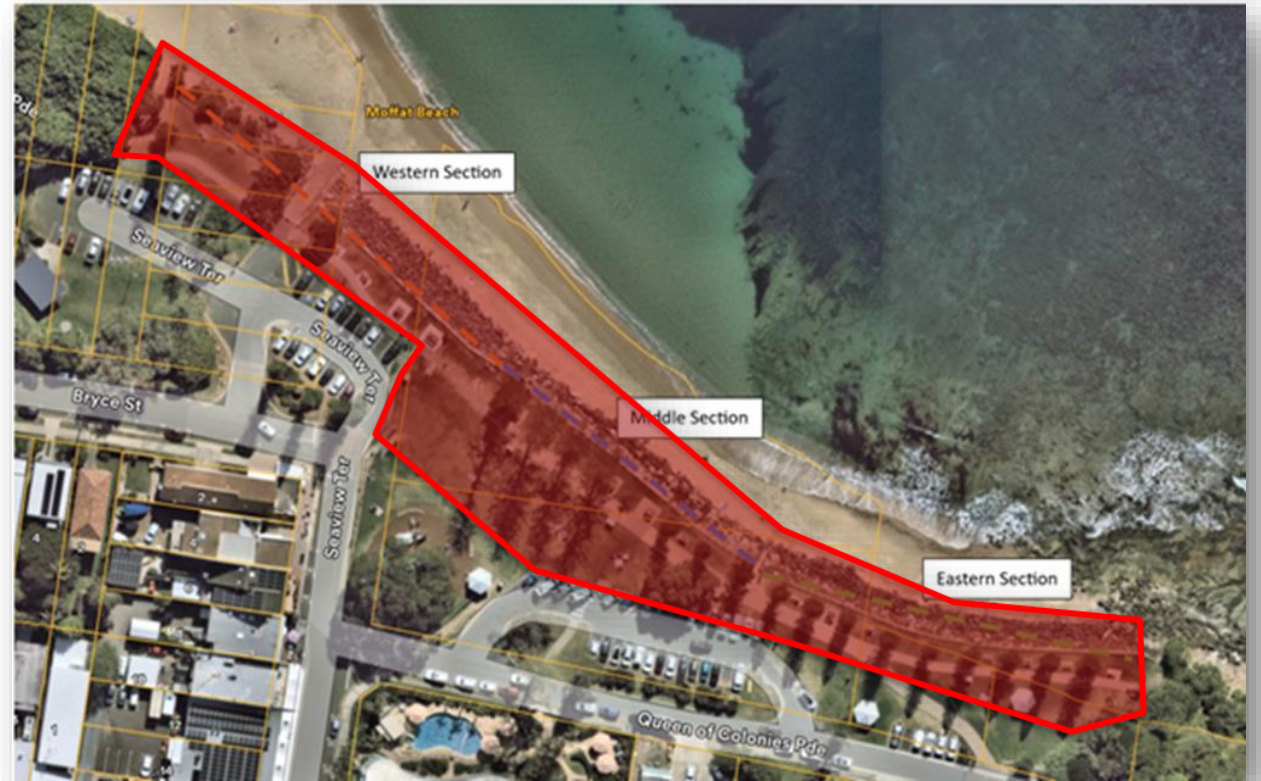
- Western Section (QRA funded) – rock seawall design and construction
- Middle Section (SCC funded) – rock seawall design and construction
- Eastern Section – design only (note construction not currently funded)

- Vehicle access ramp (DTMR funded) – design and construction integrated with seawall
- Beach accesses (QRA and SCC funded) – design and construction integrated with seawall
- Open space landscape and amenity immediately behind the seawall, including surrounding parklands, plantings, coastal pathway, seating, tables, beach showers, etc. (SCC funded)
