# Monitoring Report

## Maroochydore Beach Nourishment Trial

Sunshine Coast Council

7 June 2023

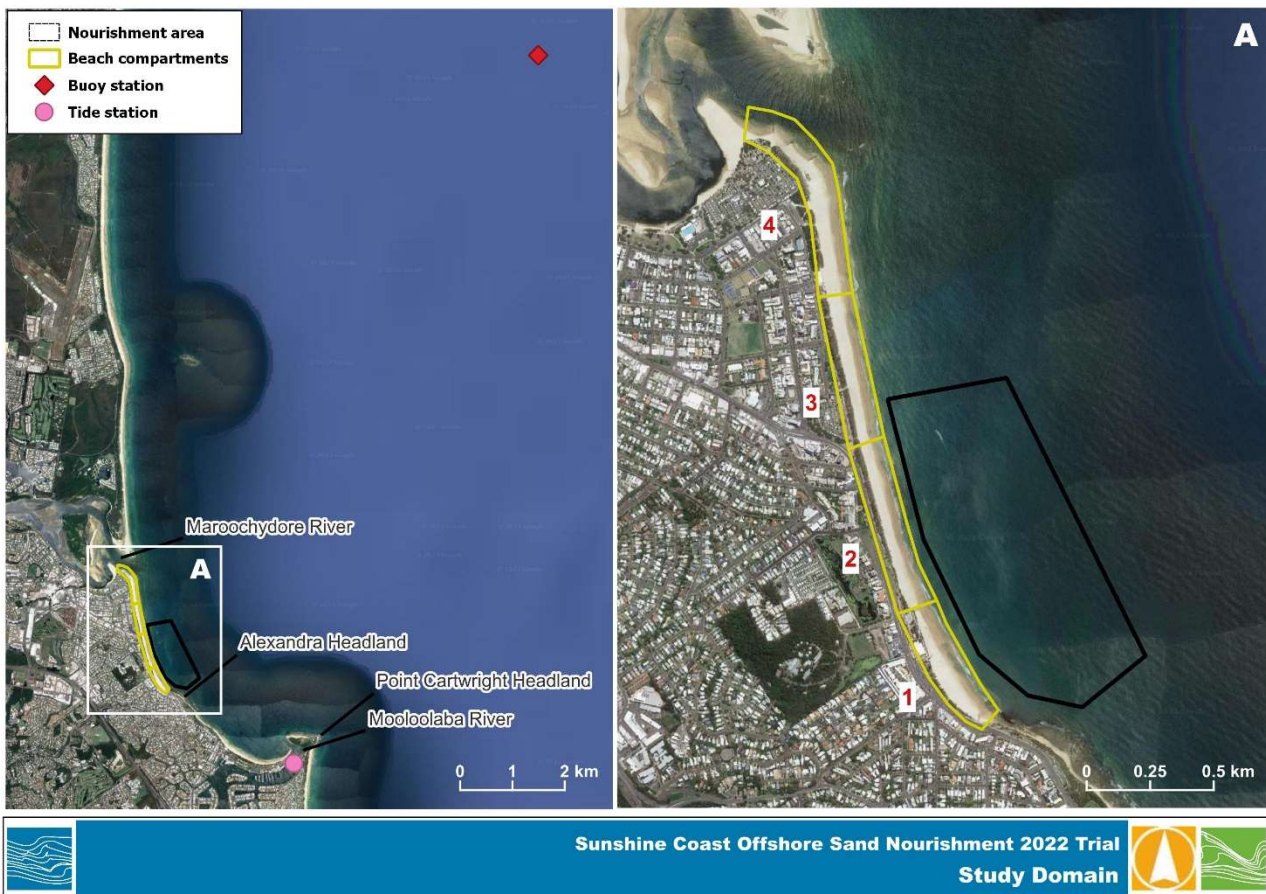
Figure 1-1 indicates the location of the area investigated for nourishment and the location of four beach compartments, each approximately 500m wide, from the Alexandra Headland to the Maroochydore River estuary. The location of sand deposition occurred on the northern section of the nourishment area to avoid covering existing reefs offshore Alexandra Headland.

Figure 1-1 Nearshore Nourishment Area

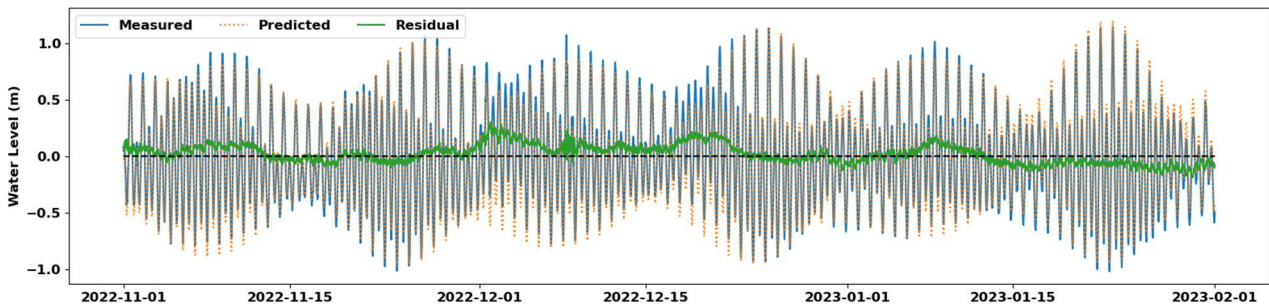
Figure 3-1 shows the record of water levels in the Mooloolaba harbour gathered by the Queensland Department of Environment and Science from November 2022 to February 2023. The water level in the ocean can be forecasted using astronomical tide calculations. The Figure shows the difference, called “residual”, between the theoretical astronomical tidal levels and the measurement. The water levels were slightly more elevated than the astronomical tide the month after the nourishment, with typically a +100mm residual. Such positive residual increases the risk of coastal inundation and erosion.

Figure 3-1 Water level at Storm Tide Gauge

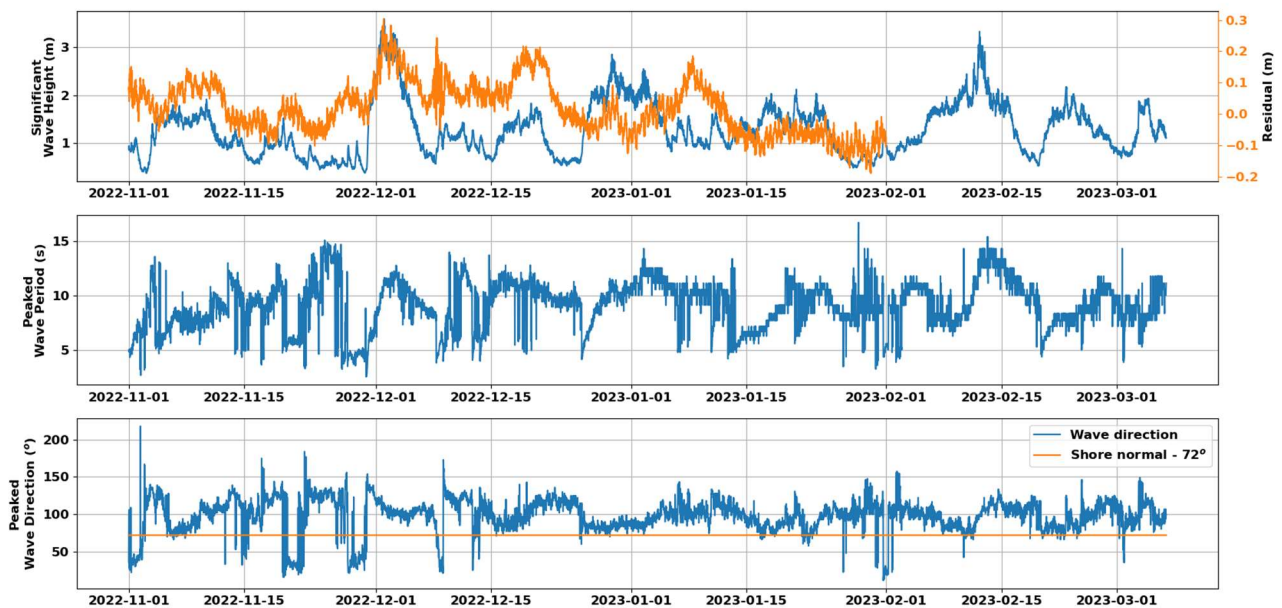
Figure 3-2 shows the wave parameters recorded at the Mooloolaba wave river buoy by the Queensland Department of Environment and Science from November 2022 to March 2023. The Glossary provides background information on recorded wave parameters, including Significant Wave Height (Hs), Peak Period (Tp) and Wave Direction. For convenience, the water level residuals have been plotted over Hs, and this shows that the residual is often positive during and after storms. The Significant wave height peaked slightly over 3.0m on two occasions during this period, in early December and mid-February.

Figure 3-2 Mooloolaba wave parameters

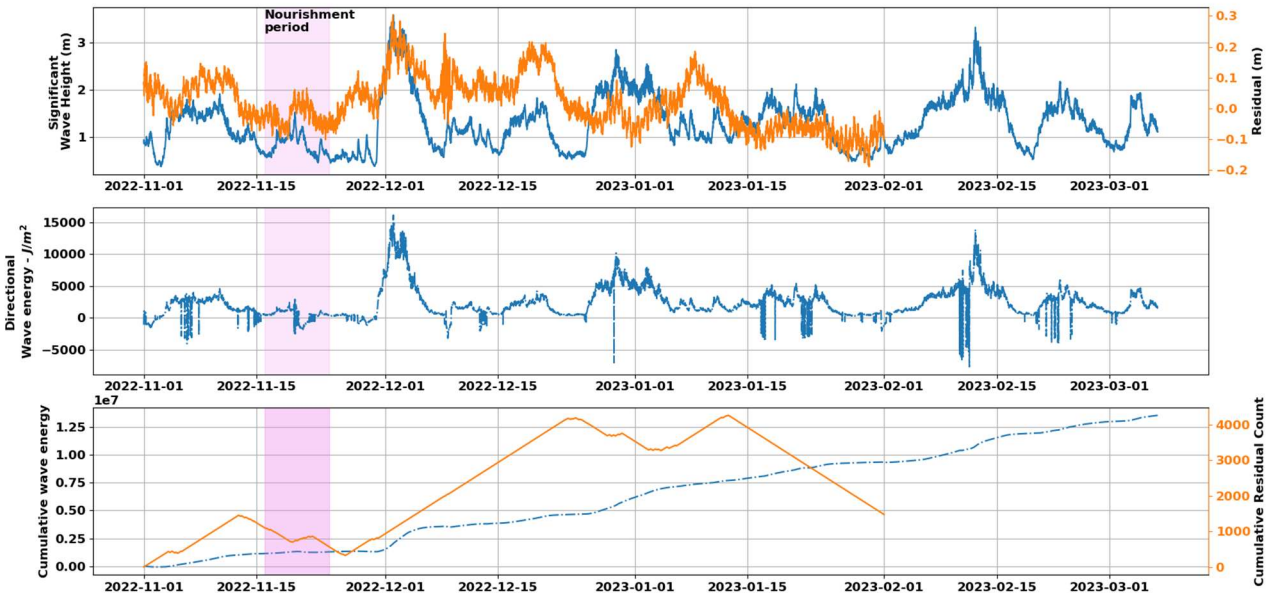
Figure 3-3 shows directional wave energy parameters during and after the nearshore nourishment works. A storm early in December kicked off a prolonged trend of south-easterly waves and positive residual. These smooth southerly wave conditions of summer 2023 slowly generated a net flow of sand towards the North.

**Figure 3-3 Directional surf-zone energy**

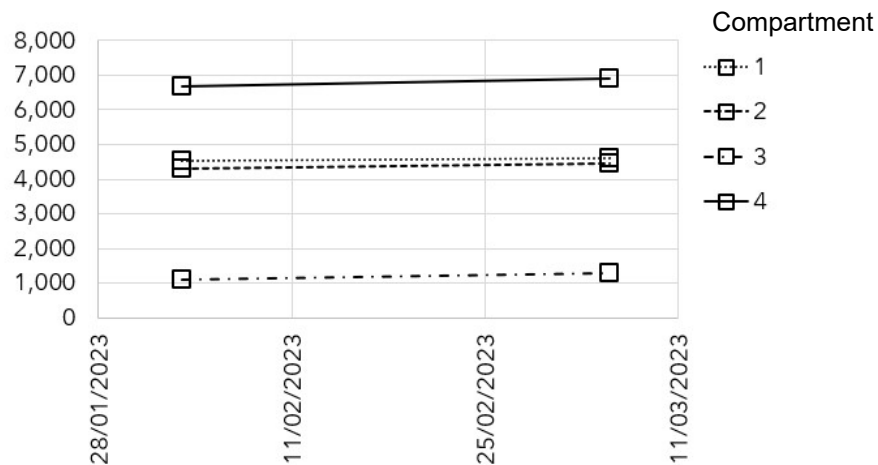
Figure 3-4 shows the Maroochydore upper beach volume change over time following the nearshore nourishment. The beach volume has increased in all four compartments as shown on Figure 3-5.

**Figure 3-4 Upper beach volume change in the four compartments**

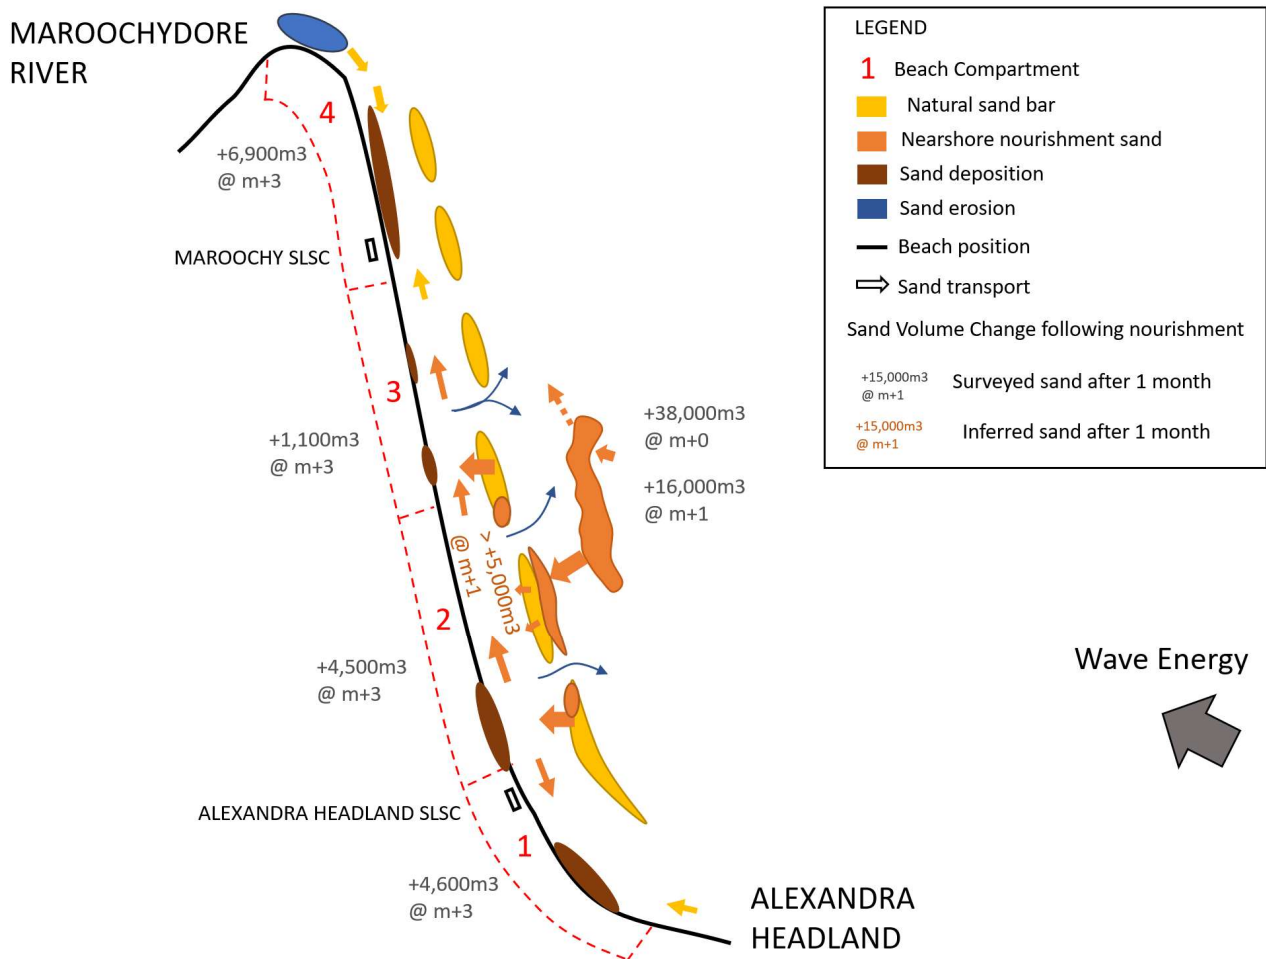
Figure 3-5 summarises the effect of the nourishment campaign 3 months after the nearshore nourishment works were completed. This summary arises from the merged upper beach survey and bathymetric survey shown in Figure 4-7 Appendix B and from the metocean analysis.

**Figure 3-5 Beach morphological changes and nearshore nourishment sand budget**

The convergence of sand transport in Compartments 1 and 4 likely contributed to sand volume gain in these Compartments. A significant fraction of the sand has spread across the surf zone or onto the intertidal beach.

- 16,000m<sup>3</sup> of sand remained at the initial sand deposition area (40%) in a reserve deposit
- The northern edge of the sand deposit spread sand northward and shoreward, while the southern edge of the sand deposit fed the surf zone and bulked up the sand bar shoreward from the deposition area. Sand bars moved onshore North and south of the deposition area.
- A significant sand deposition occurred with over 17,000m<sup>3</sup> of sand gain in the intertidal area
- At least 5,000m<sup>3</sup> of sand (12%) remained in the wave-breaking zone
- A small volume of sand (2 to 5%) leaked to the North of the sand deposit

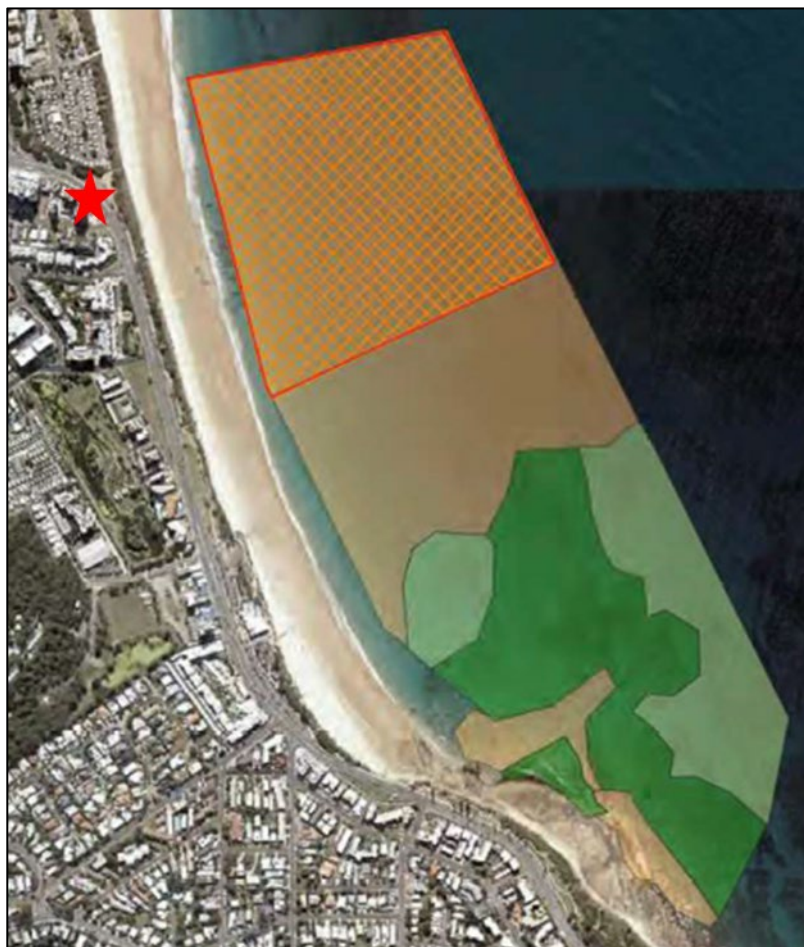
*Figure 1: Location map showing study site with location of video camera (red star) and sand nourishment placement (orange polygon).*

A Nearshore Nourishment Trial at Maroochydore Beach took place from Wednesday 16 November to Thursday 24 November 2022 at Maroochydore Beach. Surf amenity was monitored using a video camera mounted on a tripod from level 6 (~19m AHD) and level 7 (~22m AHD) balconies of Beachfront Towers on the 15<sup>th</sup> November and 24<sup>th</sup> November 2022, respectively (Figure 1).

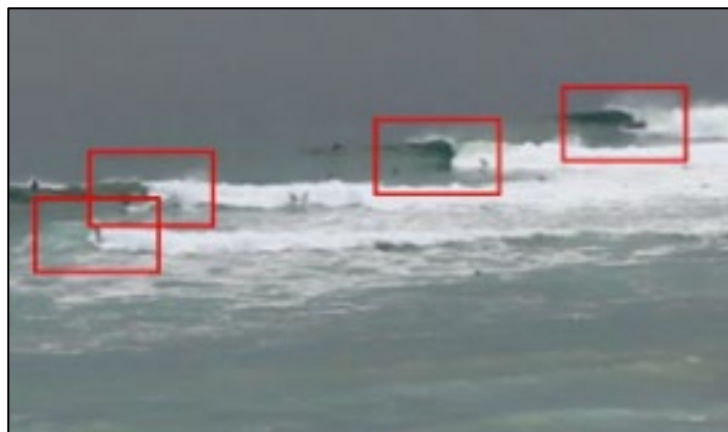
Video was analysed using the wave peel tracking (WPT) algorithm proposed by Thompson et al. (2021). In short, the machine learning algorithm detects the wave peeling region (boundary between the breaking wave and face of the wave, Figure 2) and tracks it as the wave crest breaks and travels towards the shoreline. The algorithms can then calculate the duration, length, breaking direction (right vs left) and speed of waves from rectified imagery.

*Figure 2: Examples of wave peel regions (red polygons). From: Thompson et al. (2021).*

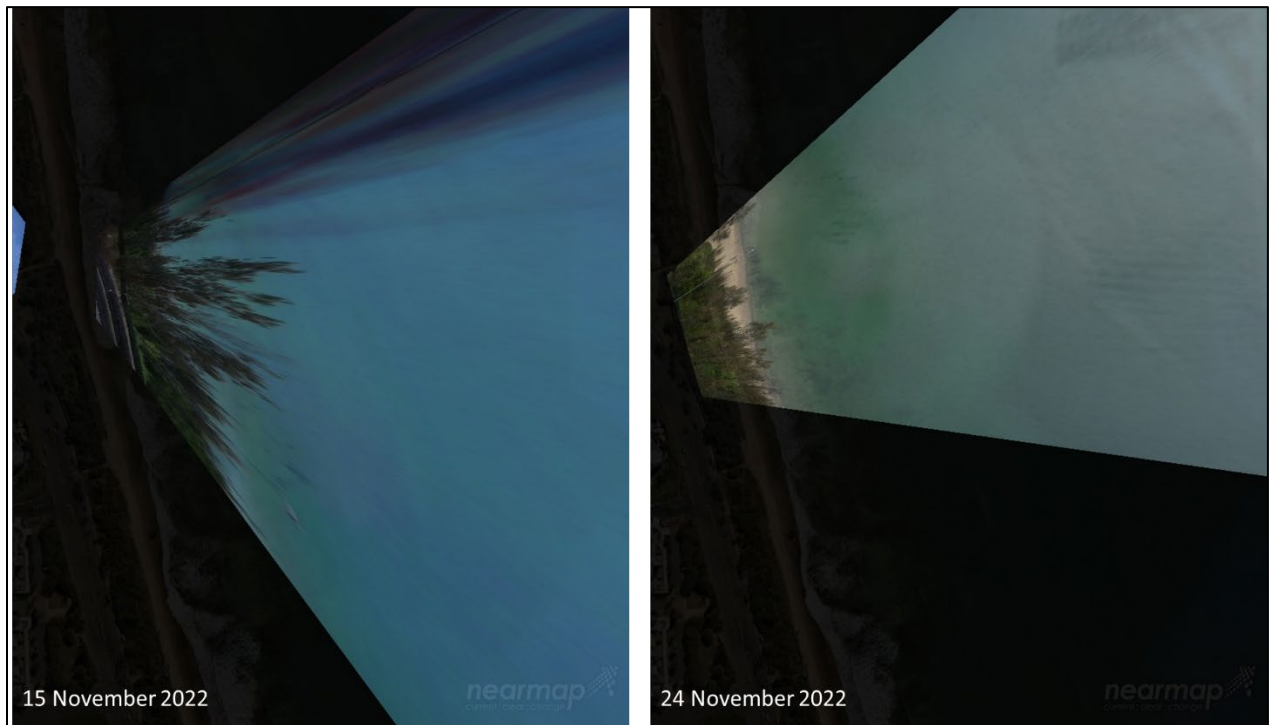
Video rectification was successful, but the lower section of the pre-nourishment monitoring (15 November 2022) was blocked by some trees due to shooting from a lower elevation (level 6) (Figure 3). Unfortunately, the lower level was the only available for the monitoring date. This was solved for the post-nourishment video. However, the masking of some waves made the exact comparison between monitoring dates unfeasible.

*Figure 3: Video rectification for both monitoring days*

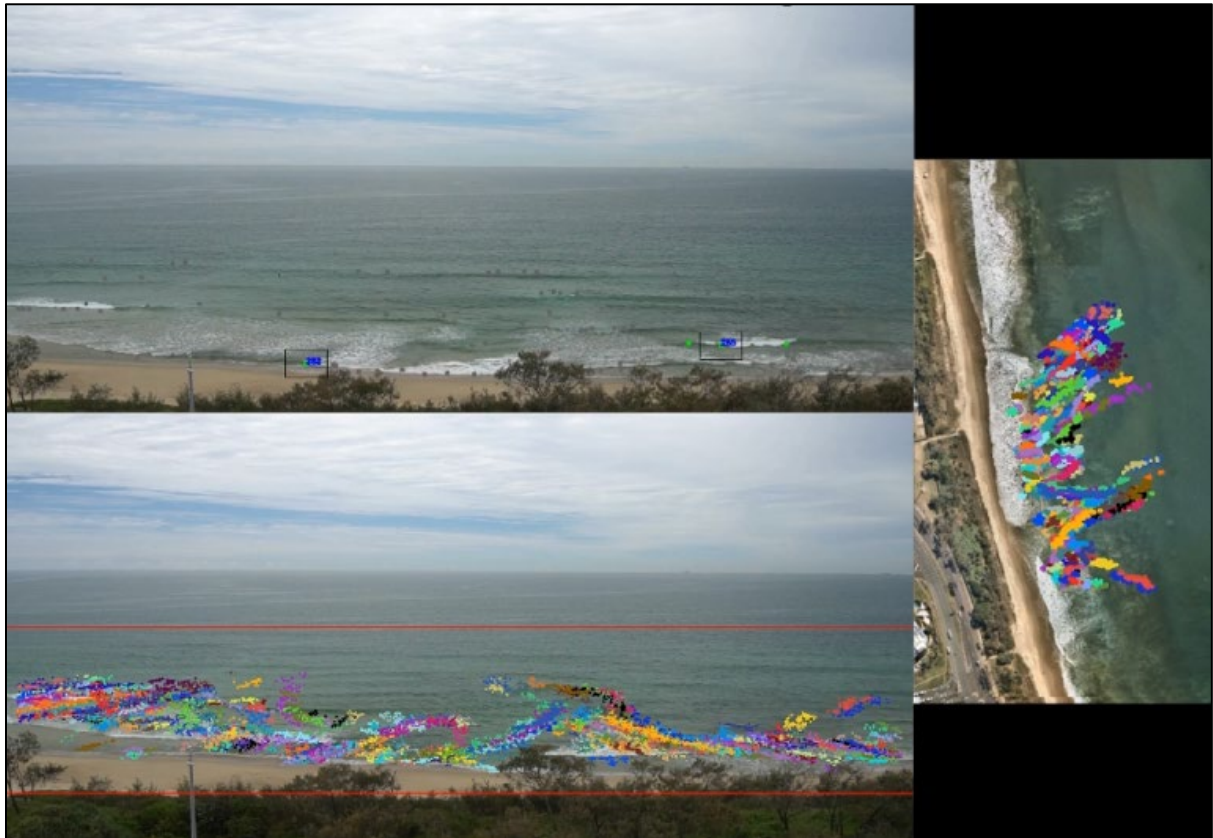
The tracking of individual waves agreed with the few GPS tracks recorded by the surfer. Figure 4 shows the GPS tracks (top panel), total number of individual waves detected and tracked overlaid on oblique (bottom panel) and rectified imagery (right panel).

*Figure 4: Individual waves detected and tracked on 24/11/2022*

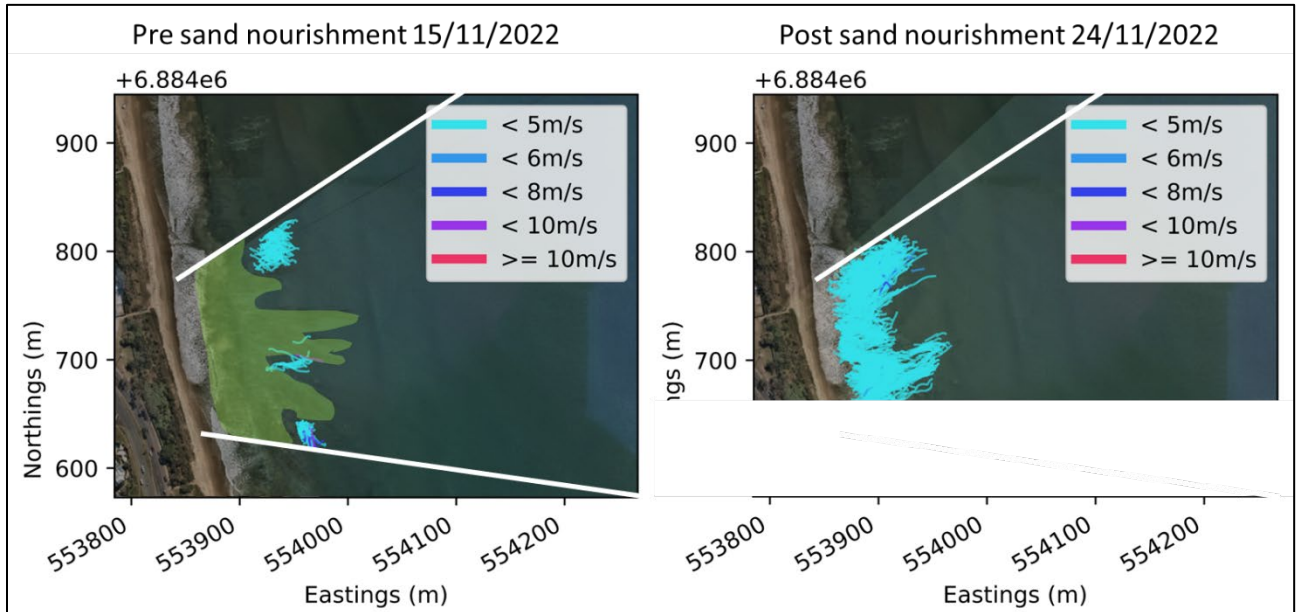
Wave speed averaged 4 m/s on both days (Figure 7). This was expected given the wave conditions during the monitoring days.

Figure 7: Wave speed (meters/seconds) for both monitoring days

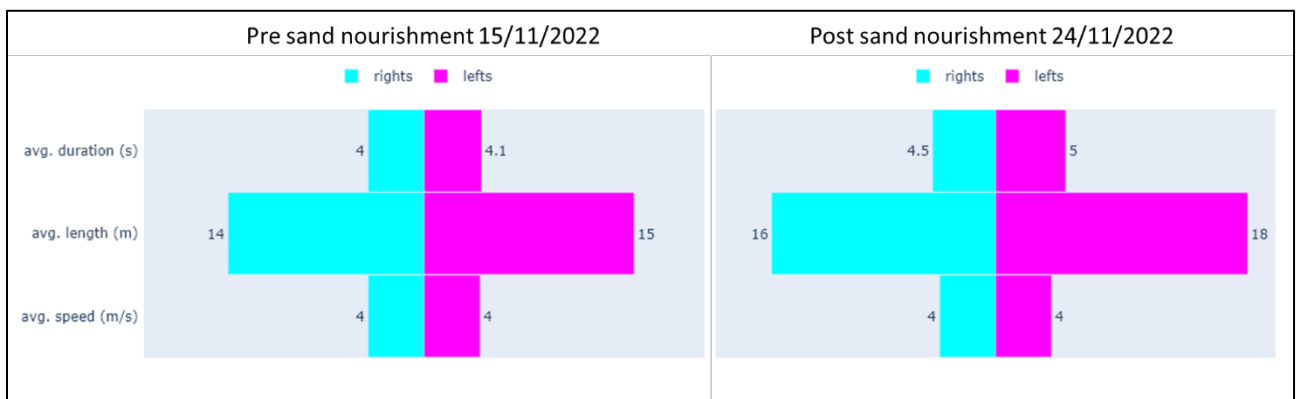
Overall, wave duration, length, and speed, as detected and tracked by the WPT algorithm, were very similar on both the pre- and post-nourishment monitoring days (Figure 8). However, it is important to note that there were significantly more surfing tracks recorded post sand nourishment due to no tree obstruction to the field of view, therefore metrics are not well suited for comparison. Similarly, average ride durations and lengths were slightly greater post sand nourishment; however, this increase was most likely due to truncation of surfing tracks pre- sand nourishment from the tree obstruction.

Figure 8: Summary metrics for both monitoring days

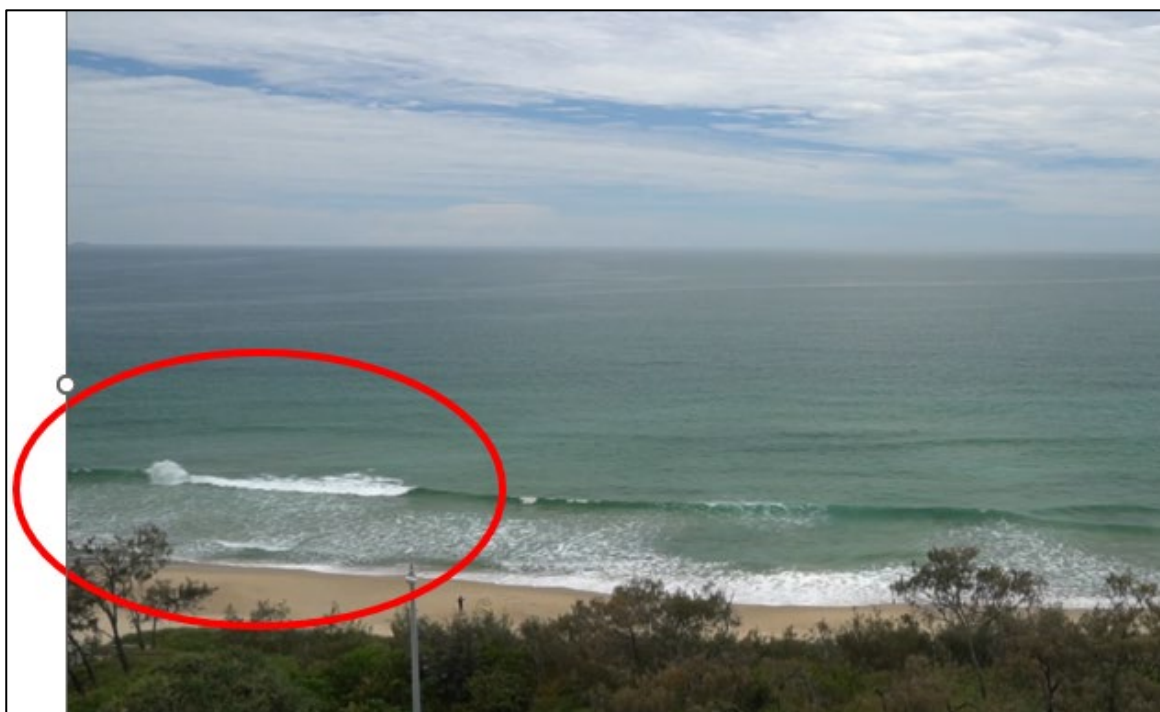
The only difference observed between pre- and post-nourishment days was the presence of reflected waves shoreward of the sand nourishment region (Figure 9). The GPS verification surfer observed that it was difficult to catch some waves due to the reflected waves. Beach slopes in the swash zone region were observed to be steep with large grain size sand. This was possibly due to coarser grain size in the swash zone causing steeper shorefaces and hence wave reflection; however, it also could simply have been due to the slight change in wave direction and period between pre and post nourishment dates, or just a naturally occurring coincidence. Bathymetric survey data should be analysed to investigate further.

*Figure 9: Presence of reflected waves on the post-nourishment monitoring day*

- Undesirable wave reflection was noticed in the post sand nourishment surf amenity assessment. This was possibly due to coarser grain size in the swash zone causing steeper shorefaces and hence wave reflection; however, it also could simply have been due to the slight change in wave direction and period between pre- and post-nourishment dates, or just a naturally occurring coincidence. Bathymetric survey data should be analysed to investigate further.

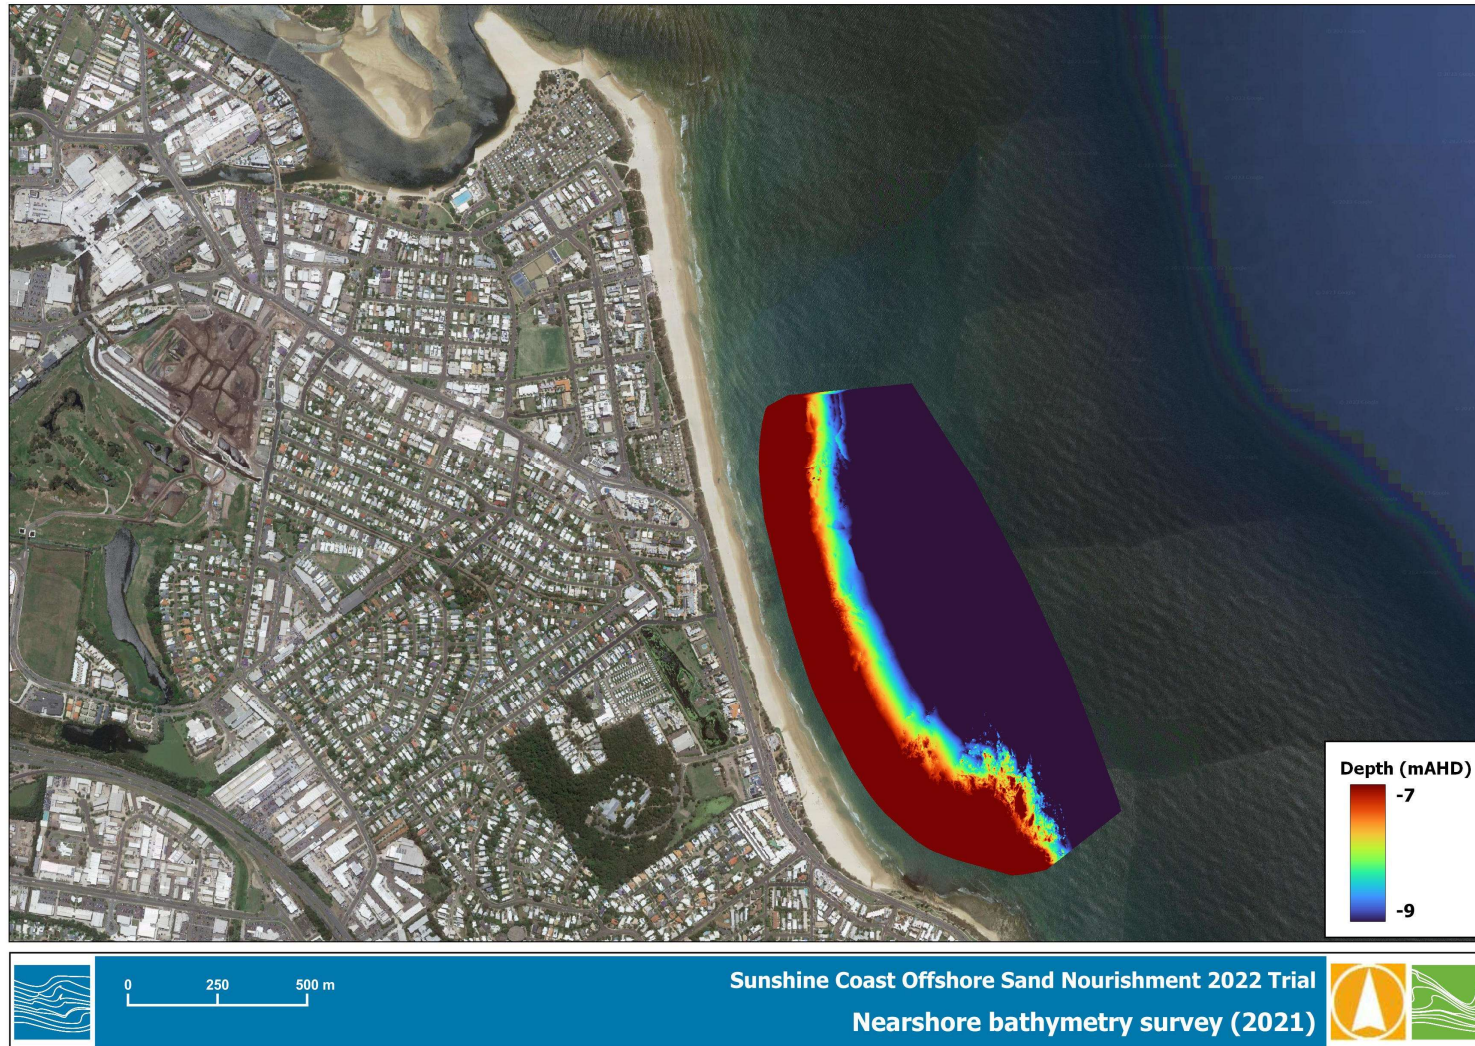
Figure 4-1 Multi-Beam Echo Sonar Survey, 2021

The Port of Brisbane carried out three Multi Beam Echo Sonar (MBES) bathymetric surveys, attached in Appendix B on Figure 4-1, Figure 4-2 and Figure 4-4 in in Appendix B.

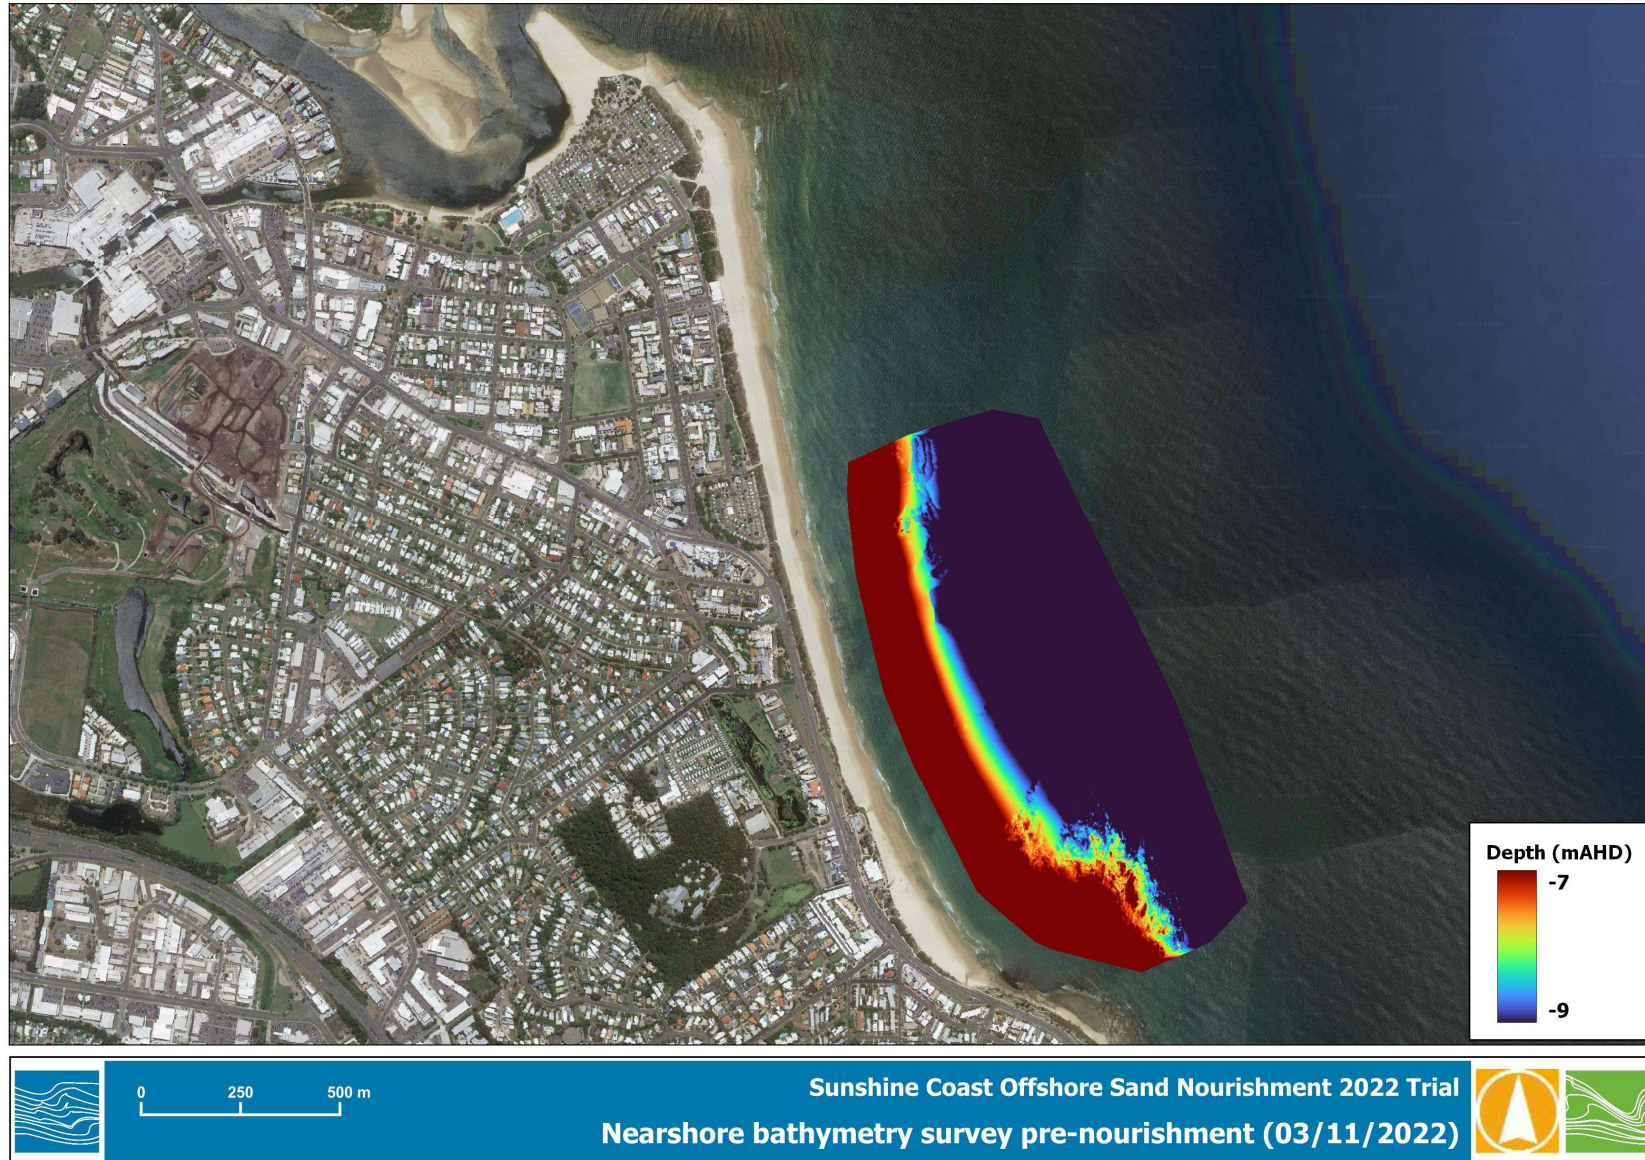
Figure 4-2 Pre-nourishment Multi-Beam Echo Sonar survey

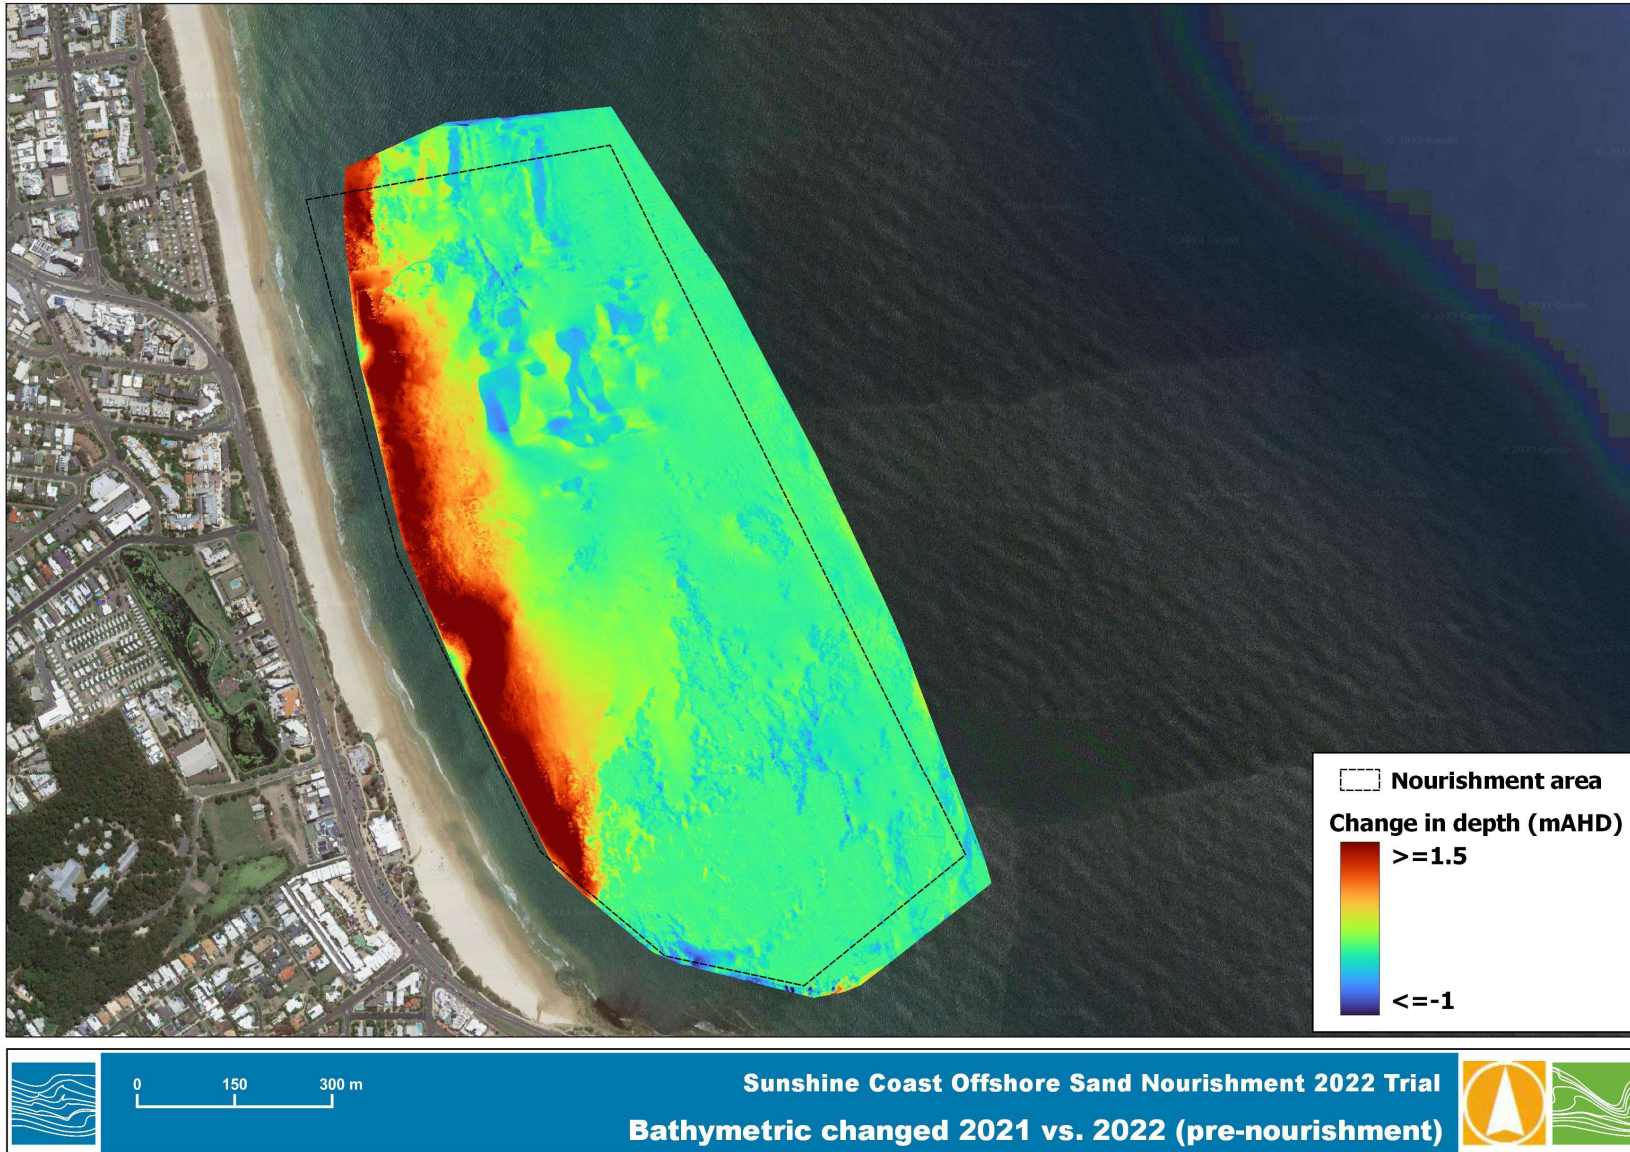
Figure 4-3 One-year bathymetric changes – before nourishment

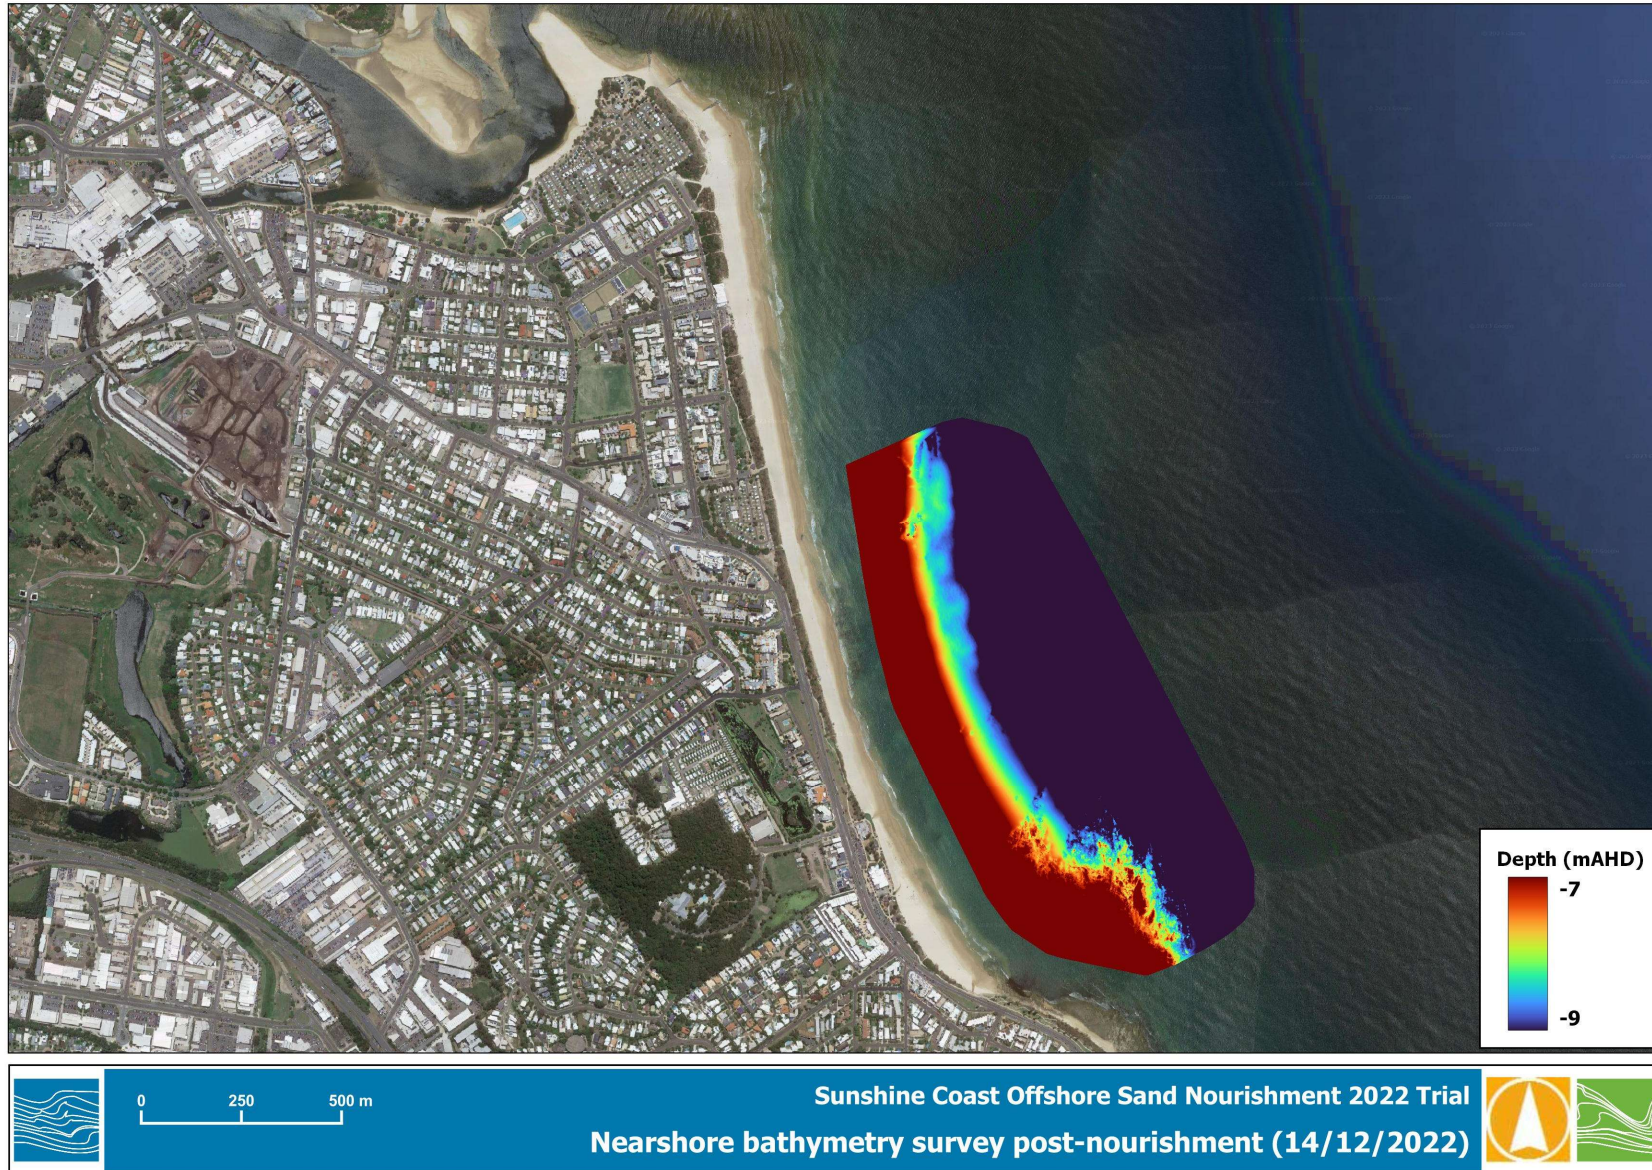
Figure 4-4 Post-nourishment Multi-Beam Echo Sonar survey - 24 days

Figure 4-4 in Appendix B shows the seabed changes over one year before the nourishment works. During that period, an expansive natural sand bar formed at 7.5m. Some sand was found to have naturally moved on the Alexandra Headland reefs. Sand was also found to move in deeper depth, down to -10.0m.

Figure 4-4 in Appendix B shows the seabed change, approximately 24 days (approximately one month) following the nearshore nourishment works. The sand placement is located at the North of the nourishment area, well away from the Alexandra Headland reef system. As such, the impact of the nearshore sand nourishment trial on the Alexandra Headland Reef was negligible.

This Figure also overlays the “Brisbane” dredge location while placing sand either by rainbowing or bottom dumping. The nourishment was performed at approximately -8.0m, as per Contract and Permits.

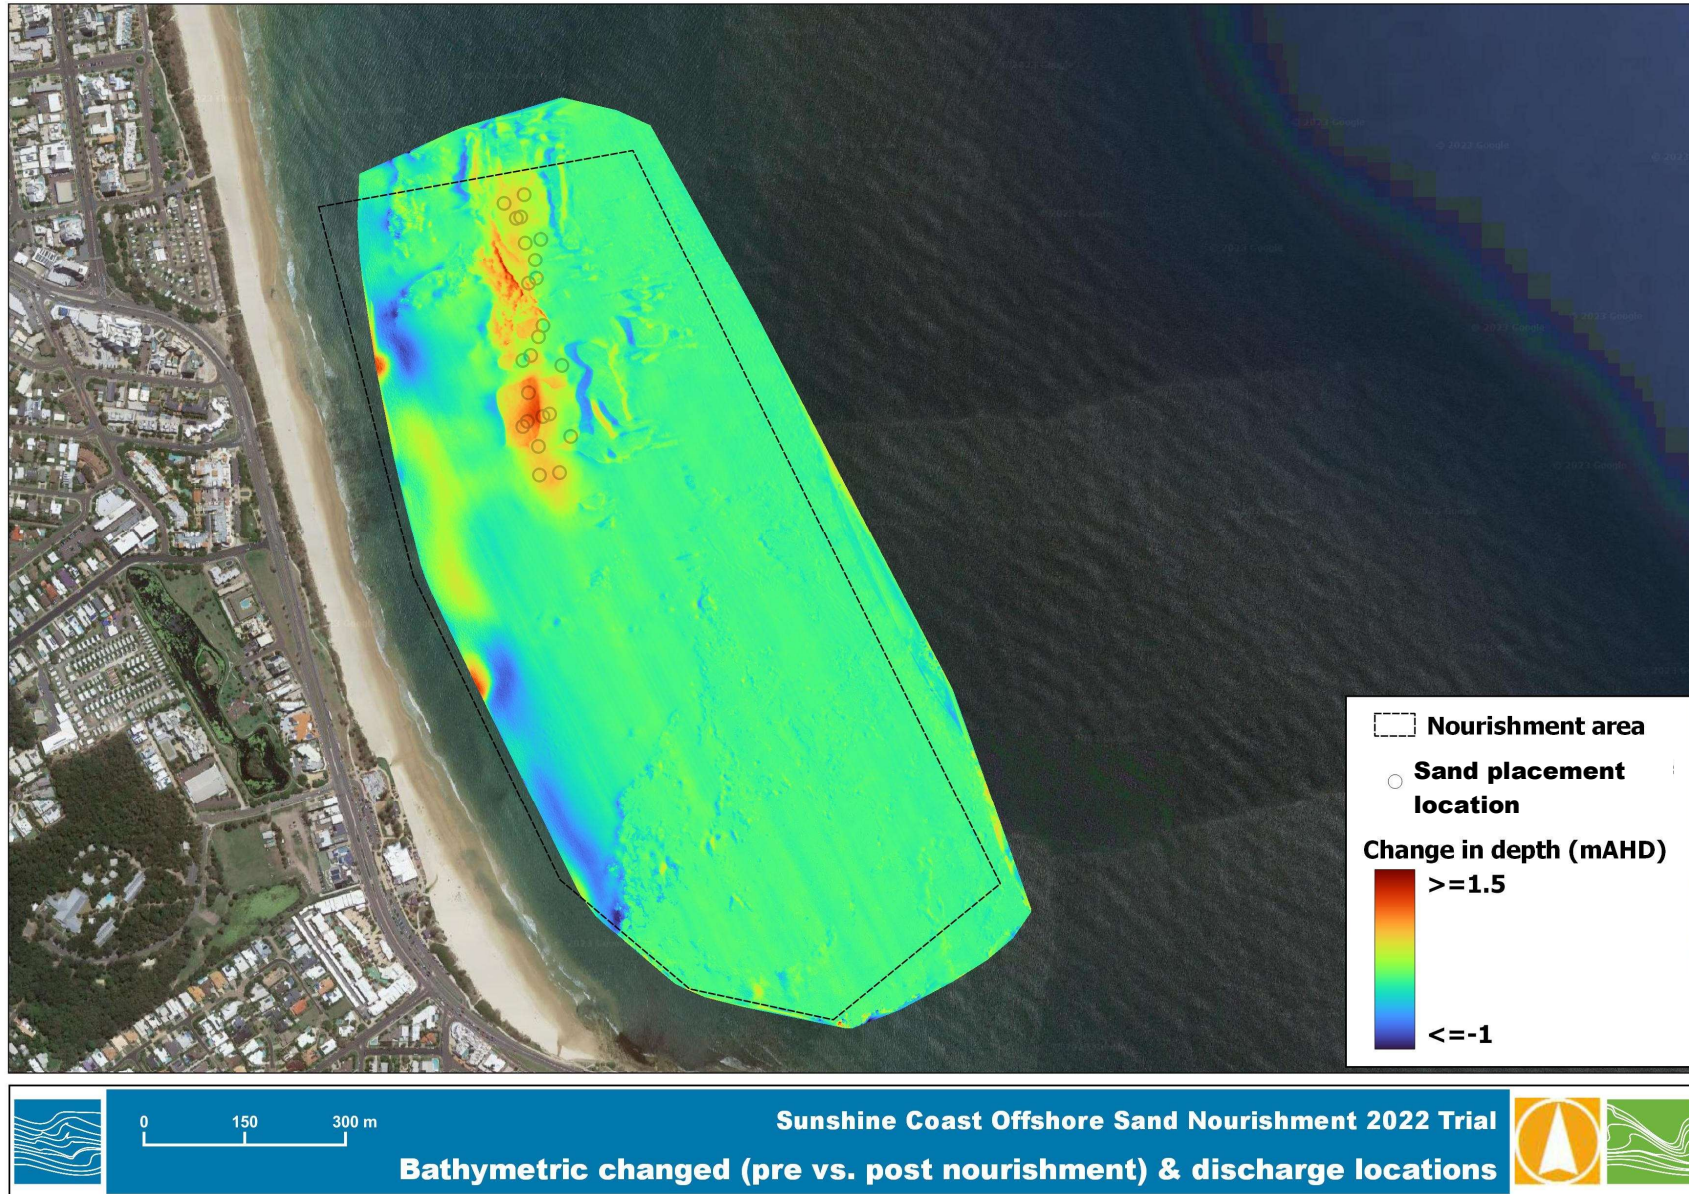
Figure 4-5 One-month bathymetric changes after nourishment

Figure 4-5 in Appendix B shows the change in bathymetry between the pre-nourishment and post-nourishment MBES surveys, over approximately one month. This period included the early December 2022 storm. The Figure shows that the nourishment sand is generally located 50m landward from the dredge location at the North of the sand deposition area. The south dredge locations remained well aligned with the sand deposition area.

Out of the 38,000m<sup>3</sup> of sand placed by the “Brisbane”, approximately 16,000m<sup>3</sup> remained near the original sand deposition area. Therefore, 60% of the nearshore sand volume moved out of the initial sand deposition area following the early December storm. This sand would have moved in the surf zone or the intertidal beach. The surf-zone, including the sand bar and beach through systems, cannot be surveyed accurately because of wave breaking and shallow water hazards.

The coastal sand bars generally migrated onshore during that first month, especially the bar south and North of the sand deposition area. However, immediately onshore from the sand deposition area, the bar remained in position and appeared to have welded to the nearshore nourishment sand mounds.
