# Monitoring Report

## Maroochydore Beach Nourishment Trial

Sunshine Coast Council

7 June 2023

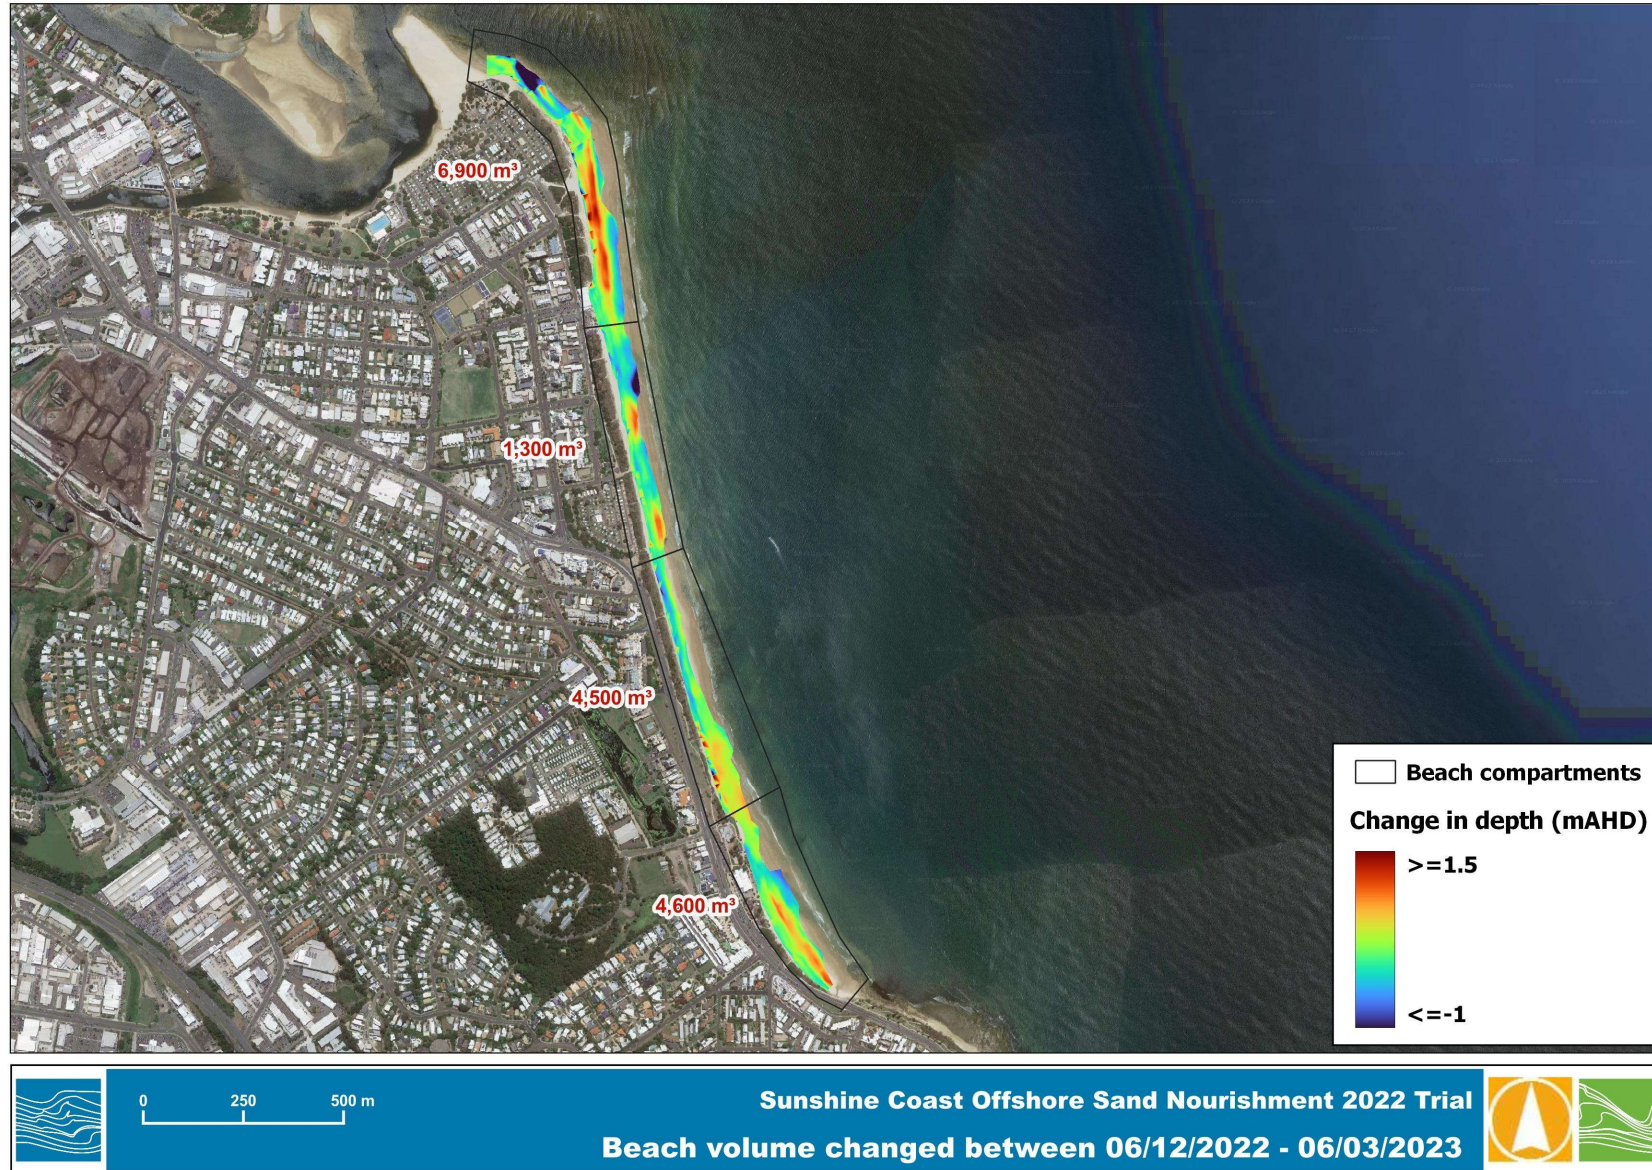
Figure 4-6 Three months beach volume change

Figure 4-6 in Appendix B shows the upper beach changes three months following nourishment. There was no beach erosion except near the Maroochydoore River Entrance. Sand accumulation is generally higher upstream and downstream the sand deposition area, specifically North of compartment 3 and South of compartment 2. The beach volume increased consistently in Compartment 1 and Compartment 4 as well.

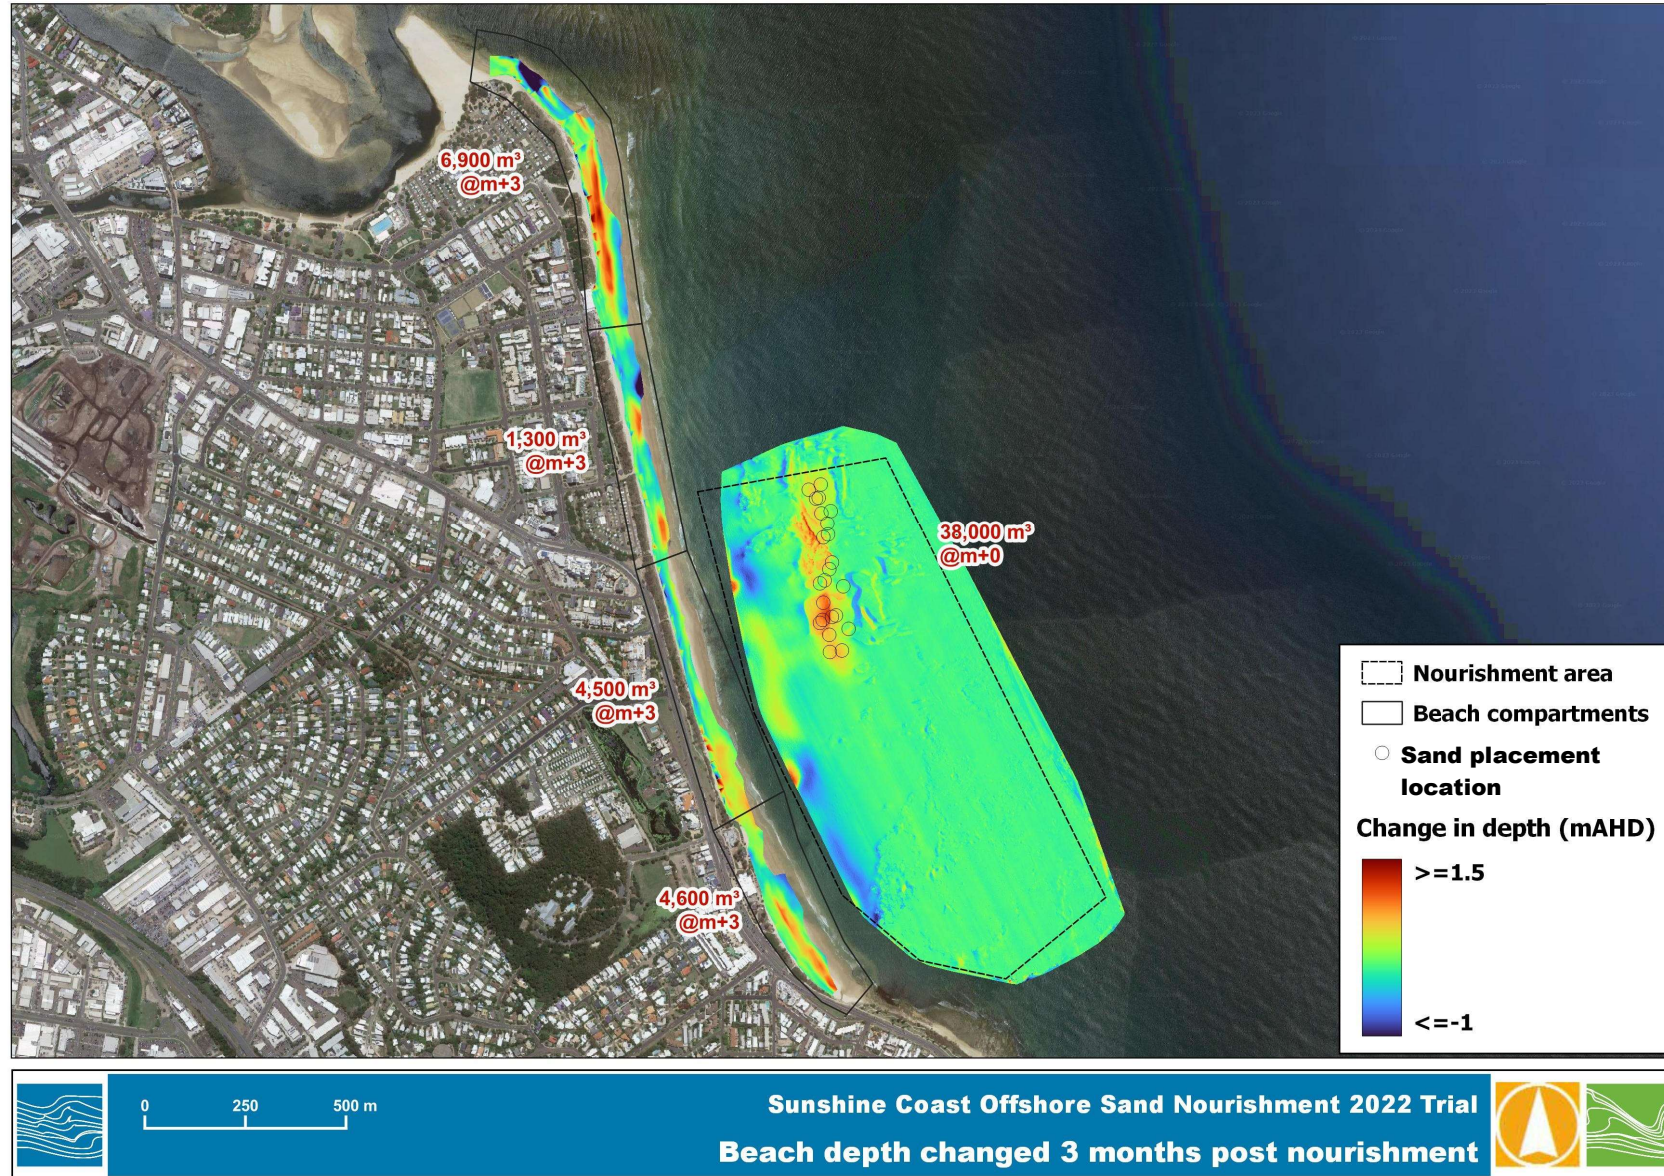
Figure 4-7 Merged topographic and bathymetric beach surveys

Figure 3-5 summarises the effect of the nourishment campaign 3 months after the nearshore nourishment works were completed. This summary arises from the merged upper beach survey and bathymetric survey shown in Figure 4-7 Appendix B and from the metocean analysis.
