APPENDIX 9 – HYDRODYNAMICS

A9.1 INTRODUCTION

The aim of the Lake Currimundi Dynamics Study is to provide an adaptive management plan for the entrance of the lake. This area has changed considerably over the years due to anthropogenic and/or natural actions. Over the few decades or so, the population has grown considerably and the catchment area has developed with the creation of canals and the latest connection to Lake Kawana. This has raised certain issues within the community including water quality, beach and bank erosion and biting midge nuisances. In order to address these issues a continuous on-going monitoring program was proposed. The field exercises described below were aimed at collecting water quality data, hydrodynamic data and bathymetric surveys of the entrance in order to create a database of information on which a monitoring program could be based, and to calibrate a hydrodynamic model for scenario simulation.

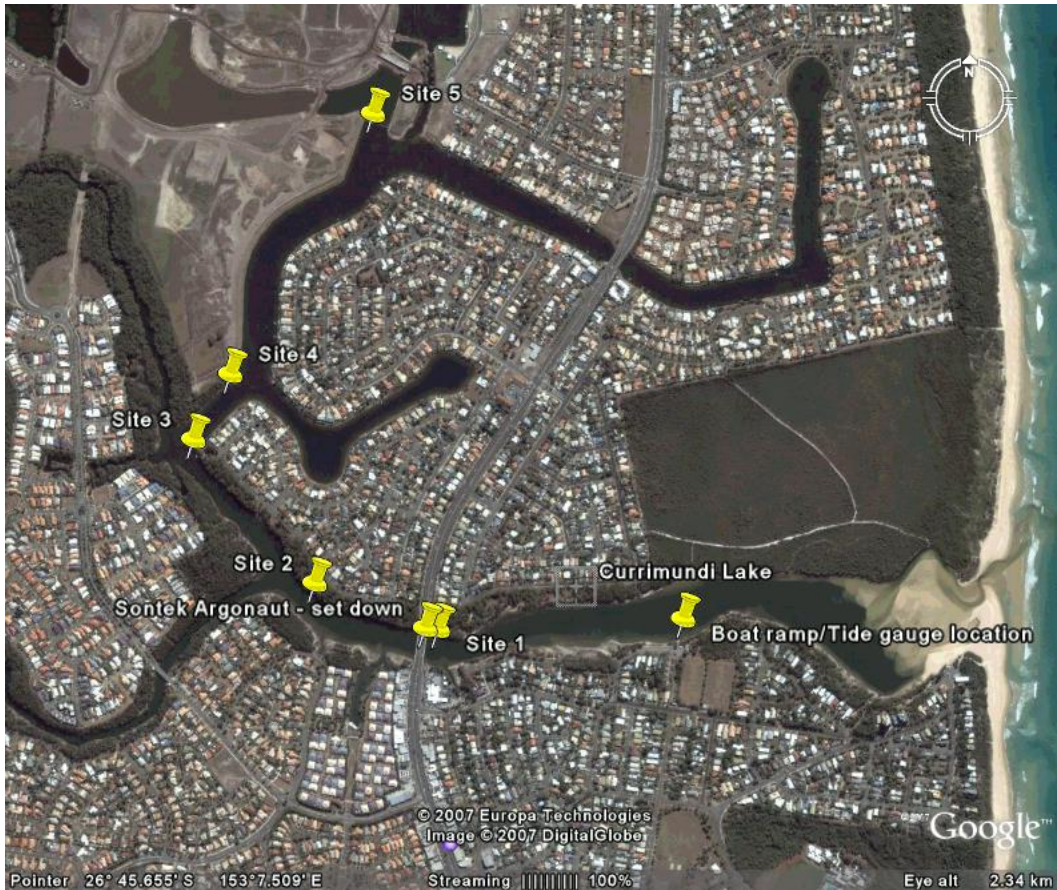
Figure A9.1: Map of Lake Currimundi with field trip no.1 site locations (Source: Google Earth)

A hydrographic survey was carried out over a two-day period, 26 and 27 July 2007, using a SonTek Argonaut velocity profiler and other various equipment. Five sites (see Figure A9.1) along the lake were analysed and the GPS location of each site was noted as well as the water temperature, depth and water flow direction.

The water height was measured using the tide board at the boat ramp (see Figure A9.1). Measurements were taken approximately every hour for the days leading up to the sand re-profiling (see Figures A9.2 and A9.3). This was done to see how much influence the tide had on the water levels in the lake.

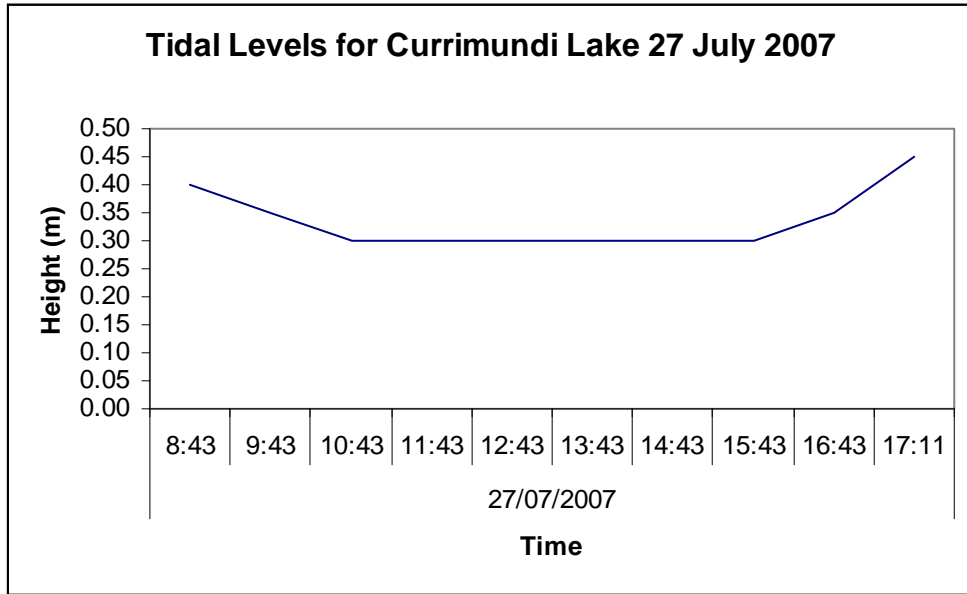
Figure A9.3: Tide levels for Lake Currimundi for 27/07/07

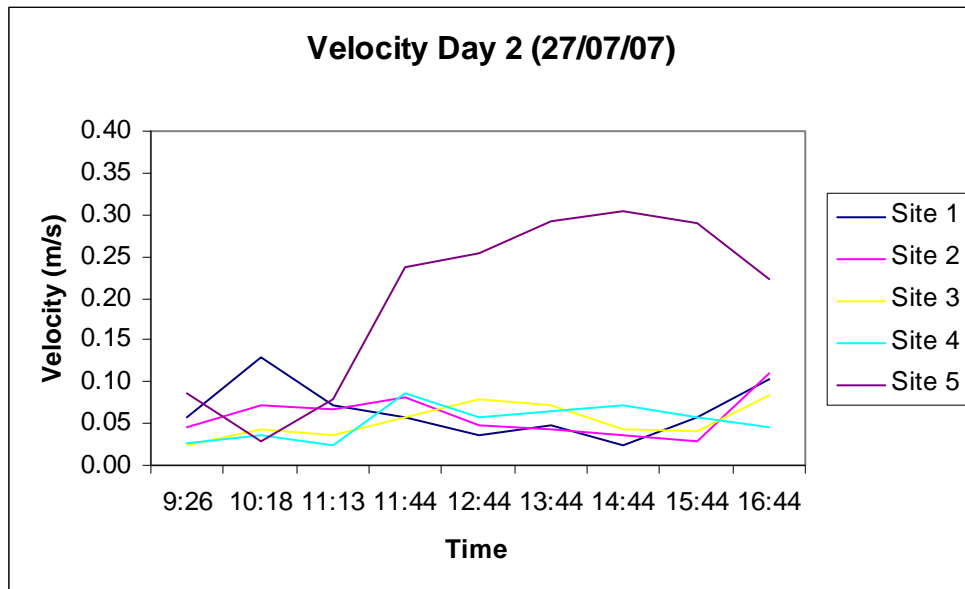
Figure A9.5: Velocity readings for Lake Currimundi on 27/07/07

The measured velocity (m/sec) is representative and realistic for a typical estuarine environment. Velocity levels were higher at site 5 located at the Lake Kawana weir (see Figures A9.4 and A9.5).

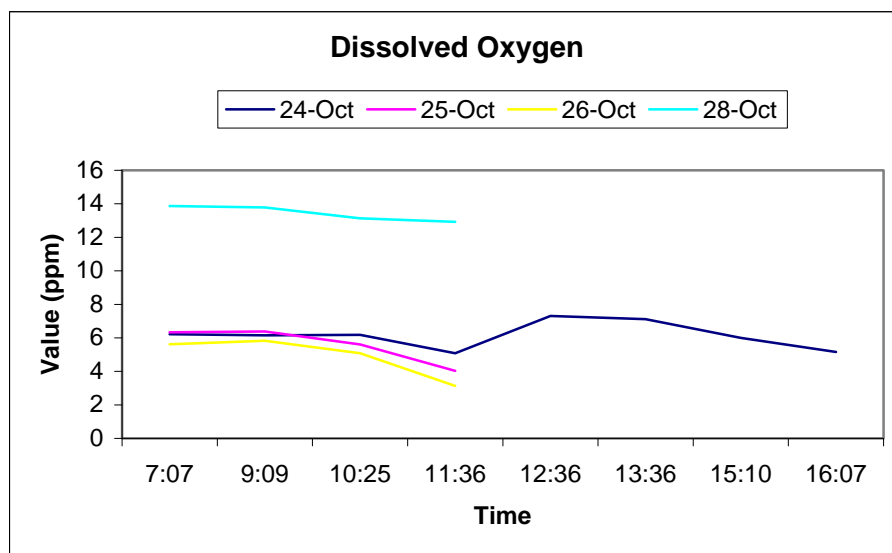
Figure A9.6: Dissolved Oxygen data collected at the Argonaut site using YeoKal

Using YeoKal and TDS instruments the water quality parameters of dissolved oxygen (ppm) (see Figure A9.6), temperature (°C) (see Figure A9.7), conductivity (ms/cm) (see Figure A9.8) and pH (see Figure A9.9) were measured. These measurements were taken at eight locations through out the lake and canal system (see Figure A9.1). At each site measurements were taken at the surface and then at 1.0 m intervals to the bottom. The measurements were taken both before and after the opening of the entrance on the 26th October 2007.

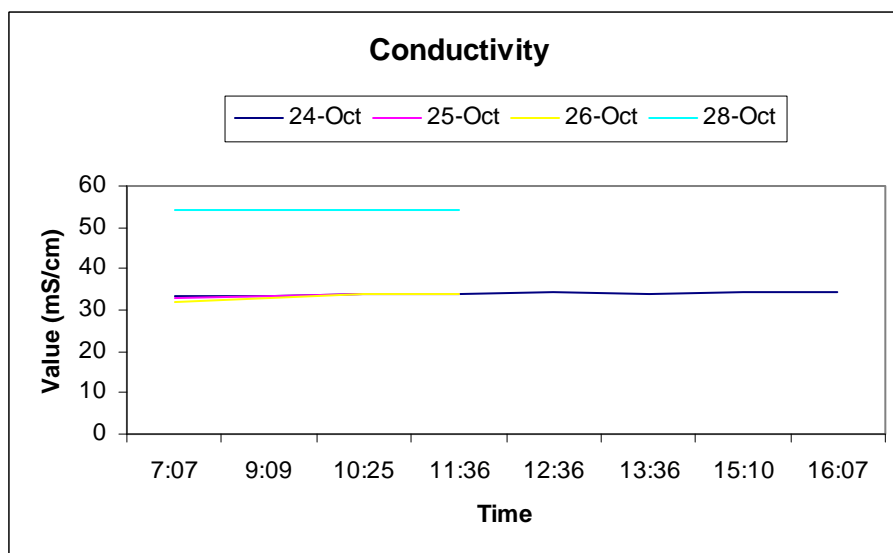
Figure A9.8: Conductivity data collected at the Argonaut site using YeoKal

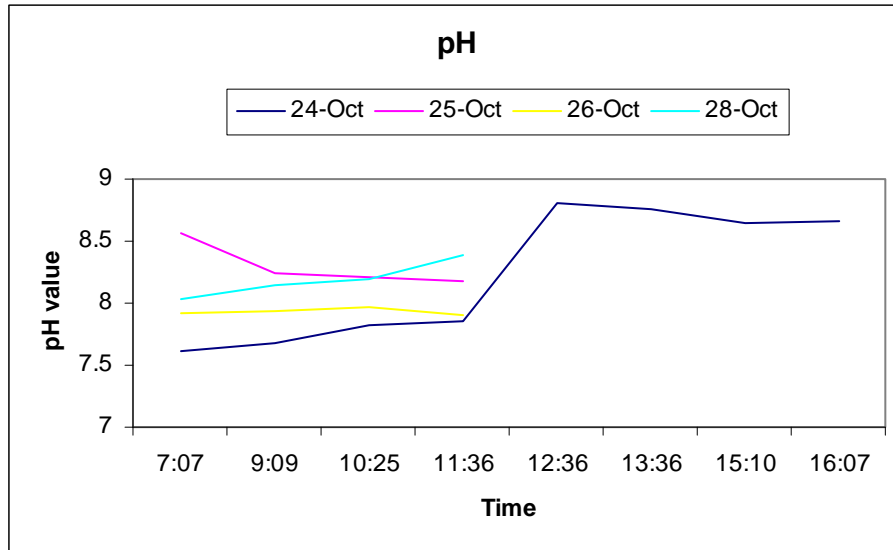
Figure A9.9: pH data collected at the Argonaut site using YeoKal

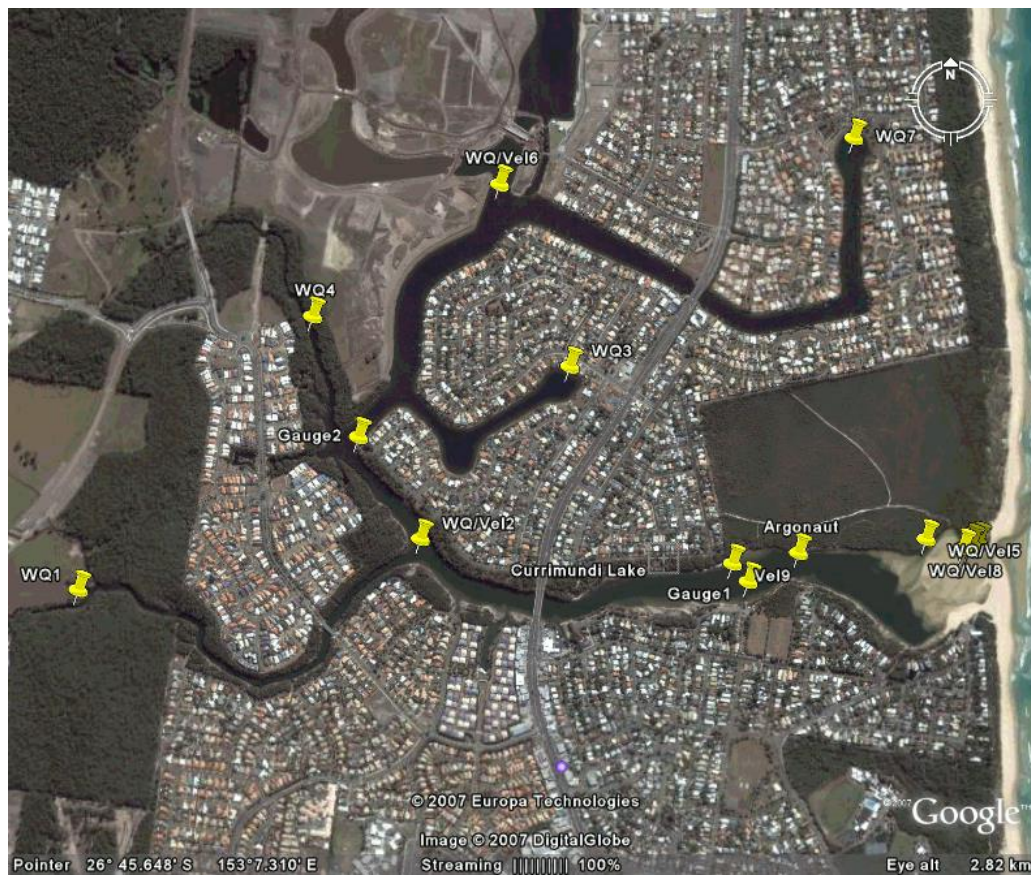
Figure A9.22a: Map of Lake Currimundi with field trip no.2 site locations (Source: Google Earth) WQ=Water quality sites, Vel=Velocity sites

The Argonaut current profiler was launched at 11:30am on the 24th of October 2007 upstream of the boat ramp near the middle of the channel (See Figure A9.22a) at a depth of 2.9 m and the most likely place to identify a measurable current flow. The Argonaut was left in this location for the duration of the study and retrieved at 3:57pm on the 29th of October 2007. The results are shown in Figure A9.23 and represent velocity magnitude and direction, and pressure measurement (not converted to water level).

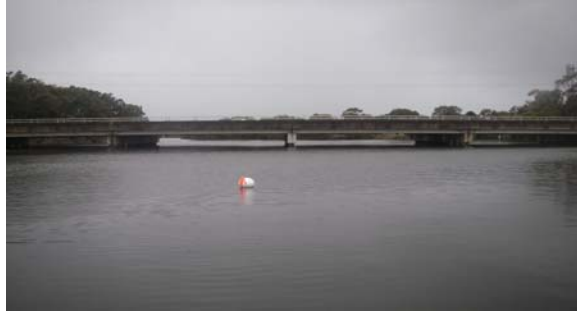
The SonTek Argonaut XR was placed in the middle of the lake bed (Figures A9.25 and A9.26).

Figure A9.26: Localisation of the SonTek Argonaut XR

The equipment was calibrated with a sixty seconds sampling interval and a ten second averaging interval at sampling rate of 3000 kHz. The Argonaut was placed in a relatively straight section of the lake, downstream from the SonTek ADP cross section location (Figure A9.24), at 4:30 PM on 29 May 2008 while the lake entrance was closed. Waypoints were taken using a handheld GPS.

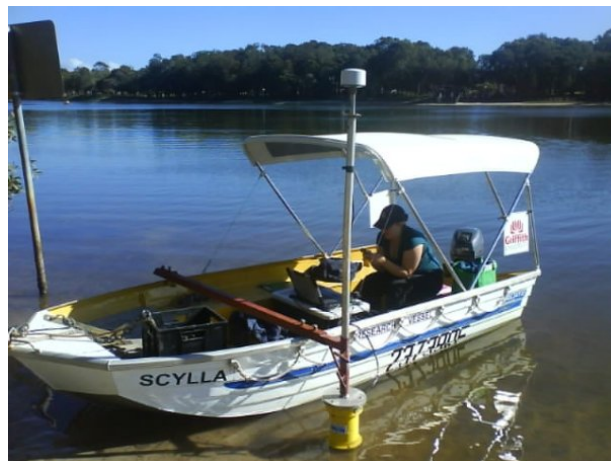
Figure A9.28: Scylla Boat with the SonTek ADP

The SonTek ADP is used as a mobile device. During the research period it was mounted on the port side of 'Scylla' (Figure A9.27 and A9.28). The top of the ADP was located at the surface of the water due to the low depth of the lake. The transducers were 30 cm under the surface, sending an acoustic beam downward into a water column while travelling in a cross section of the lake.

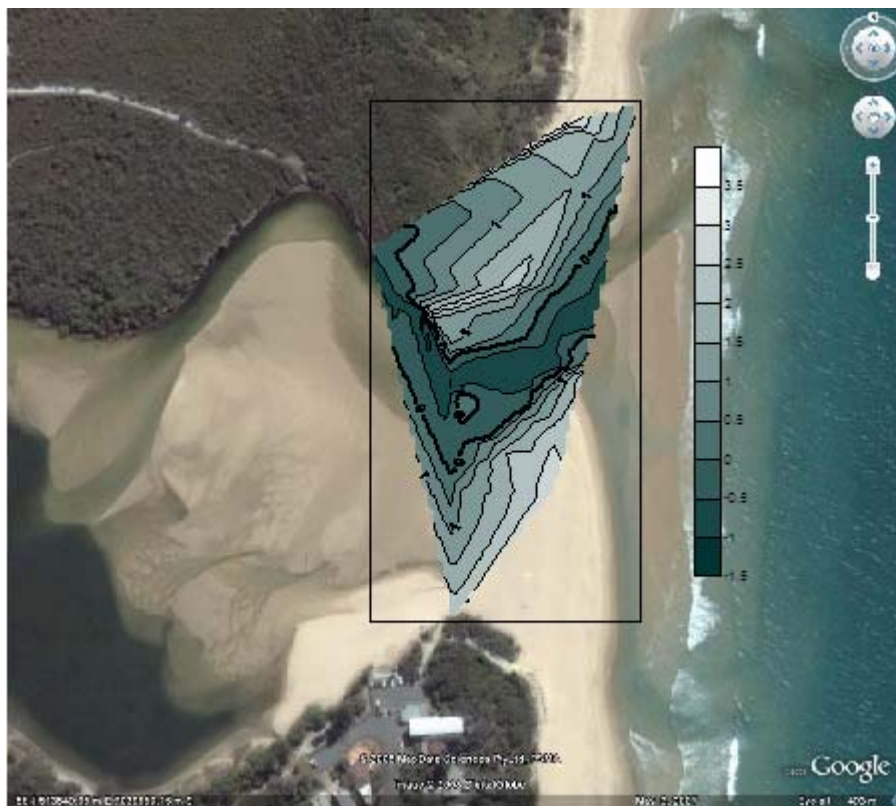
Figure A9.31: The survey of the 3rd of June 2008 after the opening

Daily changes in the entrance morphology were noticed and recorded especially after the entrance was opened on 23 May 2008. Some changes noticed included the natural removal of excess sand left after the entrance opening, the ever changing depth and location of the entrance channel and the gradual exposure of rock along the environmental park. During the surveying, community members showed a keen interest in the work being conducted. Many stopped to enquire about the purpose of the research.

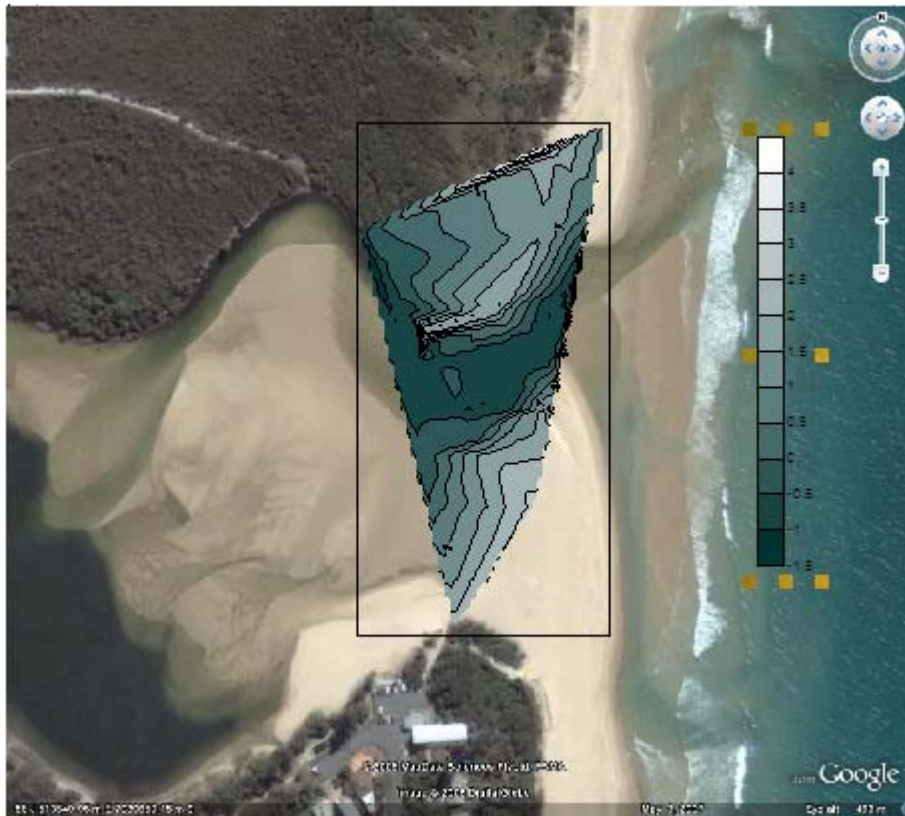
Figure A9.32: The survey of the 6th of June 2008

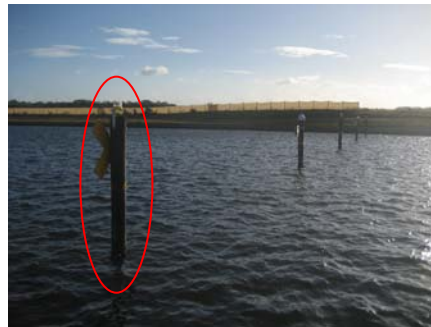
Figure A9.37: Tide gauge No.3 (XR-420-CTD Serial: 13229): Pangali/Tokara Canal next to the weir

either side of the weir (Figure A9.37 and A9.38). A tide gauge was also placed at the pontoon on 25 April 2008, one month prior to the fieldtrip (Figure A9.36).

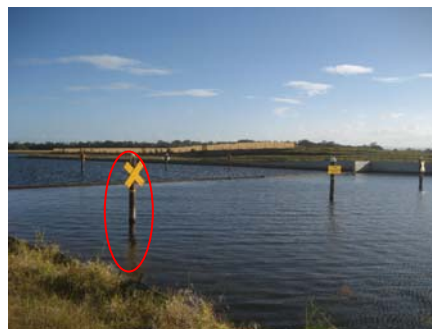
Figure A9.38: Tide gauge No.4 (TWR-2050 Serial: 12537) in the Lake Kawana near the weir

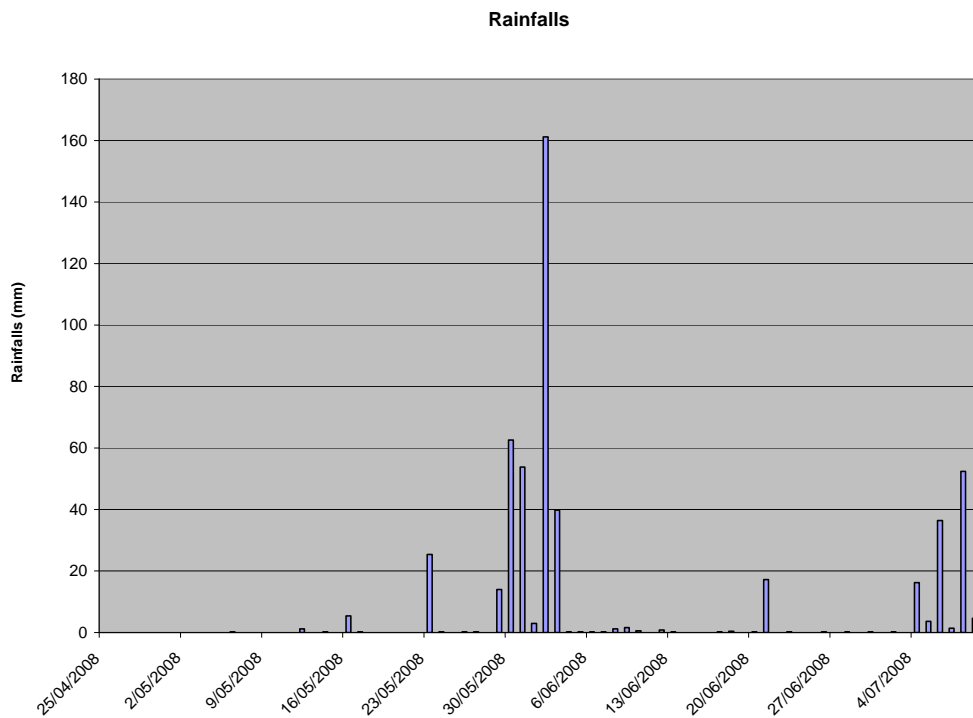
Figure 1 Rainfalls on Maroochydore from 25/04/2008 to 09/07/2008

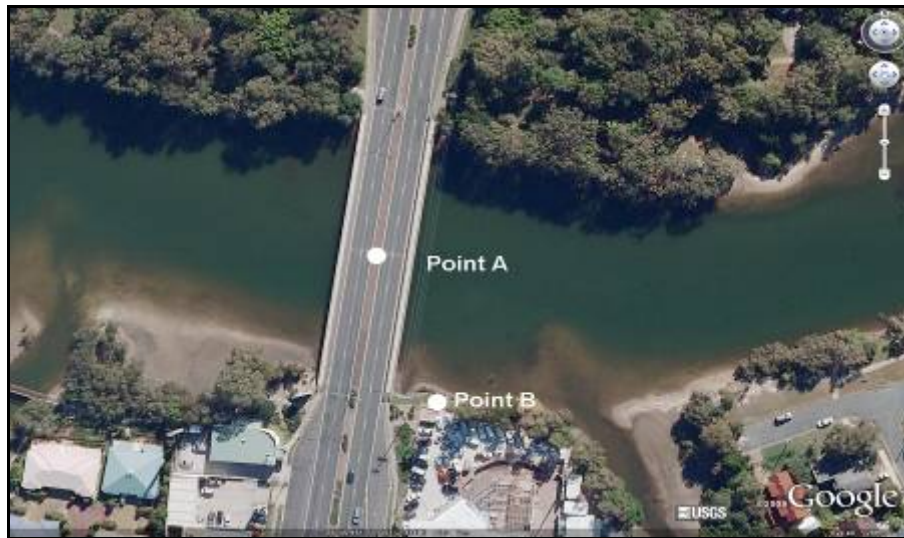
Figure 1. Plan of Currimundi Bridge

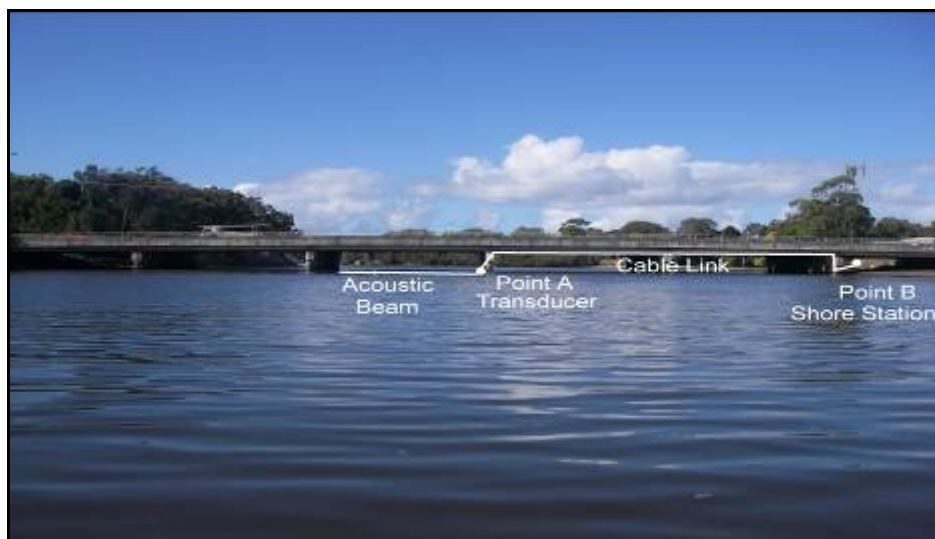
Figure 2. Side View of Currimundi Bridge
