21 May 2024

WRL Ref: WRL2023066 LR20240521 JTC

Mooloolaba foreshore central meeting place: Overview of coastal management and coastal engineering

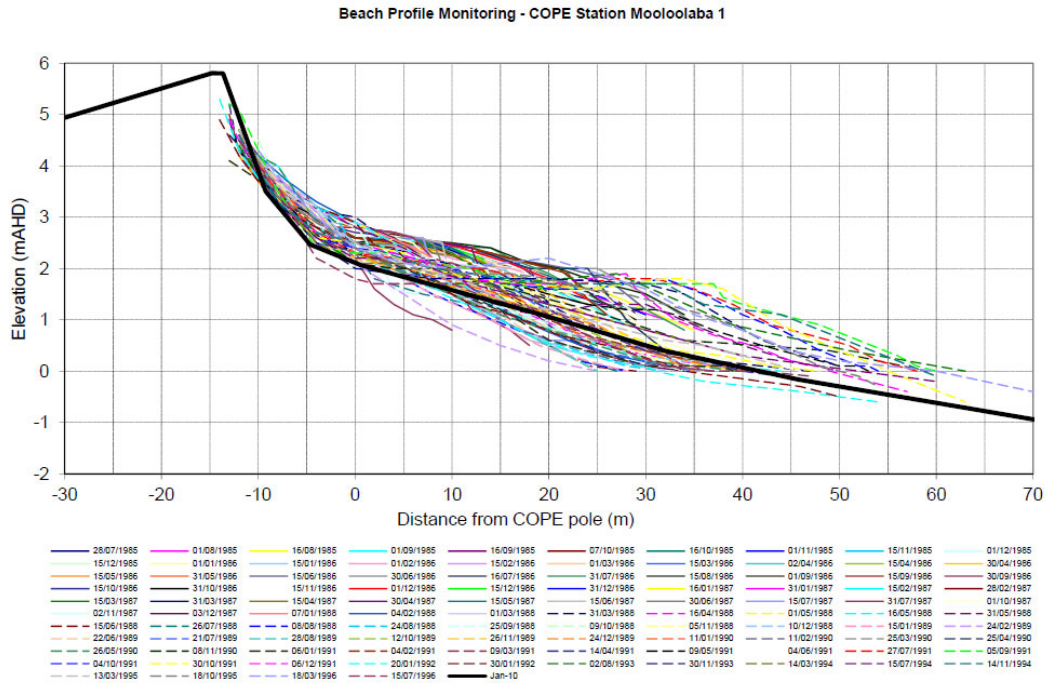
Figure 4.3 Envelope of beach profiles from 1985 to 2010 (Mooloolaba 1 COPE station)

The beach profile has been measured on over 100 occasions (Figure 4.3) at Mooloolaba within the Coastal Observation Program Engineering (COPE program) since 1985 and 14 times in Council surveys (Figure 4.4) since 2014. Aerial photos are available since 1940 and were qualitatively analysed in BMT WBM (2013, not reviewed by WRL). These aerial photos would require additional work involving tidal correction for the waterline position if they were to be analysed quantitatively.

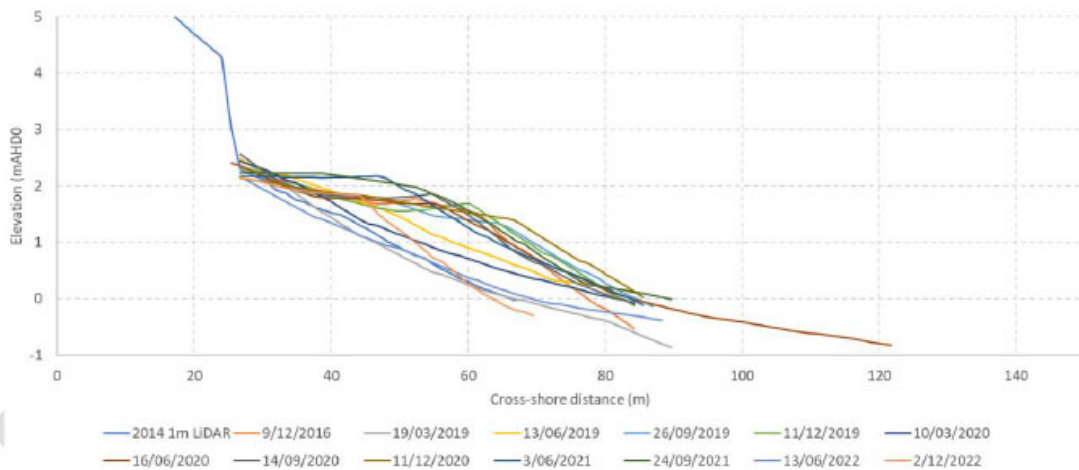
Figure 4.4 Sunshine Coast Council surveys adjacent to Mooloolaba SLSC (2014 to 2022)

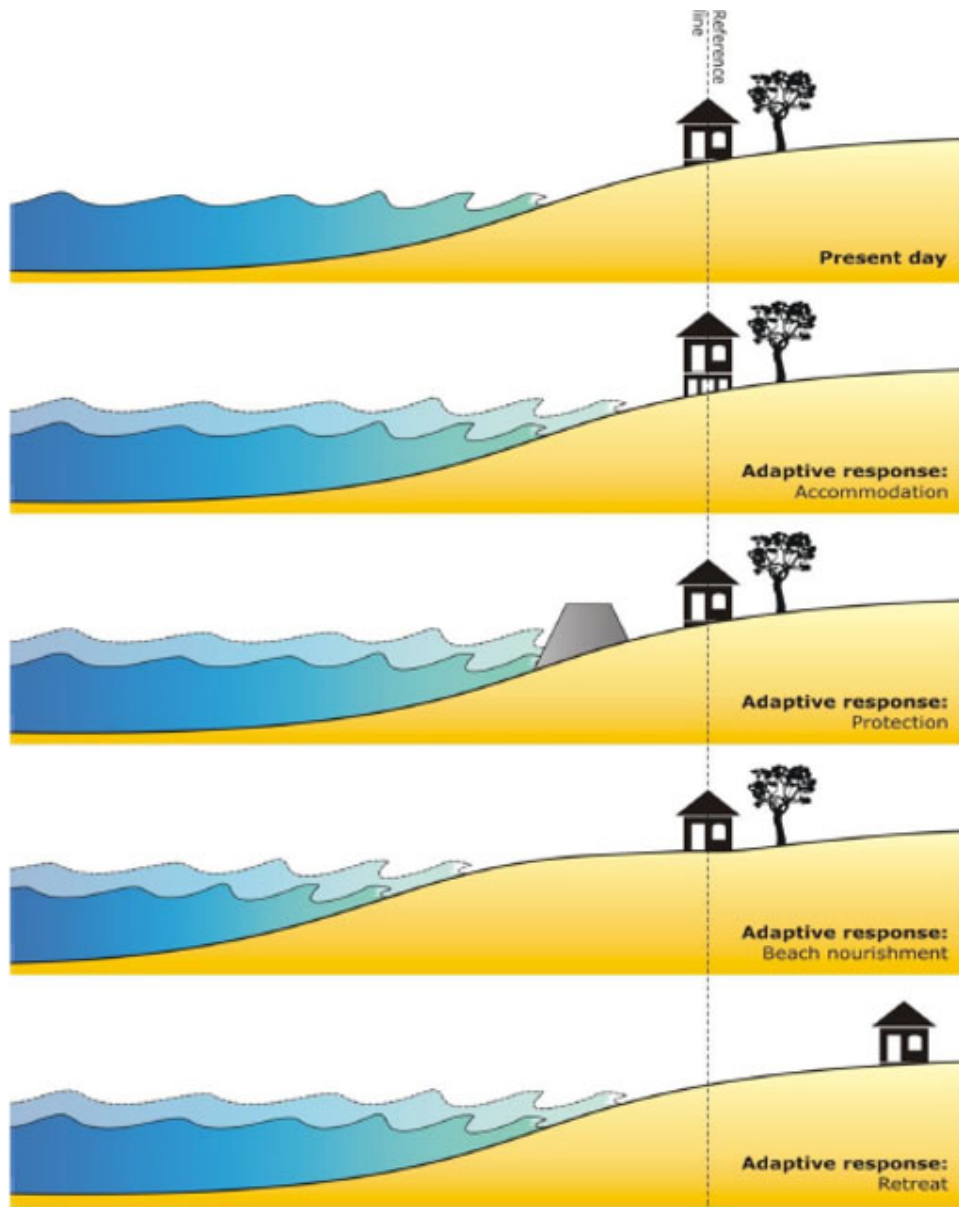
Figure 5.1 Coastal management options

Coastal management can adopt philosophies of (Figure 5.1):

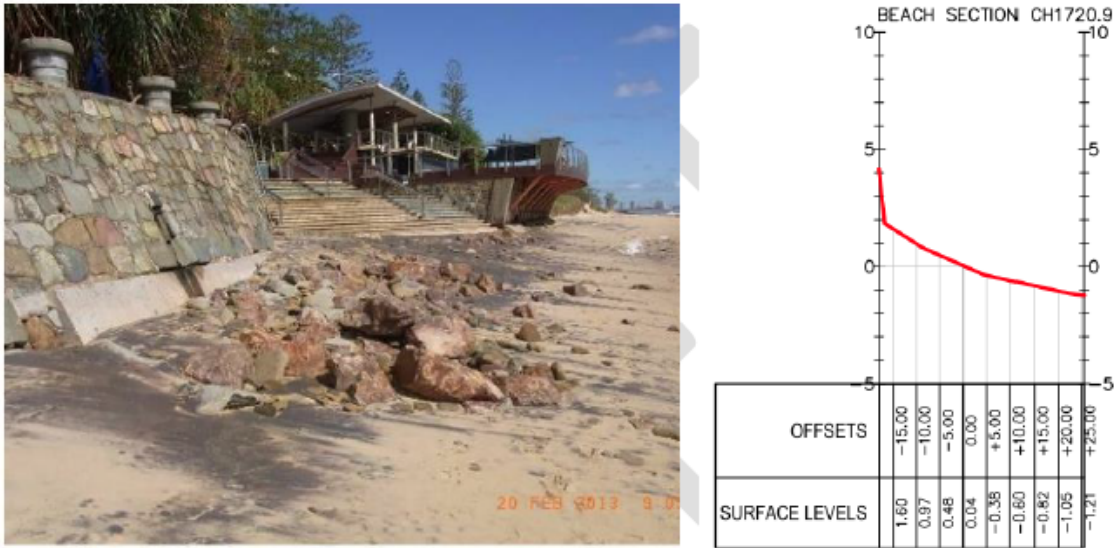
Figure 5.3 Present seawall following TC Oswald 2013

In practice, real world coastal management usually involves a combination of several of the above. Mooloolaba presently utilizes soft sand dunes for most of its frontage, with some sand nourishment from dredging the river mouth and shoal, and a vertical seawall fronting the SLSC and parkland (Figure 5.2 and Figure 5.3).

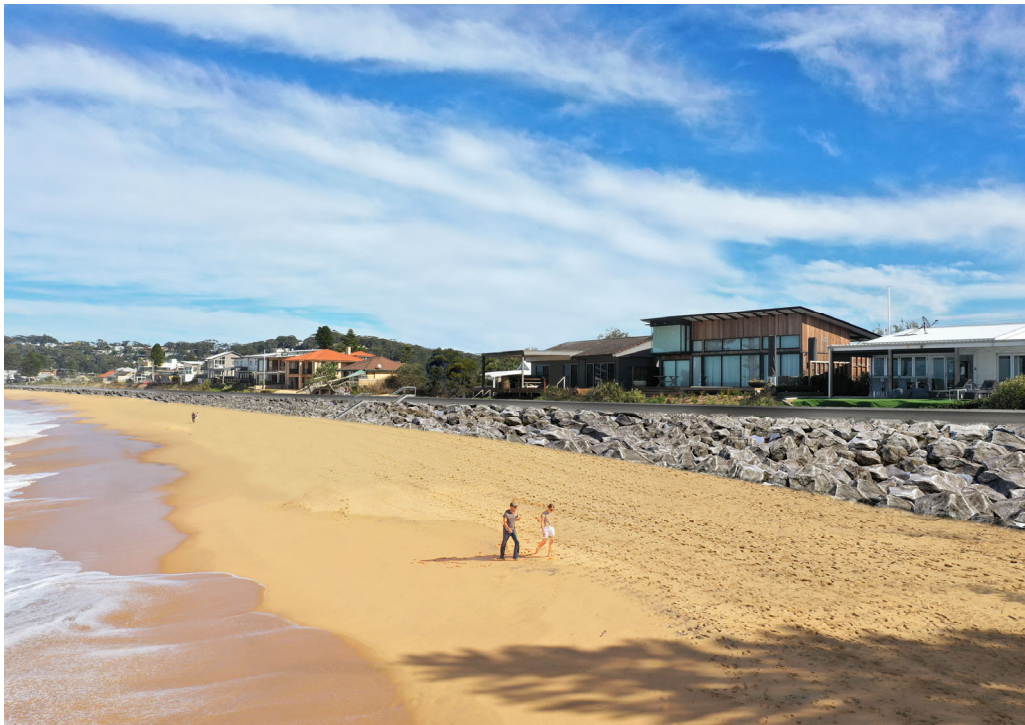
Figure 6.1 Rock rubble seawall option (not Mooloolaba, Terras, 2021)

- Rock rubble (Figure 6.1, not Mooloolaba)
- Vertical (Figure 6.2, not Mooloolaba)
- Terraced/stepped (Figure 6.3, not Mooloolaba)
- The terraced/stepped seawall proposed for Mooloolaba is shown in Figure 6.4 and Figure 6.5

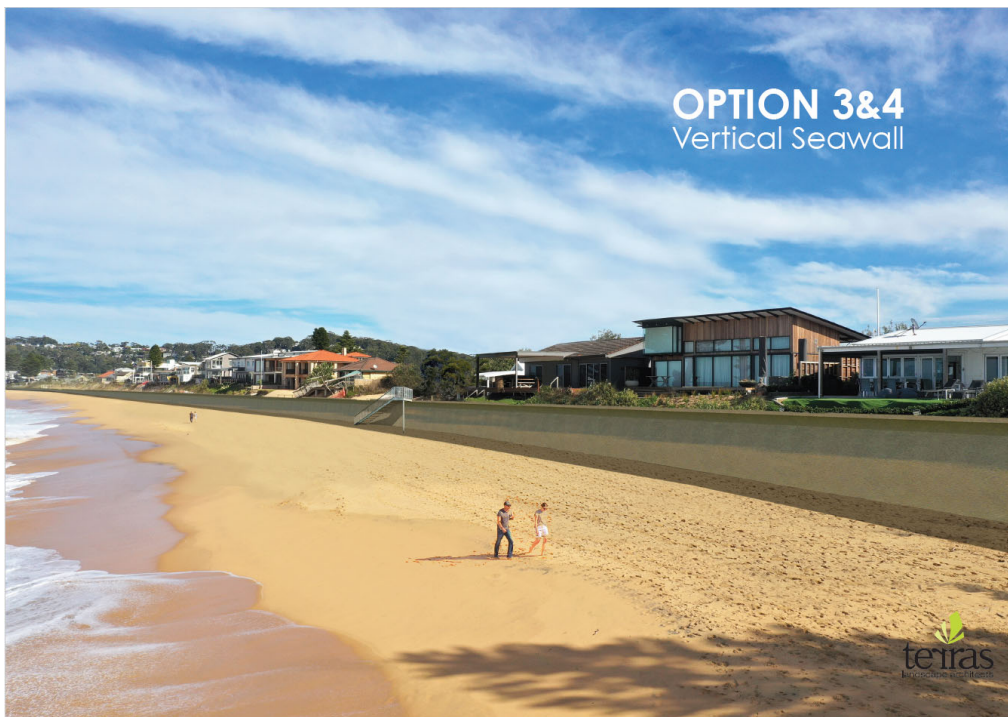
Figure 6.2 Vertical seawall option (not Mooloolaba, Terras, 2021)

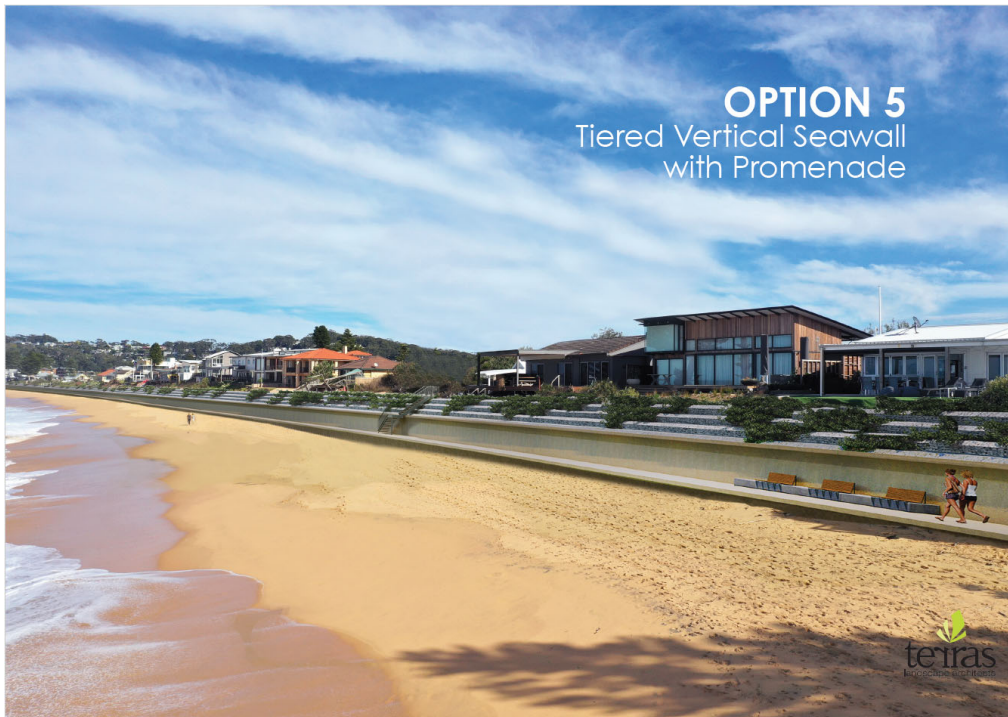
Figure 6.3 Terraced seawall option (not Mooloolaba, Terras, 2021)

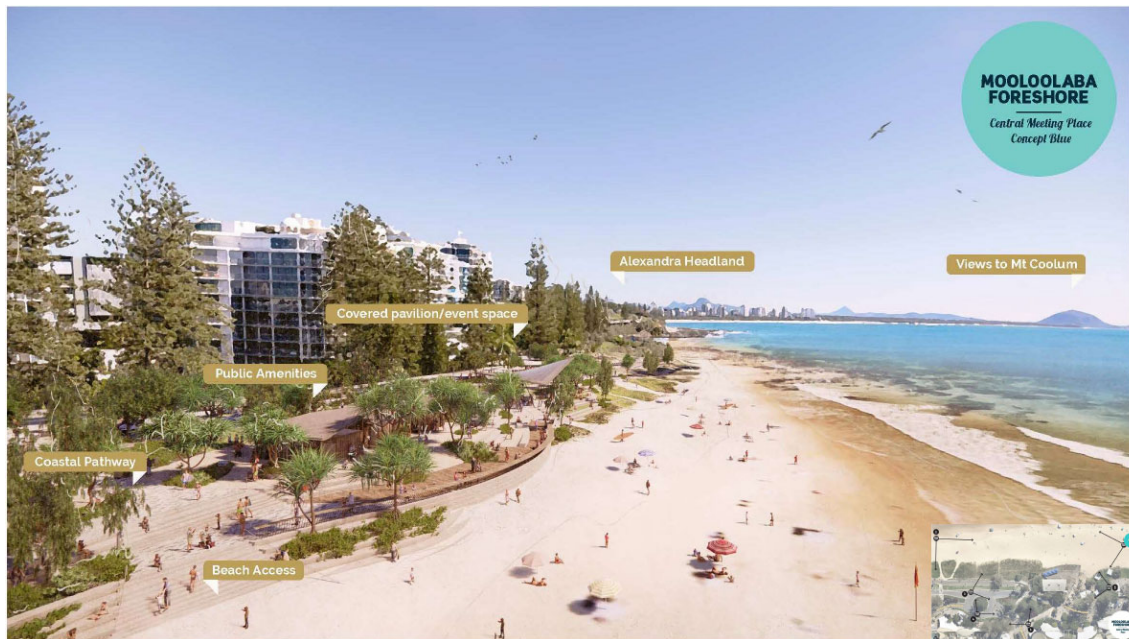
Figure 6.4 Terraced seawall proposed for Mooloolaba from south (SCC, 2023)

The present proposal for Mooloolaba (Figure 6.4 and Figure 6.5) for a stepped/terraced seawall offers the following advantages:

- Provides an engineering level of protection (1 in 100 to 1 in 1000 year ARI, out to 2065) to the parkland, roads and SLSC clubhouse
- Provides visual and spatial connectivity between the parkland and the beach
- Allows beach access for people with low mobility and those with prams
- Allows beach access for SLSC and lifeguard equipment
- It is sufficiently set back from the waterline, such that under present day sea level, waves will only impact it on rare occasions - during large waves, high tides and eroded beach states

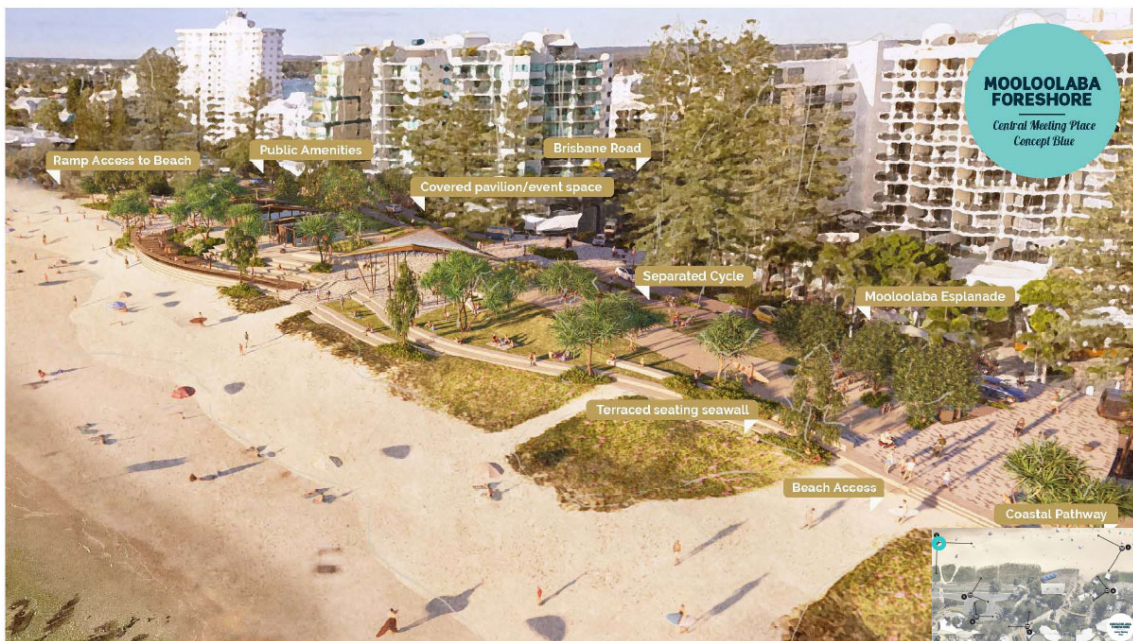
Figure 6.5 Terraced seawall proposed for Mooloolaba from north (SCC, 2023)

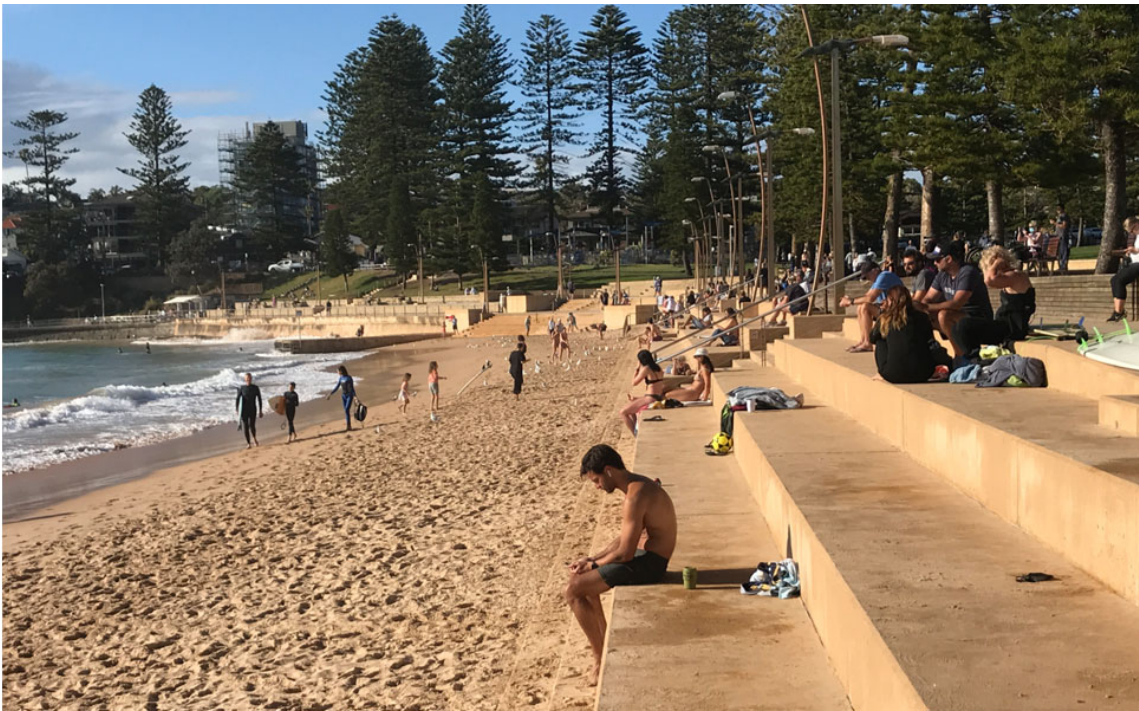
Figure 6.6 Stepped seawall at Dee Why NSW (James Carley)

- Surfers Paradise
- Kingscliff
- Coffs Harbour
- South West Rocks
- Terrigal
- Dee Why (Figure 6.6)
- Manly (Figure 6.7)
- Coogee

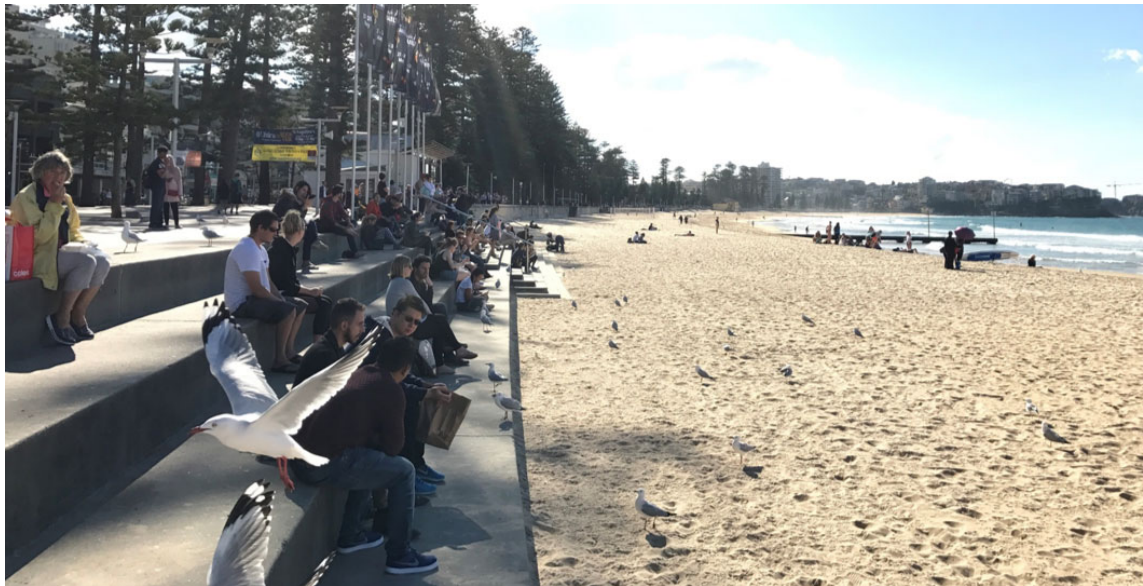
Figure 6.7 Stepped seawall at Manly NSW (James Carley)

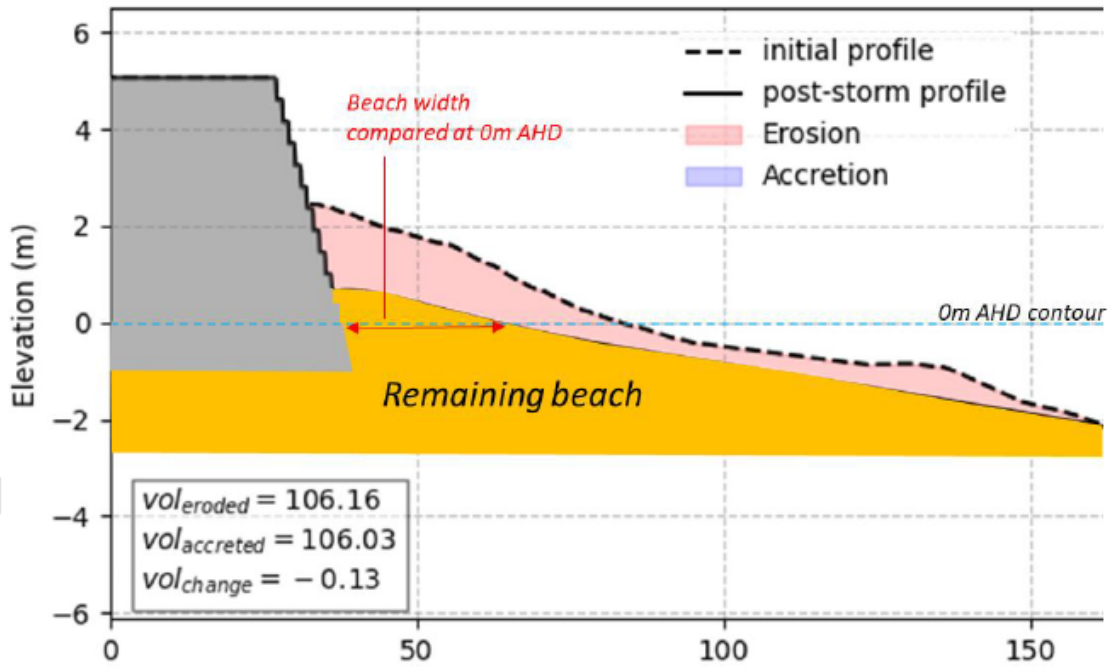
Figure 7.3 Erosion modelling

JBP used the measured/calculated storm waves to run a well accepted erosion model (XBEACH) to estimate beach erosion and sand scour fronting the seawall (Figure 7.3). The calculated erosion volumes were consistent with measurements from other beaches of the Australian east coast.
