REGIONAL GROYNE FIELD REPORT AND CONDITION ENVIRONMENTAL OPERATIONS

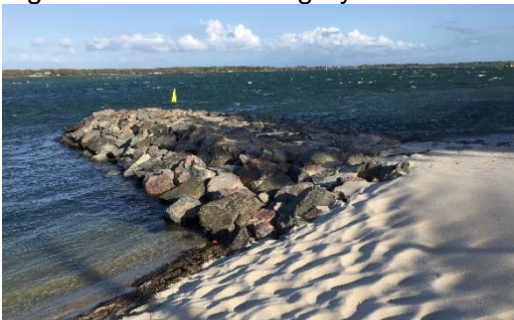
Figure 1: Rock type groyne (SCC, 2017)

There are currently three different types of groynes managed with council. These groynes include rock, hybrid and GSC (geo-synthetic container). A rock groyne consists of layers of placed rock to form a semi-impermeable barrier and typically have a 50-70 year design life. These structures do require high capital expenditure initially to construct but conversely maintenance costs are minimal for the life of the structure, Figure 1 shows a rock groyne.

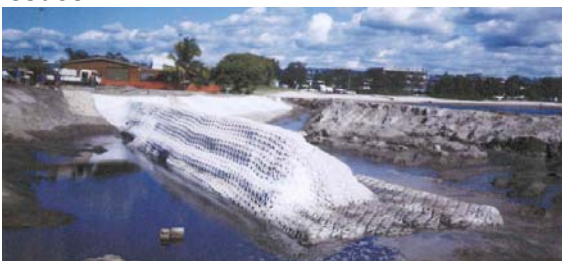
Figure 2: Hybrid groyne (MSC, 1994)

The next type of structure is a hybrid structure of a GSC core with outer concrete mattress. This type of structures are only found within the Cotton Tree foreshore area and has proven successful despite some long term durability and maintenance issues.

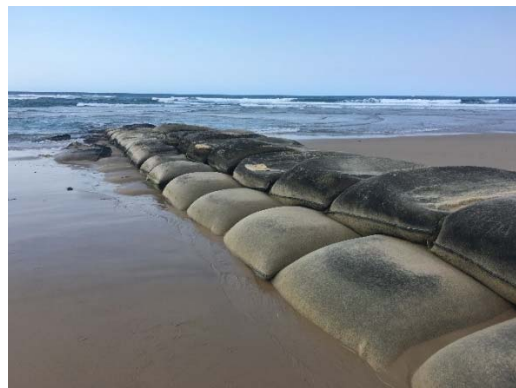
Figure 3: GSC style groyne (SCC, 2017)

The final groyne type is constructed purely from GSC's whereby geofabric is manufactured into a bag then filled with insitu or imported material. The filled bags are sealed and placed in an interlocking fashion to form a structure. The advantage of this method is rapid construction and lower initial construction costs. Figure 3 shows a GSC groyne.

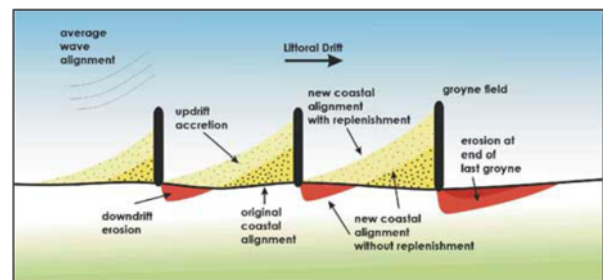
Figure 4: Groyne field diagram (DPAW, 2012)

Groynes provide a special type of foreshore protection. They are typically constructed perpendicular to the beach profile creating a nearly impermeable structure which aims to trap any sediments caught in the long shore and littoral drift. Accretion on the upstream face of the structure is the desirable final result as the sediments settle out of suspension.
