Causes of declining ecosystem health grades in the Pumicestone Passage

Findings of the Pumicestone Passage Technical Working Group

Final version
December 2011

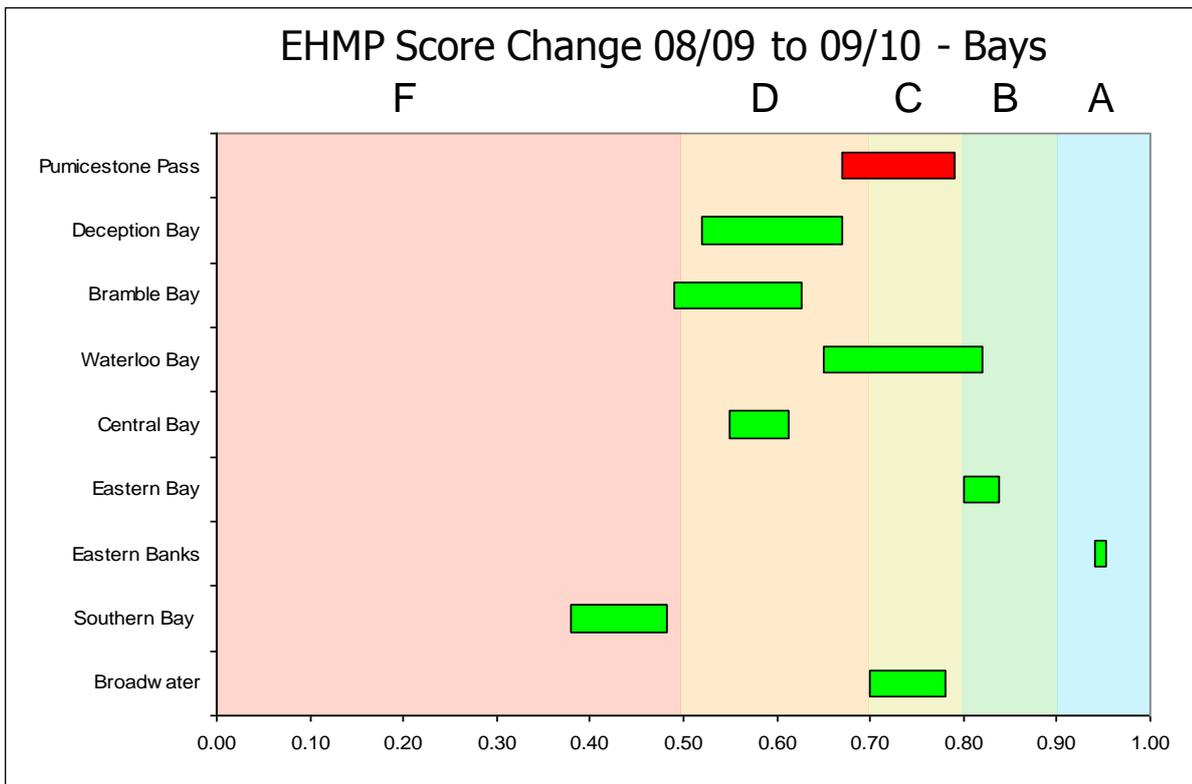
Figure 2: Change in Ecosystem Health Score from 08/09 to 09/10, based on Ecosystem Health Monitoring Program (EHMP) data. Green bars indicating a positive and red bar indicating a negative change. Data sourced from Department of Environment and Resource Management

As part of the Healthy Waterways' Ecosystem Health Monitoring Program (EHMP), trends in water quality across South East Queensland have been monitored monthly over the past decade. The results show that the ecosystem health of the Passage has generally been 'good' (a grade of 'B'). However, since 2008, total nitrogen (TN) has increased in the central and northern section of the Passages, resulting in a continuous decline in the ecosystem health score for the waterway. In 2010, the Passage dropped to its lowest score since the beginning of the EHMP—a 'poor' grade (D+) (Figure).

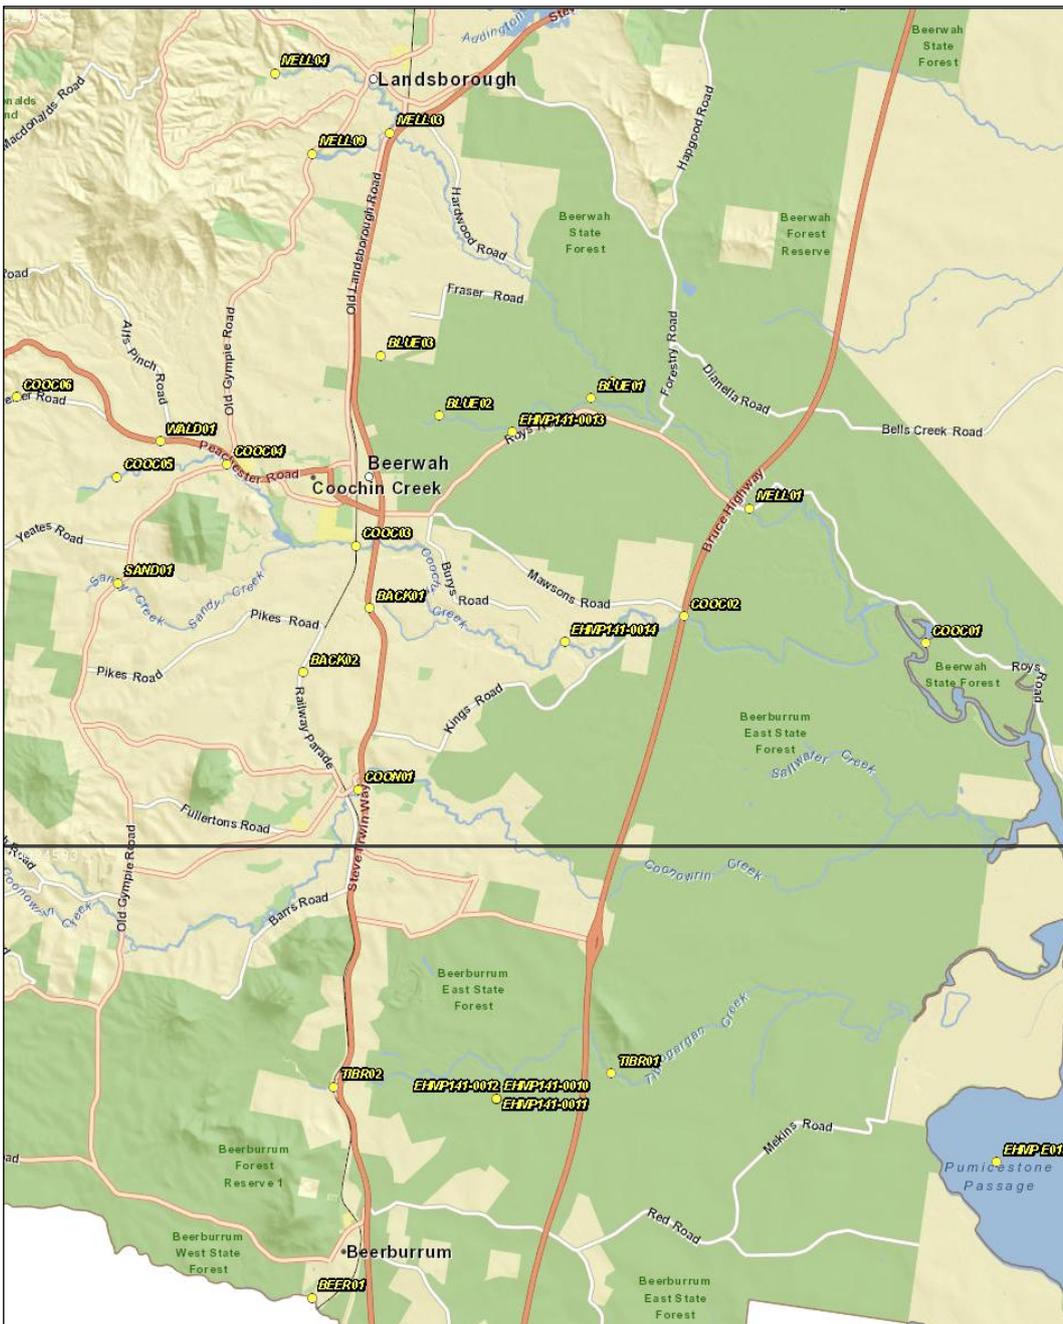
Figure 3: Location of Sunshine Coast Council's monitoring sites

Data from local monitoring programs undertaken by council staff are also available; however, data collected is mainly restricted to biophysical water quality parameters and has not been collected consistently over the same period. Figure shows SCC's local monitoring sites within tributaries of the central Pumicestone Passage and Table 2 summarises data collected between 2007 and 2009 at those sites.

SCC's local monitoring data was compared with relevant EHMP sites. Oxidised and total nitrogen concentrations were very high in middle to upper Coochin Creek and Back Creek, in the area around Beerwah. There were also site-specific spikes of ammonia and/or dissolved phosphorus in Mellum, Bluegum and Sandy Creeks.

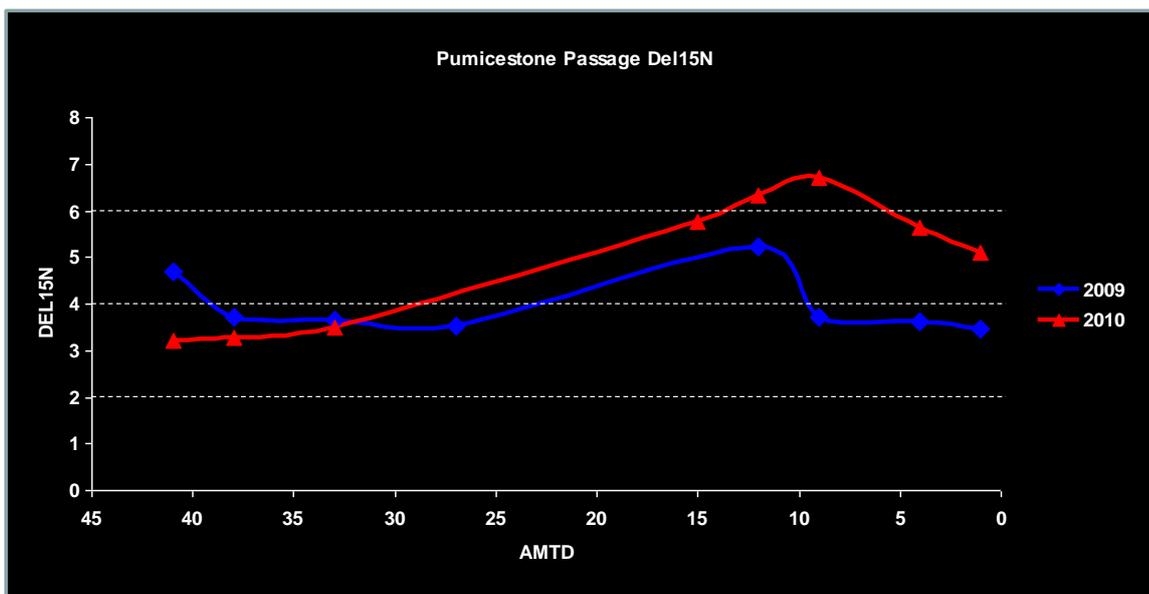
Figure 4: $\delta^{15}\text{N}$ ratio data along the Pumicestone Passage. AMTD = Adopted Middle Thread Distance in kilometres (45 = southern and 0 = northern opening) (DERM data)

The highest values measured in the Pumicestone Passage during the EHMP—values greater than 6.7—were found near the mouth of the Coochin Creek estuary, in the central-northern end of the Passage (Figure 4). By way of reference, 6 is typical of septic waste.

The most likely scenario is that higher loads of nitrogen are coming through upper Coochin Creek and are getting processed in the lower Coochin estuary. However, a high $\delta^{15}\text{N}$ value does not necessarily mean more nitrogen in the system; it simply indicates where the nitrogen has come from or how much it has been processed. Therefore, the recent increase in $\delta^{15}\text{N}$ in the northern Passage is probably due to a more-saturated catchment (groundwater and soil) combined with increased nitrogen runoff. The higher $\delta^{15}\text{N}$ signatures measured in 2010 may be primarily due to increased run-off in the preceding years (Figure), and hence, pre-saturation of the catchment; however, conclusive interpretations cannot be drawn from the present data.

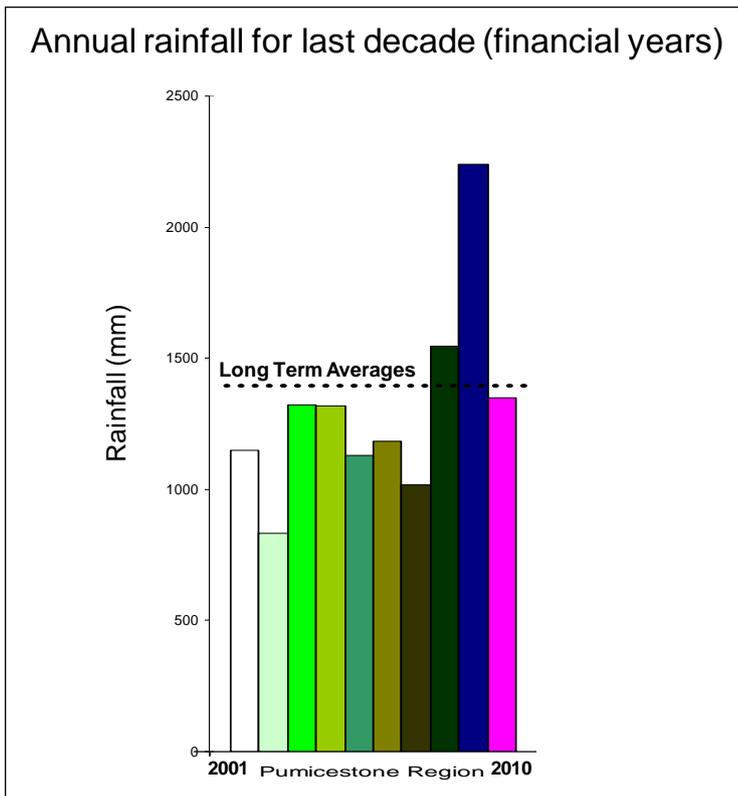
Figure 5: Annual rainfall for the last decade (2001-2010). Dotted line indicates the long-term average (DERM data)

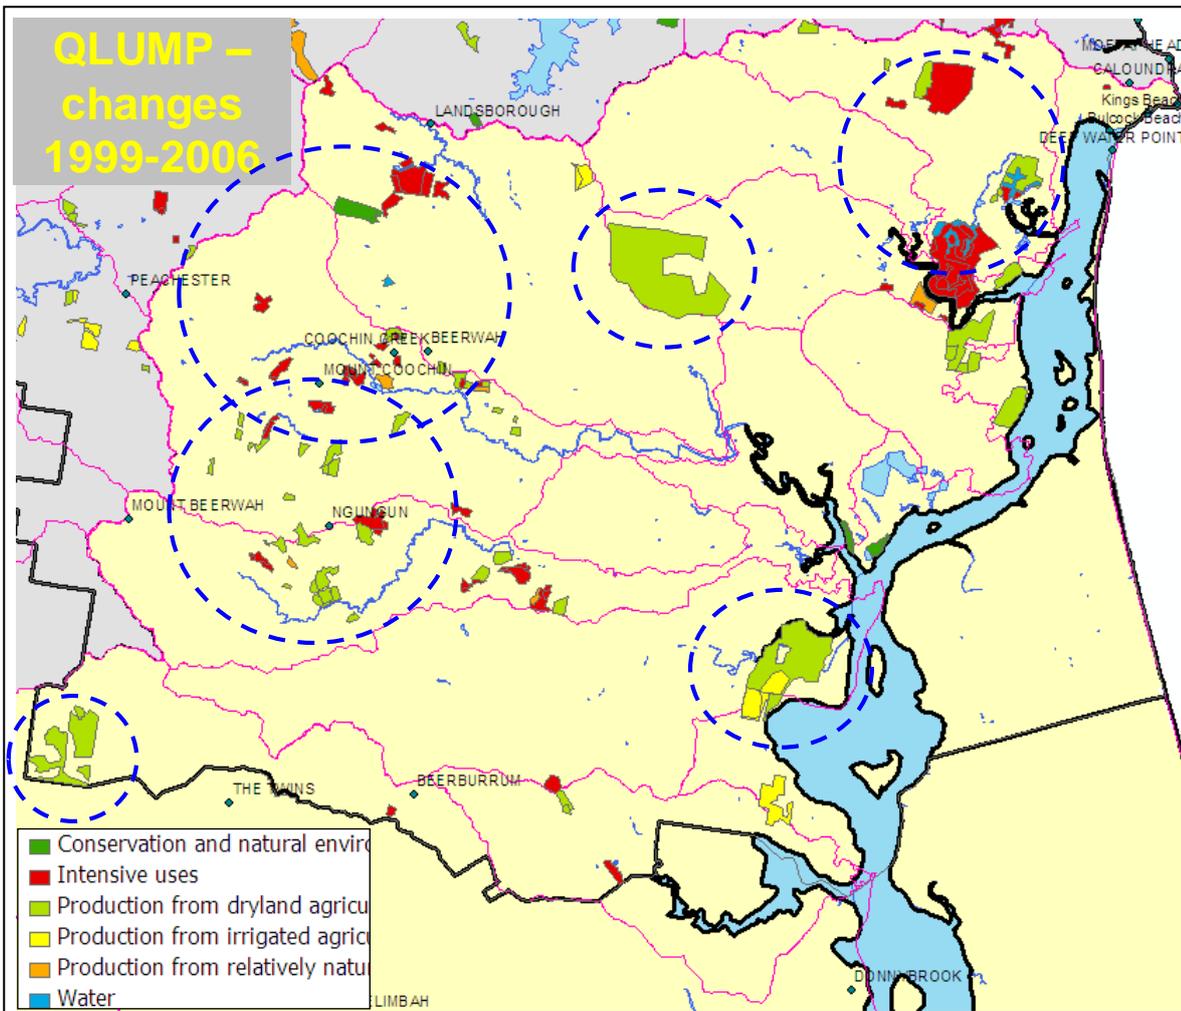
Figure 6: Map of land-use change sourced from Queensland Land Use Mapping Project (QLUMP). Coloured parcels have changed between 1999 and 2006

The Queensland Land Use Mapping Project (QLUMP) mapped land use across Queensland in 1999, and followed up with a review of the mapping in 2006 (Figure) (<http://www.derm.qld.gov.au/science/lump/>).

The group noted that the period of most intense land-use changes (since 2007), and thus of most concern, had not been captured by those recent map updates of land-use change. This crucial knowledge gap had to be filled if any meaningful estimation of catchment input from different land-uses was to be established. Figure and Figure illustrate recent efforts of MBRC, DEEDI and others to develop updated land-use mapping within the Pumicestone Passage catchment, based on recent aerial photography and other ground-truthing activities.

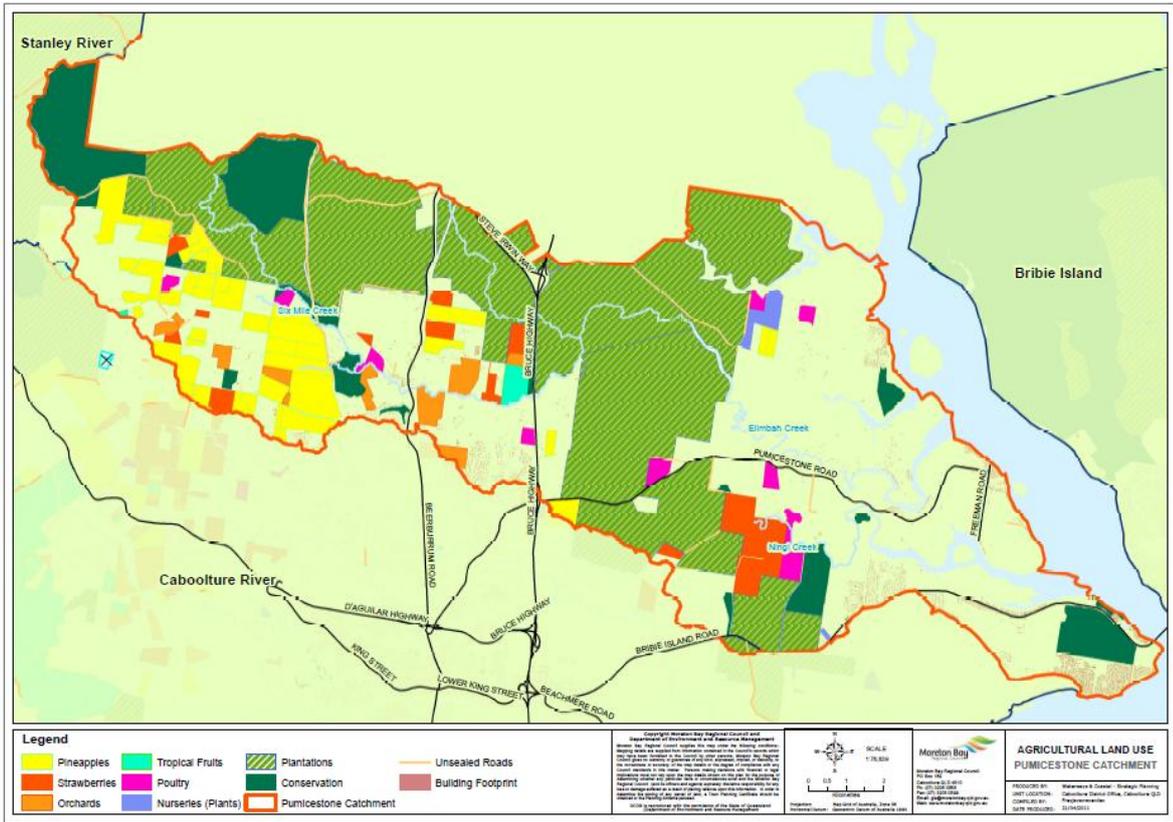
Figure 7: Agricultural land-use map from Moreton Bay Regional Council for the southern part of the Pumicestone Passage catchment

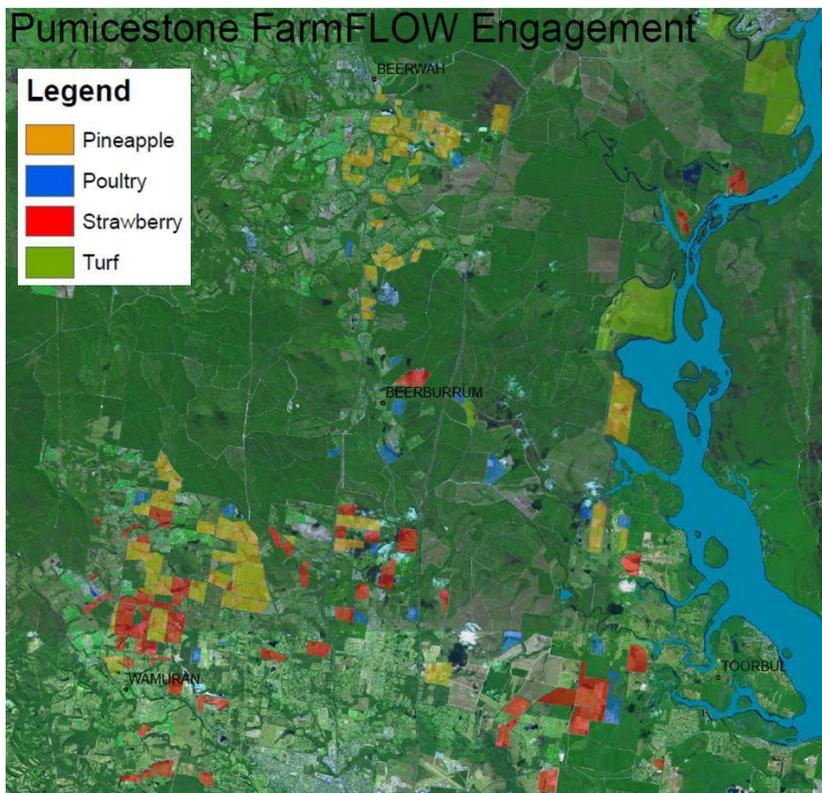
Figure 8: Map of confirmed agricultural land-use parcels in the northern Pumicestone Passage catchment. Sourced from FarmFLOW project (SEQ Catchment and DEEDI)

Mapping showed that presently, the most common agricultural land uses in the Pumicestone catchment (excluding forestry) are pineapples, poultry, strawberries and turf. Changes in land use

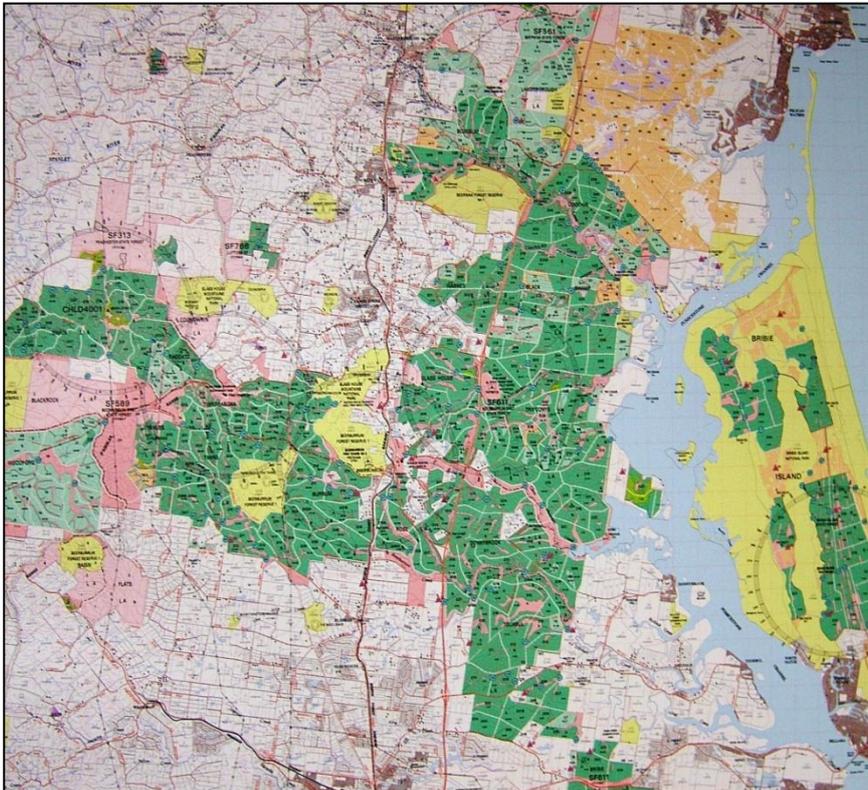
Figure 9: Pine Forestry Plantations in the Pumicestone Passage Catchment. Photograph of FPQ map. Green= active forestry; pink= buffers; yellow= state/conservation; red= active forestry, cleared and planted within the past 5 years; salmon = cleared and not active forestry

The PPTWG investigated and discussed recent clearing (2006-2011), fertilizer application, recreational use and other issues relevant to potential impacts on local waterway health. A map is presented (Figure), highlighting all areas where new planting occurred in the last 5 years. Based on the map, the following conclusions were made:

- The overall cleared area, compared to total forestry area, is relatively small (<10%);
- The largest area of forest cleared in the past 5 years was on northern Bribie Island (in 2007)
- No active clearing occurred between 2008-2010.

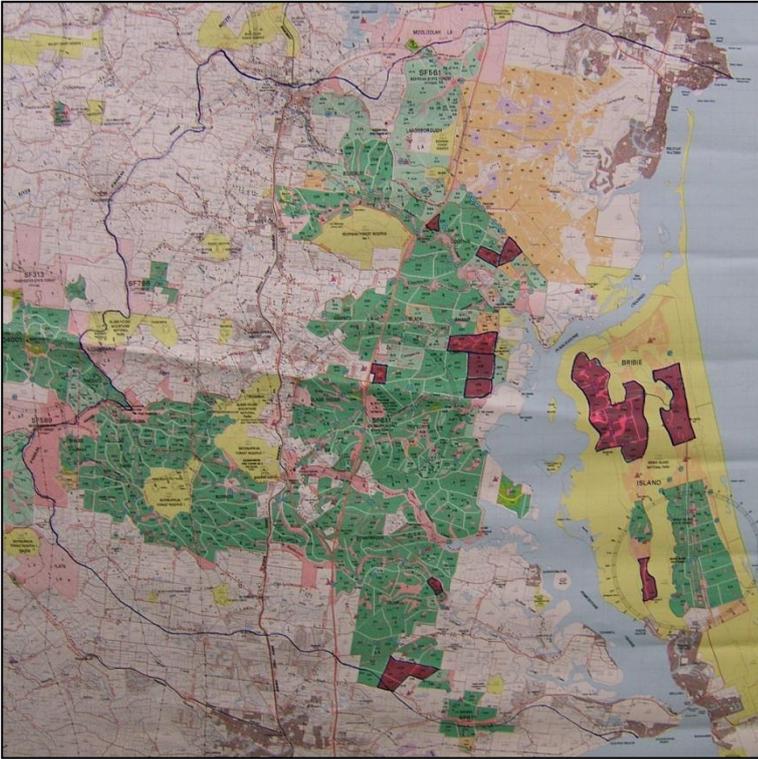
Figure 10: Recently cleared Pine Forestry Plantations in the Pumicestone Passage Catchment (2007-2010) (red areas). Photograph of FPQ map
