S.S. Dicky Archaeological Management Planning Documentation

Heritage Impact Assessment

FINAL DRAFT

S.S. Dicky
26° 41' 51.37", 153° 08' 21.65" (WGS 84)
Dicky Beach
Caloundra
NSW

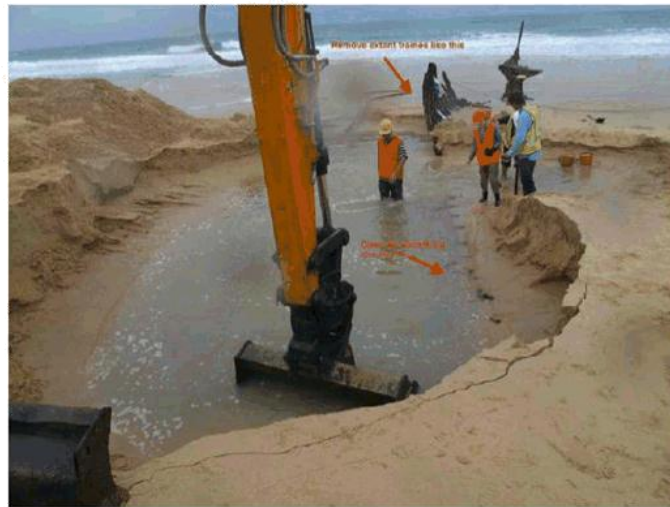
Figure 43. Example of where frames are to be cut down to on starboard side. The stubs in the foreground are the tips of the floors, the frames having been removed by recent storm surges. (Cosmos Archaeology, 28 April, 2014)

- Removal of loose wreck debris from around the wreck;
- Removal of frames and hull sections above the turn of the bilge and/or where the floor frames end (see Figure 17 and Figure 43);
- Removal of the remnant stern assembly (Figure 44 and Figure 45);
- Reinforcement of the remaining upright stanchion close to the bow, and;
- On-going removal of loose wreckage as it becomes exposed.

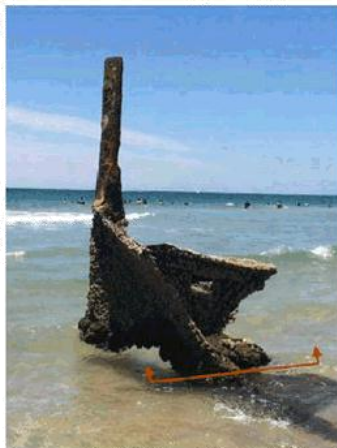
Figure 44. Indicative cut for the removal of the stern assembly. View from the starboard side. (Cosmos Archaeology, 19 December, 2014)

The removal of the stern assembly does not entirely conform to the rationale of the dangers posed by the mostly buried remains as it is the most conspicuous feature of the wreck and is never buried. However, the stern assembly is unstable and wobbles when pushed with minimal force. This has led to the re-evaluation of the long term stability of the feature it is considered that the collapse of the stern assembly will very likely occur within the next decade. To pre-empt its collapse, it was thought best for the stability of the wreck to remove it in a controlled manner. Cutting will take place at a location at the stern which will not destabilise the stern area of the wreck.

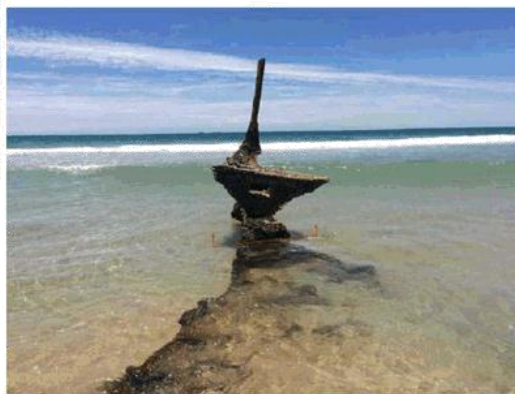
Figure 45. Indicative cut for the removal of the stern assembly. View from inside the wreck. (Cosmos Archaeology, 19 December, 2014)
