CONSERVATION ASSESSMENT OF KRAUSS DISPLAY OPTIONS

KRAUSS TRAM DISPLAY BUILDING BUDERIM QLD

CLIENT:
SUNSHINE COAST COUNCIL

DATE: MARCH 2017

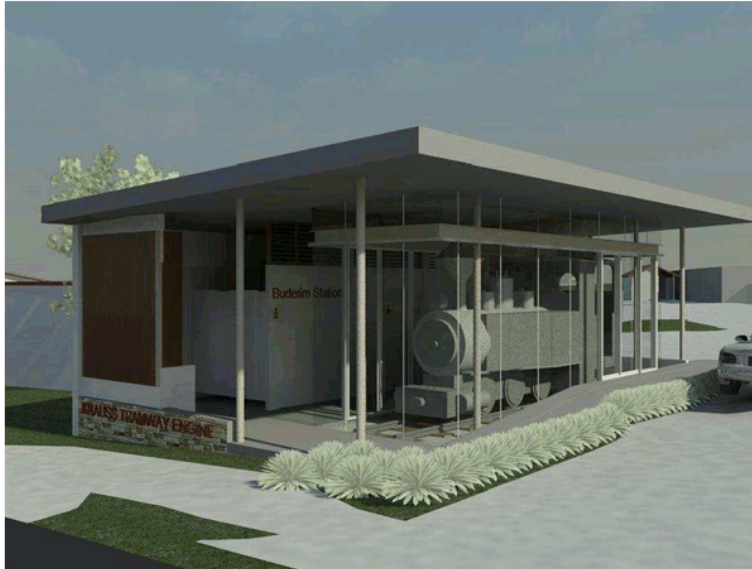
4.1 Concept Design – Buderim Design Studio (2015)

Description

Floor to ceiling glazing that encloses all of the main Krauss display area

Insufficient space and not recommended due to environmental conditions.

A very high level of routine maintenance and preservation housekeeping will be required. The paint coating is expected to fail in these conditions, leading to accelerated corrosion. A large scale restoration of the paint coating will likely need to be undertaken every 15 years if a high quality paint is used; and every 10 years if low quality paint is used.

The Krauss can't be maintained in a stable condition for the lifespan of the display building if kept in this environment. If the Krauss had been assessed as having a lower level of historical significance; then poorer storage, poorer physical condition, and its use as a demonstration object with a shorter lifespan could be justified. However these factors could make it unsuitable for selection in a display building with a 25-50 year lifespan.

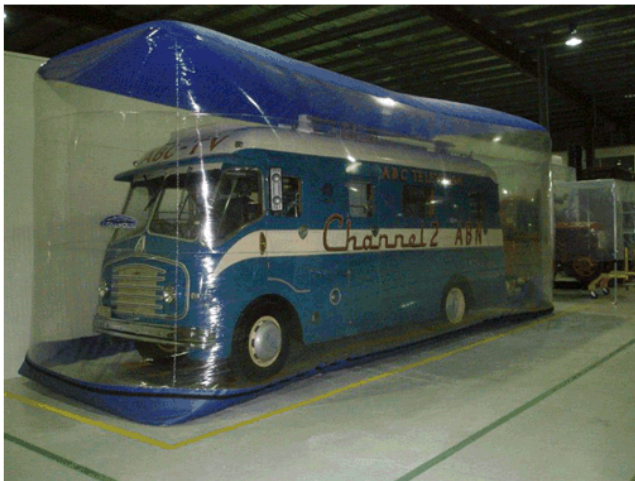
Indoor inflatable Carcoon \$2790.00 including delivery & GST running costs for this size approx. 30c per day plus dehumidifier cost

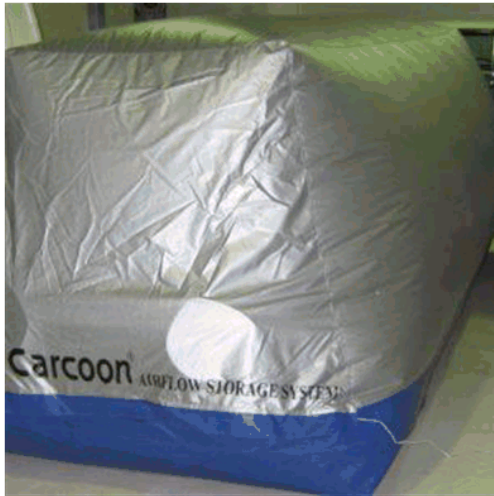
Outdoor Single Skin Carcoon \$2790.00 including delivery & GST

Single Skin units are intended for use in semi-sheltered situations, like carports. They provide additional protection from UV light.

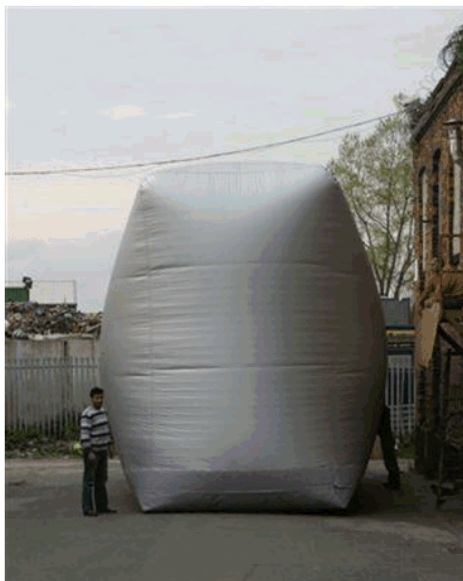
**Outdoor Double Skin Carcoon \$3390.00 including delivery & GST**

This is effectively 'a bubble within a bubble'; this model is designed to help protect vehicles in an outdoor environment. The outdoor Carcoon uses two layers of a special alloy coated material with an insulating air gap between each skin, this configuration along with a thick insulated base mat increase protection from the cold and damp, and also from high light levels.

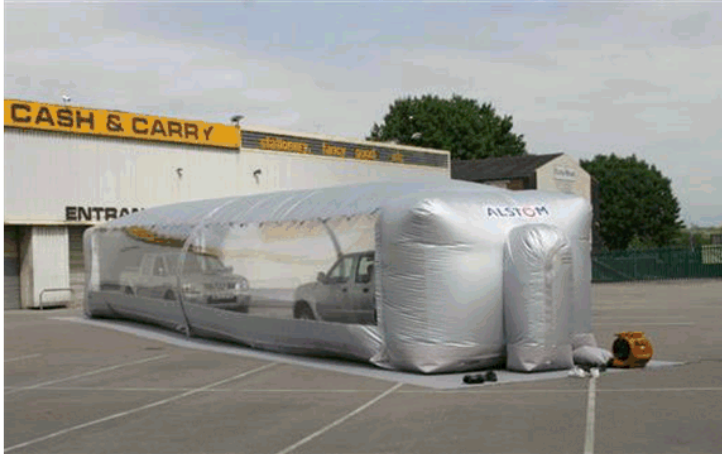
**Outdoor workstation Carcoon:**

This structure can be custom made, and would allow the Krauss to be worked on and the structure entered without dismantling the top half of the Carcoon.

Cost estimate – \$13,980.00
