PUMICESTONE PASSAGE
ADVISORY TASK FORCE

Erosion
fact sheet
03

Northern Bribie Island

What are the potential risks from a tidal breakthrough?

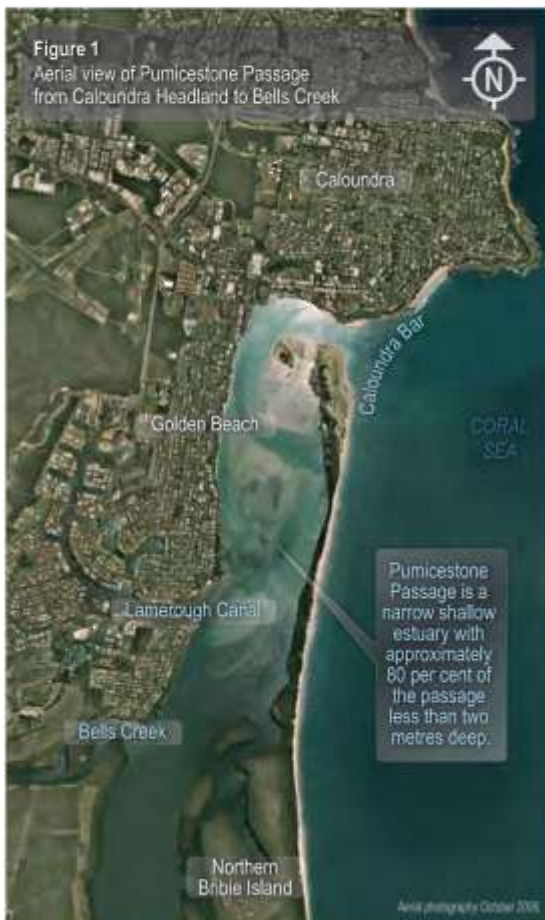
Figure 1
Aerial view of Pumicestone Passage
from Caloundra Headland to Bells Creek

Pumicestone Passage is a narrow shallow estuary with approximately 80 per cent of the passage less than two metres deep.

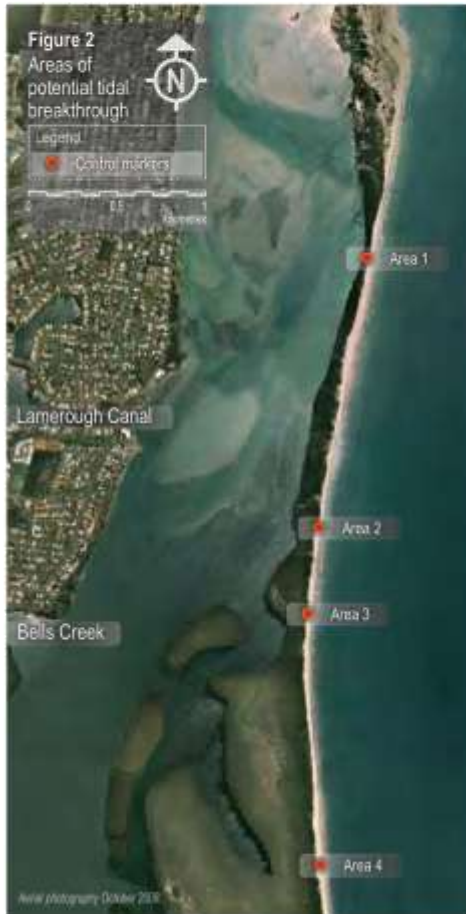
Figure 2
Areas of
potential tidal
breakthrough

Along the northern end of Bribie Island four locations have been identified by DERM which are considered vulnerable to a breakthrough. The four locations are narrow with low dunes and have experienced major wave overtopping events in the last two years (refer to Figure 2).

The study highlights that a scenario of storm waves occurring with a high tide and/or storm surge event could result in one or several breakthroughs occurring at once.

Recognising the rate of recession of the beach on northern Bribie Island is around one metre per year and the width of the island in some areas is only 30 metres wide, it is highly likely that a tidal breakthrough will occur within the next 20-30 years, although a breakthrough may occur at any time in response to a significant storm event.

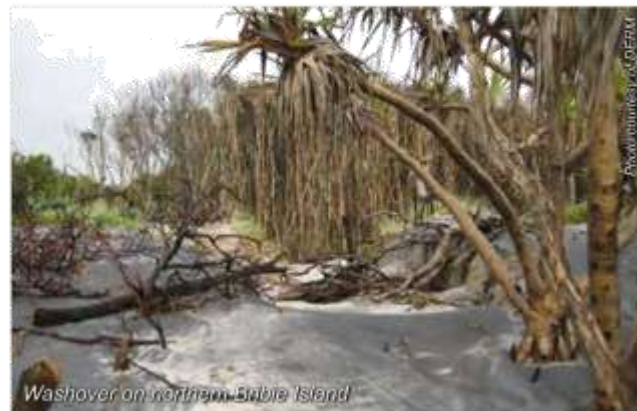
Washover on northern Bribie Island

In this instance a tidal breakthrough is when storm waves wash across northern Bribie Island lowering the dunes. As the level lowers tidal flows can then continue to deepen the channel which forms a new deep entrance to Pumicestone Passage. The process may take days or years and is dependent on weather and tide conditions, especially storms and cyclones.

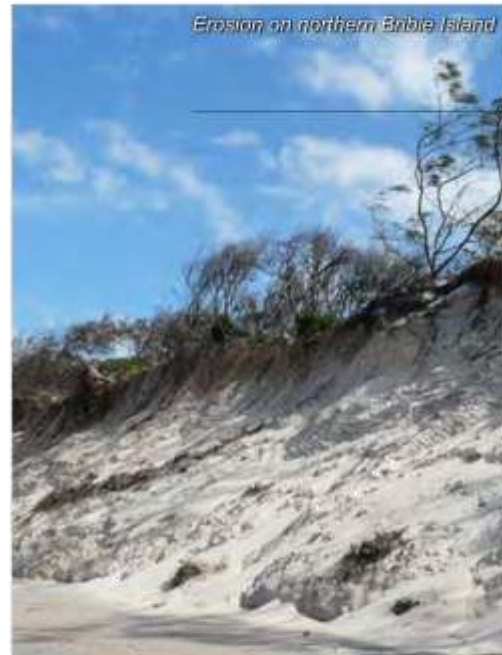
Erosion on northern Bribie Island

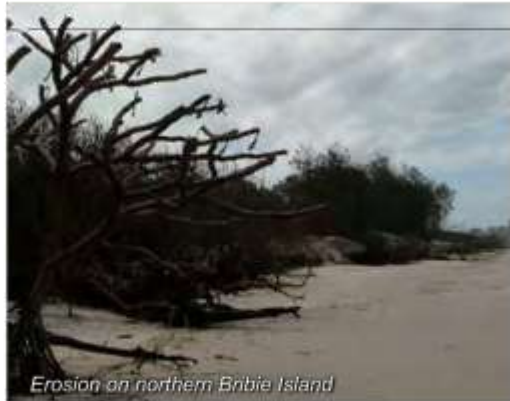
Erosion on northern Bribie Island
