GEOTECHNICAL INVESTIGATION

NOOSA WATERS ESTATE
NOOSAVILLE

REVTMENT WALL STABILITY

**RE: GEOTECHNICAL INVESTIGATION
REVETMENT WALL STABILITY
NOOSA WATERS ESTATE - NOOSAVILLE**

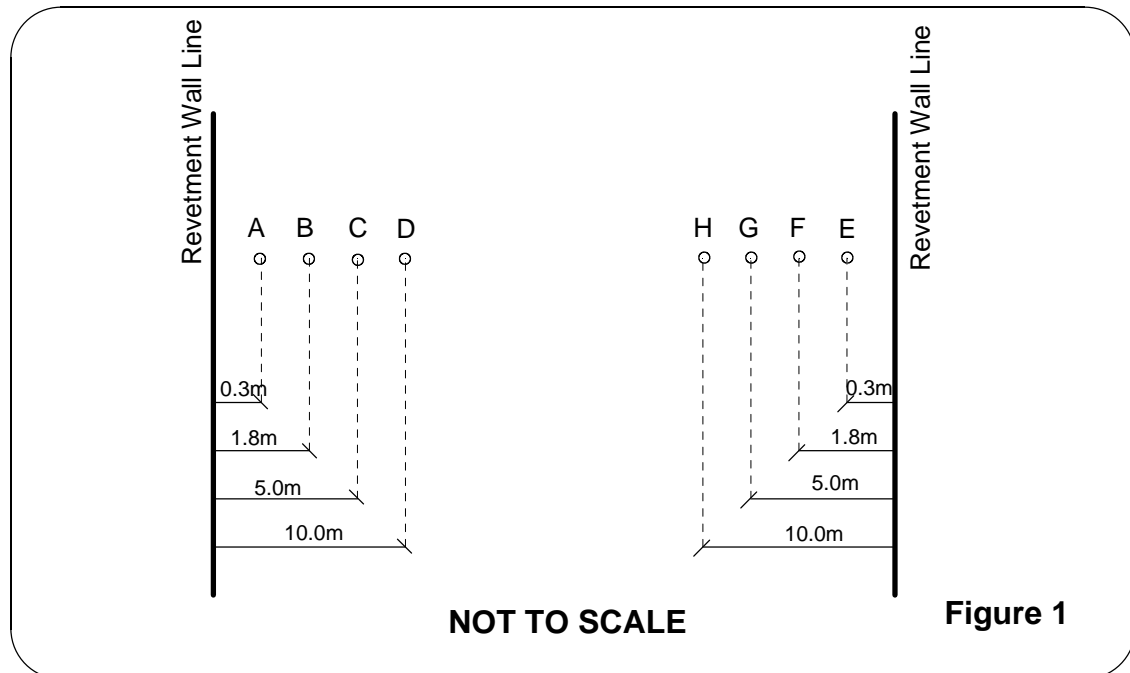
Tests were commenced at lake bed level with most tests recording no penetration resistance within the upper level very loose strata.

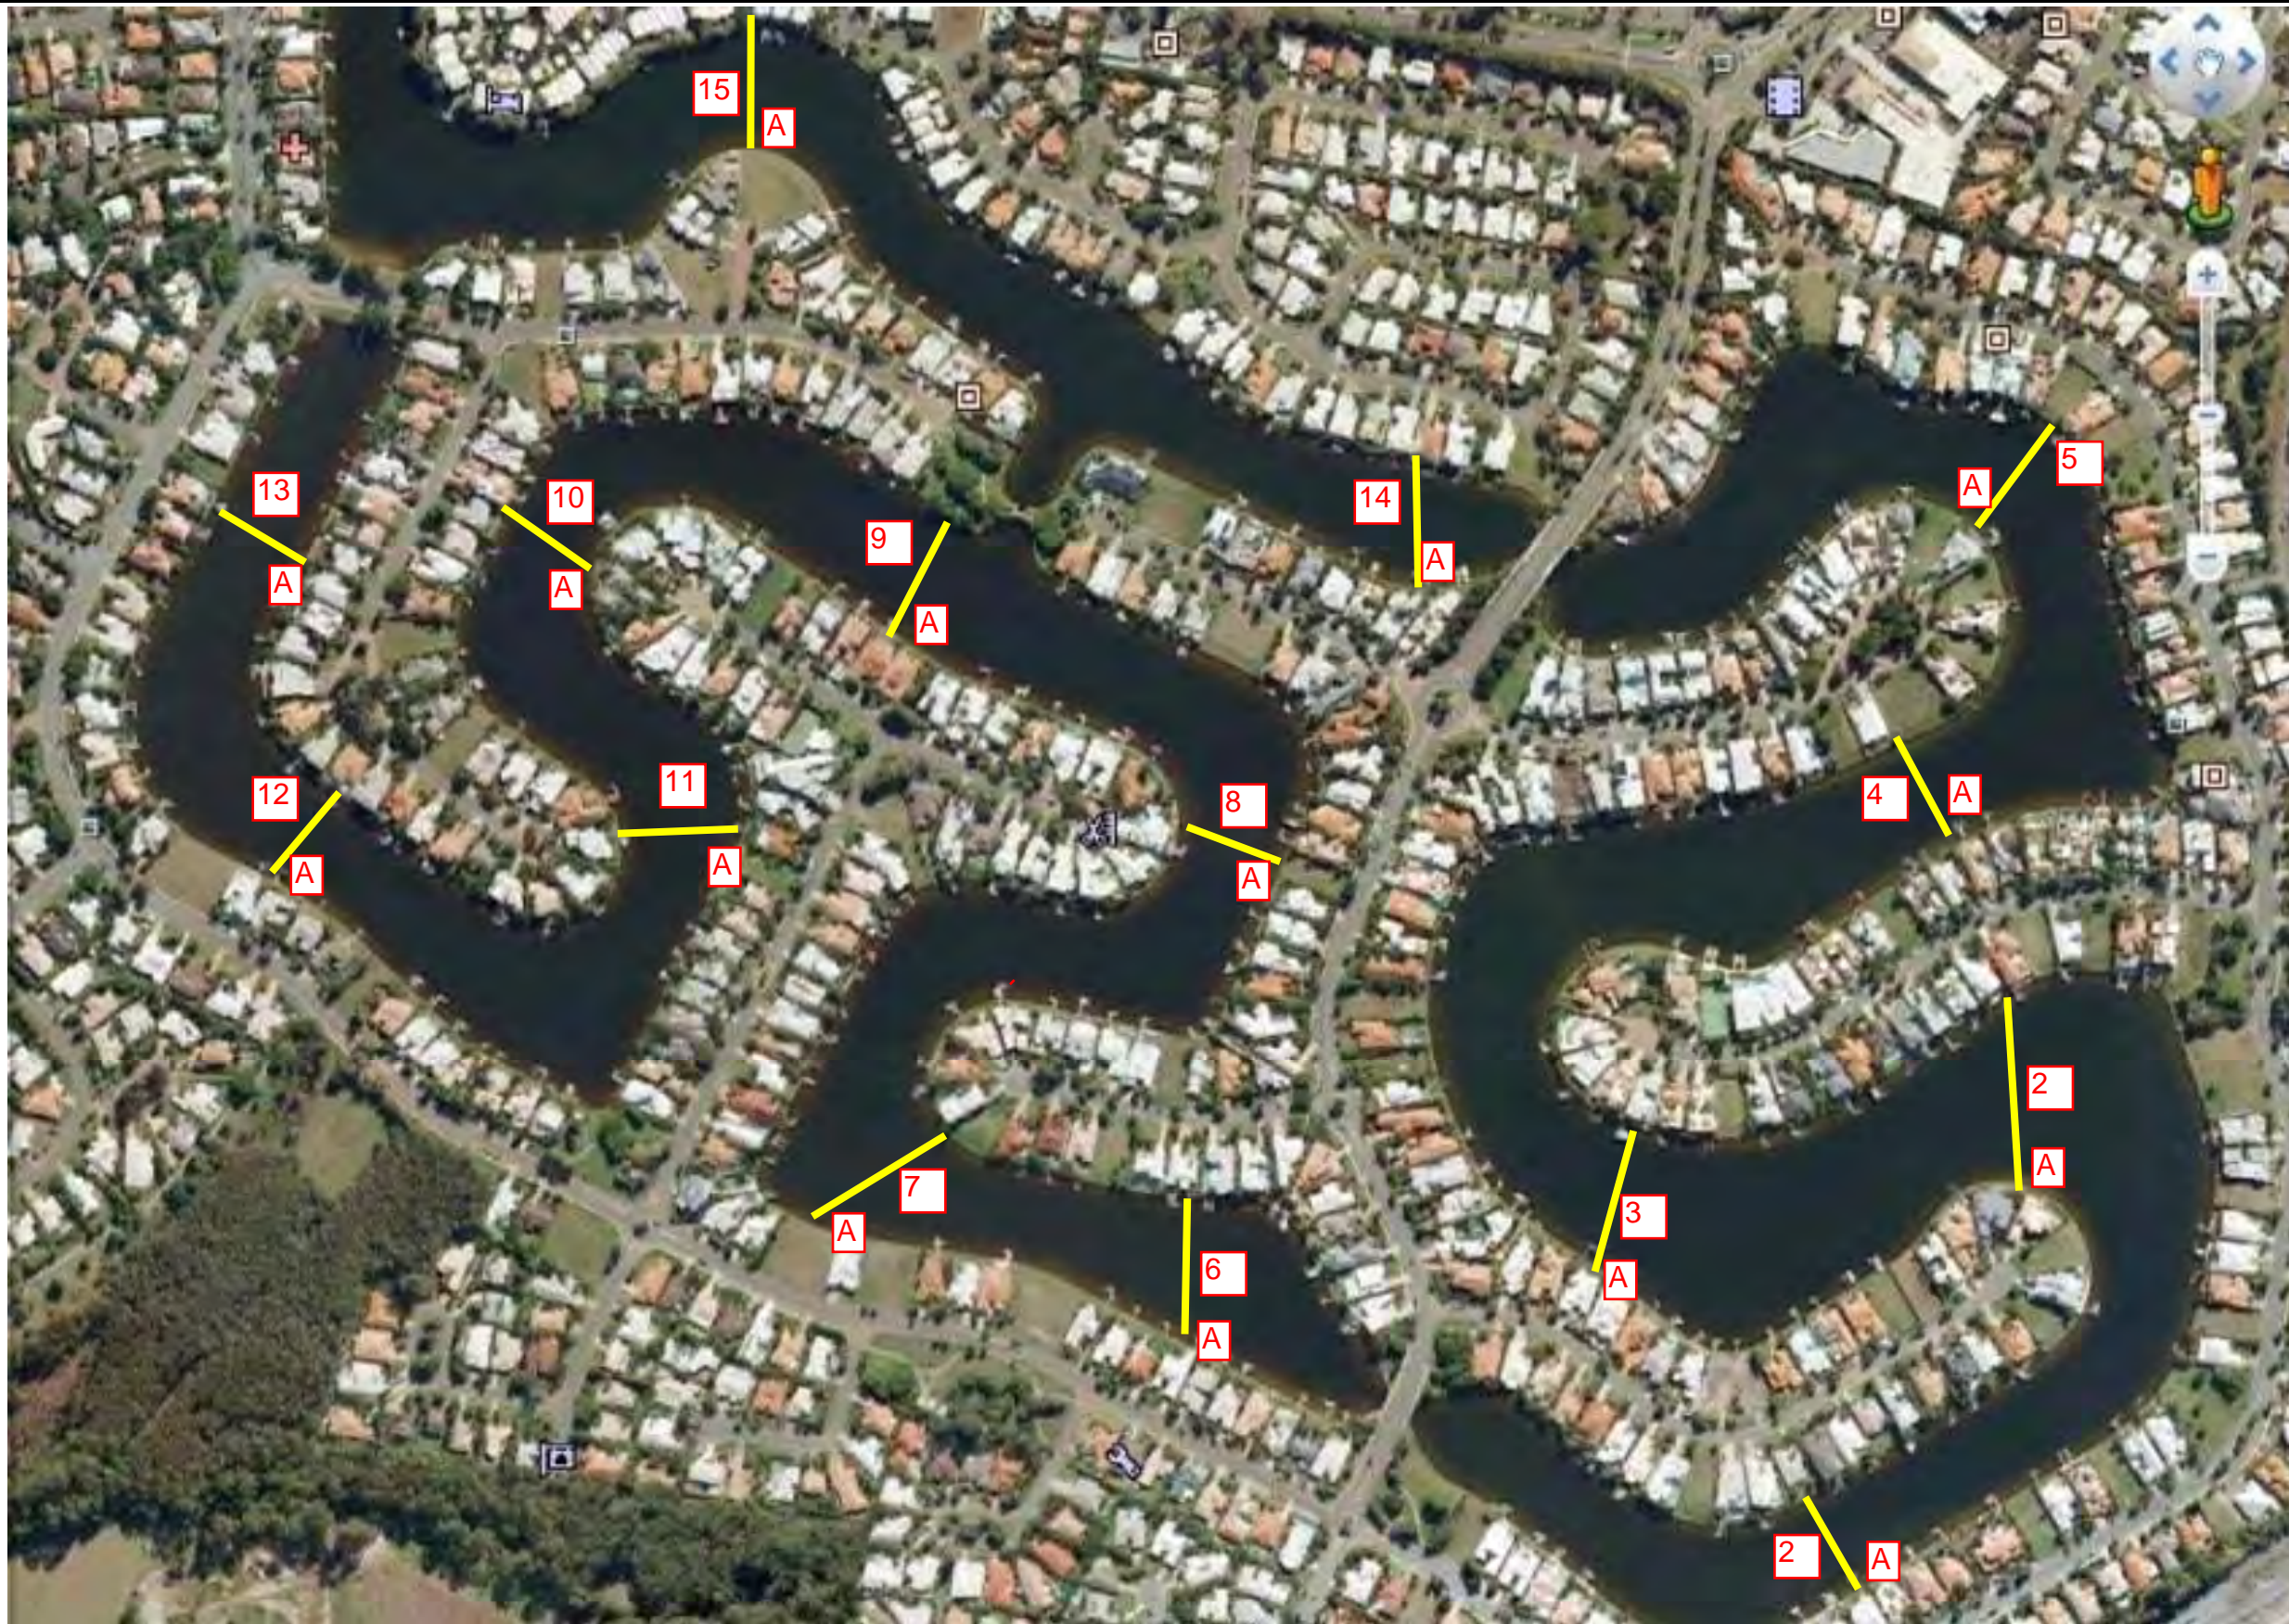
APPENDIX D
SECTIONS -
GEOTECHNICAL INVESTIGATION
DRAWING NO. 112-14835-01

Drawn TP	Project Geotechnical Investigation - Sections Location Noosa Waters Estate - Noosaville Client Sunshine Coast Council	Drawing No. 112-14835-01 A3
Date 2013		
Checked
