Erosion on the Passage side of Bribie Island

PUMICESTONE
 PASSAGE
 ADVISORY
 TASK FORCE

Prepared by Pumicestone Passage Advisory Task Force
 © June 2008 Sunshine Coast Regional Council

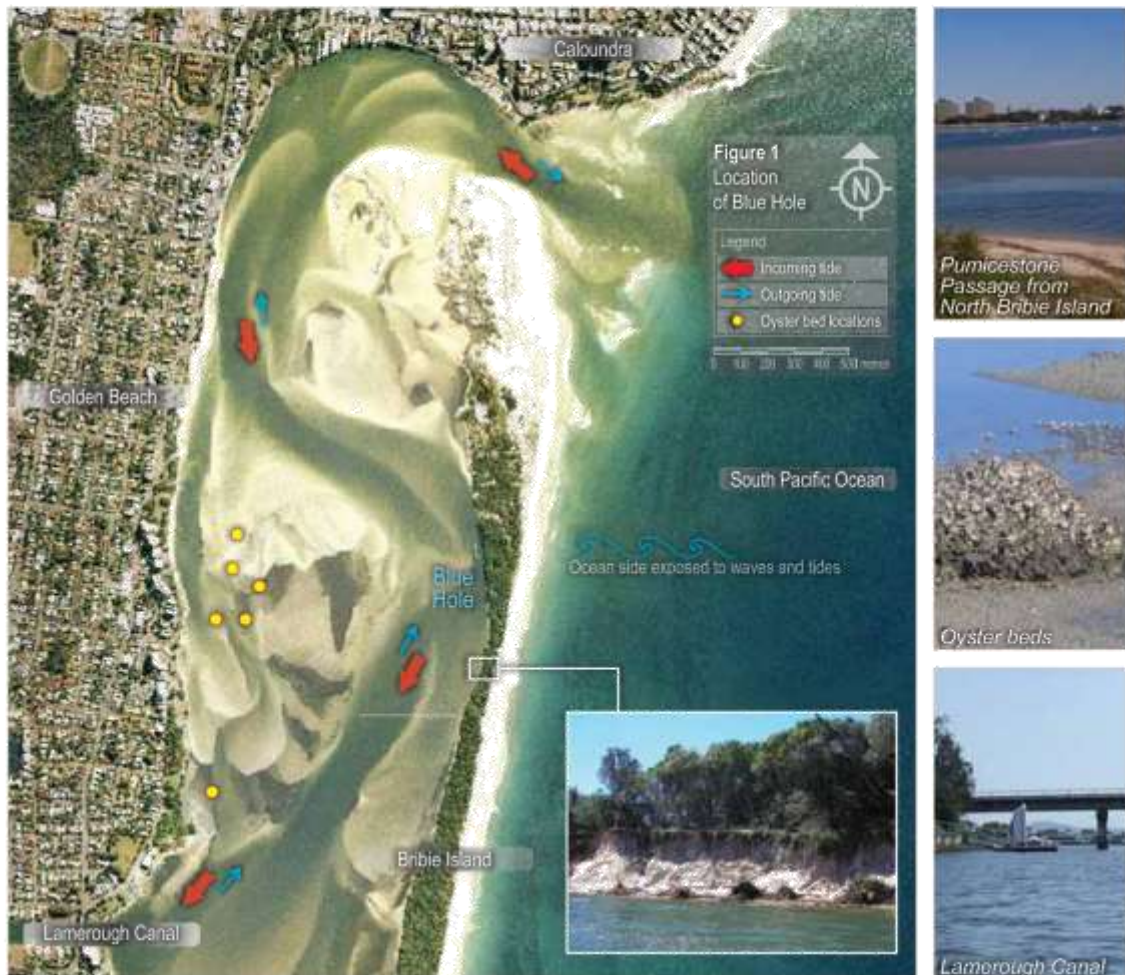
Where the main tidal channel flows against Bribie Island, in the vicinity of the Blue Hole (refer Figure 1), active erosion of the banks can be seen and this has caused much community concern.

The erosion on the Passage side of Bribie Island at the Blue Hole is considered to be a natural process. The channel has predominantly been at this location (refer Figures 2a and 2b) since first surveyed in 1865. In fact, the report showed the sandbars and channel in the Passage have been migrating north to south driven by slightly faster incoming tide flows (refer Figure 3).
