## 6 The Sunshine Coast shoreline and preferred erosion management options

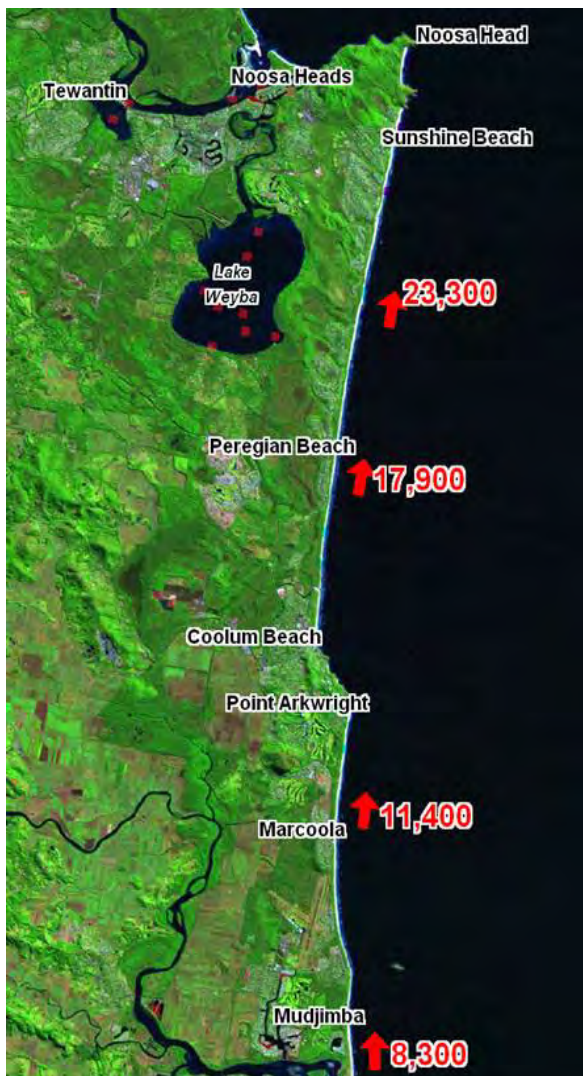
**Figure 6.1:** Potential net longshore sand transport rates (m<sup>3</sup>/yr) for Zone 1 and further north.

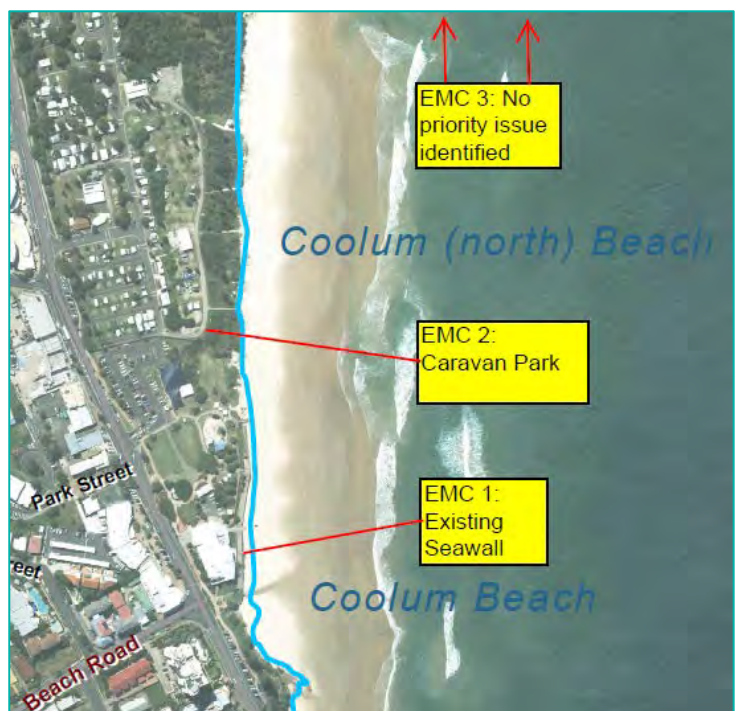
**Figure 6.1:** Air photo showing the erosion management considerations for Coolum Beach

2. The majority of the existing Holiday Park is not under immediate threat from the defined erosion event. However, future coastal hazard adaptation /risk assessment planning could consider appropriate long term use of the most seaward extent of the park (approximately one third of the total park area).

3. There are no priority erosion issues north of the Holiday Park due to the relatively

natural state of the beach and its capacity to accommodate natural processes in a relatively low risk scenario.

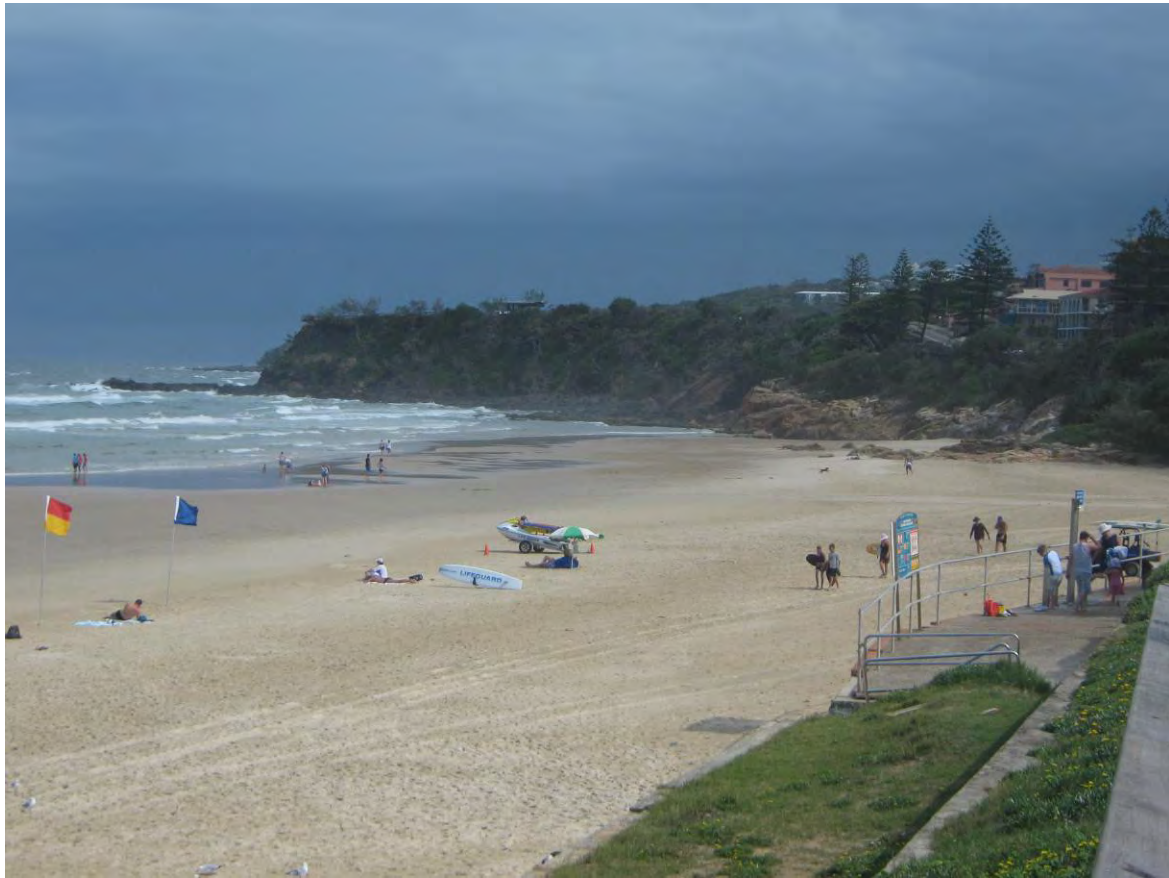
**Figure 6.2:** Coolum Beach looking towards Point Perry from the existing seawall.

**Figure 6.2**, below, shows the wide beach at Coolum Beach as seen from the existing seawall looking towards Point Perry.

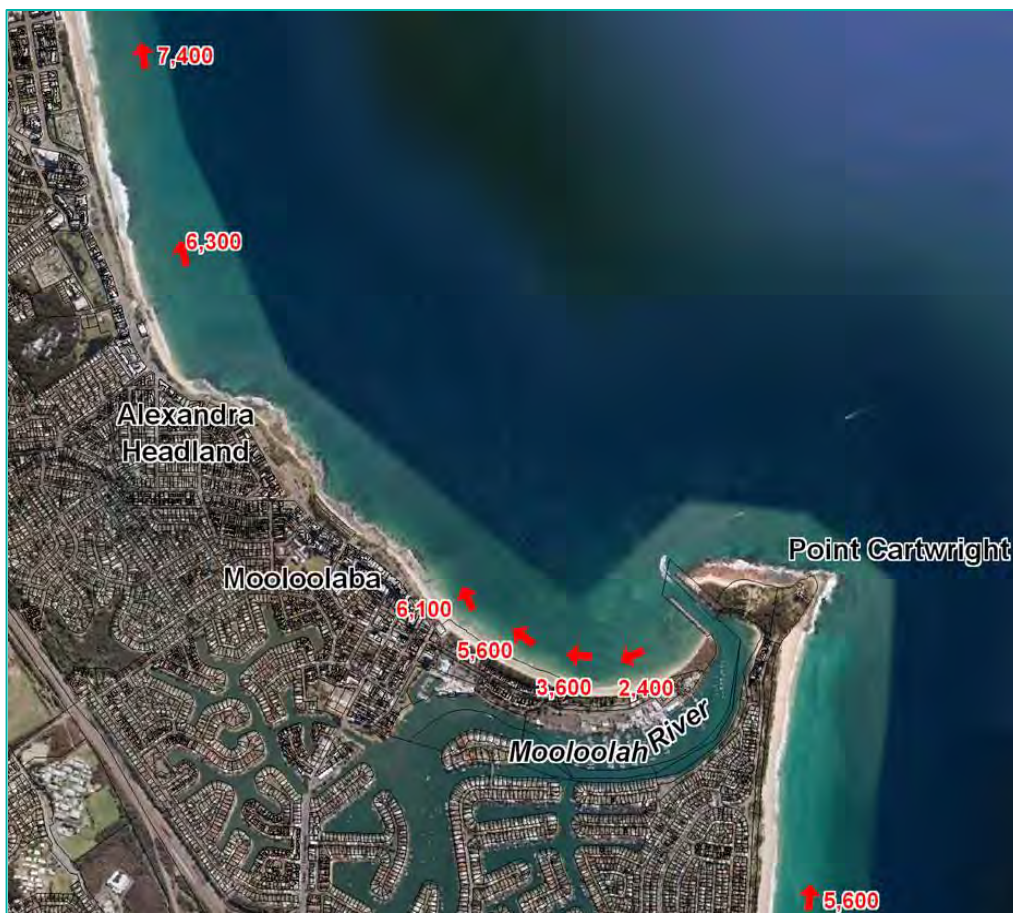
**Figure 6.3:** Potential net longshore sand transport rates ( $m^3/yr$ ) between Maroochydore Beach and Mooloolah River.

Maroochy North Shore is more exposed to open ocean conditions than the southern beach management units in this zone, with a corresponding potential net sand transport rate of  $8300m^3$  per year compared to those shown in **Figure 6.3** for the beach management units between the Maroochy and Mooloolah Rivers. Note that the potential inflow of sand from Buddina Beach to Mooloolaba Beach is  $5600m^3/yr$ , indicating only a weakly erosive potential with no significant loss due to longshore transport processes.

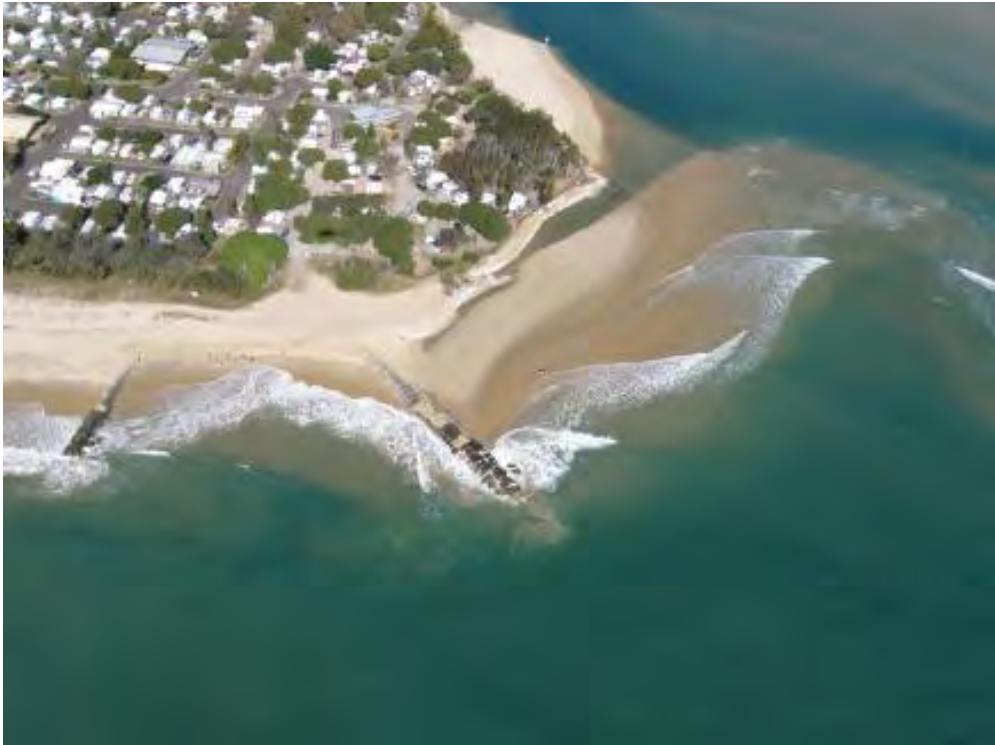
**Figure 6.6:** Maroochy River Entrance showing geotextile groynes.

Figures 6.6 and 6.7 show aerial and land based perspective views of the existing geofabric groynes at the Maroochy River entrance.

1. The existing geotextile groynes should be maintained by replacing damaged and distorted containers as required, in accordance with the relevant asset management plan. It should be noted that the geotextile containers have a lifecycle of about 25 years under ideal conditions. While not a specific priority action coming from this SEMP, comparative life cycle costing consideration should be given to reconstructing these structures using rock when planning for renewal of the structures. It is acknowledged that formalising the groynes with rock may reduce subjective visual amenity and 'user friendliness' of the structures and minimisation of these impacts should be considered in the design of such structures.

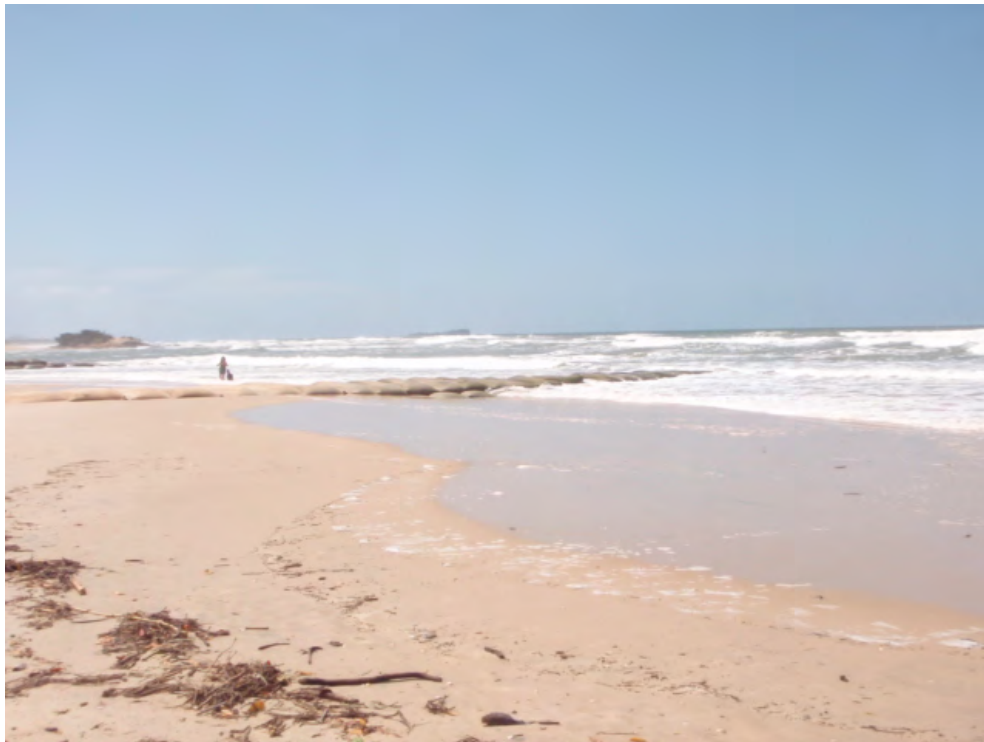
**Figure 6.7:** Geotextile Groyne at Maroochy River Entrance with Pincushion Island in the Background

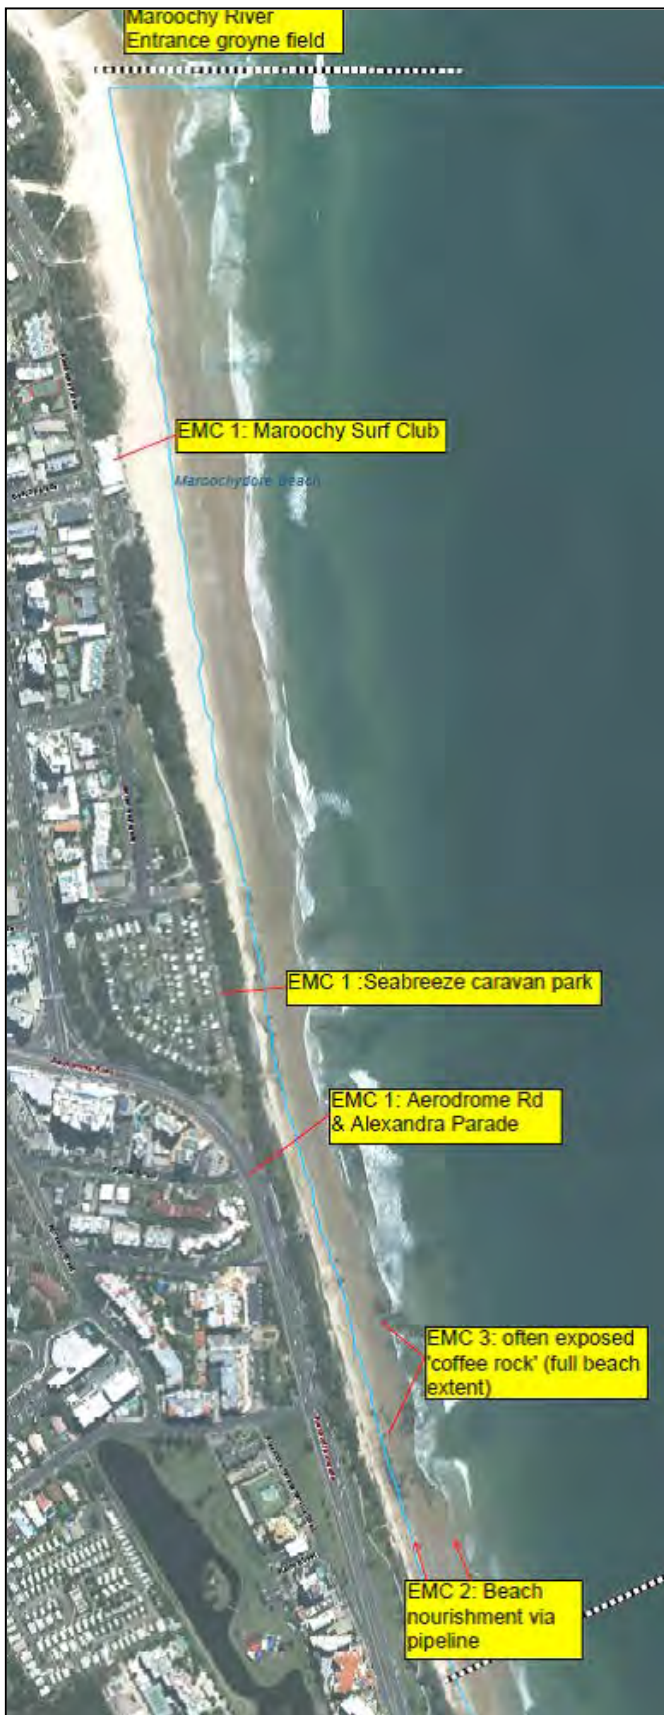
**Figure 6.9:** Annotated air photo locating the erosion management considerations for the Maroochydyore Beach Unit

1. Historically, the dune buffers of this beach management unit have generally been in good condition with a vegetated foredune between 20m and 50m wide. Extensive areas of coffee rock are also common in the nearshore area. The current defined storm erosion width (see **Section 3.1.8 Table 3.4 ETA532 and ETA 530**) varies from approximately 49m to 72m in the vicinity of Alexandra Parade. At present, infrastructure is vulnerable to erosion from the defined storm event. The width between the toe of the frontal dune and Alexandra Parade (a State controlled arterial road) is less than 20m at some locations. A buffer width of 15m has been previously defined as the “trigger” for seawall construction along this section. Note however, that this trigger is well within the defined erosion area and, therefore, infrastructure remains vulnerable to the defined event. In addition to Alexandra Parade, other infrastructure that is located within the defined erosion prone area includes the Maroochy Surf Club and the Sea Breeze Holiday Park. The Surf Club is currently protected by a seawall.

The location of Alexandra Parade and the Holiday Park carries a significant short-term erosion risk. Storm events in recent years have caused a lowering of the beach, exposed extensive areas of coffee rock, eroded dunes and damaged beach access infrastructure. The section of beach adjacent to Aerodrome Road/Alexandra Parade has been subject to erosion that has exposed imported fill material. The fill material is likely to provide some stability to the shoreline but this is not considered a suitable long-term shoreline protection measure and this also negatively affects beach amenity.

Long-term protection of the erosion prone infrastructure will probably require construction of a buried rock seawall along the seaward edge of Alexandra Parade-Aerodrome Road and the Holiday Park. A seawall provides a high level of protection to infrastructure but can negatively affect beach amenity, which may be mitigated by the current sand renourishment program. Note that the purpose of a buried seawall in the context of this SEMP is to provide protection from erosion damage but not prevent inundation of the area landward of the wall.

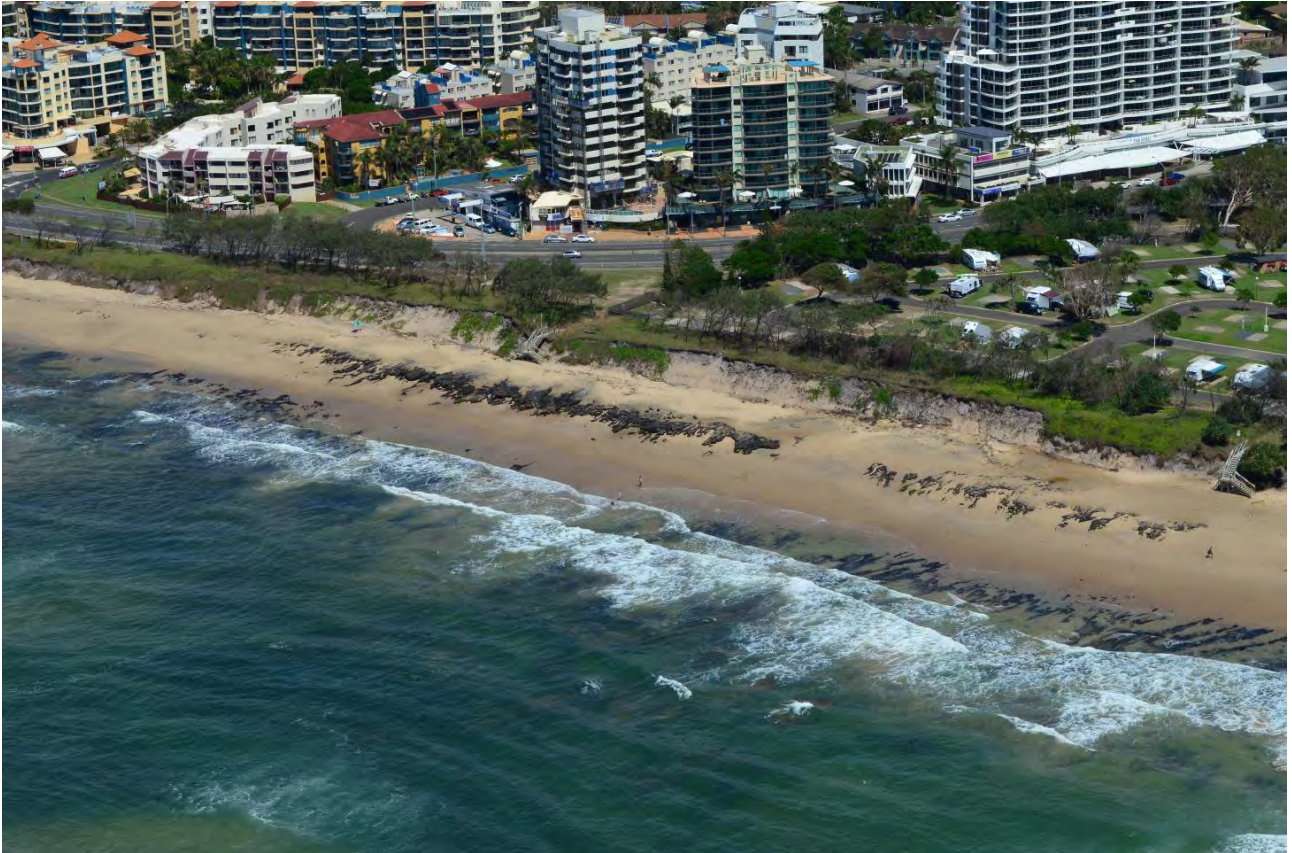
**Figure 6.10:** Maroochydore Beach erosion adjacent to the Seabreeze Holiday Park and Aerodrome Road/Alexandra Parade, March 2013

**Figure 6.10**, below, is a photograph looking south at Maroochydore beach, showing exposed coffee rock, beach access infrastructure and dunes prior to erosion that occurred early 2013.

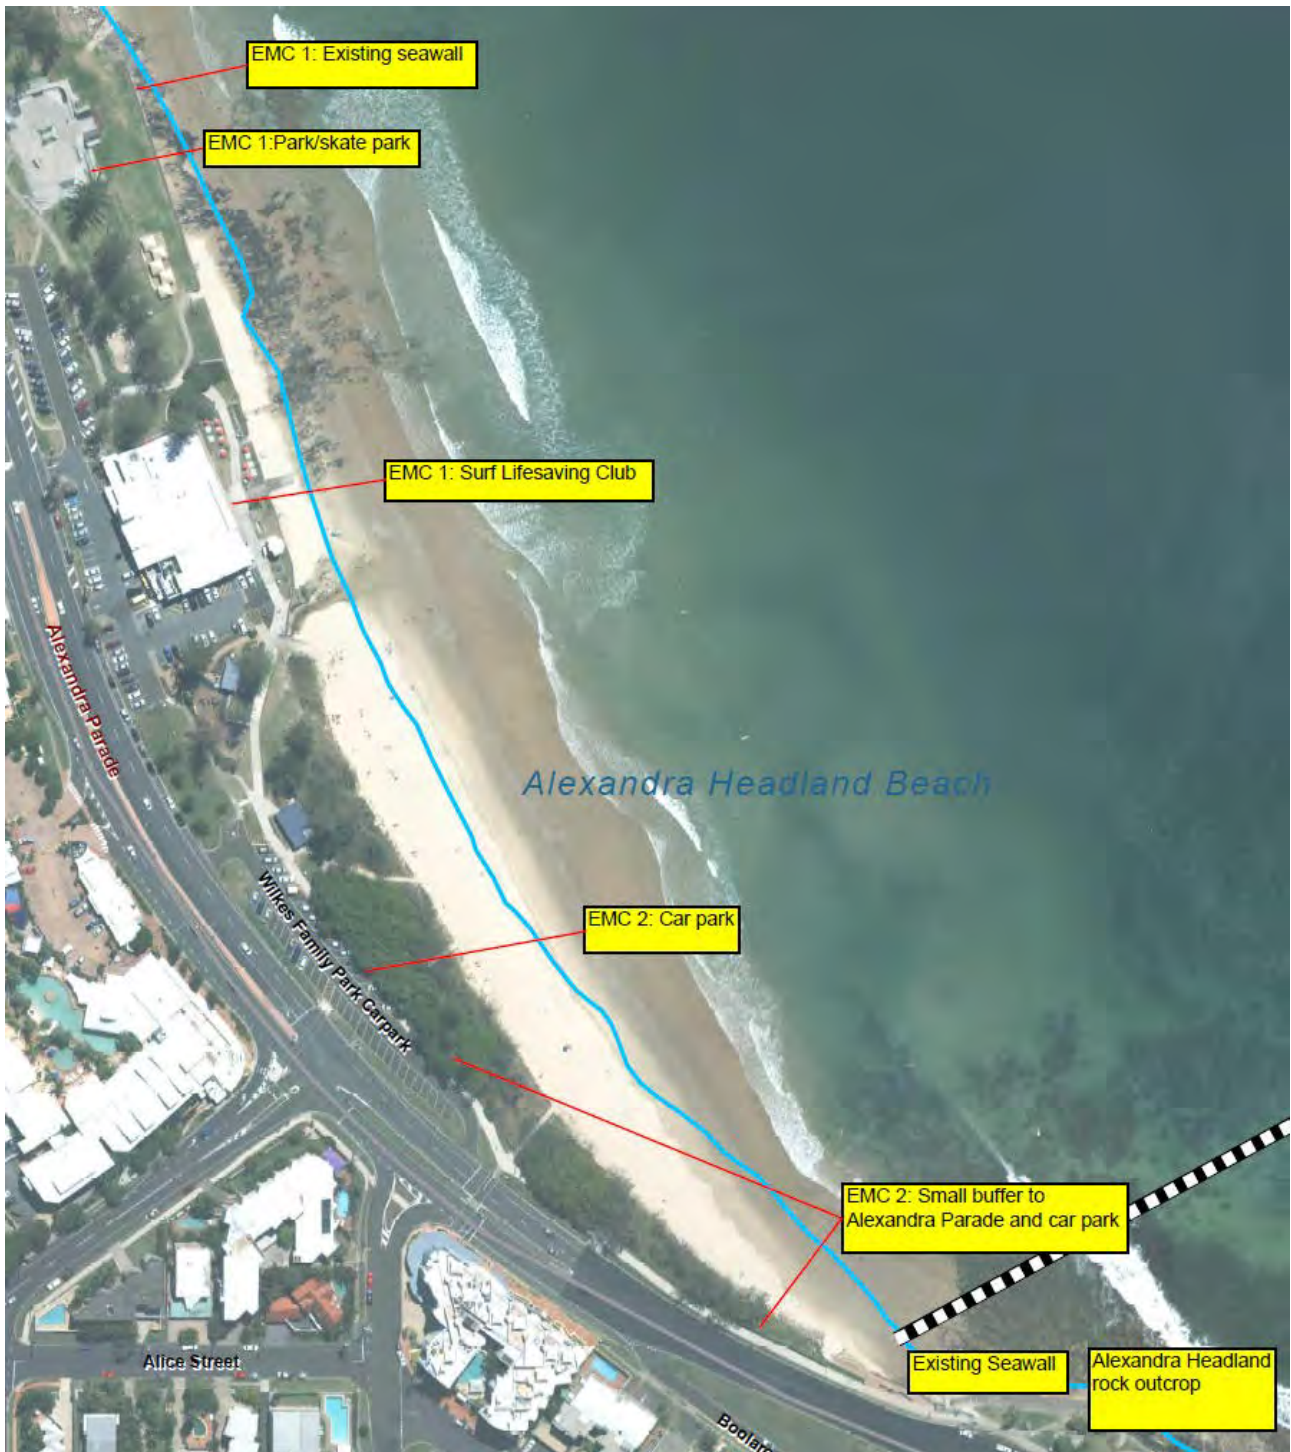
**Figure 6.11:** Annotated air photo showing the erosion management considerations for Alexandra Headland Beach

2. Further south, Alexandra Parade and the Surf Club car park are protected by a small buffer that is as narrow as 20-30m at some locations. The road at this location is State controlled arterial infrastructure. This infrastructure is within the defined storm erosion area and may require protection works to defend against current and future erosion threats.

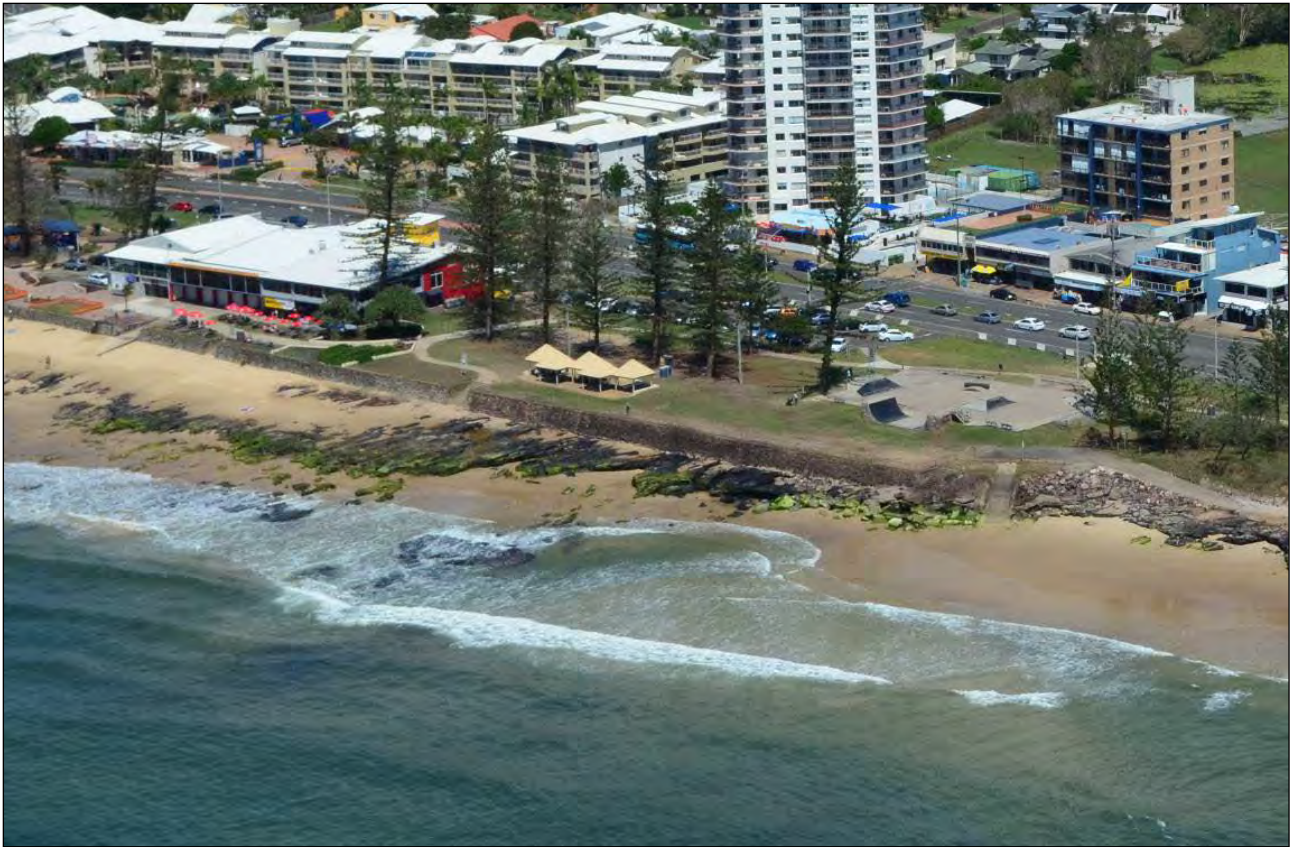
**Figure 6.12:** Exposed coffee rock at the toe of the Alexandra Headland sea wall

**Figure 6.12** next page, is a photograph looking showing the persistently exposed coffee rock in front of the seawall.

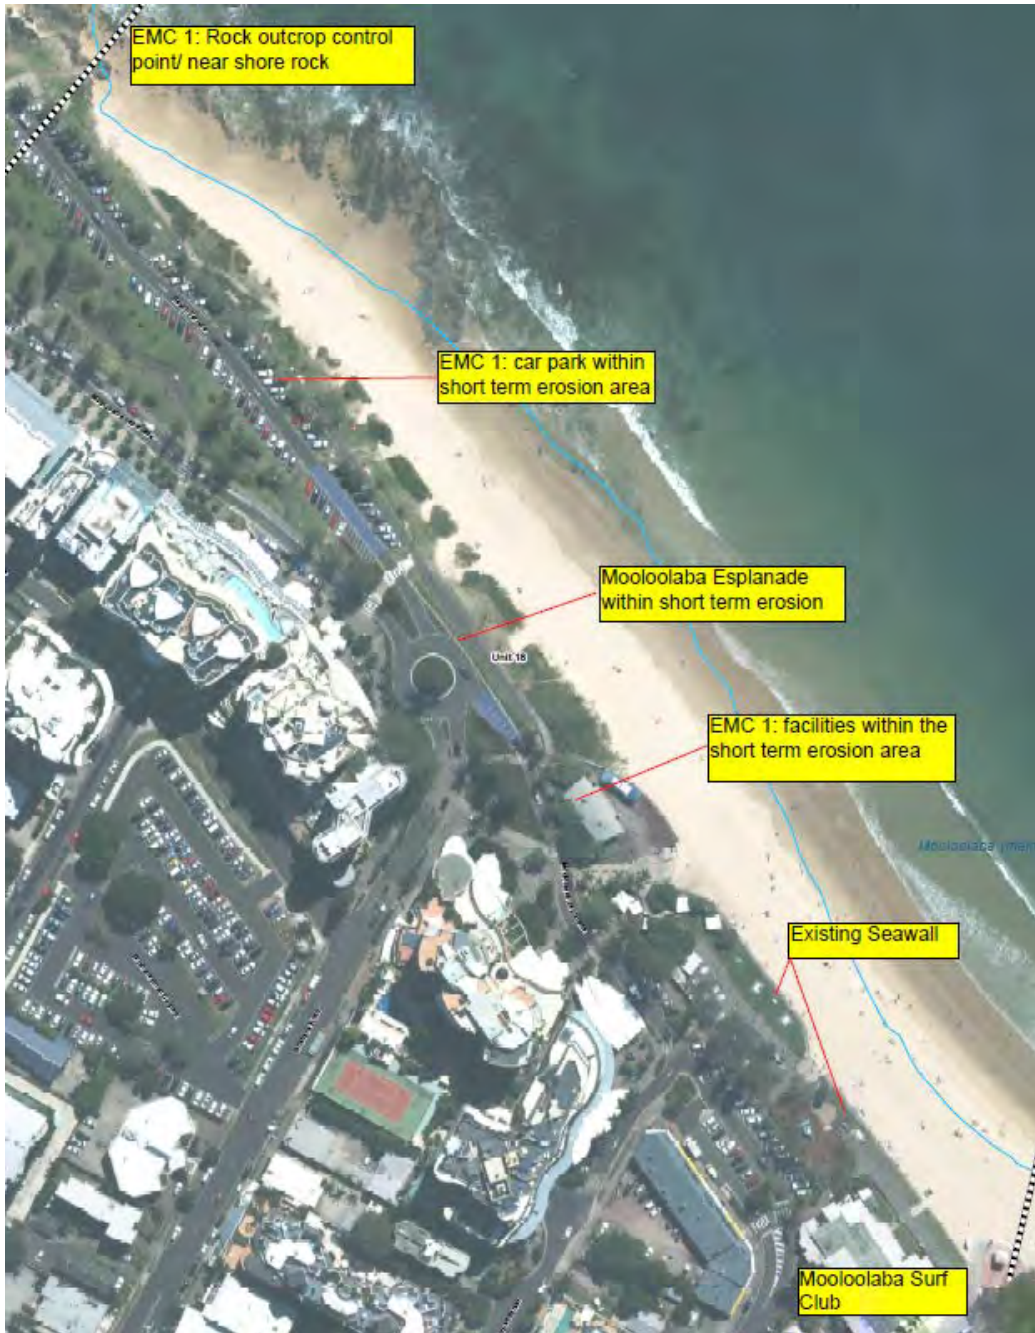
**Figure 6.13:** Annotated air photo locating the erosion management considerations for Mooloolaba Beach North

1. Mooloolaba Esplanade and car park, toilet facilities and Beach Terrace are within the defined storm erosion prone area, with no or minimal buffer and, in places, light concrete armouring (geotextile formed concrete) which is showing signs of deterioration. Hard protection works will likely be required given the projected erosion threat to existing development along this shoreline. Hard protection in the northern section may be delayed due to existing buffers being approximately equal to the width of the defined storm erosion area and particularly if improved protection is provided through dune restoration activities and beach nourishment at Mooloolaba Beach South. Beach amenity may be reduced from time to time when seawalls perform their role of protecting infrastructure during storms, even during events that are smaller than the defined event. It is expected that the beaches may take weeks to months to recover from these events (depending on conditions) and preservation of beach amenity will be dependent on beach nourishment.

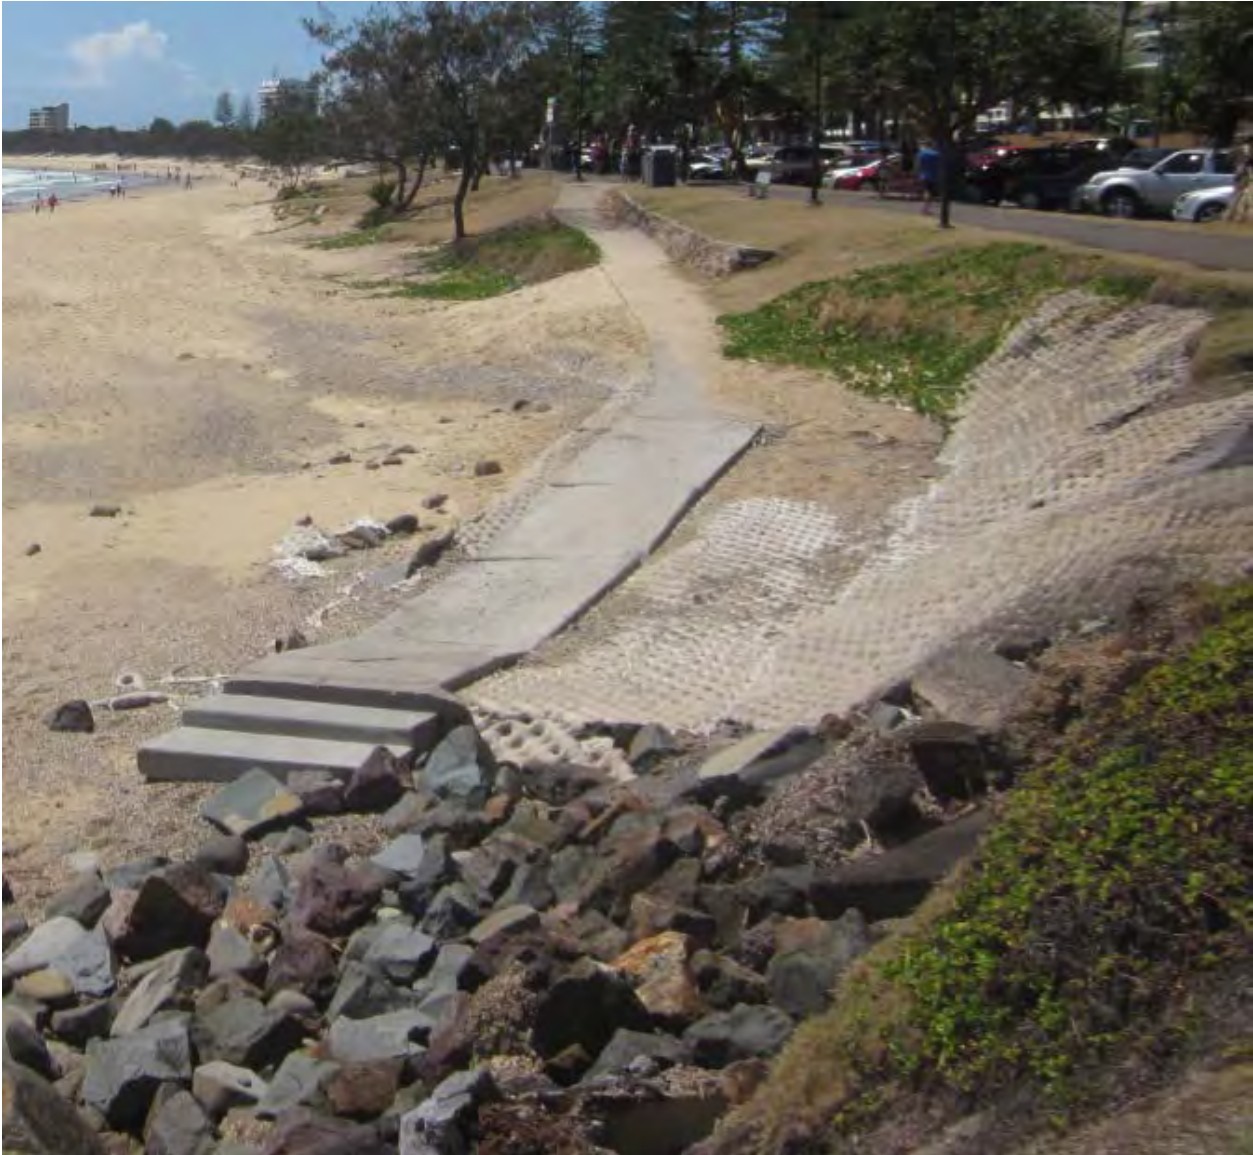
**Figure 6.14:** deteriorating rock seawall and light geo-formed concrete armoring at Mooloolaba Beach North

**Figure 6.14,** below, shows the minimal buffer to infrastructure and deteriorating protection works in the northern section of this beach management unit.

Repair/renewal of existing seawalls is estimated at \$400,000.

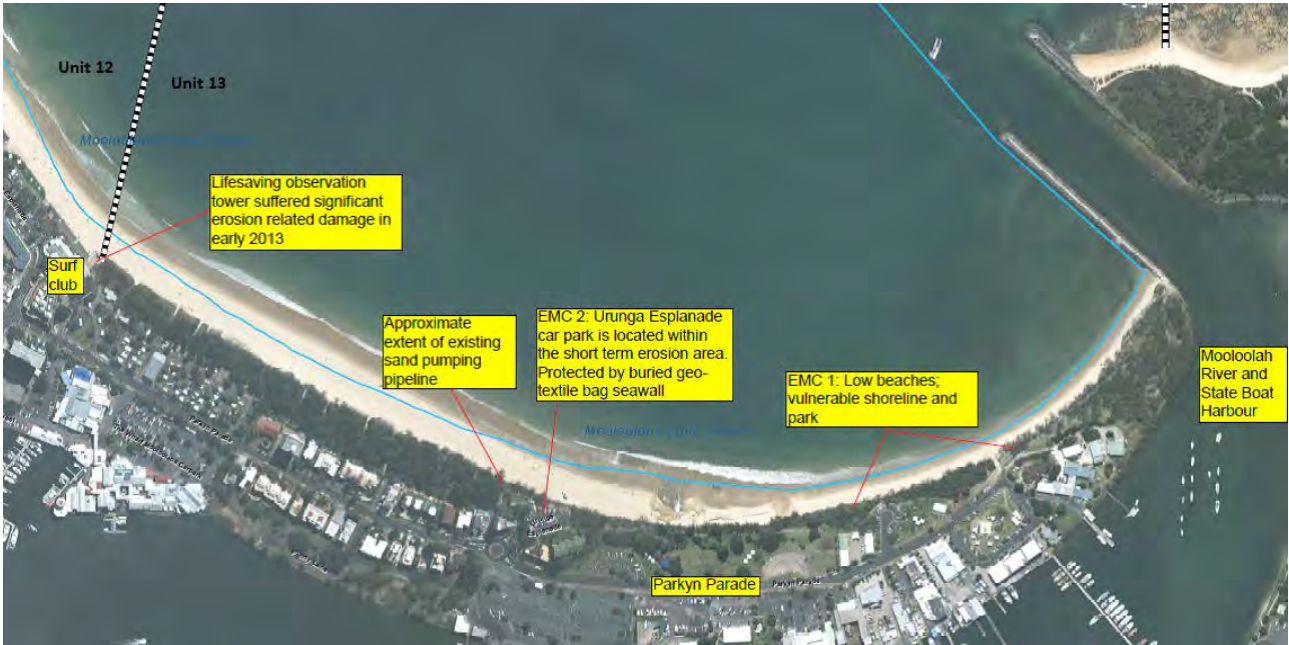
**Figure 6.15:** Annotated air photo locating the erosion management considerations for Mooloolaba Beach South

2. Urunga Esplanade car park is located within the defined storm event erosion area. A geofabric sandbag seawall (emergency works) and sand nourishment (with beach reprofiling) provides medium term protection. Formalisation and extension of protection works may be required and should be considered as part of coastal hazard adaptation/ risk management planning. Careful consideration should be given to any proposal to extend the current seawall protection works.

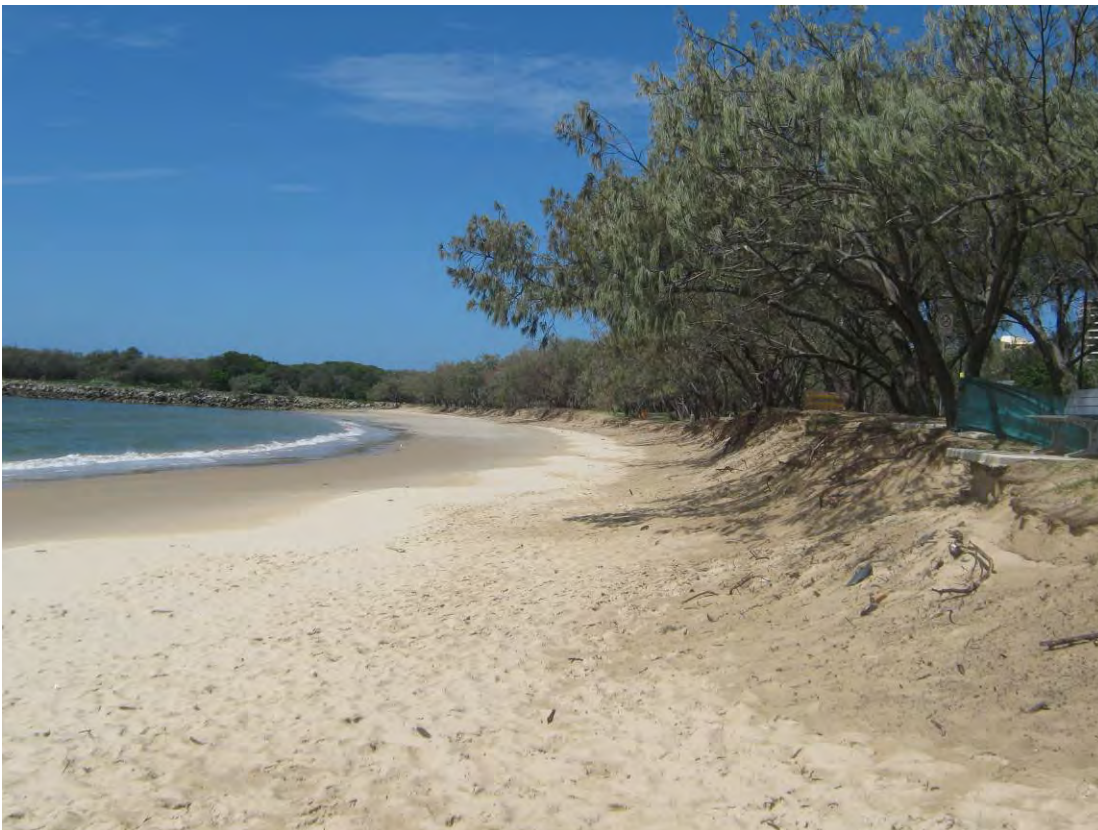
**Figure 6.16:** Photograph showing the low beach and dunes, looking towards the river.

**Figures 6.16 and 6.18** show the low beach and dunes of the beach management unit and the Urunga Esplanade car park, respectively.

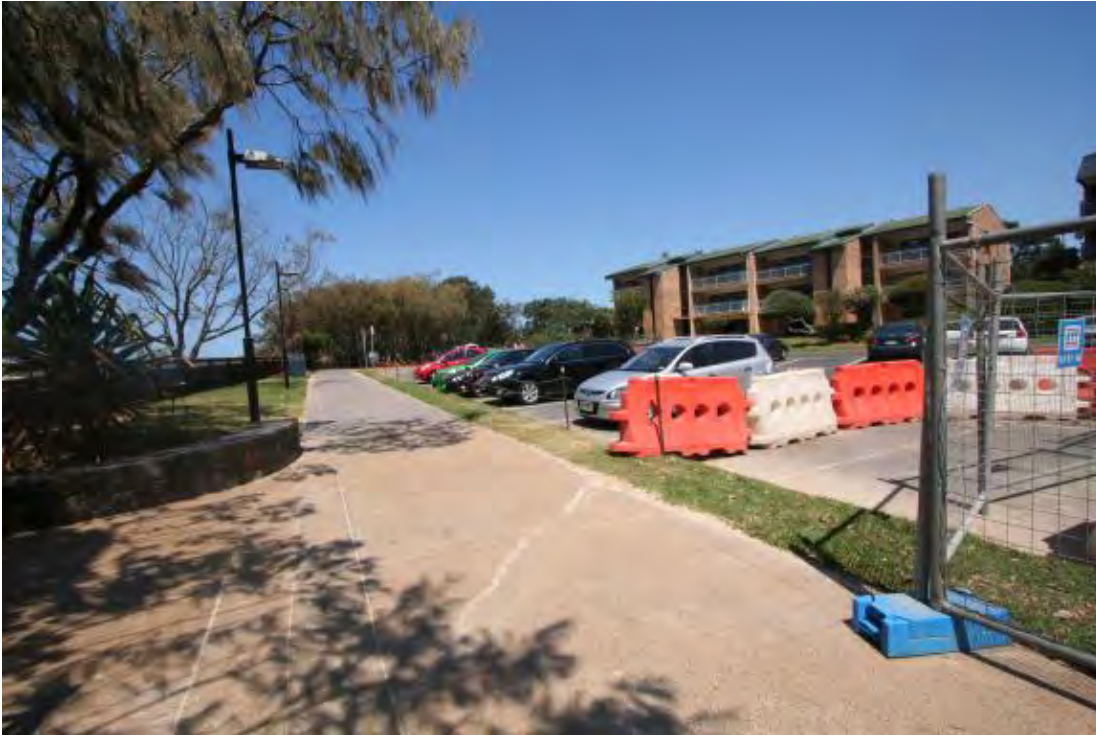
**Figure 6.17:** Urunga Esplanade car park is located within the defined storm event erosion area and is protected by a geofabric sandbag seawall and sand nourishment

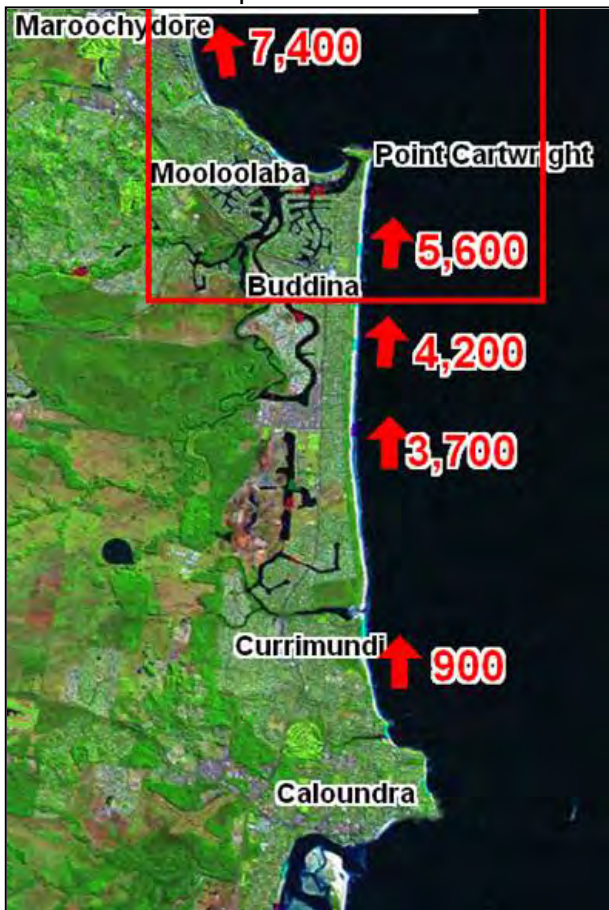
**Figure 6.18:** Potential net longshore sand transport rates ( $m^3/yr$ ) for Coastal Management Zone 3.

shoreline. Caloundra Headland represents a sand transport divide, with longshore transport directed away from the headland to both the north and south. The sediment budgets of the beaches north and south of Caloundra Headland are therefore considered independent of one another.

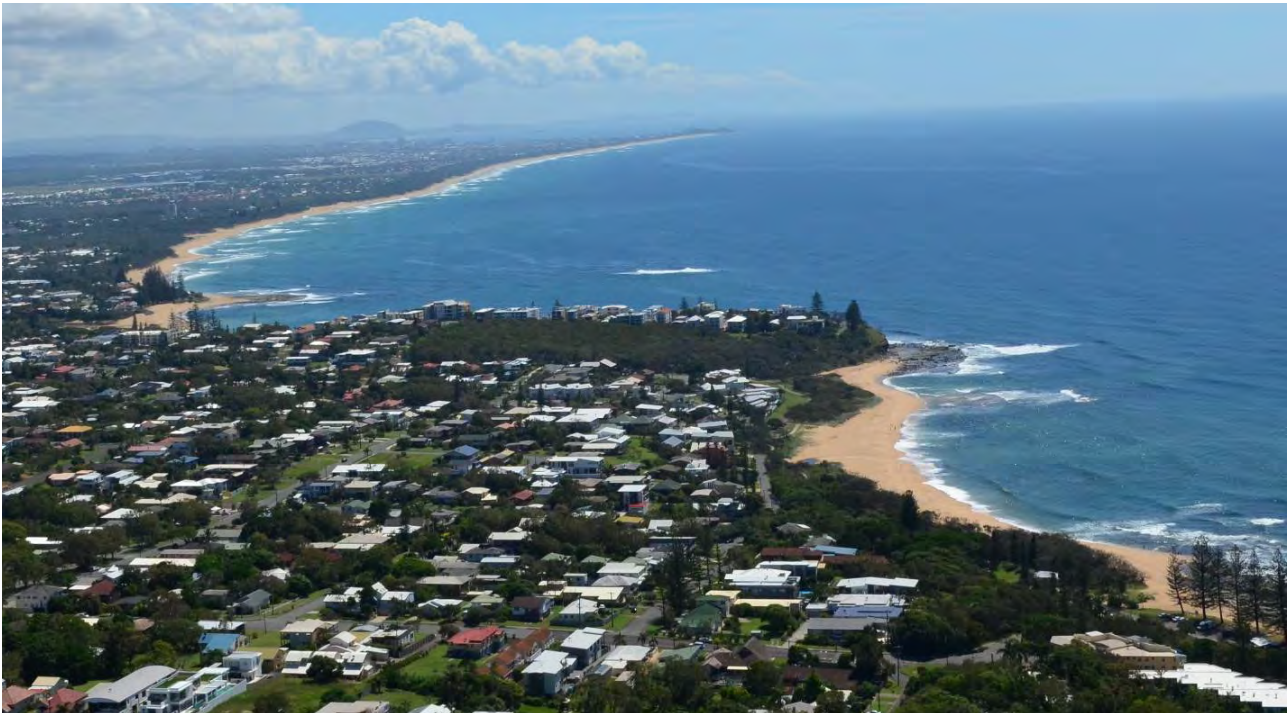
**Figure 6.19:** Zone 3 Looking north form Shelly Beach

The shoreline and inner shelf between Caloundra Headland and Currimundi are characterised by exposed sections of bedrock separated by patches of sand less than 1m thick (Jones 1992). There is a limited onshore supply of sand and the exposed rock may suggest a slowly eroding

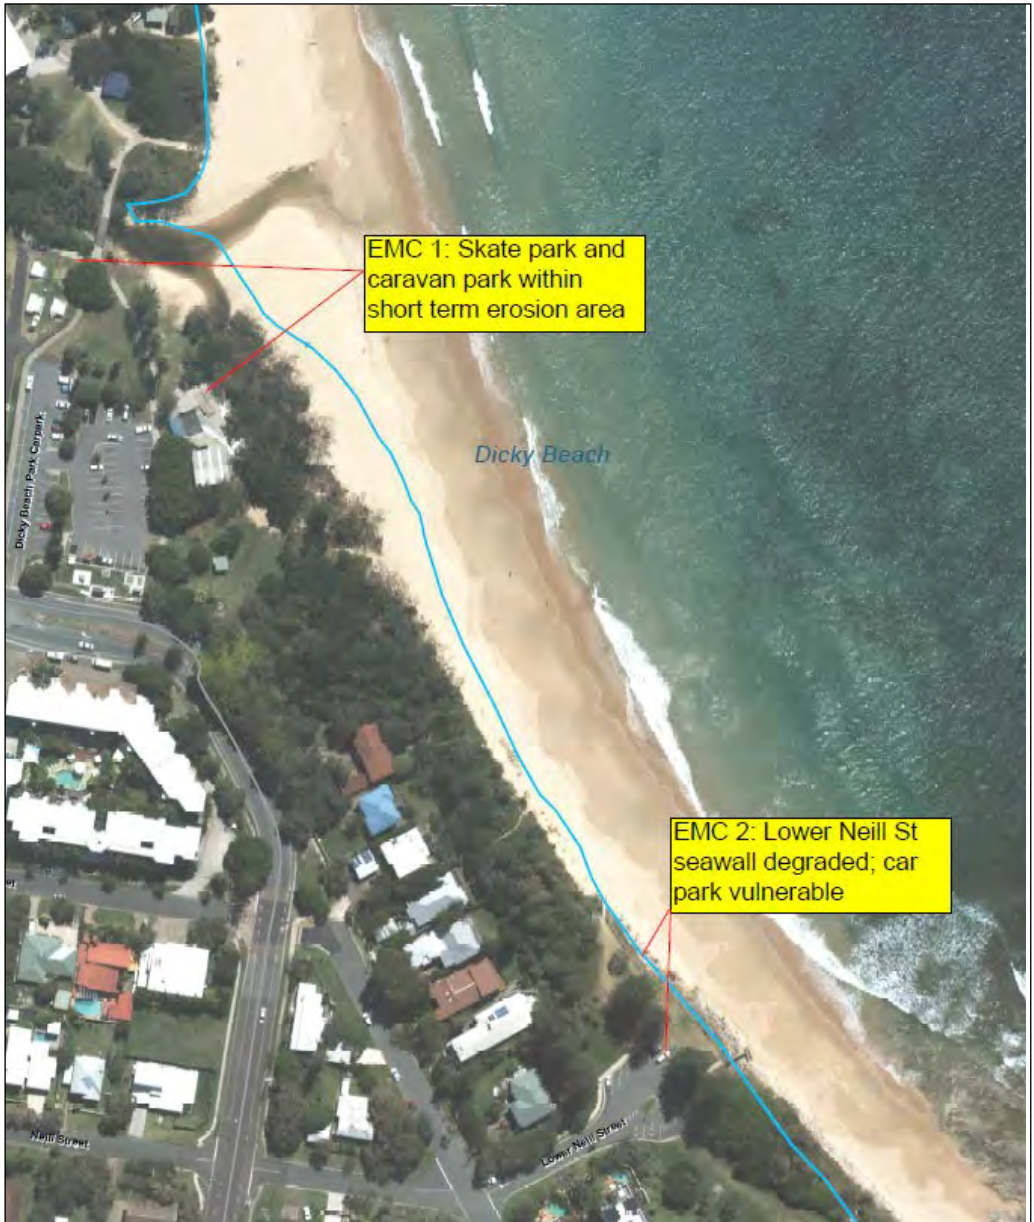
**Figure 6.20:** Air photo showing the erosion management considerations for Dicky Beach

1. The skate park and north eastern tip of the Dicky Beach Holiday Park, located south of Bunbubah Creek, is within the defined storm erosion area. This asset is not currently protected and consideration should be given to the case for protection under Coastal Hazard Adaptation/risk assessment planning.
2. The Lower Neill Street car park is located within the defined storm erosion area and is protected by an existing seawall. This existing seawall has deteriorated to the extent that the car park and the culturally significant Norfolk Pines may be under threat of erosion associated with the defined storm event. The existing wall, although in need of repair, is providing some erosion protection.

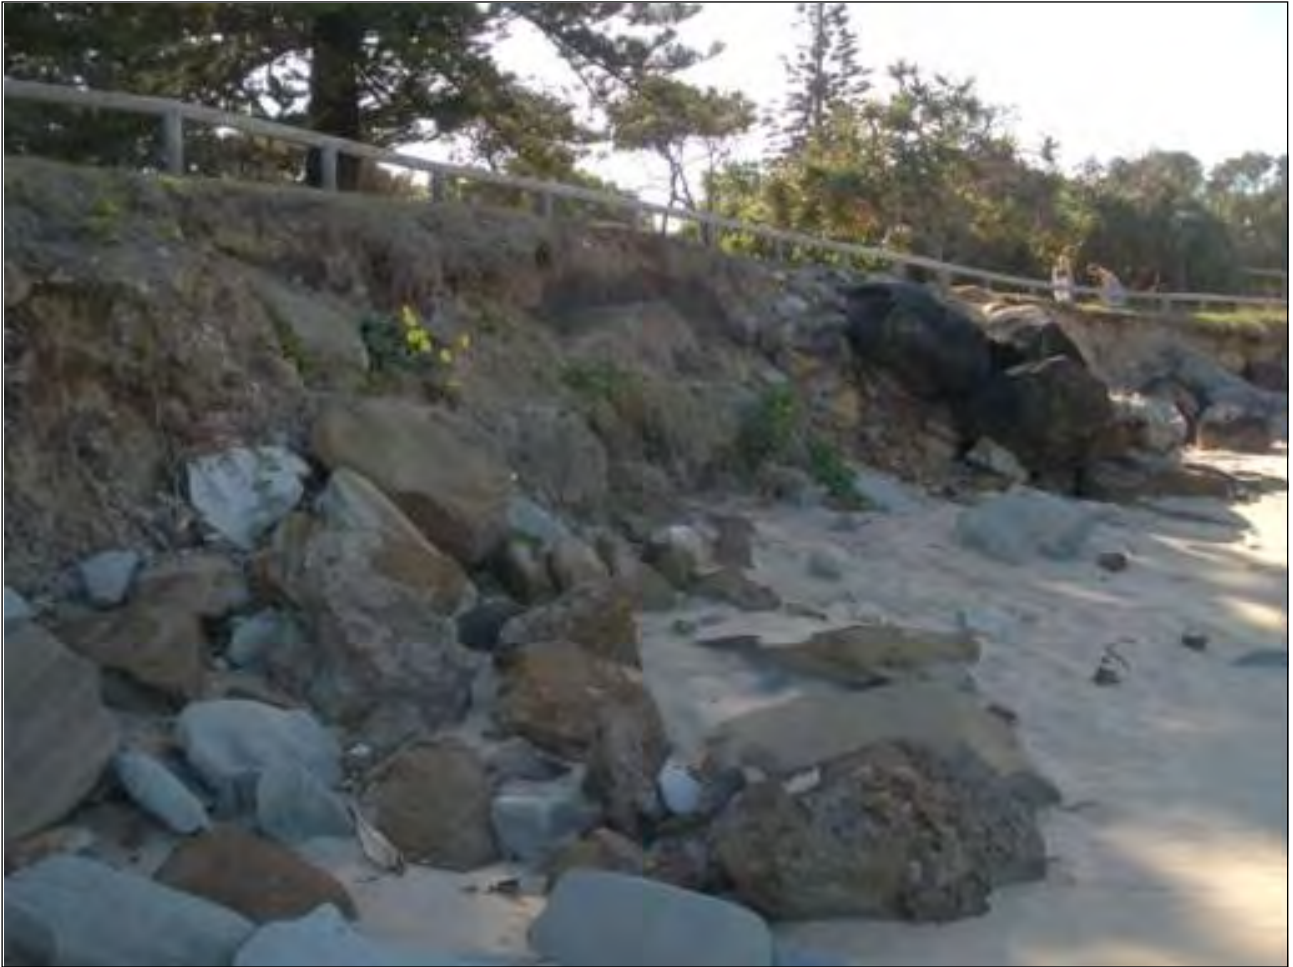
**Figure 6.21:** Degraded rock seawall protecting Lower Neill St car park, Dicky Beach

**Figure 6.21**, on the next page, shows the deteriorated state of the existing seawall at Lower Neill Street, Dick Beach.

Repair of the existing rock revetment/seawall is estimated at \$200 000.
