## 6 The Sunshine Coast shoreline and preferred erosion management options

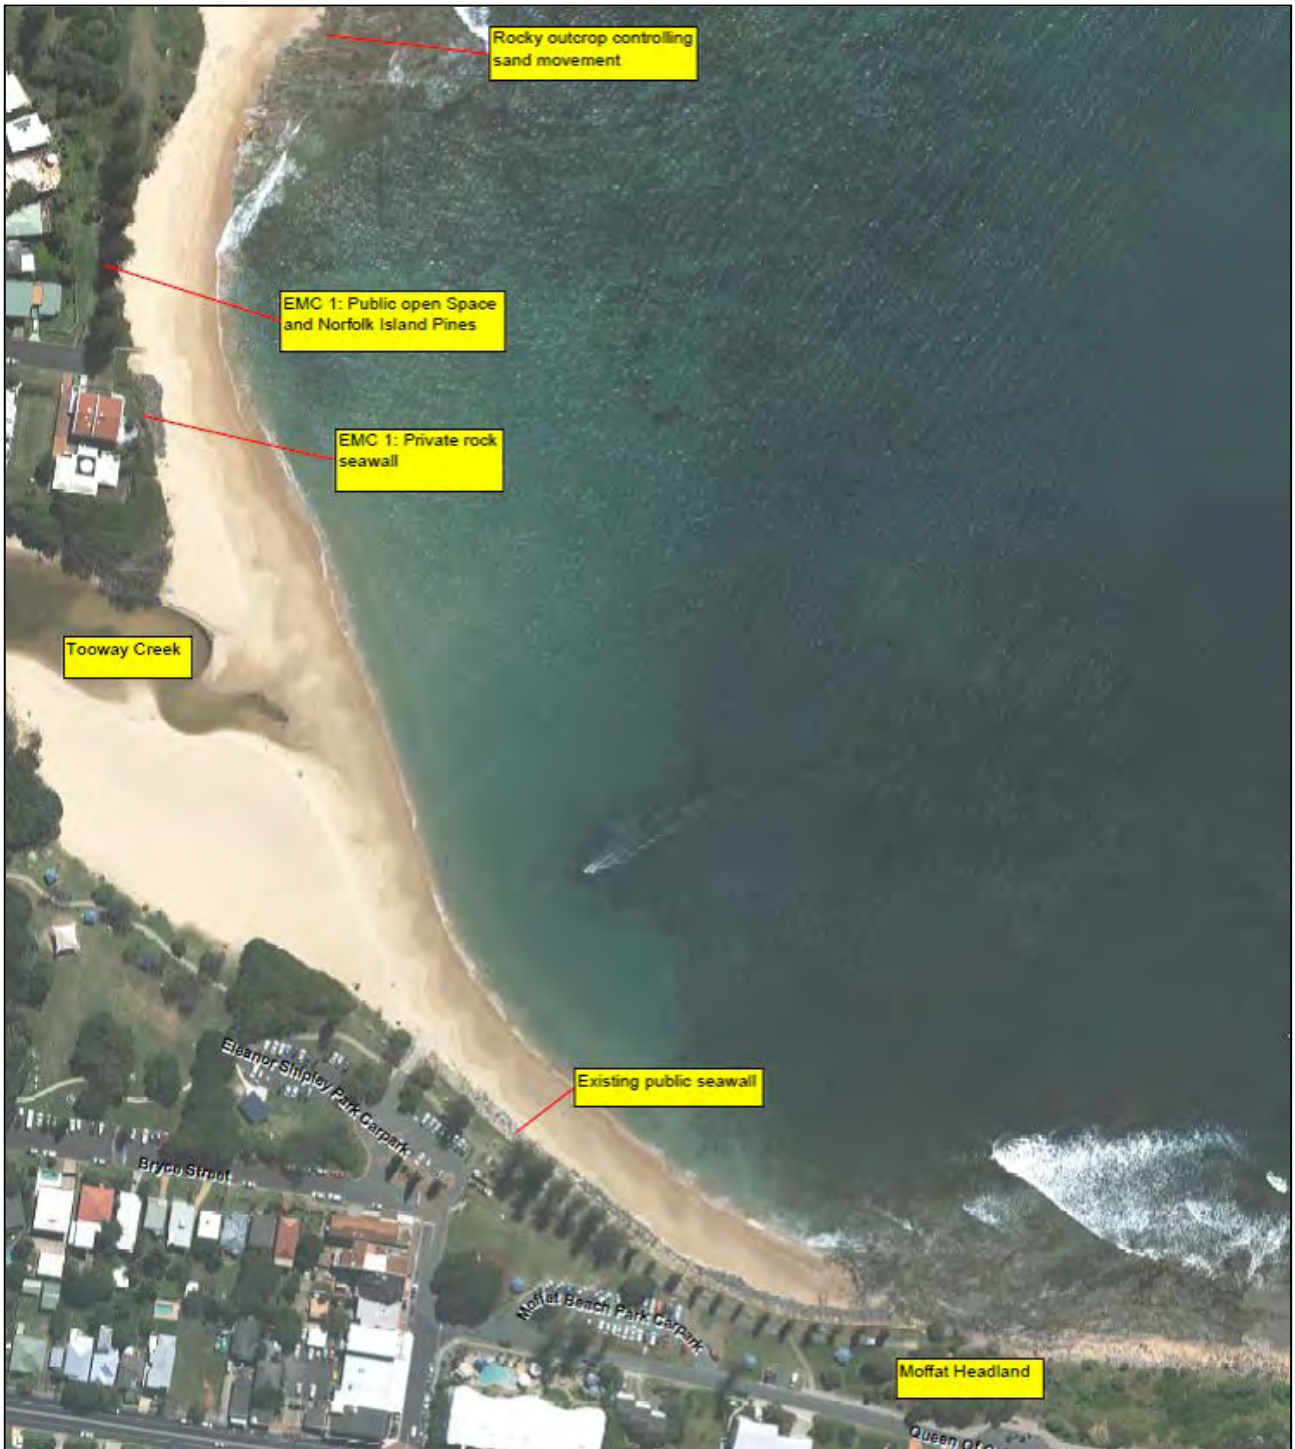
**Figure 6.22:** Annotated air photo of Moffat Beach showing the listed erosion management considerations

1. The Council controlled 'beach and dune system', to the north of Tooway Creek is currently vulnerable to erosion. Consequences of a moderate to large storm event may include the loss of park frontage and the loss of public assets (including beach, beach access infrastructure and open space that includes culturally valued Norfolk Island Pines). A private seawall constructed as emergency works is located to the south of this area.

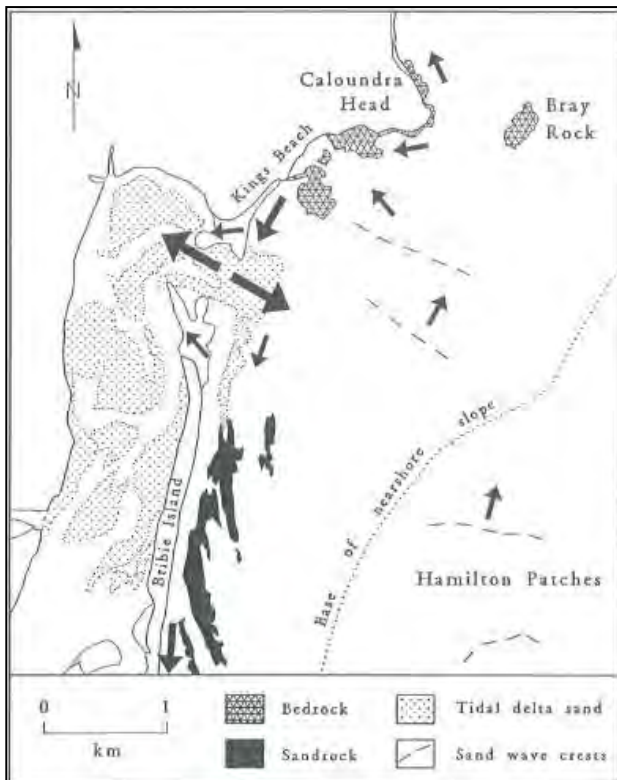
**Figure 6.23:** Sediment transport divide – sand transport to the north and south of Caloundra Head (from Jones 1992)

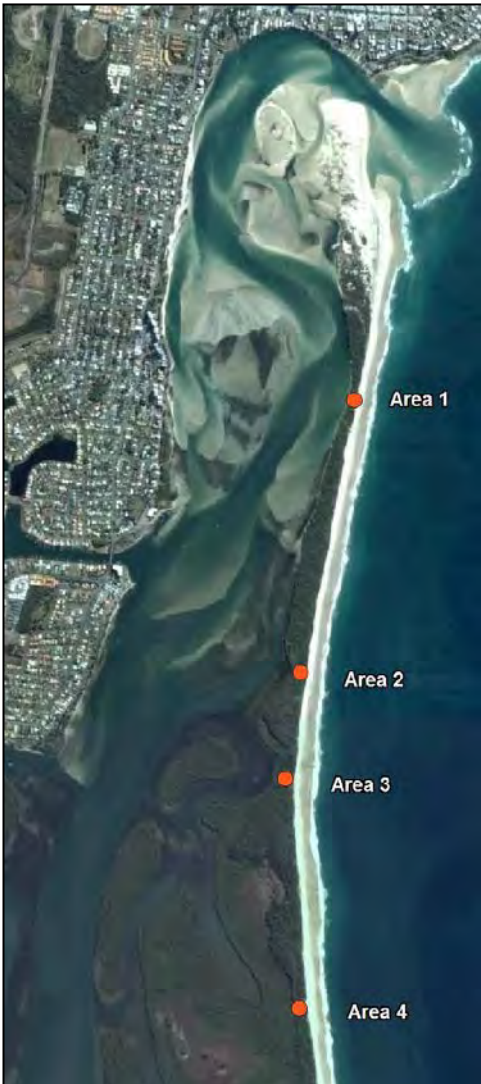
**Figure 6.24:** Most likely areas for a potential breakthrough

The term 'breakthrough' refers to the erosion of the island to the extent that a new deep-water entrance is established. Four main areas on the northern tip of Bribie Island are identified as being most susceptible. A risk assessment (Aurecon 2009) identified various breakthrough scenarios and the potential risk this posed to the mainland. **Figure 6.24** shows the four most likely points of breakthrough.

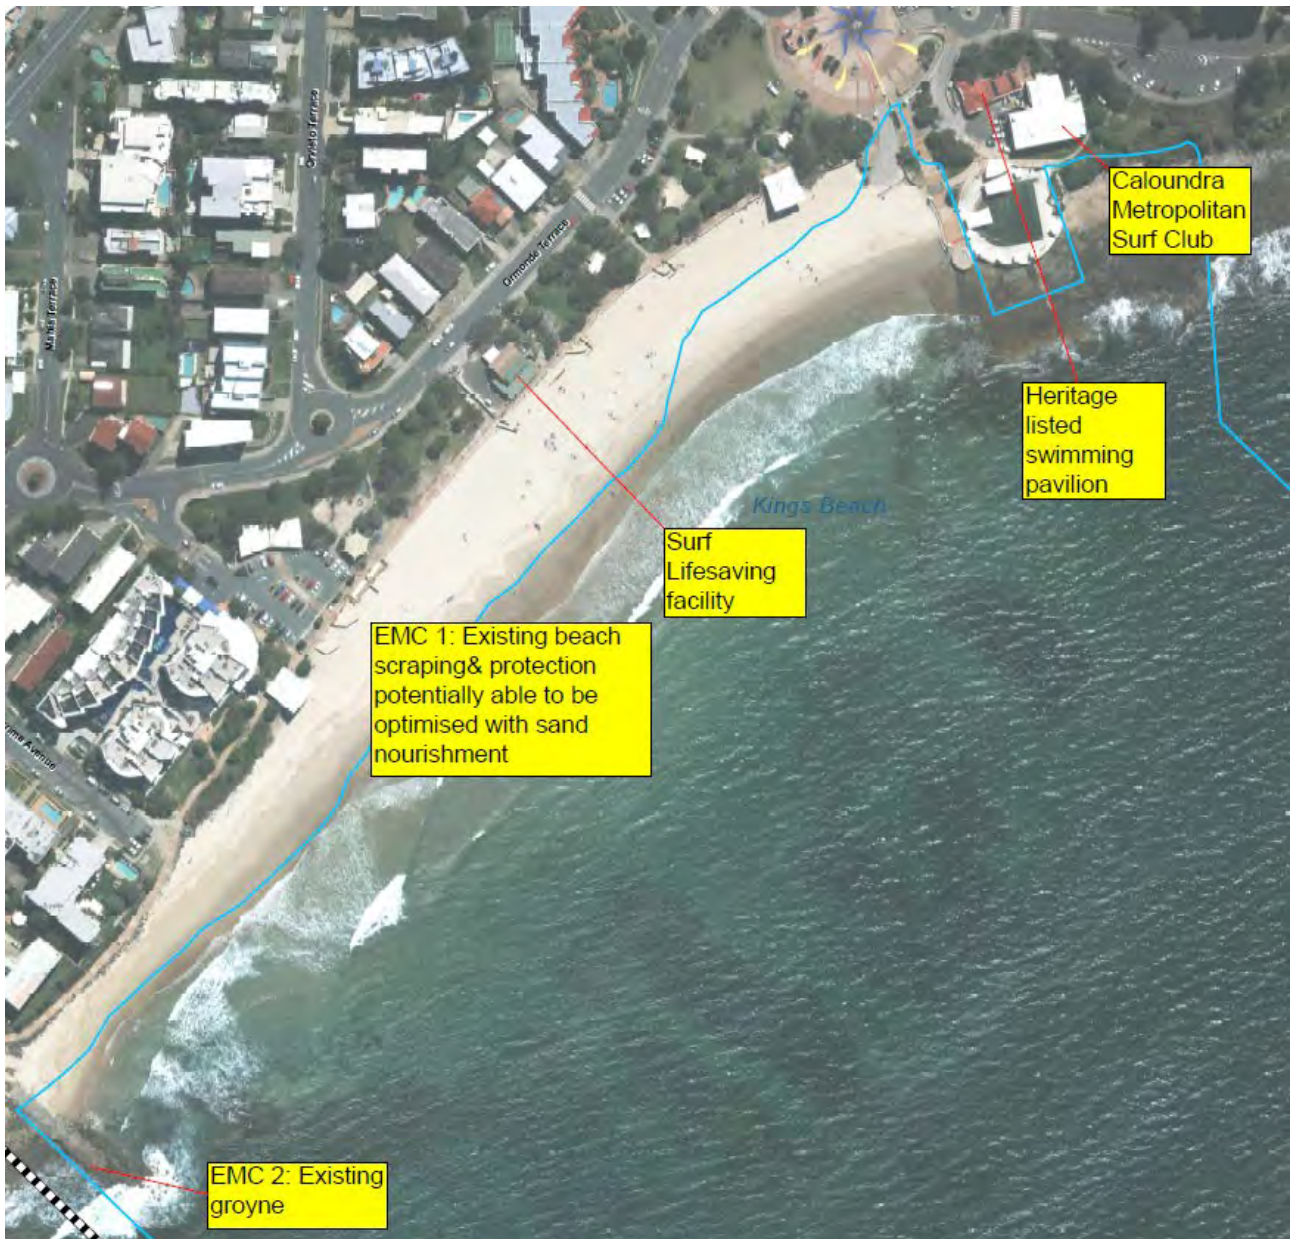
**Figure 6.25:** Annotated aerial image of Kings Beach showing listed erosion management considerations

2. The introduction of additional sand to the beach system should be hybridised with an upgrade and seaward extension of the southern groyne. If the groyne is not upgraded, the additional sand would have the potential to bypass the existing structure and move south toward Caloundra Bar. Even without the addition of nourishment sand, the long-term suitability of the existing groyne remains uncertain. The aging structure may not be a suitable height to interrupt sediment transport if sea level rise projections are realised.

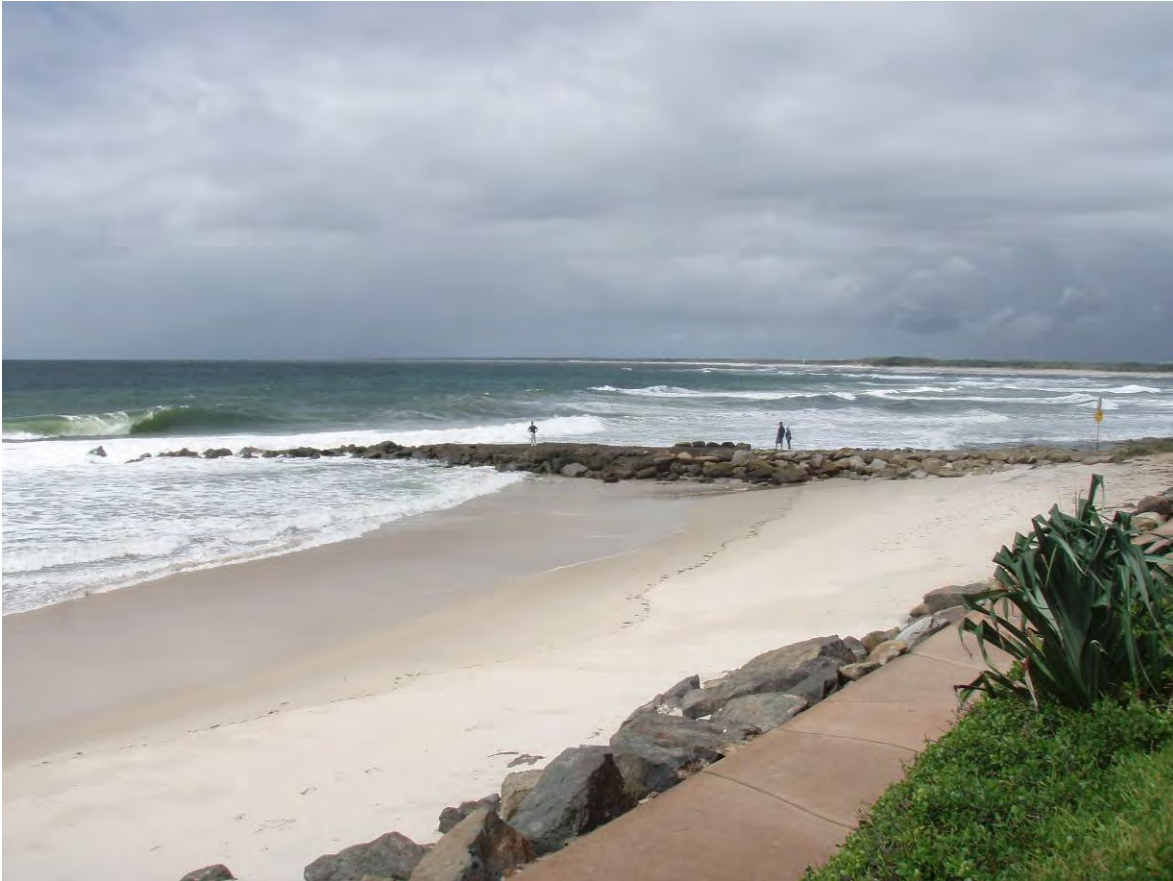
**Figure 6.26:** Photo of the existing groyne at Kings Beach, looking towards Bribie Island

**Figure 6.26,** on the next page, shows the existing groyne at Kings beach.

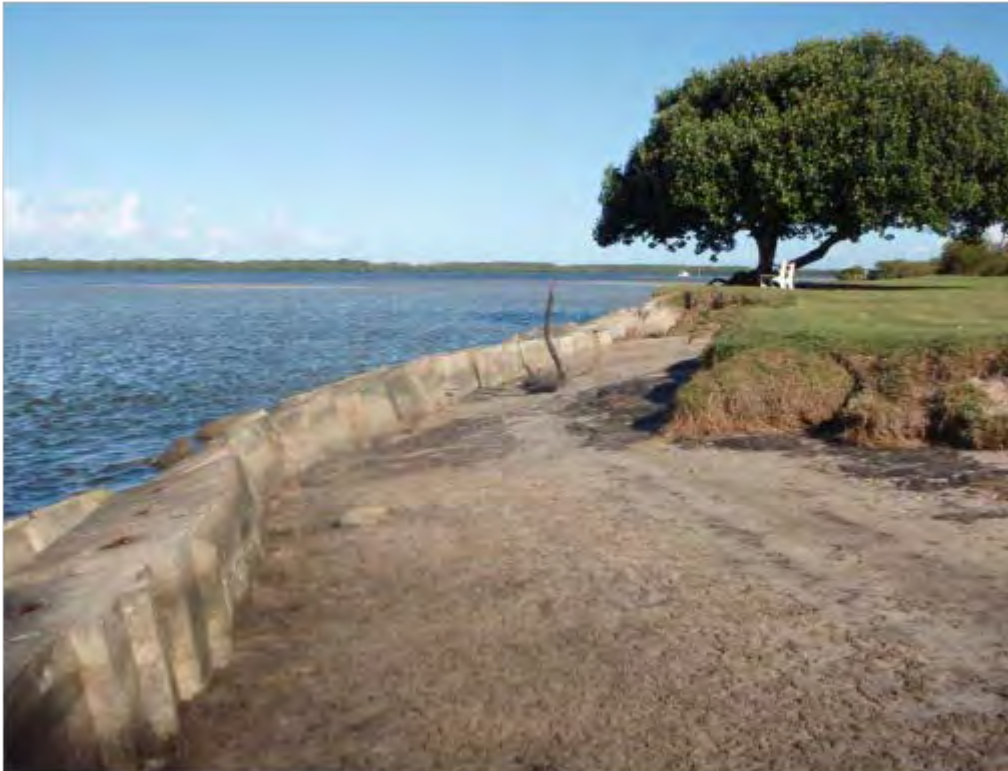
**Figure 6.28:** Photograph showing erosion behind concrete blocks placed at Navel Cadets Base (EMC 1)

**Figures 6.28** and **6.29**, on the next page, show erosion at the Naval Cadet Base and boat ramp, respectively.

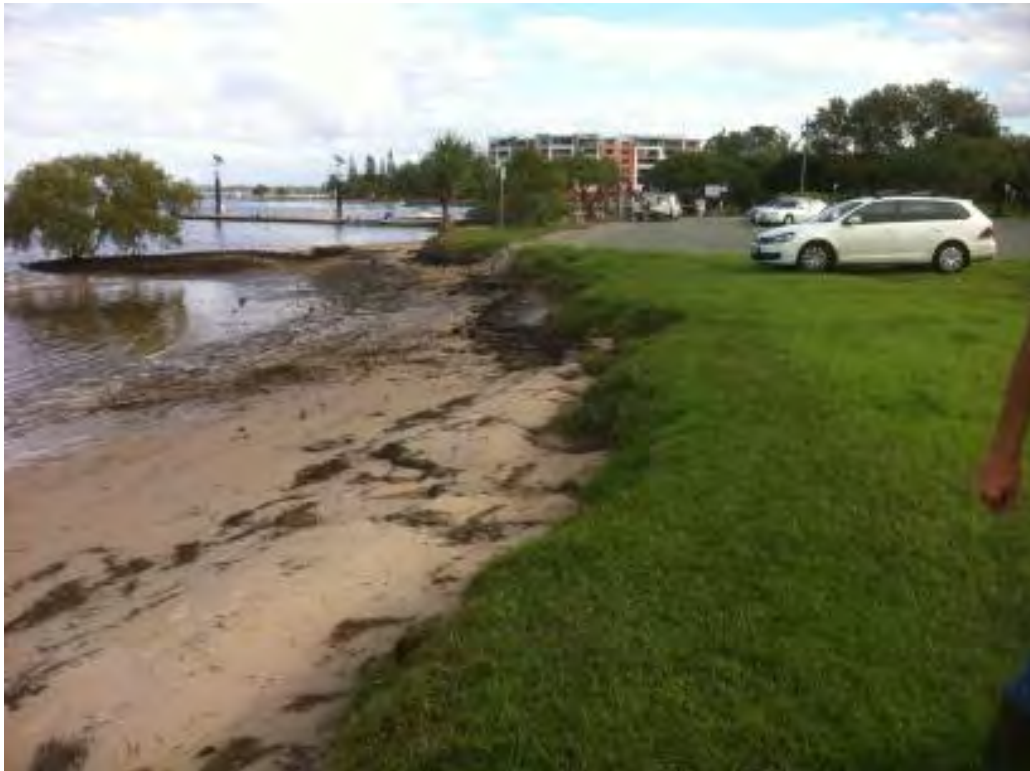
**Figure 6.29:** Photograph showing erosion of the shoreline at the Boat Ramp car park (EMC 3)

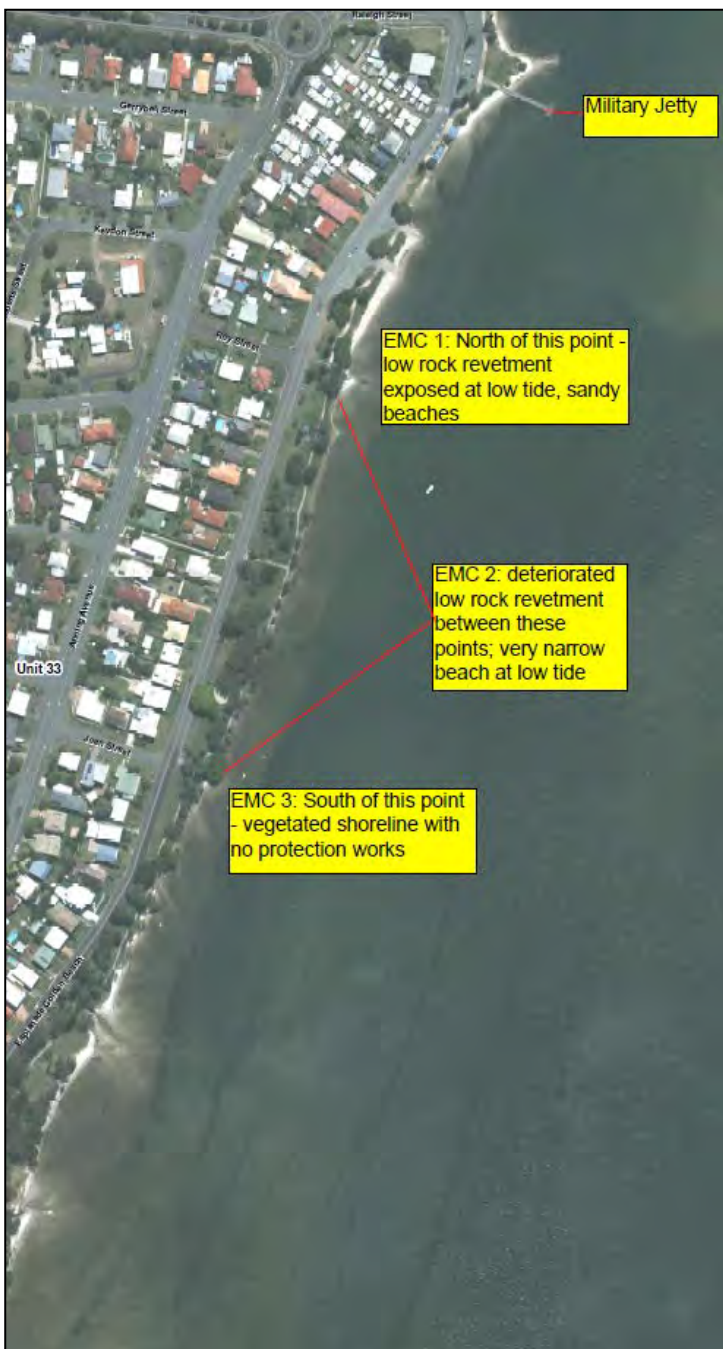
**Figure 6.30:** Annotated aerial image showing the listed erosion management considerations for Lamerough Canal to Bells Creek

**Erosion management considerations** – see **Figure 6.30** for location of the listed considerations

This section of the Golden Beach shoreline is potentially the most vulnerable to the erosion related effects of the various Bribie Island breakthrough scenarios (refer to **Section 6.6.1 Potential Bribie Island breakthrough**).

Specific erosion management considerations follow (see **Figure 6.30**).

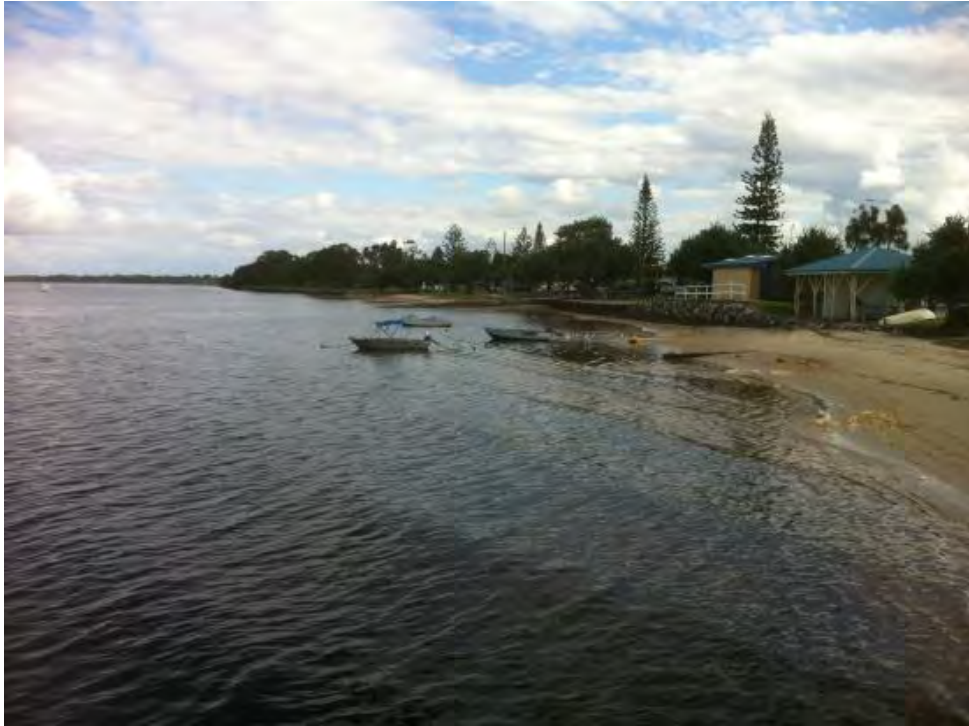
**Figure 6.31:** high recreation use beach south of Lamerough Canal showing narrow beaches and low sea walls (EMC1)

**Figures 6.31** and **6.32**, on the next page, show example of the shoreline as discussed above for EMC 1 and EMC 2, respectively.

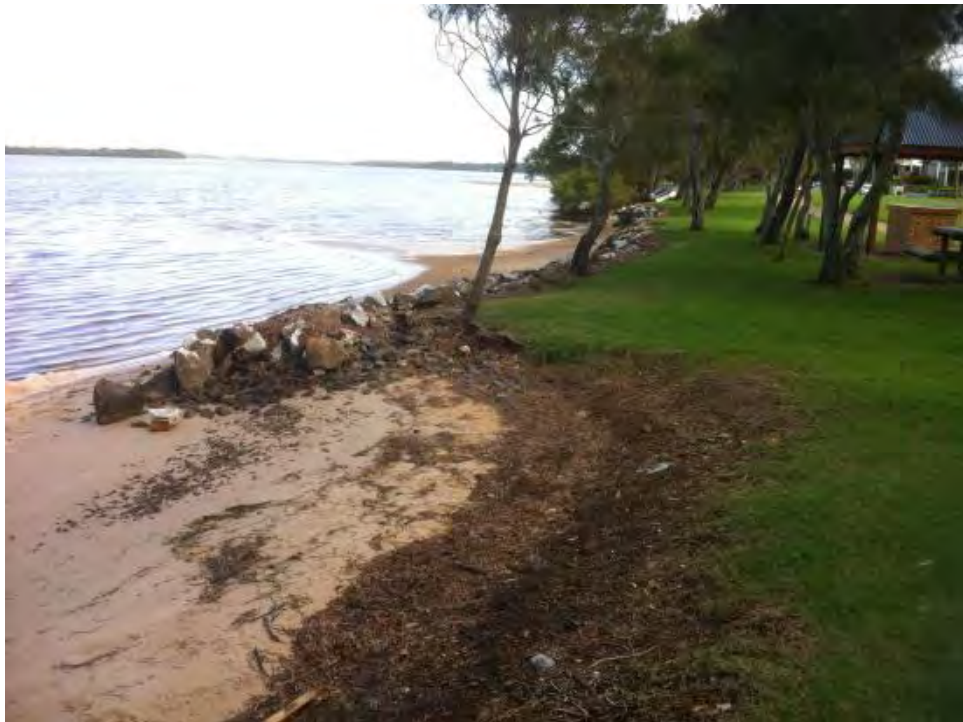
**Figure 6.32:** low revetment and adjacent erosion south of Lamerough Canal (EMC 2)
