# Maroochydore Beach Nourishment Project Evaluation

August 2016

BMT WBM Pty Ltd Level 8, 200 Creek Street Brisbane Qld 4000 Australia PO Box 203, Spring Hill 4004  Tel: +61 7 3831 6744 Fax: +61 7 3832 3627  ABN 54 010 830 421  <a href="http://www.bmtwbm.com.au">www.bmtwbm.com.au</a>	<b>Document:</b>	R.B21974.001.01.evaluation.docx
	<b>Title:</b>	Maroochydore Beach Nourishment Project Evaluation
	<b>Project Manager:</b>	Matthew Barnes
	<b>Author:</b>	Matthew Barnes and Jeremy Visser
	<b>Client:</b>	Sunshine Coast Council
	<b>Client Contact:</b>	Michael Anderson
	<b>Client Reference:</b>	
<b>Synopsis:</b> A summary and evaluation of the Maroochydore Beach Nourishment Project

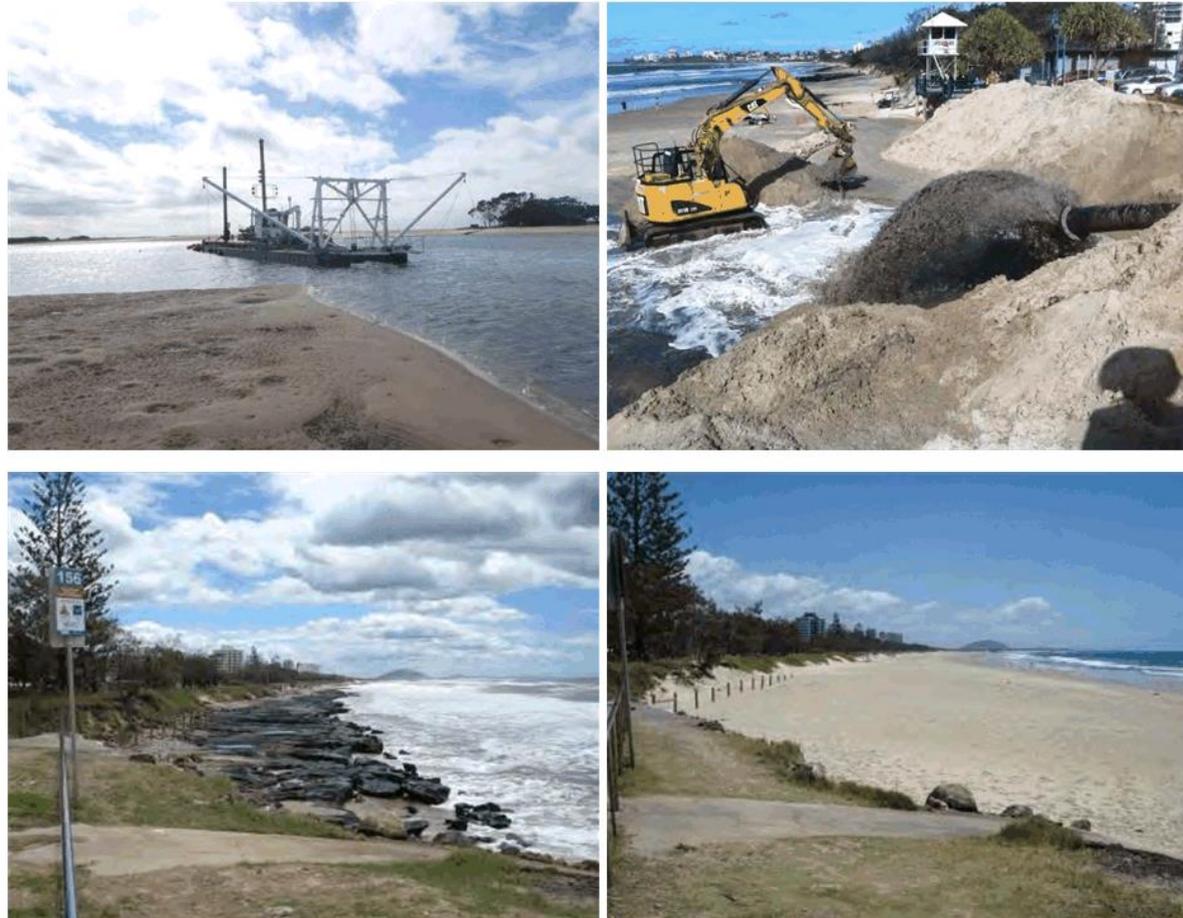
Figure 3-2 Stage 1 Dredging and Nourishment (clockwise from top left): Birdon Pty Ltd CSD Dogo in the Lower Maroochy River; Sand Delivery to Maroochydoore Beach; Beach Condition after Nourishment Works; Beach Condition before Nourishment Works

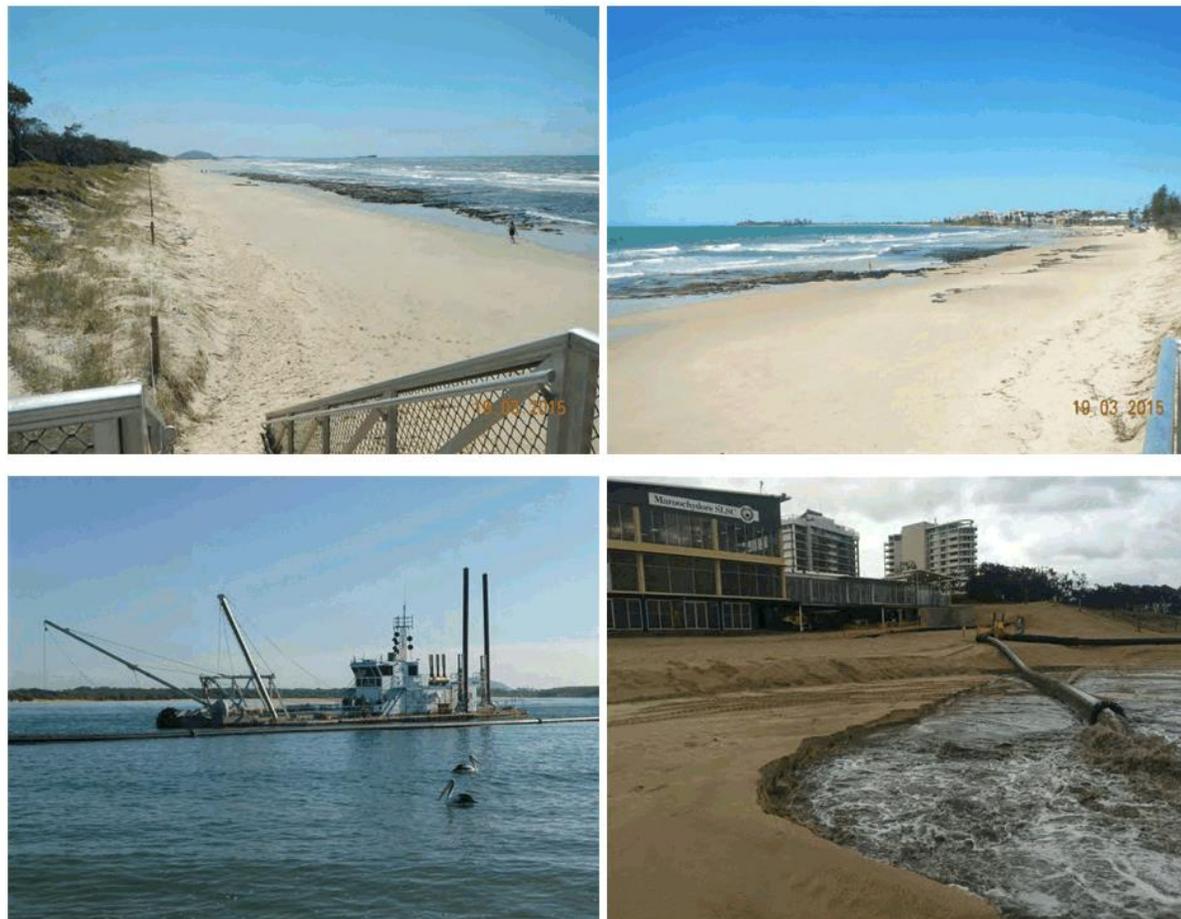
Figure 3-3 Stage 2 Dredging and Nourishment (clockwise from top left): Pre-works Beach Condition North; Pre-works Beach Condition South; Pipeline Sand Delivery to Maroochydoore Beach; Neumann CSD *Nu Endeavour* in the Lower Maroochy River

The second dredging and nourishment campaign involved the relocation of 75,000 m<sup>3</sup> of sand and was completed by Neumann Contractors Pty Ltd during June and July 2015. The beach was in a fair condition prior to the works with some patches of coffee rock visible in the vicinity of the Okinja Road beach access (see Figure 3-3). Prior to dredging, an amendment to the lower Maroochy River sand extraction footprint in order to avoid undesirable silt material was approved by DEHP.

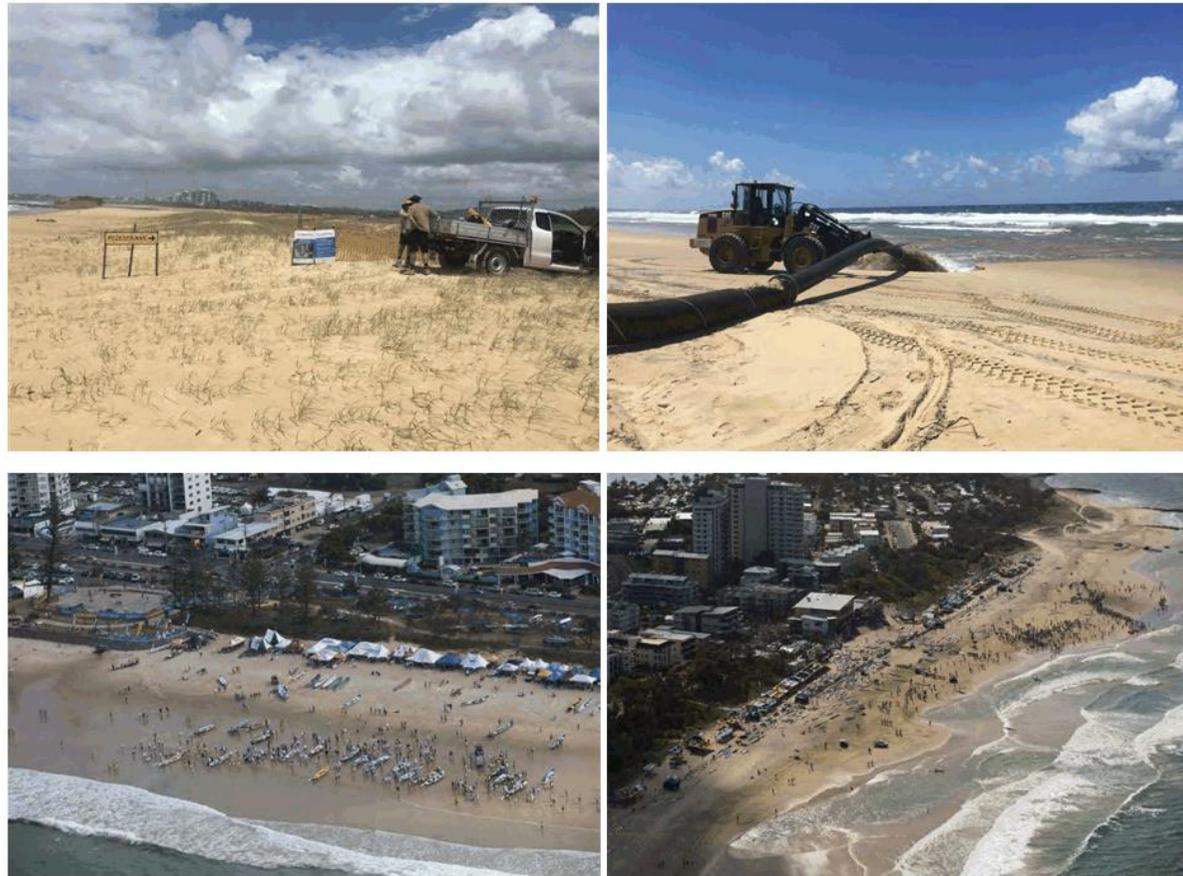
Figure 3-4 Stage 3 Dredging and Nourishment (clockwise from top left): Restricted Pedestrian Access at North Shore Spit; Sand Delivery to Maroochydore Beach; 'The Aussies' at Maroochydore Beach, April 2016

The third and final nourishment campaign was undertaken by Neumann Contractors Pty Ltd during February and March 2016. This 'top up' campaign relocated 20,000 m<sup>3</sup> of sand in order to provide a resilient and safe beach for the Australian Surf Lifesaving Championships ('The Aussies') held between 16 and 24 April 2016 (see Figure 3-4). Prior to dredging an amendment to the EPBC referral and DEHP permit conditions to allow dredging during the months of February and March was approved. The amendment required an area at North Shore Spit to be closed to the public to provide undisturbed habitat for migratory shorebirds.

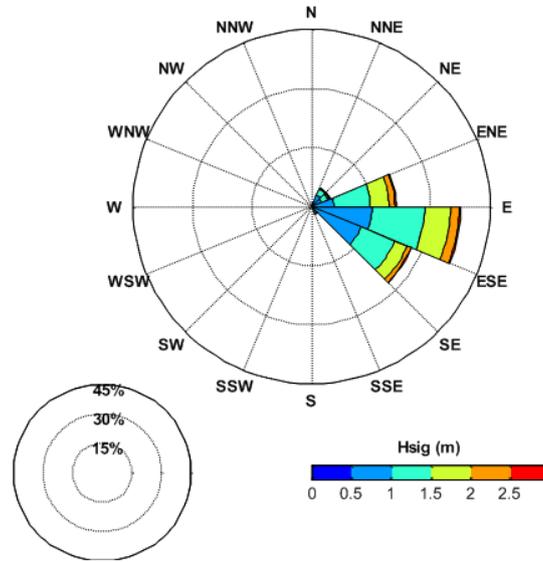
Figure 4-6 Wave Rose at Mooloolaba Wave Buoy during the Project (data provided by DSITI)

MOOLOOLABA WAVE BUOY 01/05/2013 to 01/01/2016

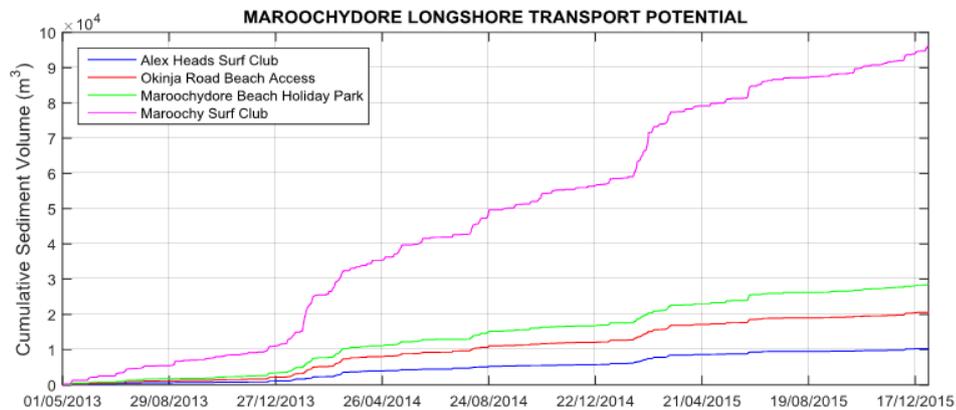
Figure 4-9 Cumulative Volume of Longshore Sediment Transport

The net and gross wave-driven longshore sediment transport between Alexandra Heads and Maroochy Surf Clubs was calculated using the CERC equation and the estimated inshore wave climate. Figure 4-9 shows the cumulative longshore sediment transport volume for the Project period (positive gradient is in the northerly direction). It is noted that the reported transport rates represent transport potentials. Actual sand transport rates may be restricted by the availability of sand. For example, at locations where exposed coffee rock exists on the beach or in surf zone from time to time, the actual longshore sand transport rates may be smaller than those predicted. Results of the longshore sediment transport modelling are summarised below:

- The net northerly littoral drift transported approximately 35,000 m<sup>3</sup>/year of sand out of the Maroochydore Beach compartment. It is assumed that this sand either enters and deposits in the lower Maroochy River or bypasses the entrance and is transported to the North Shore Spit. A much smaller volume (<4,000 m<sup>3</sup>/year) is predicted to enter the beach compartment at Alexandra Heads. The average annual deficit of sand is therefore approximately 30,000 m<sup>3</sup>.

- Between October 2013 and April 2014 approximately 50% of the placed sand was moved from upper beach to a location seaward of the survey limits. During this period the beach profile adjusted from the 'constructed' condition toward a theoretical equilibrium with the prevailing coastal processes. This sand was not lost from the beach system but rather relocated from the upper beach to the nearshore (or 'surf zone') area. The cross-shore transport estimates provided in Table 4-4 suggest erosion conditions were dominant during January, February and March 2014. A steep gradient in longshore sediment transport to the north was also estimated during these months (see Figure 4-9).

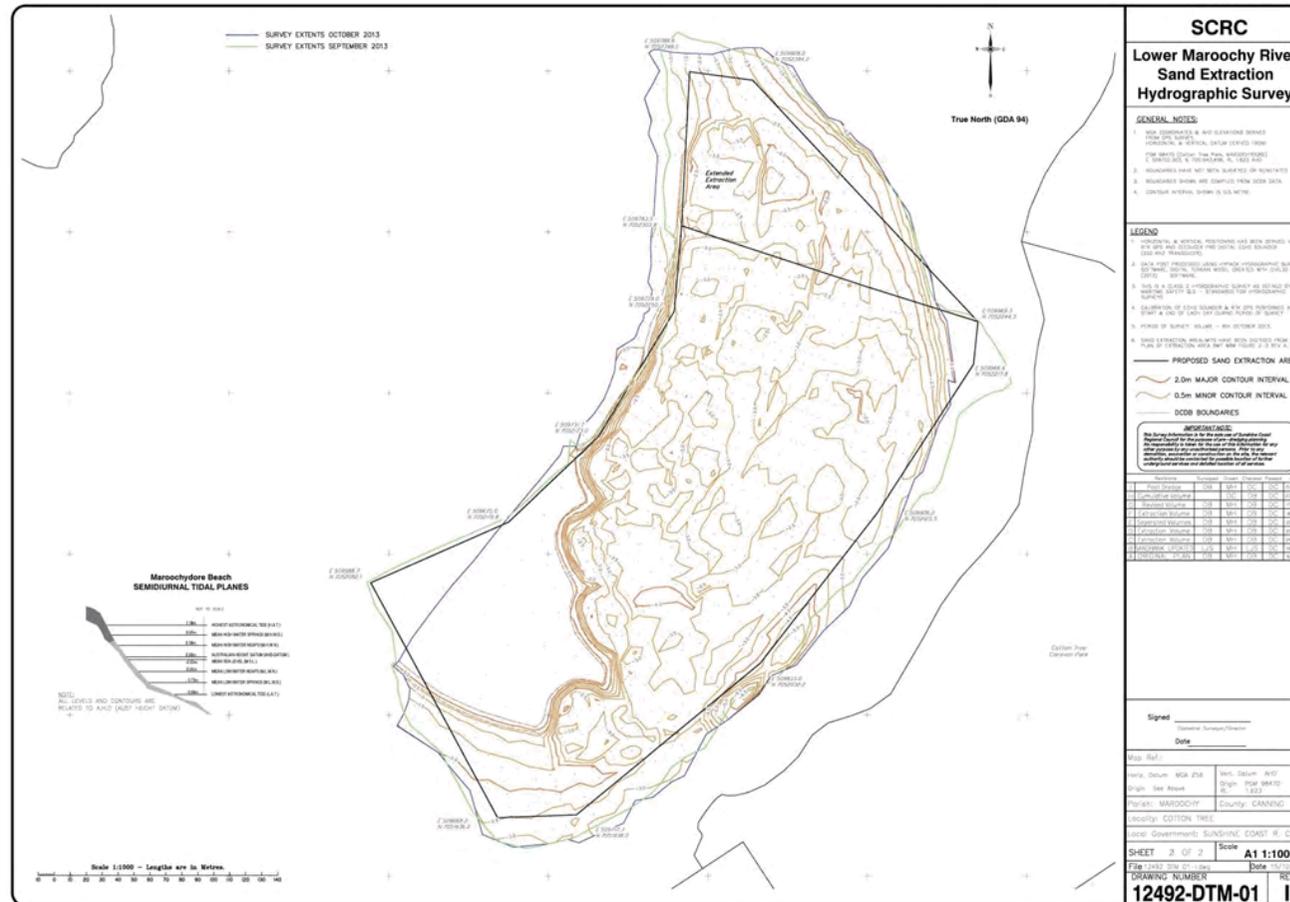
The Stage 1 post-works hydrographic survey of the permitted sand extraction area is shown in Figure 5-1. Throughout this area sand was dredged to an average elevation of -3.0 mAHD, corresponding to a sand volume of approximately 125,000 m<sup>3</sup>.

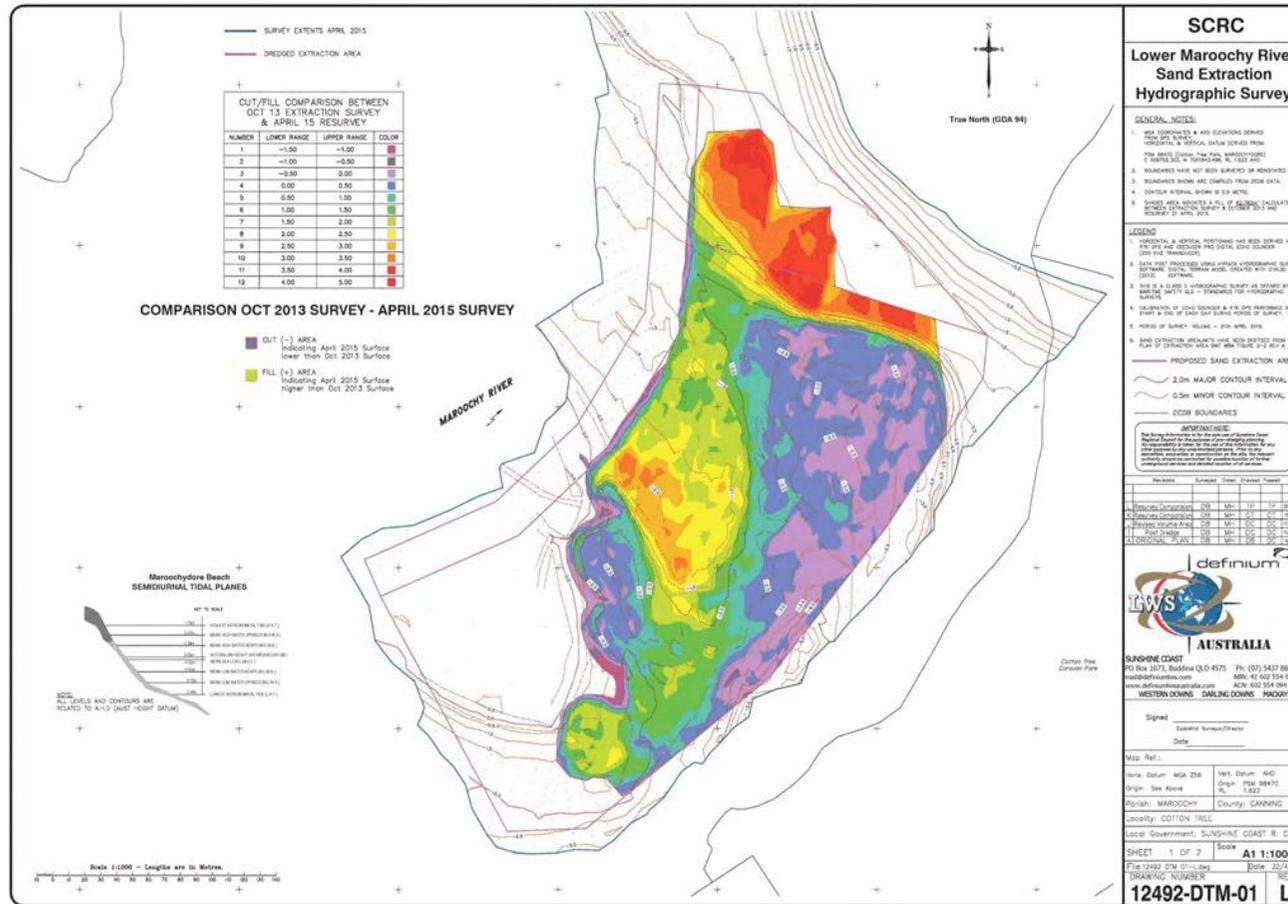
Figure 5-2 Infilling of the Permitted Dredge Footprint between October 2013 and April 2015

Most of the available volume was attributed to material that infilled the permitted sand extraction area since the previous dredging and renourishment campaign. Figure 5-2 provides a comparison of hydrographic surveys obtained at the completion of the 2013 dredging and prior to the commencement of Stage 2 dredging in 2015. This comparison suggests a fill volume of 73,327 m<sup>3</sup> (indicated under General Notes in Figure 5-2) between October 2013 and June 2015 which corresponds to an infilling rate of approximately 50,000 m<sup>3</sup>/year. Based on this finding and the existing dredging and renourishment practices, Council could expect the lower Maroochy River sand source to sustainably provide up to 100,000 m<sup>3</sup> every two years (subject to ongoing monitoring).
