Technical Memorandum

From:	Matthew Barnes	To:	Michael Anderson
Date:	21 June 2016	CC:	
Subject:	Maroochy River Mouth Coastal Management - Preliminary Options Assessment

This technical memorandum provides a preliminary option assessment for enhanced coastal management at the Maroochy River entrance and Maroochydore Beach. Four broad options are considered:

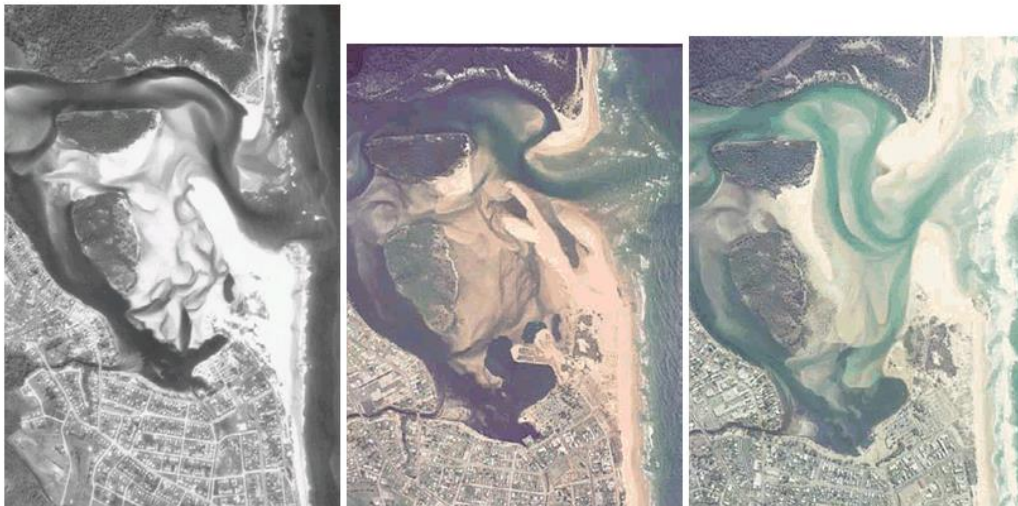
Figure 1-2 Maroochy River Entrance in 1967 (left), 1974 (middle) and 1979 (right)

The historical record shows significant sand accumulation in the river mouth during the 1940s and 1950s that effectively closed off the southern channel connection to the sea. This led to the formation of a dominant northern channel. The ongoing erosion of the northern spit eventually caused a breakthrough during the 1960s, just south of where Twin Waters is located today.

From the late 1970s, the northern entrance channel commenced migrating southwards and the northern spit grew. During this period the southern channel also reconnected to the sea. By the early 1990s, the southern channel had become very dominant and erosive pressure on the river bank near the Cotton Tree Holiday Park resulted in the construction of two geotextile groynes in 1995. Continued erosive pressure resulted in a breakthrough to the south of Pincushion Island in 1999¹. Ongoing recession at the Cotton Tree Holiday Park resulted in the construction of the southern geotextile groyne and some geotextile seawall sections in 2001. A further three geotextile groynes and seawalls were constructed in 2003. The intention of these groynes and seawalls was to protect the Cotton Tree Holiday Park whilst maintaining some amenity on the beaches between the groynes.

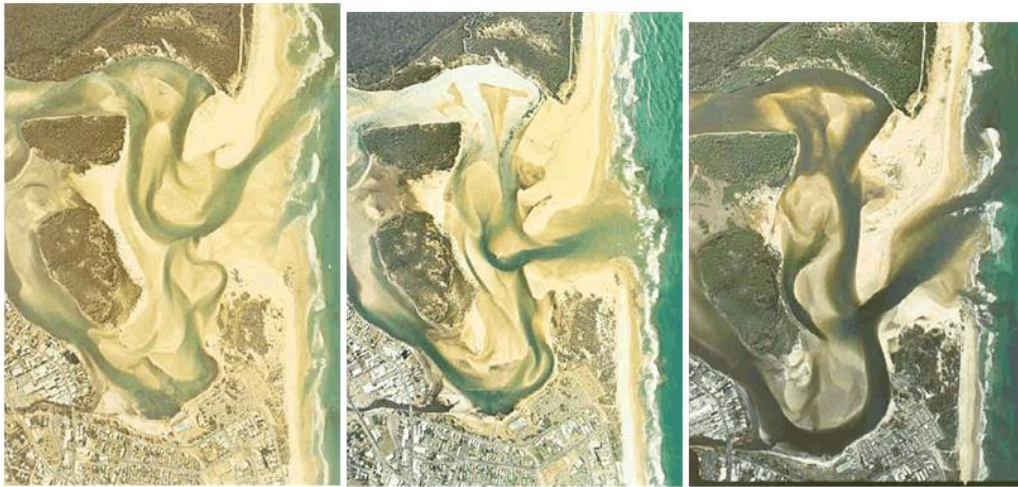
Figure 1-3 Maroochy River Entrance in 1982 (left), 1985 (middle) and 1988 (right)

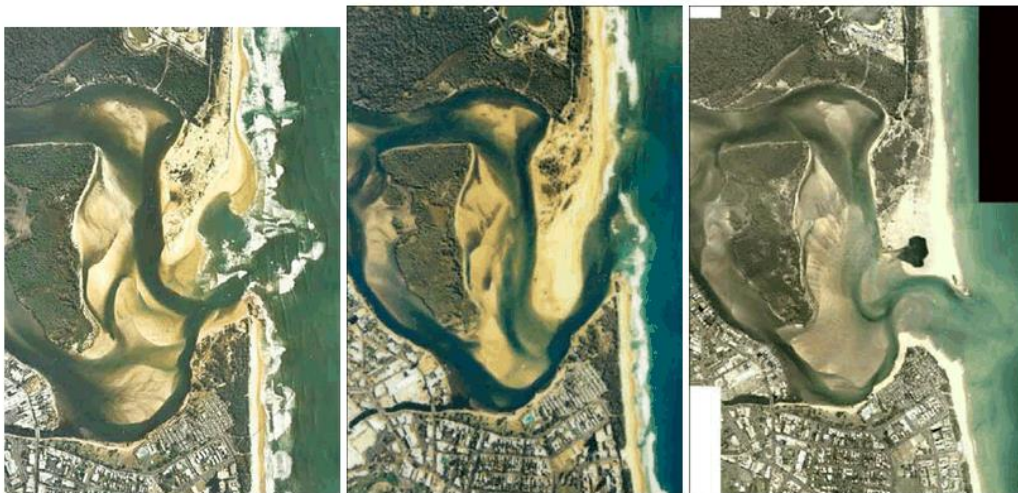
Figure 1-4 Maroochy River Entrance in 1992 (left), 1995 (middle) and 2003 (right)

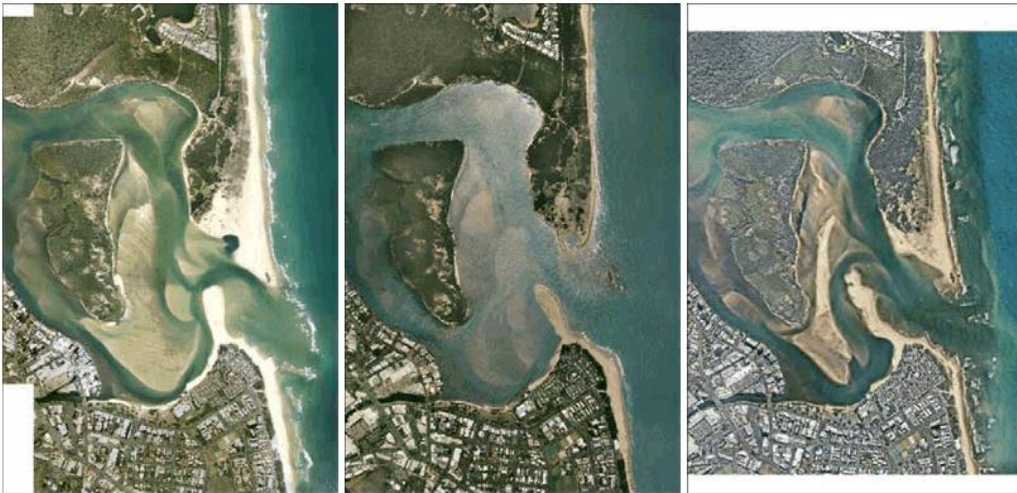
Figure 1-5 Maroochy River Entrance in 2005 (left), 2008 (middle) and 2015 (right)

The entrance position to the south of Pincushion Island has remained dynamically stable over the past decade. Presently, both the northern and southern channels are open. The northern spit is vegetated and connected to Pincushion Island. The lower estuary naturally infills with sand delivered from the south and transported by Maroochydore Beach littoral processes.

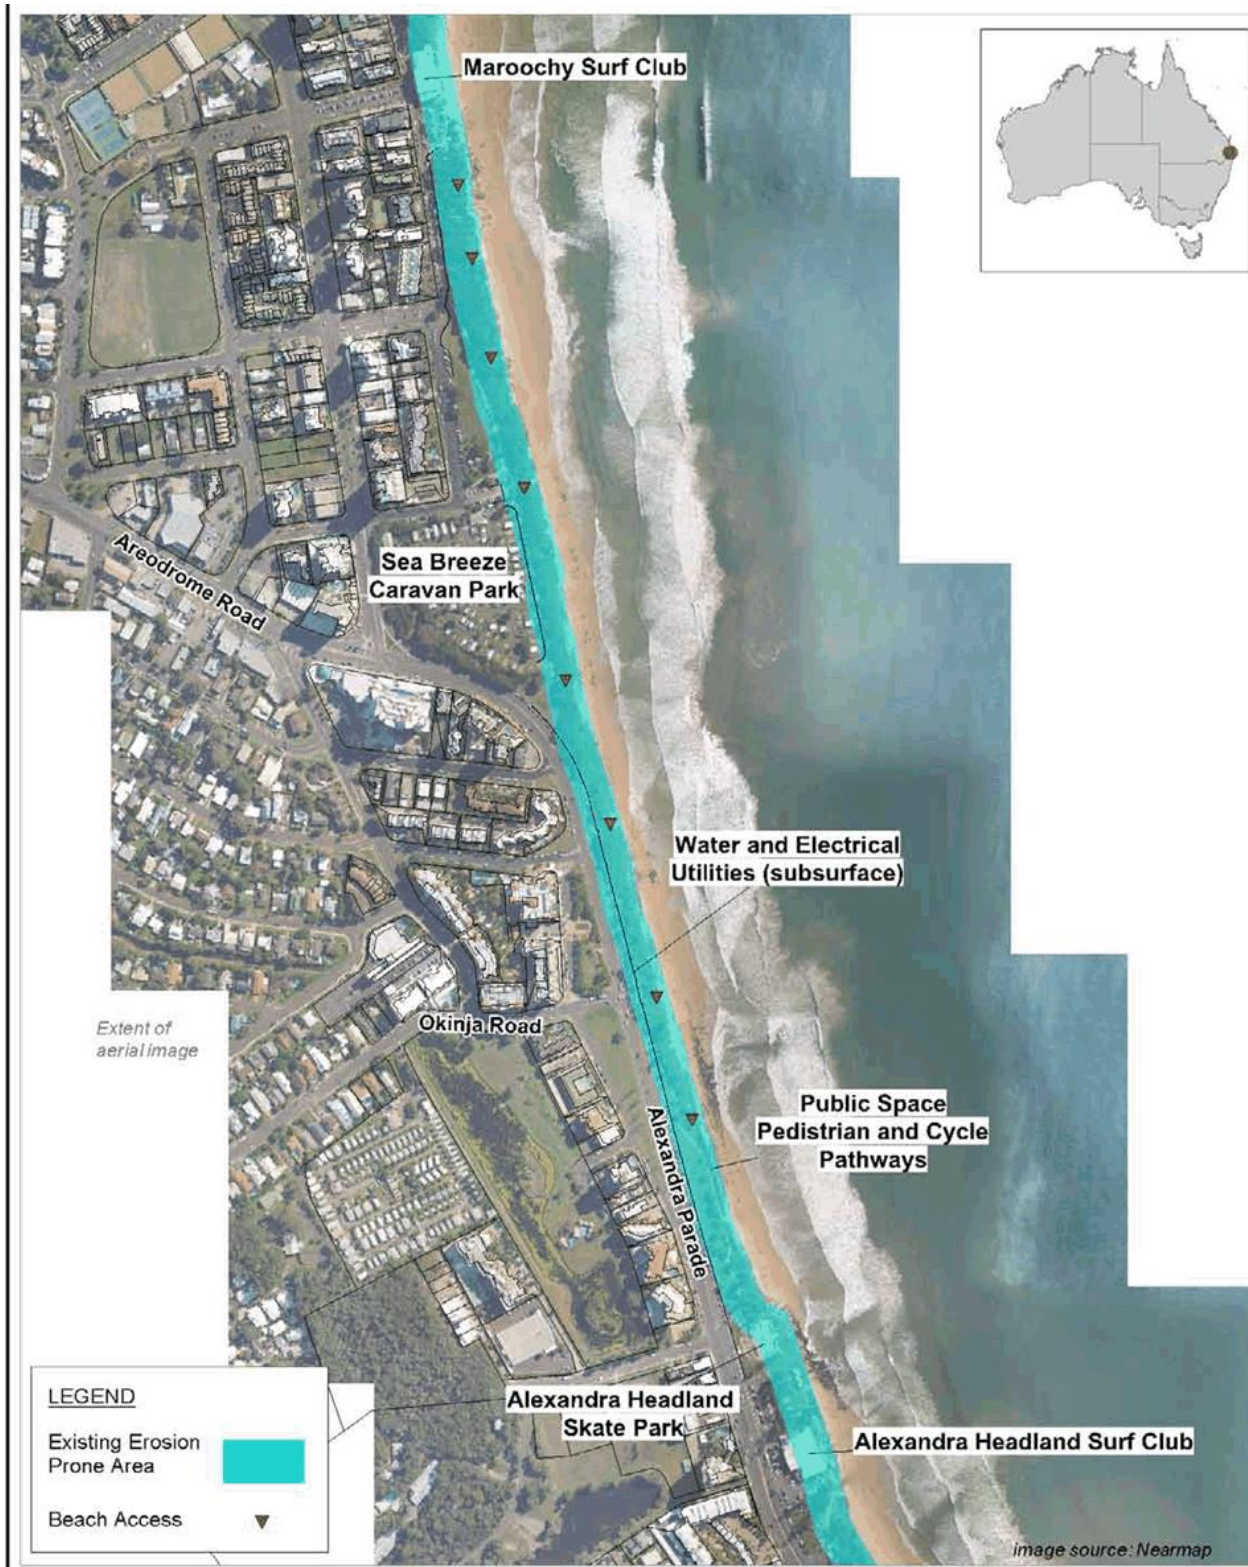
Figure:
2-3

Title:
Maroochyore Beach Assets

Coastal processes studies previously undertaken by BMT WBM on behalf of SCC (BMT WBM, 2014) calculated an average design storm erosion width of 45 m for this beach unit. The total design storm erosion volume for the beach unit is estimated to be 240,00m³. Erosion of this volume could cause extensive damage to existing land-based assets and infrastructure, depending on the pre-storm beach and shoreline position. Built assets currently within the 45 m design storm erosion width include:

- Aerodrome Road/Alexandra Parade, a State-controlled road;
- Maroochydore Beach Holiday Park;
- Beach access points;
- Public space including pedestrian and cycle pathways; and
- Subsurface water and electricity utilities.

These are indicated in Figure 2-3.

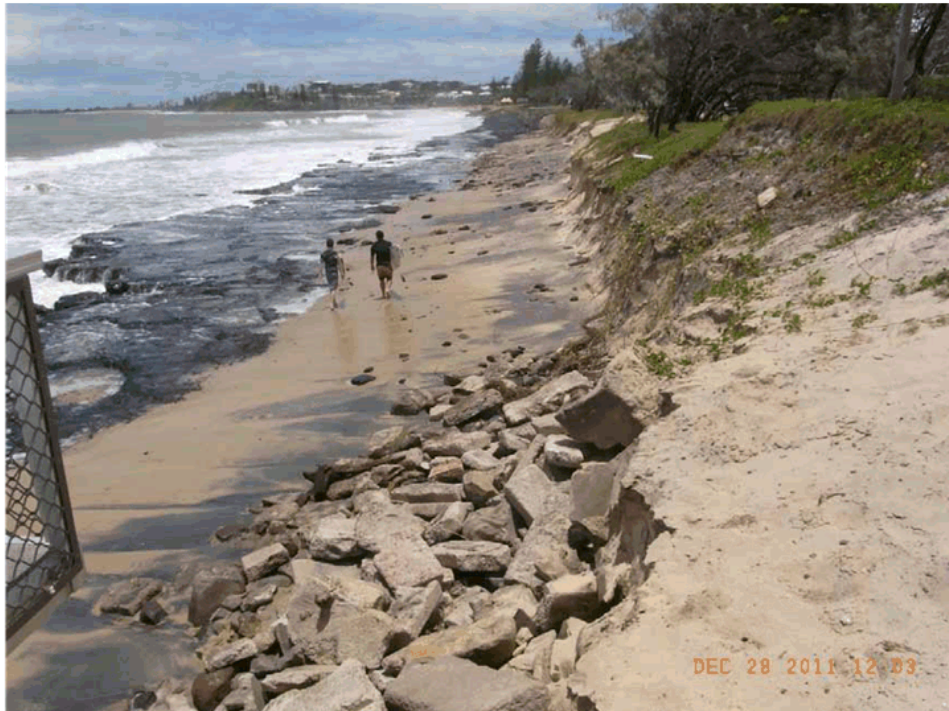
Figure 2-4 Examples of eroded beach with exposed coffee rock and fill material, prior to the Maroochydore Beach Renourishment Project (photo courtesy of SCC, 2011)

During erosion events, particularly prior to the Maroochydore Beach Renourishment Project (refer Section 2.2.2), areas of indurated sands become exposed across the foreshore. This most commonly occurs between 1 m AHD and -1 m AHD. Concrete and other 'fill material' also becomes exposed at the toe of the sand dune. It is uncertain how much of this fill material has been placed on the beach but it is suspected to occur across the dune/foreshore between the Alexandra Headland Surf Lifesaving Club and Maroochydore Beach Holiday Park. The beach in an eroded state is shown in Figure 2-4.

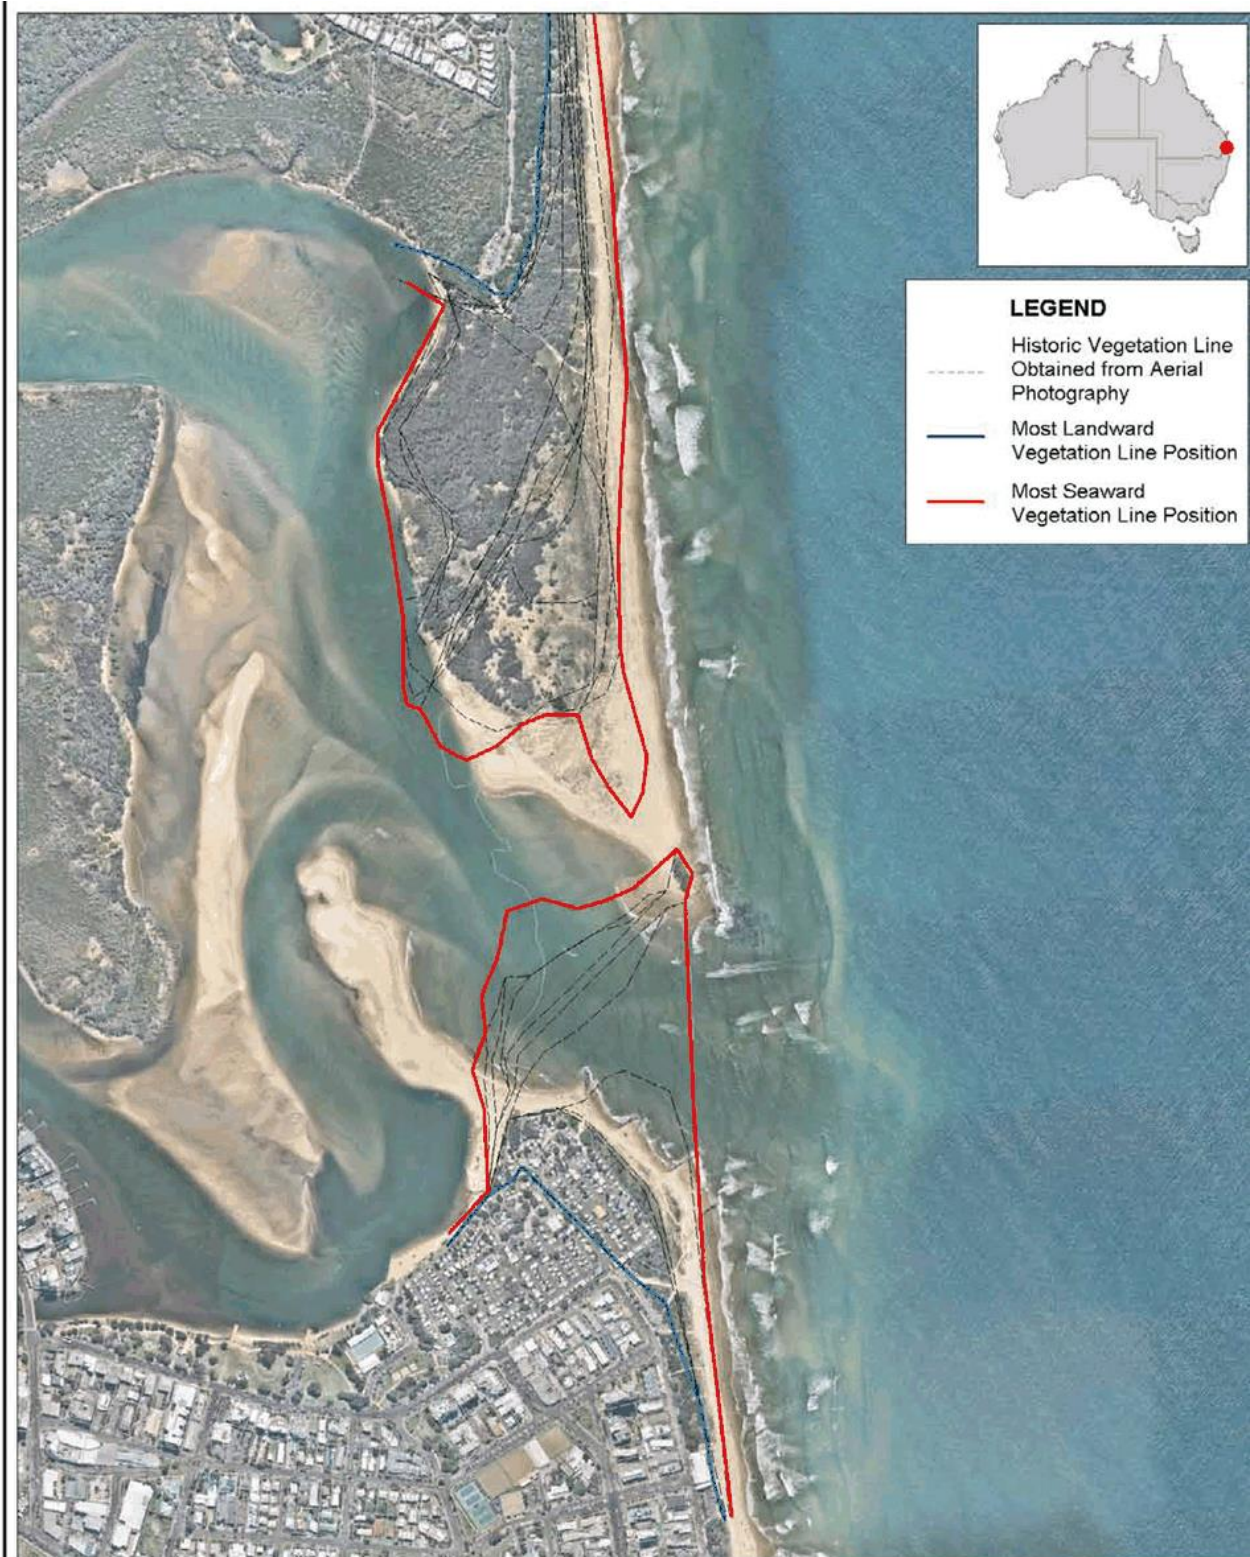
Figure:
2-5

Title:
Maroochy River Entrance and Northern Maroochydore Beach Historical Positions

The available historical data suggests the Maroochydore Beach alignment is shaped by the position of the Maroochy River channel. This influence is estimated to extend up to 1.5 km south along the coastline from Cotton Tree to the Okinja Road beach access point (Beach Access 154). Figure 2-5 presents a comparison of the historical dune vegetation at the northern section of Maroochydore Beach and suggests a more northerly shoreline alignment when Pincushion Island is connected to Cotton Tree.

The benefit of the more northern aligned shoreline is a seaward extension of the beach width and the additional volume of sand that remains in the nearshore zone (thereby improving beach amenity and resilience to storm erosion). This is demonstrated in Figure 2-6 which compares historical beach profiles at Maroochydore. During the 1970s, 80s and 90s (i.e. when Cotton Tree and Pincushion Island were connected) a milder offshore gradient was measured through the nearshore zone (between approximately -1 m AHD and -15 m AHD). The offshore profile in 2011 is steeper which suggests a reduced volume of sand in the nearshore zone.

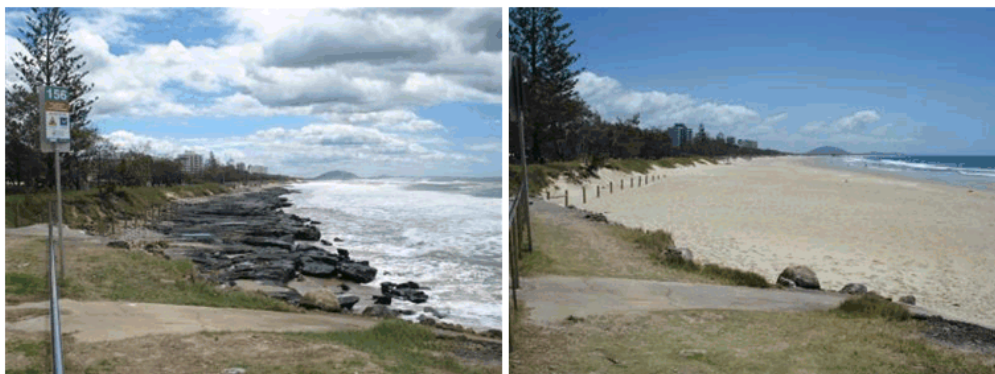
Figure 2-7 Before (left) and After (right) Maroochyde Beach Renourishment Project Stage One (photos courtesy of Birdon Pty Ltd)

Stage one of the Maroochydore Renourishment Project was completed in 2013 and involved relocation approximately 125,000 m³ of sand from a permitted area within the lower Maroochy River to Maroochydore Beach. The sand was relocated via a Cutter Suction Dredge (CSD) and pipeline. The dredge can be seen working within the permitted area in aerial image dated 11/08/2013 in Figure 2-2. Before and after renourishment photos are shown in Figure 2-7.

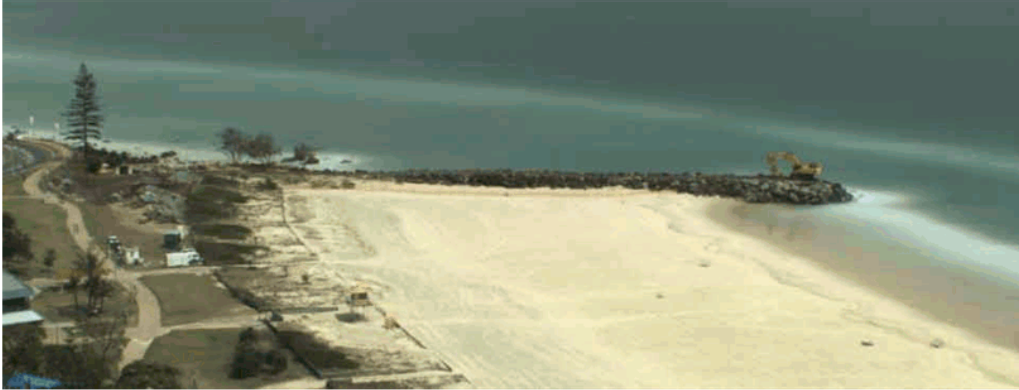
Figure 3-6 Kirra Groyne Extension Works (WRL Coastal Imaging, 2013)

Approximately 31,000 tonne of rock is required for Option 2. This estimate is based on the assumptions and groyne cross-section described in Section 3.2 over a 200 m length. A groyne of similar dimensions located at Kirra, Gold Coast, is shown in Figure 3-6.

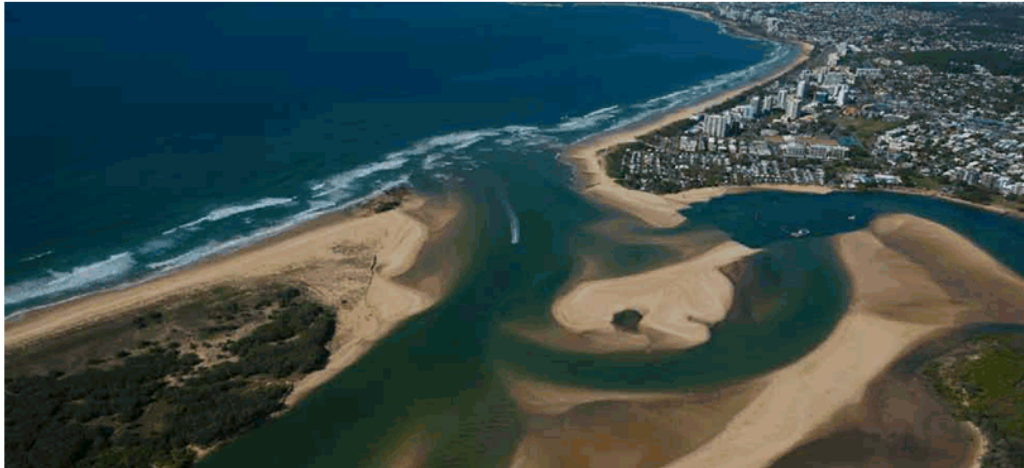
Figure 3-7 Maroochy River Mouth Dredging Works (photo courtesy of SCC, 2015)

The estimates above assume a cut depth to 3 metres below AHD and a fill elevation to 2.5 metres above AHD. The cut volume would be transferred to the fill area via cutter suction dredge (CSD) and slurry pipeline. Additional sand (approximately 110,000 m³) from other locations within the Maroochy River mouth would be required to achieve the design fill volume.
