## Sunshine Coast Regional Council Coastal Processes Study for the Sunshine Coast

Final Report May 2013

Title :	Sunshine Coast Regional Council - Coastal Processes Study for the Sunshine Coast
Author :	Matt Barnes, Chris Huxley and Malcolm Andrews
Synopsis :	This technical report describes dominant coastal processes between Caloundra Head Bells Creek and Sunshine Beach
	This report was commissioned by Sunshine Coast Council and was funded with support from Australian Government's Caring for our Country Program and SEQ Catchments.

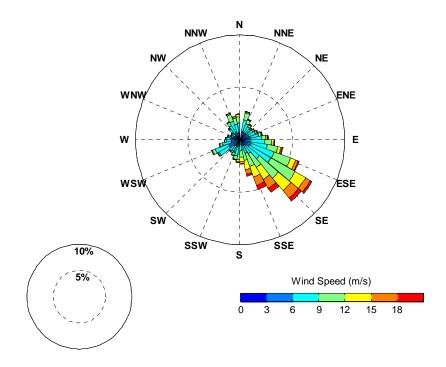
A long term average wind rose based on recorded data from Cape Moreton Lighthouse (BOM weather station 40043, indicated in Figure 3-1) is provided in Figure 2-1 and shows the directional spread of wind speed over the open ocean. It is noted that the Cape Moreton weather station is elevated and therefore the wind speeds are generally higher that those observed at the coast.

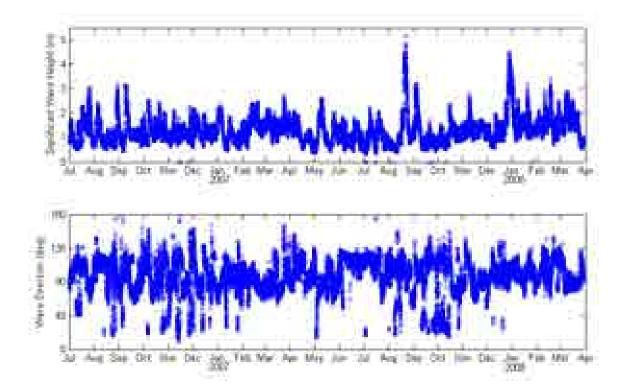
Figure 2-2 Recorded Significant Wave Height and Direction July 2006 to April 2008 -Mooloolaba Wave Buoy

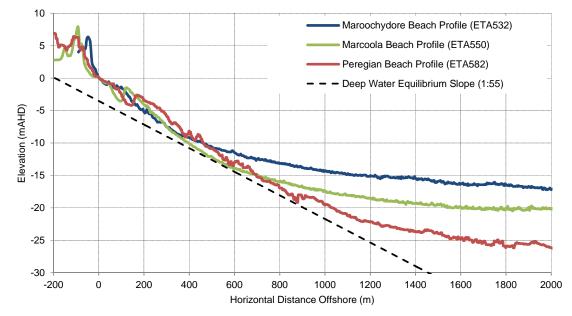
#### Figure 2-4 Sunshine Coast Beach Profiles Compared with Deep Water Equilibrium Slope

As mentioned in Section 1.3.1, it is possible that a sediment source from the inner continental shelf may be acting to supply small volumes of sediment to Sunshine Coast beaches. This process has been hypothesised by Roy (2001), Cowell et al. (2001) and Goodwin et al. (2005) and is assumed to occur in areas where the offshore profile slope is flatter than the deepwater "equilibrium" slope, commonly observed to be approximately 1 in 55m (e.g. Patterson, 2009). Figure 2-4 shows relatively flat offshore profiles throughout the study area compared to the deep water equilibrium slope. It is expected that a small supply of sediment from the inner shelf to the active beach system (shallower than approximately -15mAHD) will occur at these locations.

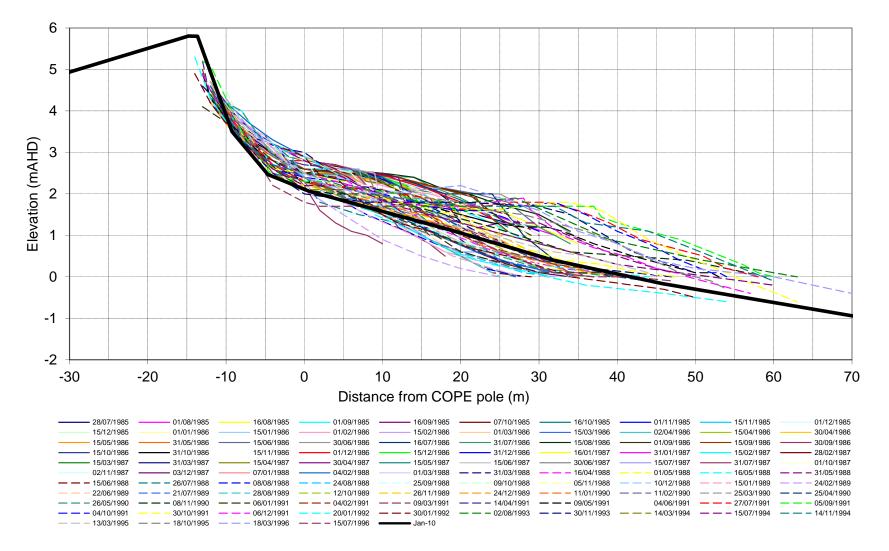
Figure 2-6 Mooloolaba 1 COPE Station Beach Profiles – February 2010 Resurvey (Solid Black Line) with 1985 to 1996 Historical Data (All Other Lines)

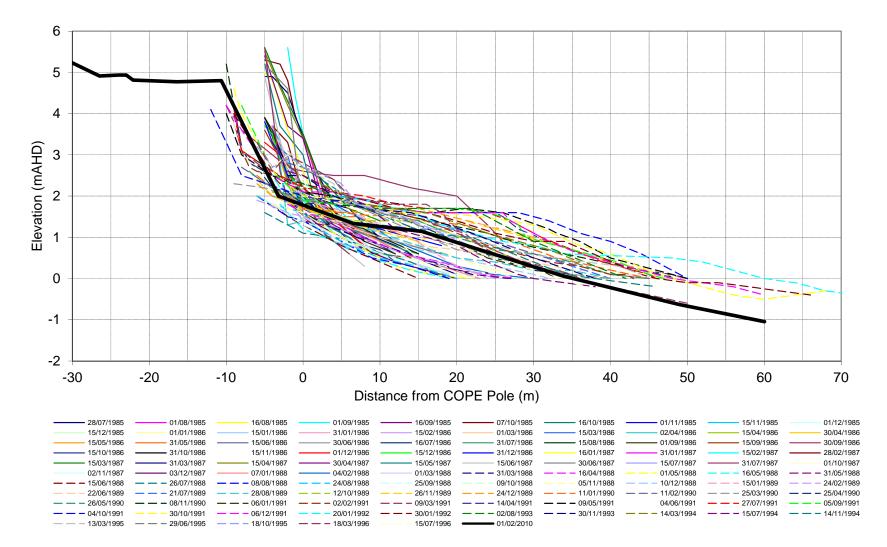
Figure 2-7 Mooloolaba 2 COPE Station Beach Profiles – February 2010 Resurvey (Solid Black Line) with 1985 to 1996 Historical Data (All Other Lines)

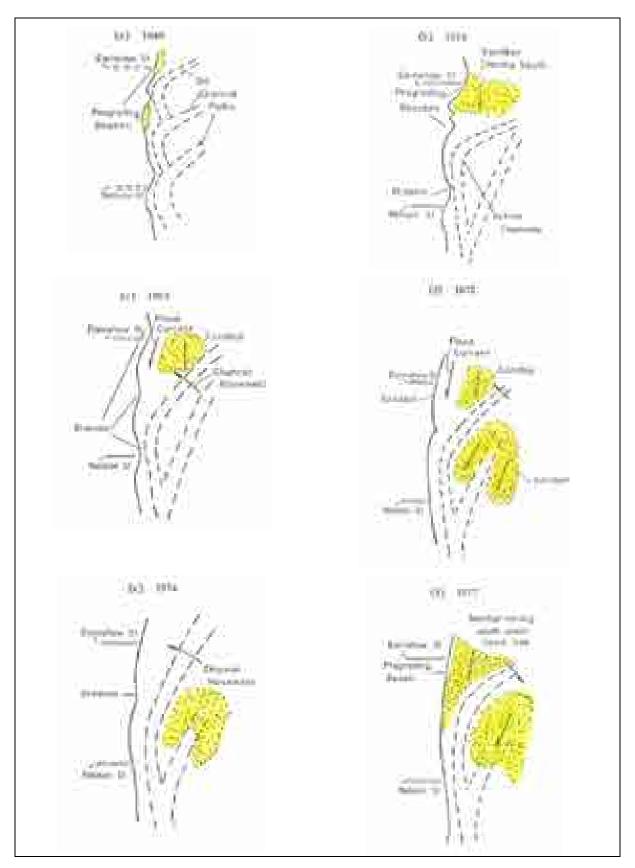
Figure 2-8 Illustrations Describing Golden Beach Shoreline Change Associated with Tidal Channel Migration between 1940 and 1977 (Riedel and Byrne, 1979)

- f) By 1977 the main channel had started to veer to the right and sand was building up opposite McLean Street. The apparent reason for this is that as the main entrance bar has moved north, Bulcock Channel has taken more of the flood tide, and there has been a resurgence of the sand bar opposite McLean Street, fed by the flood tide from Bulcock Channel. The increased sand had deflected the ebb channel to the right. This has allowed the beaches to grow between Beattie Street and Earnshaw Street.

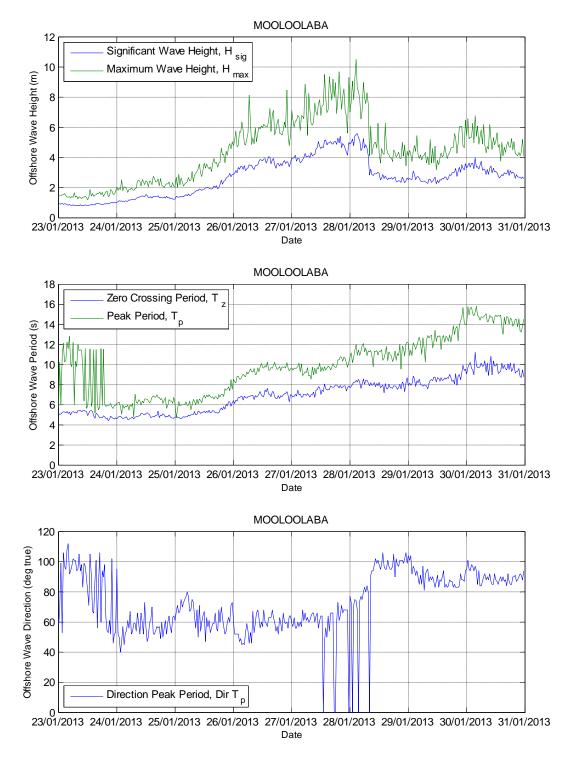
Figure 2-13 Recorded Wave Conditions Offshore from the Study Area during ex-TC Oswald (Data provided by DSITIA)

Water level and wave data recordings during ex-TC Oswald are presented in Figure 2-12 and Figure 2-13. The water level data at Mooloolaba suggest a residual tide (storm surge) peak close to 0.5m and a recorded water level (storm tide) close to Highest Astronomical Tide (HAT) occurred. This water level is approximately 1.25m lower than the 100 year ARI water level report by Hardy et al. (2004) suggesting the study area is vulnerable to significantly higher extreme water levels than that experienced during ex-TC Oswald.

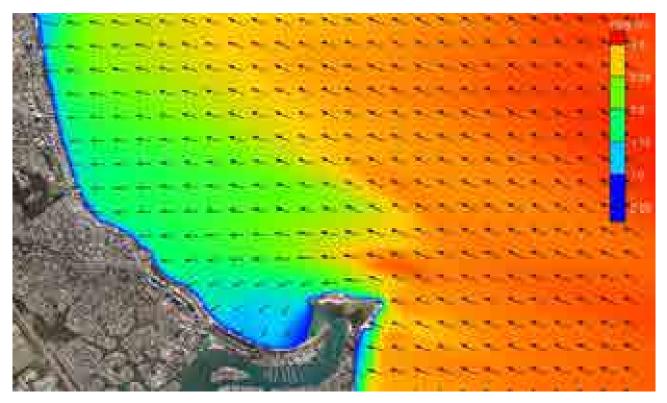
Figure 3-7 South-Easterly Swell Wave Refraction at Point Cartwright

Typically the Sunshine Coast is fully exposed to wave conditions originating from the north through east. During events from the south/southeast, Moreton Island acts as a major coastal feature sheltering a large section of the Sunshine Coast from the open ocean swell. The sheltering influence progressively decreases in magnitude moving north along the Sunshine Coast. All of the beach units within the study area are affected by this sheltering. Locally, Caloundra Head, Point Cartwright and Point Arkwright also shelter adjacent beaches to the north from south/southeast swells. Using wave model output, the sheltering influence of Point Cartwright on Mooloolaba Bay is illustrated in Figure 3-7.

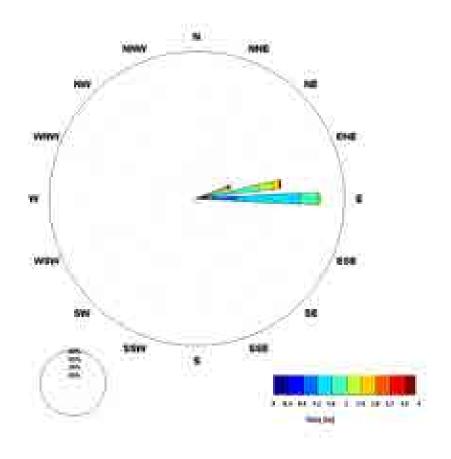
Figure 3-9 Dicky Beach Wave Rose Plot

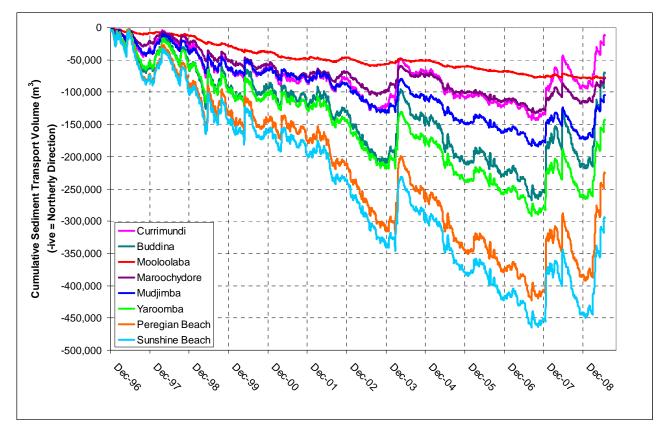
Figure 3-23 Predicted Cumulative Longshore Sediment Transport

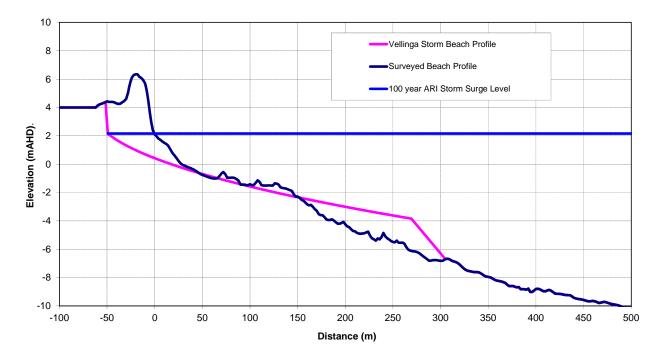
Figure 3-25 Initial Surveyed and Estimated Storm Profiles at Maroochydore Beach (ETA 532)

Table 3-13 lists the storm erosion assessment input parameters and the predicted storm erosion for the available beach profile locations. The storm erosion distance is measured landward from the position where the design water level intersects the beach profile and varies primarily due to the initial beach profile and volume of sand assumed available in the upper beach and dune (the minor differences in design storm conditions also influence the estimated erosion distance). Vellinga (1980) predicts more setback for steeper initial profiles since a greater volume of sand is required to achieve the ultimate storm profile. The initial and estimated storm erosion profile for Maroochydore (ETA 532) is shown in Figure 3-25. The estimated storm profiles for all locations are presented in Appendix H.

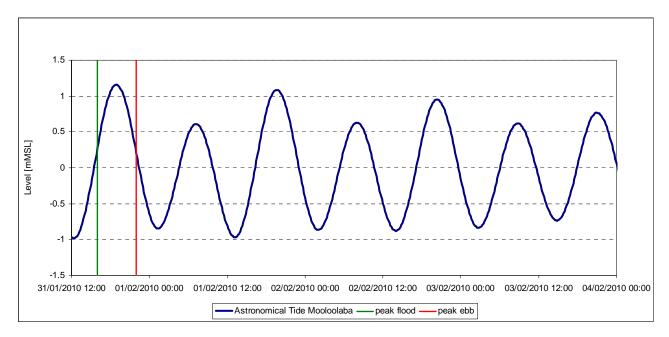
Figure 3-27 Spring Tide Period

The scenarios listed above were simulated over a spring tide period. The tidal signal and times of peak flood and peak ebb current at Mooloolaba are indicated in Figure 3-27.

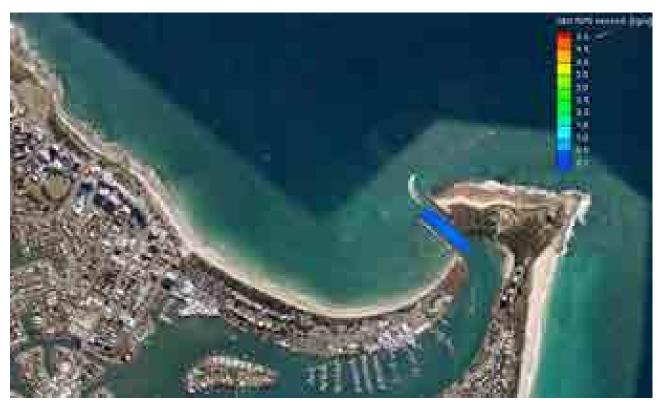
Figure 3-44 Spring Tide Period Median Sediment Transport without Wave Forcing

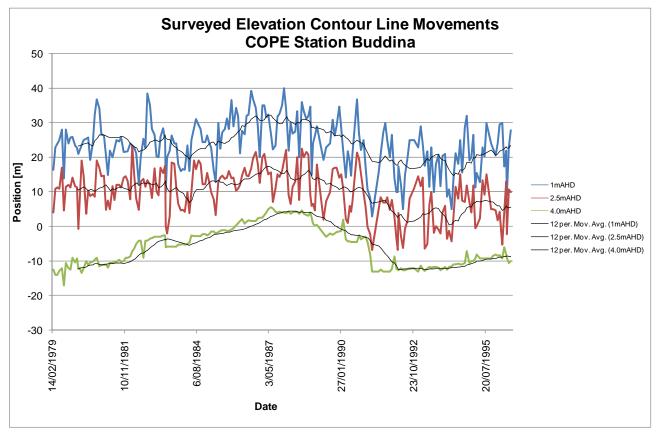
Figure A-2 Buddina Beach Shoreline Movement

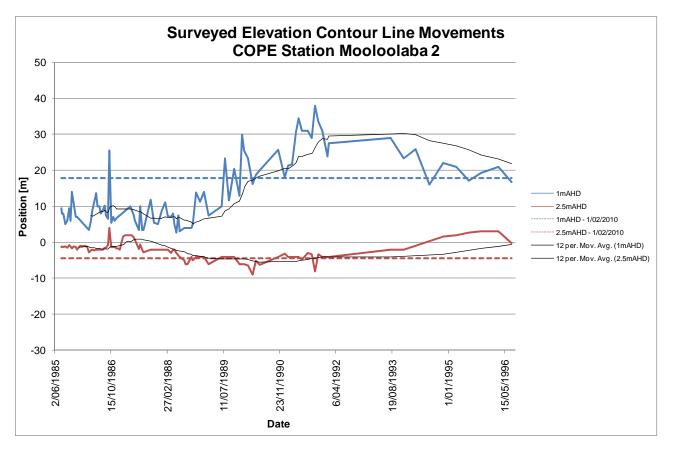
Figure A-4 Mooloolaba Beach Shoreline Movement (COPE Station 2)

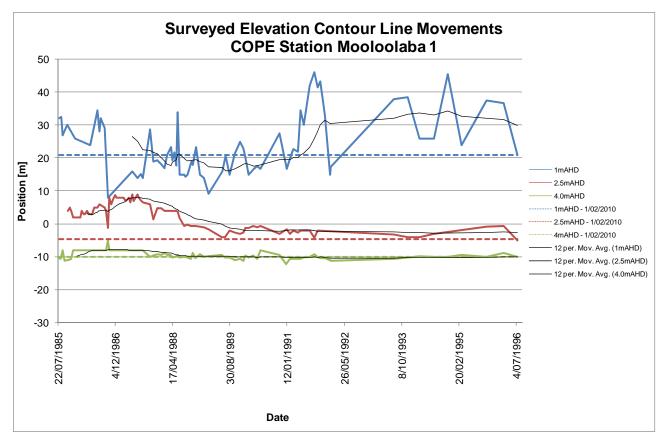
Figure A-6 Mooloolaba Beach Shoreline Movement (COPE Station 1)

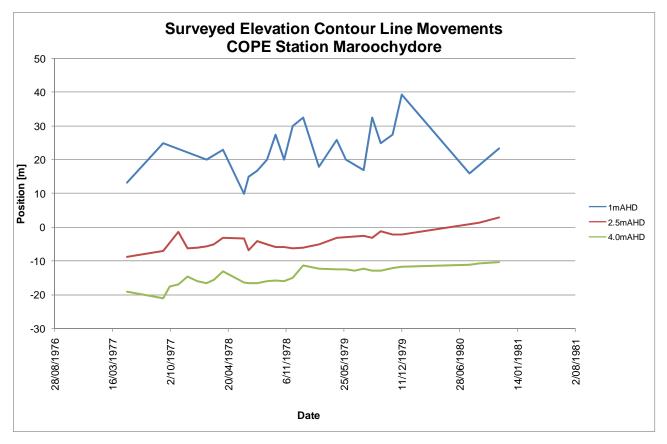
Figure A-8 Maroochydore Beach Shoreline Movement

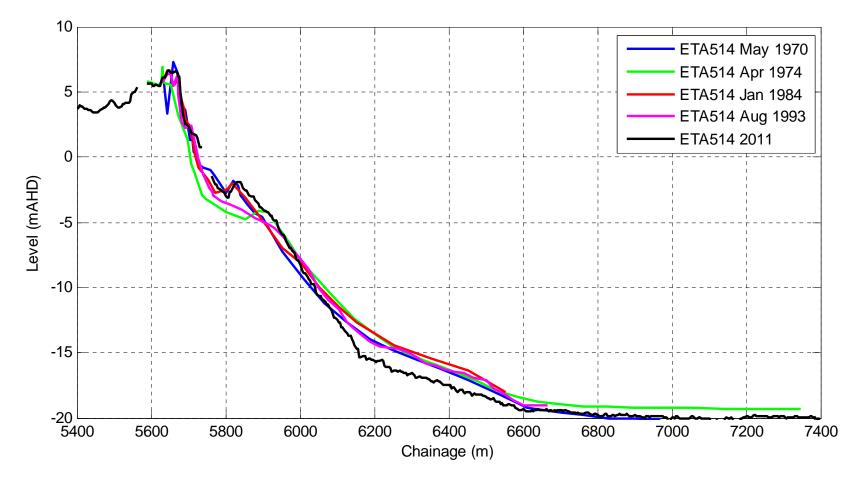
Figure B-1 ETA 514 (Buddina) Historical ETA Profiles

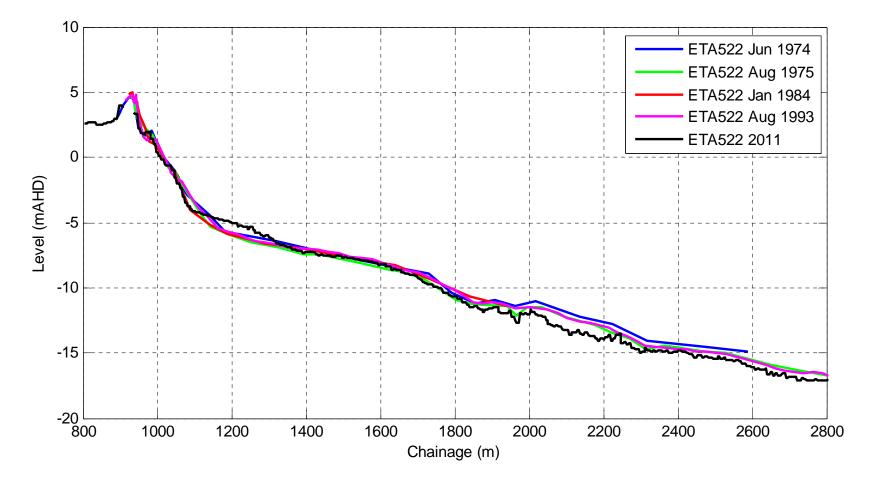
Figure B-2 ETA 522 (Mooloolaba) Historical ETA Profiles

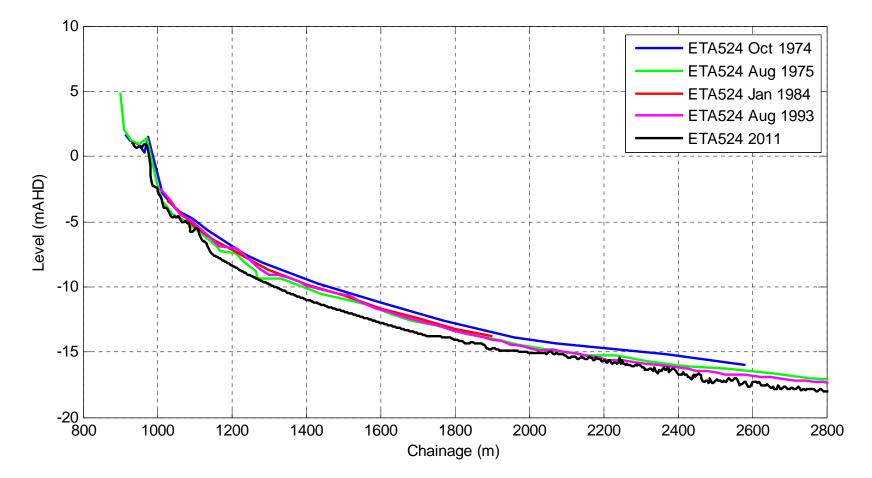
Figure B-3 ETA 524 (Mooloolaba) Historical ETA Profiles

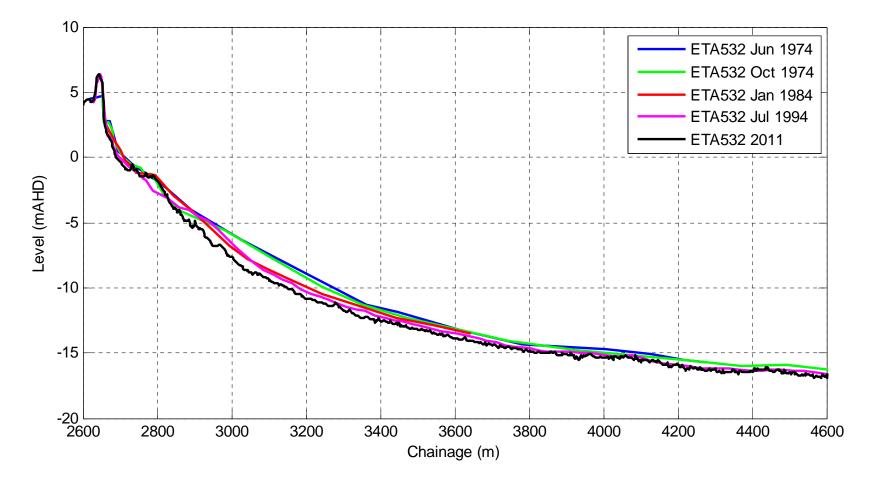
Figure B-4 ETA 524 (Maroochydore) Historical ETA Profiles

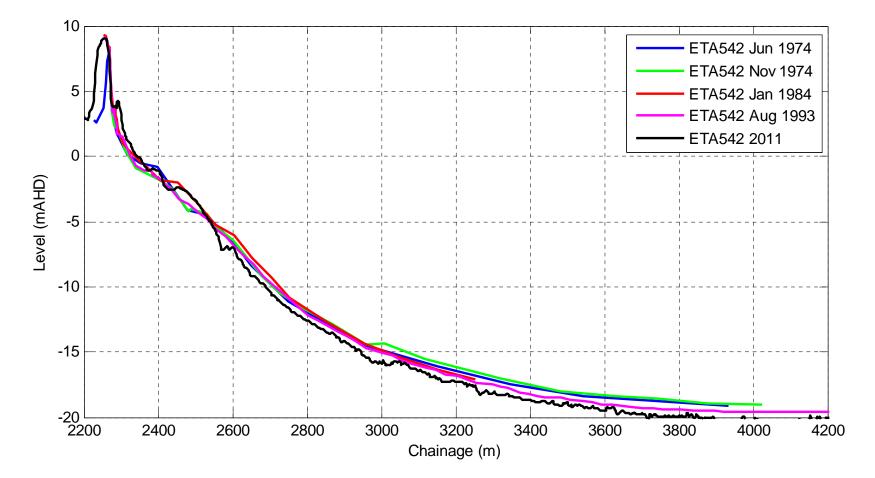
Figure B-5 ETA 524 (Between North Shore and Mudjimba) Historical ETA Profiles

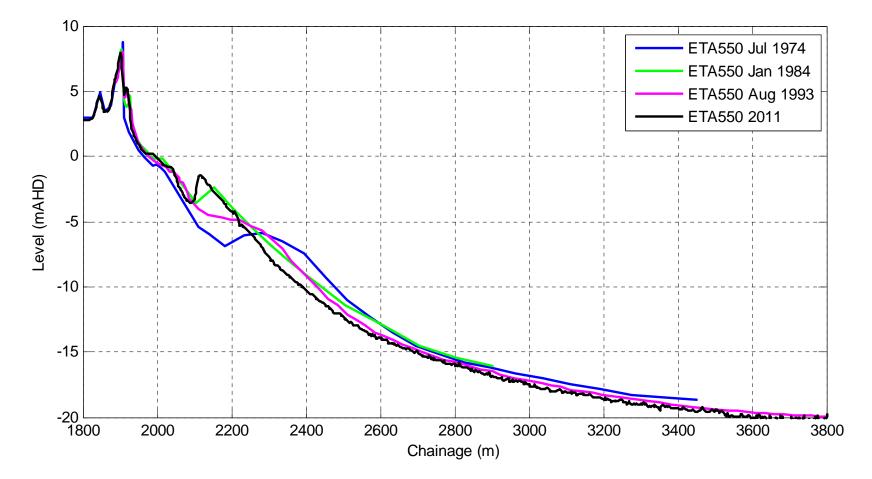
Figure B-6 ETA 550 (Marcoola) Historical ETA Profiles
