LAKE CURRIMUNDI DYNAMICS STUDY

Volume 1 : Final Report

**Griffith Centre for Coastal Management
Research Report No. 75**

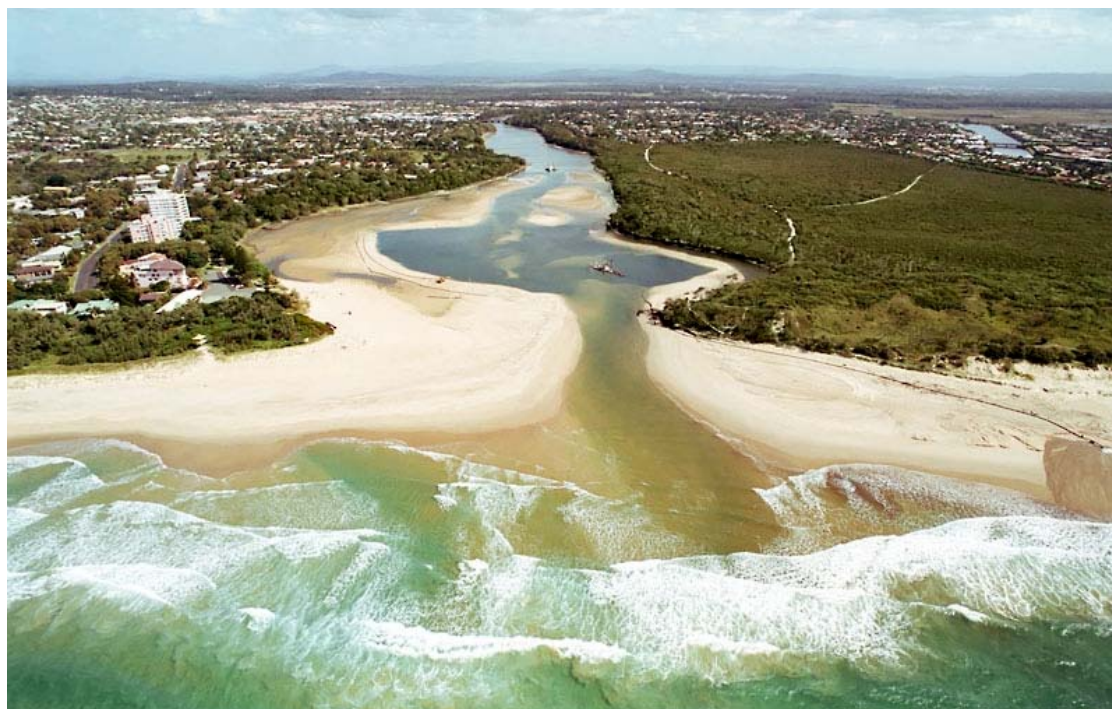
Figure 2: Sand Plug Removal 2004

Biting midge populations increased significantly following the 2004 sand plug removal (Figure 2), but midge populations are known to fluctuate over time. Given that there had been no previous dredging activity of this magnitude it is understandable that the midge increase was dramatic.

The cause is most likely that although a significant section of sand flat habitat was removed by the dredging, the increase in tidal range (not monitored) throughout the lake as a result of greater hydraulic exchange at the entrance would have increased the exposure of sand flats, and hence habitat, further upstream. Re-profiling of the northern banks would have also contributed.

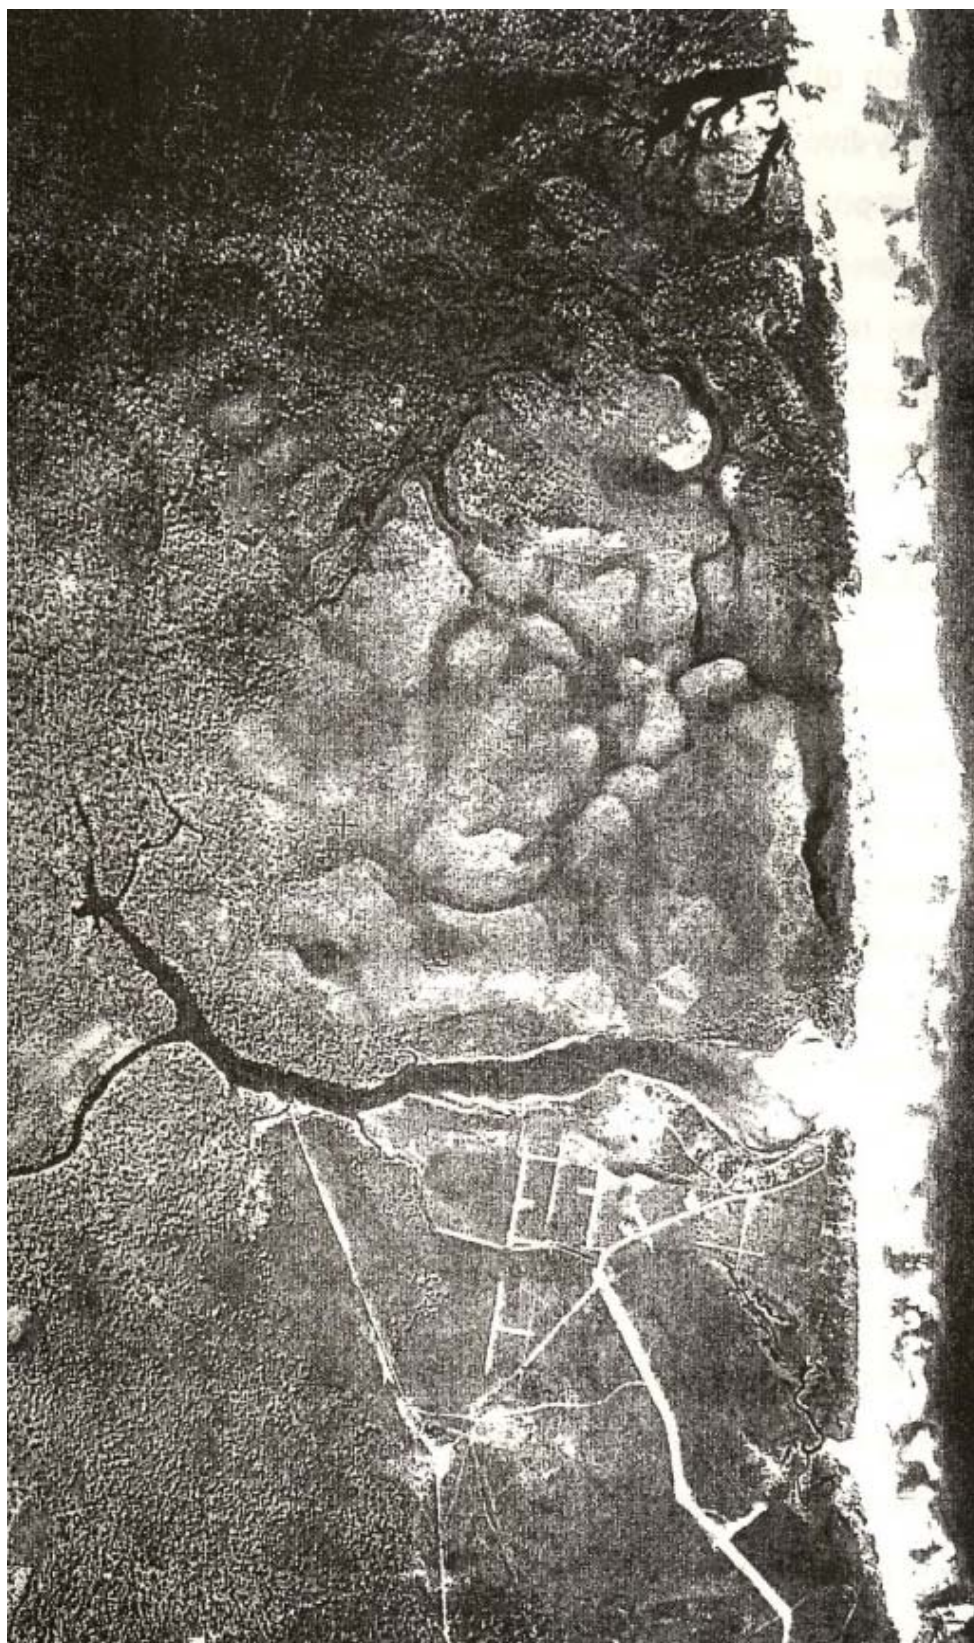
Figure 3: Lake Currimundi 1958

Historical photos and anecdotal information suggests that Currimundi was generally semi-closed with full closure on low tides (Caloundra City Council 2006). The lake was sometimes closed for months. Openings depended on fresh events. Aerial photos show a persistent sand plug.

The evidence of infilling since 2005 gives a good indication of the natural tendency for the entrance to be blocked by a sand plug and to have a small restricted meandering channel. Putting everything in context it would appear that the entrance has been basically unchanged between 1958 and 2001 despite the connection of the Pangali, Tokara and Baroona canals in the 1980s and 1990s.

There would have been an increase in tidal prism associated with these canals, but because the sand plug is dominated by beach processes, the tidal range will always be restricted provided the plug is present, and hence the increase in waterway area will be minor in influence on tidal prism. In tidal inlets of this type, there is a self-

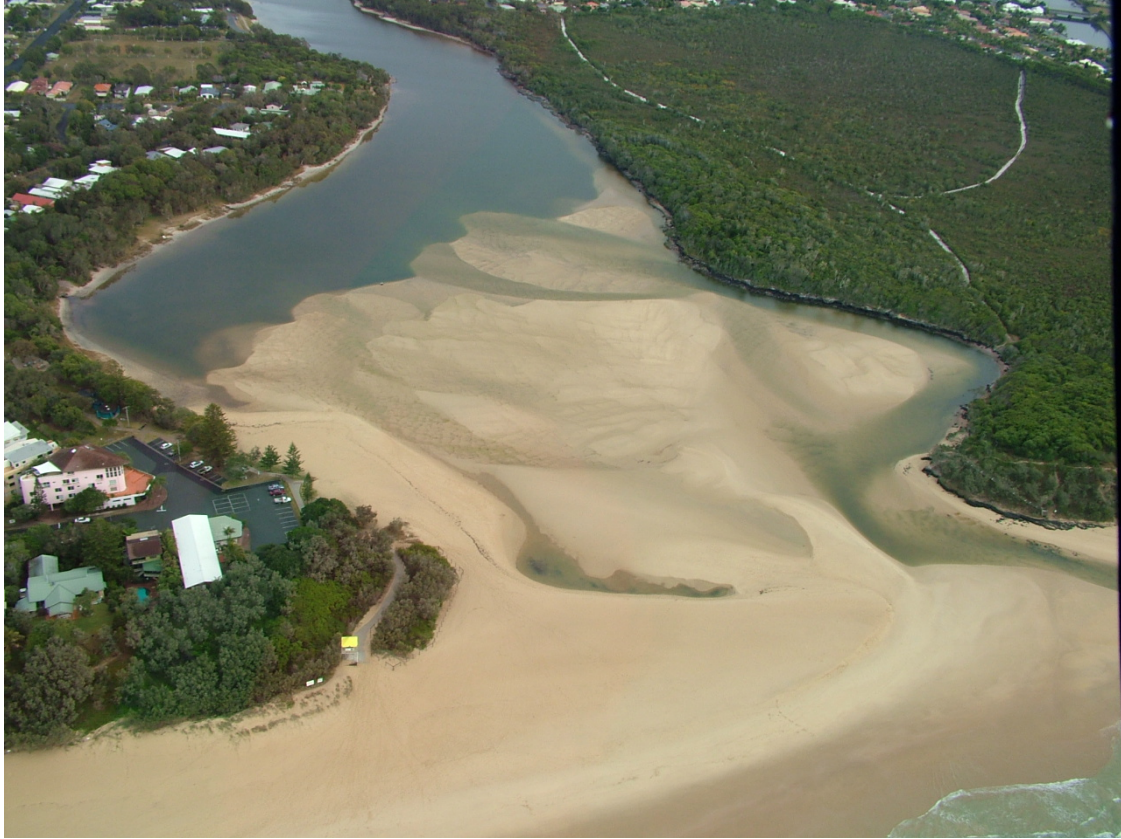
Figure 4: Entrance Conditions 2007

Aerial photographs show a rapid migration of the entrance channel from the northern bank to the south from November 2005 to July 2006, with a strong indication that the March 2006 storm was the main driving forces. This migration may have been triggered by the presence of dredge infrastructure which may have been blocking the northern channel to some extent. This resulted in erosion of infrastructure on the southern bank and subsequent action by Council to rebuild the berm and relocate the channel to the north. It should be noted that from the available aerial photos the channel predominantly has been to the north.

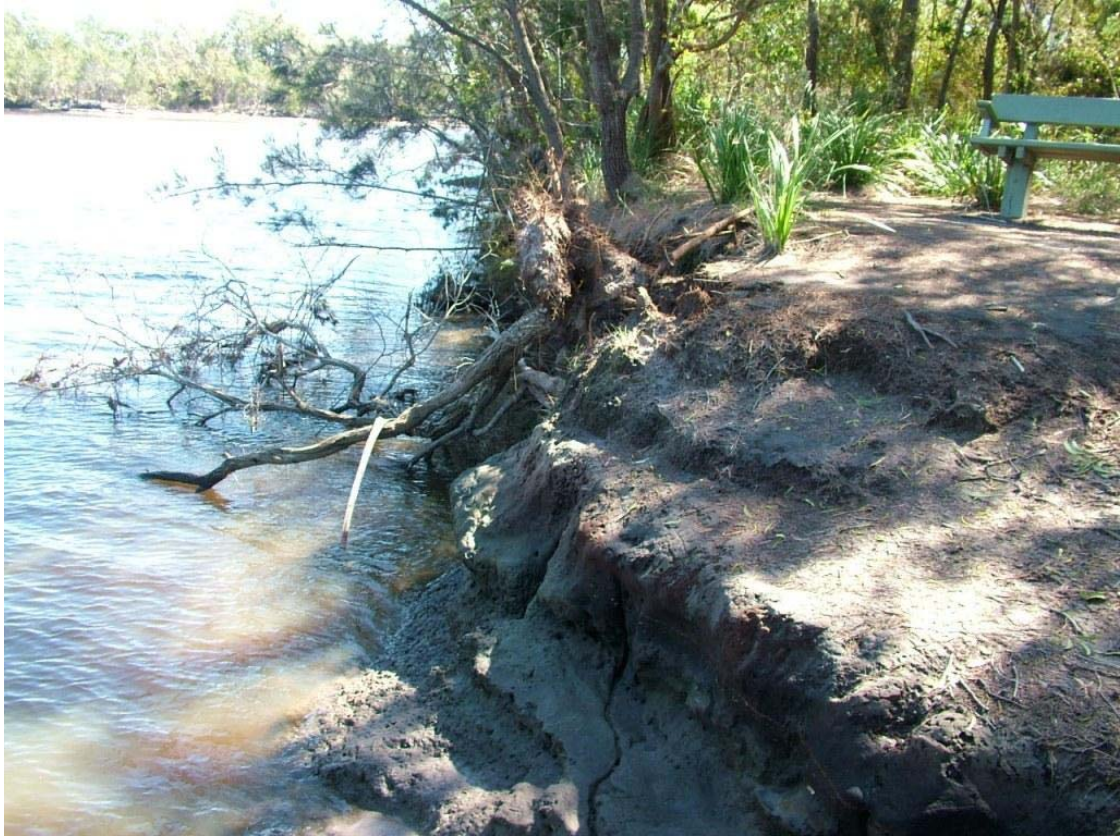
Figure 5: Typical bank erosion

As a consequence of bank erosion and other factors such as sediment wash-off from major earthworks and catchment development, there are also concerns over the changing profiles of the canals and the Currimundi system itself.

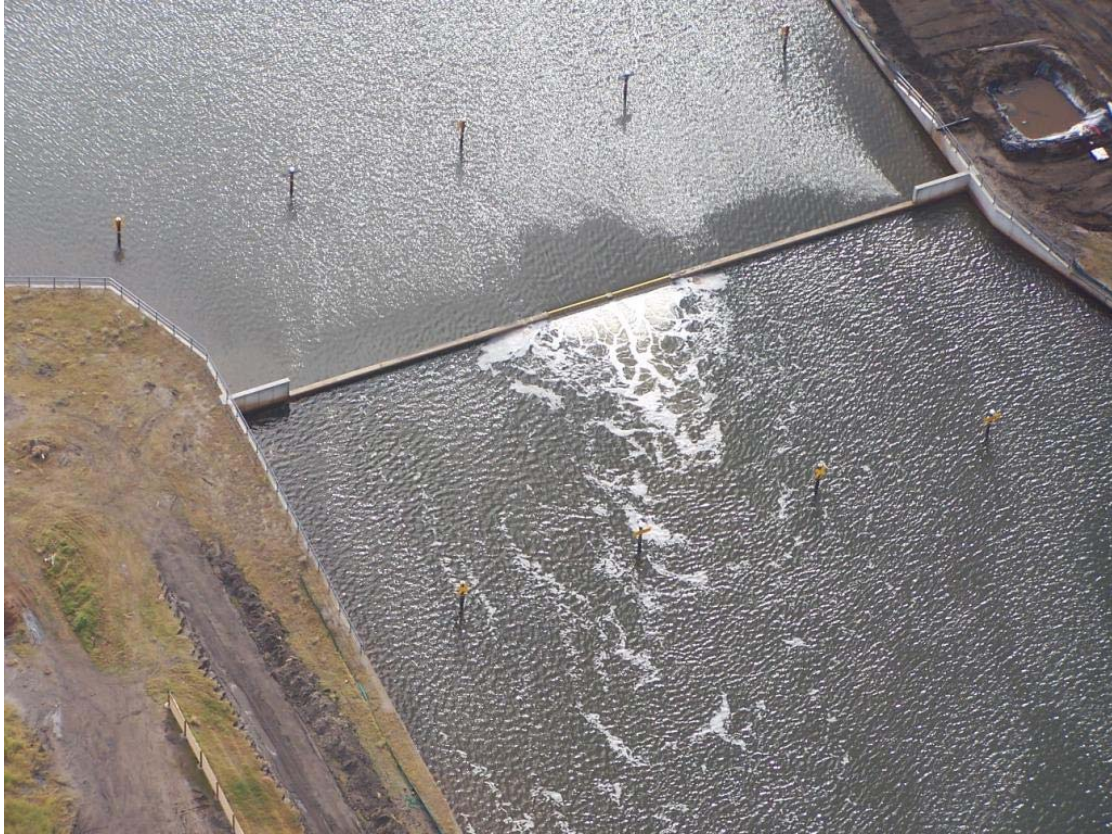
Figure 6: Lake kawana Weir 2007

Considerable concern has been raised about the impact of the connection to Lake Kawana (Figure 6). This connection is via two elements (i) an overflow weir connecting to Pangali Canal and (ii) pumped discharge from Lake Kawana into Tokara Canal via an existing stormwater pipe system. The weir is required to limit the increase in the tidal prism of Lake Currimundi and to maintain a relatively constant lake level. Water is pumped from the Mooloolah River to maintain brackish conditions and to improve the flushing characteristics of Lake Kawana. Despite some inaccurate references in earlier correspondence, it has been established that the system parameters are as follows.

There is also the issue of the proposed 300 litre/second (13 ML/day over a 12 hour cycle) of lake water discharged to the top end of Tokara Canal via an existing stormwater pipe. This discharge would form part of the overall Lake Kawana circulation system, but may increase the incidences of discolouration of the canals. Anecdotal reports of discolouration of water in the canal to date are consistent with fines and colour being discharged from the new developments. Whether this represents a real deterioration in water quality is still unclear.

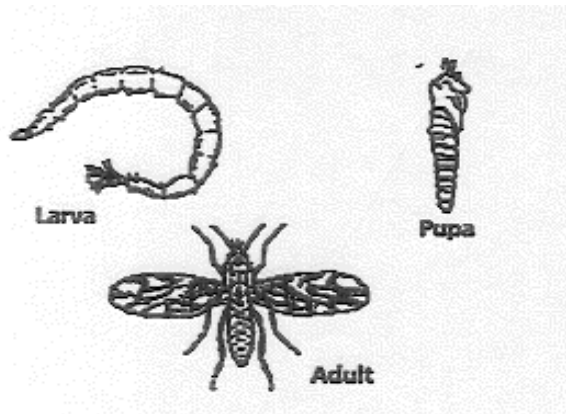
Figure 8: Stages of the Biting Midge Lifecycle

Estuarine biting midge undergoes complete metamorphosis during their lifecycle (see Figure 8). The female lays her microscopic white eggs on damp sand in the intertidal beach zone. After about a week these eggs hatch into a white worm like larvae that burrow into the sand to live and feed. Here it undergoes four stages of growth (instars), each getting successively larger until it reaches about 5mm in length. This larval stage generally takes about five weeks and when complete it migrates to the surface of the sand and pupates. This air breathing stage is largely immobile and it is where the development of the winged adult takes place. After about four days the pupal case hardens and cracks open, the adult midge emerges, allows its wings to dry and then flies off to join other swarming adult midges or to harbour in shady vegetation nearby. The lifecycle is shorter during the warmer summer months and during cold winters the midge larvae can slow or even suspend development for some months. The hatching of adults is closely aligned to the lunar cycle and large numbers of adults can appear to arrive within the space of a couple of days.

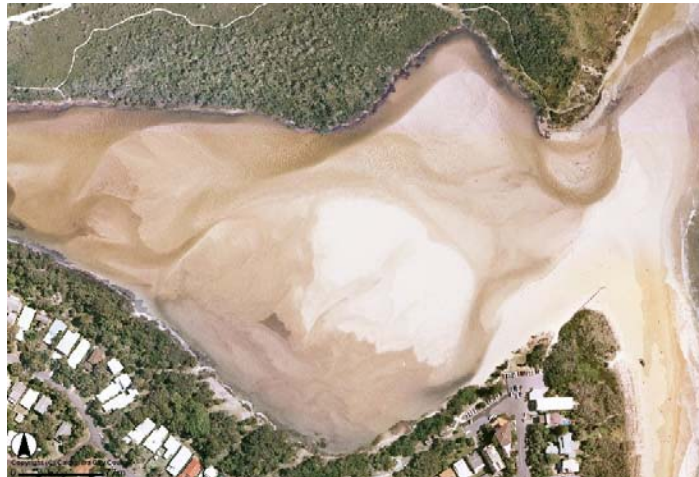
Figure 9: Lake Mouth & Sand Plug 2003

In early 2004 work began to remove the large sand plug (see Figure 9) that had accumulated inside the mouth of the lake to reduce the risk of upstream flooding. Around the same time larval biting midge sampling had identified that the southern half of the sand plug was ideal larval habitat with densities over 1000 larvae per square metre often recorded. That section of the sand plug had been stable for many years and contained high levels of organic matter. Complaints of adult activity were regularly recorded from the area.

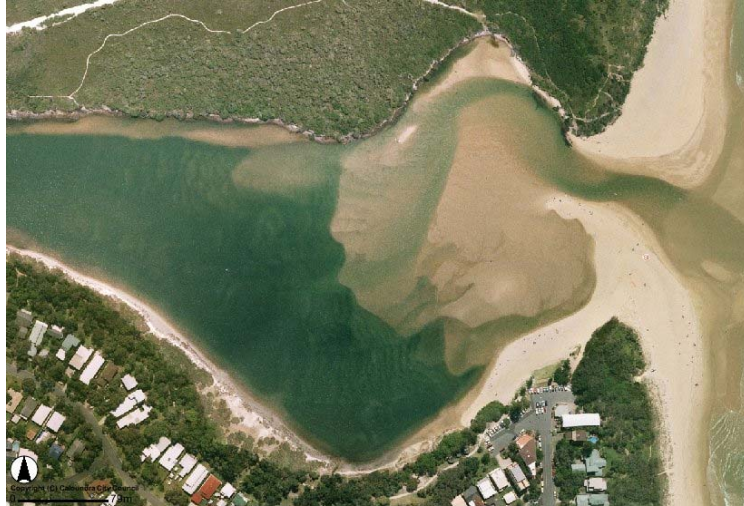
Figure 10: Reduced Midge Breeding Habitat 2005

To address the midge problem the dredging plan was amended to include more of this larval habitat so that it was removed and a much narrower, steeper beach on the southern bank was established (see Figure 10). About 20,000 square metres of larval midge habitat was removed and only about 1000 square metres of possible habitat remained along the southern beach.

As a result adult biting midge almost vanished from the ocean end of the lake for several years and now only low levels of larval activity are recorded along the southern beach.

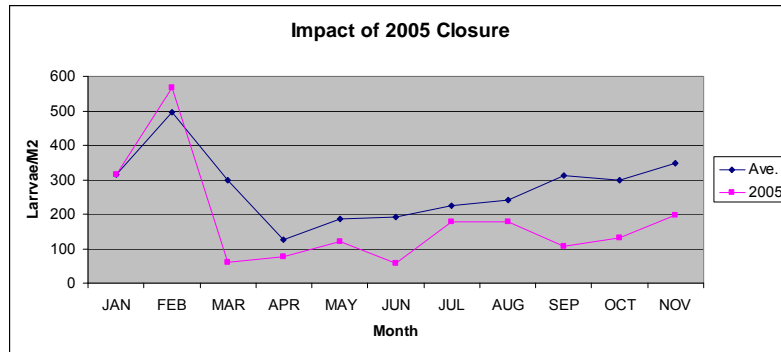
Figure 11: Lake Closure February 2005

The lake was closed in mid February 2005 and larval midge populations were monitored at several sites on a weekly basis. When that monitoring showed that larval populations had collapsed the lake was re-opened in mid March 2005. Midge monitoring was continued to determine if there was any ongoing impact. Figure 11 details the results:

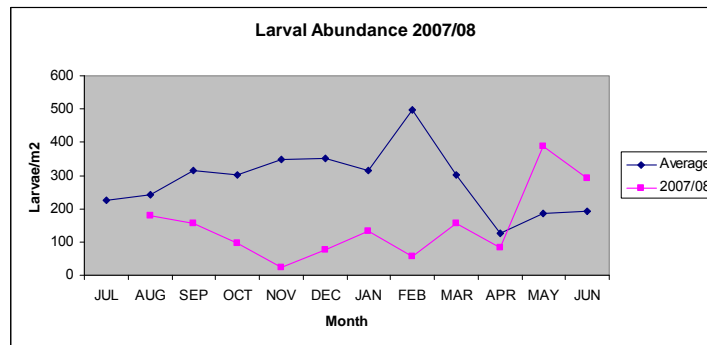
Figure 12: Lake Closure September 2007

The lake was closed in mid September 2007 and was re-opened at the end of October 2007. The impact on midge abundance was far more significant than the previous closure as detailed in Figure 12:

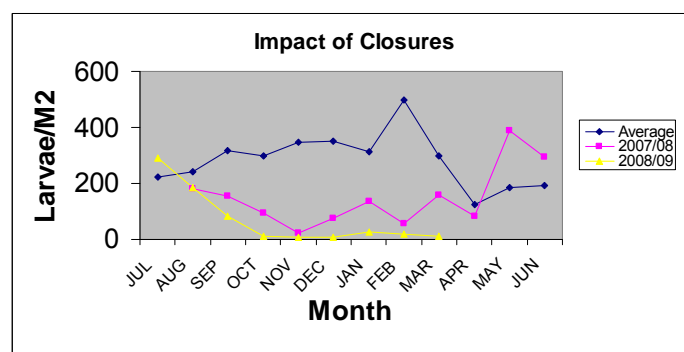
Figure 13: Lake Closure August 2008

Larval populations returned to above average levels by the winter of 2008 so the lake was closed in late August 2008 to coincide with the new moon high tides. During the previous closure in 2007 it took two weeks to raise the water level to completely cover the larval midge habitat. Due to some timely rain the midge habitat was completely submerged within a week. Also a higher water level was set to try and limit the opportunity for adult midge to lay their eggs in the damp sand just above the static water level, a phenomenon observed during the 2007 closure. Figure 13 shows the results to date:

The improved results have continued with larval abundance being 96% lower than average in the six months since re-opening the lake.

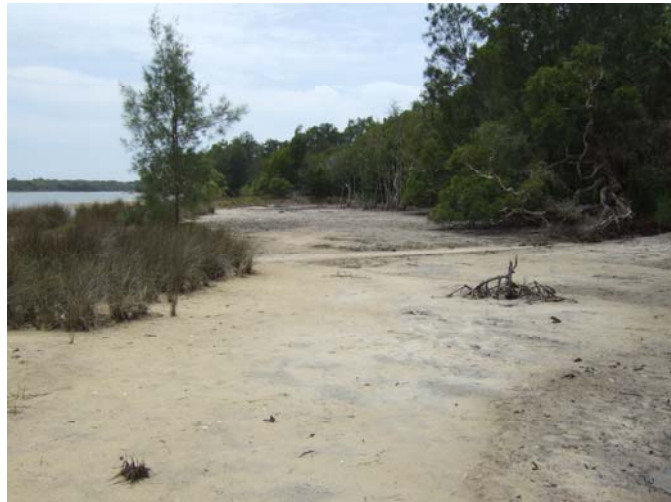
Figure 14: The Basin, prime larval midge habitat.

At one site in the lake the midge abundance is always much higher than surrounding areas and nearby residents are more regularly affected by adult midge. It is known as the Gamban Esplanade Basin (see Figure 14).

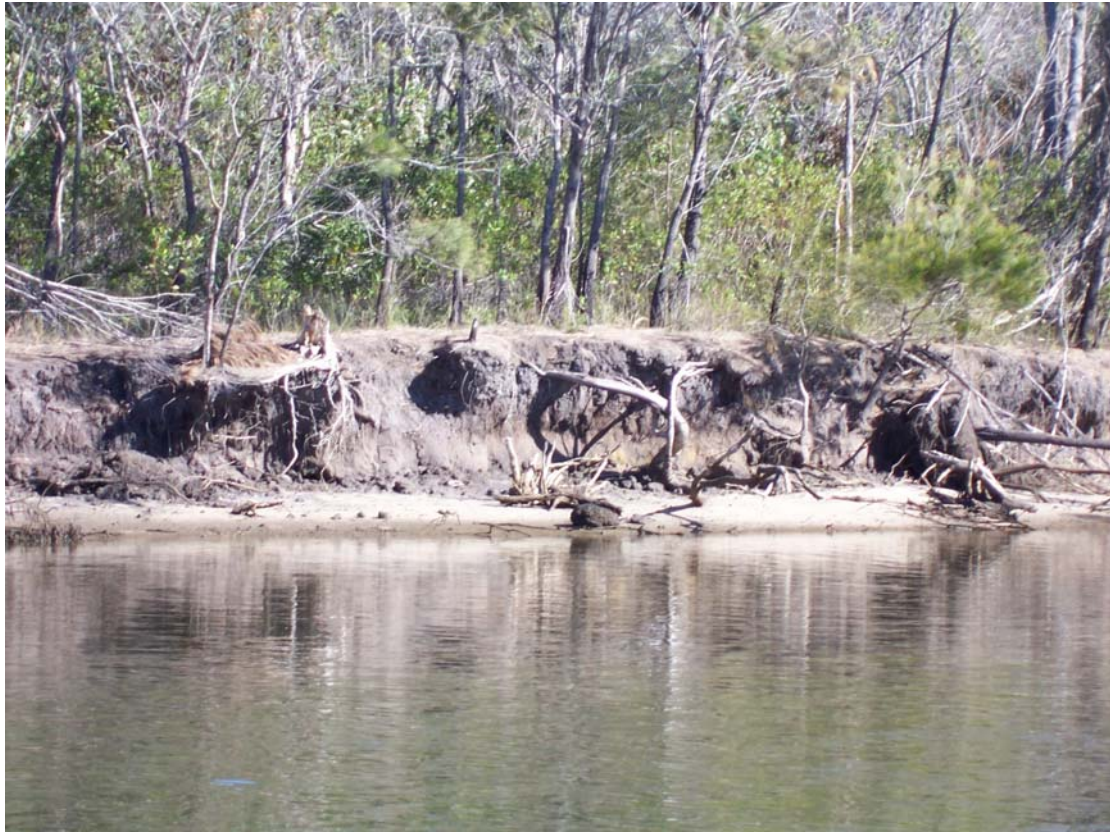
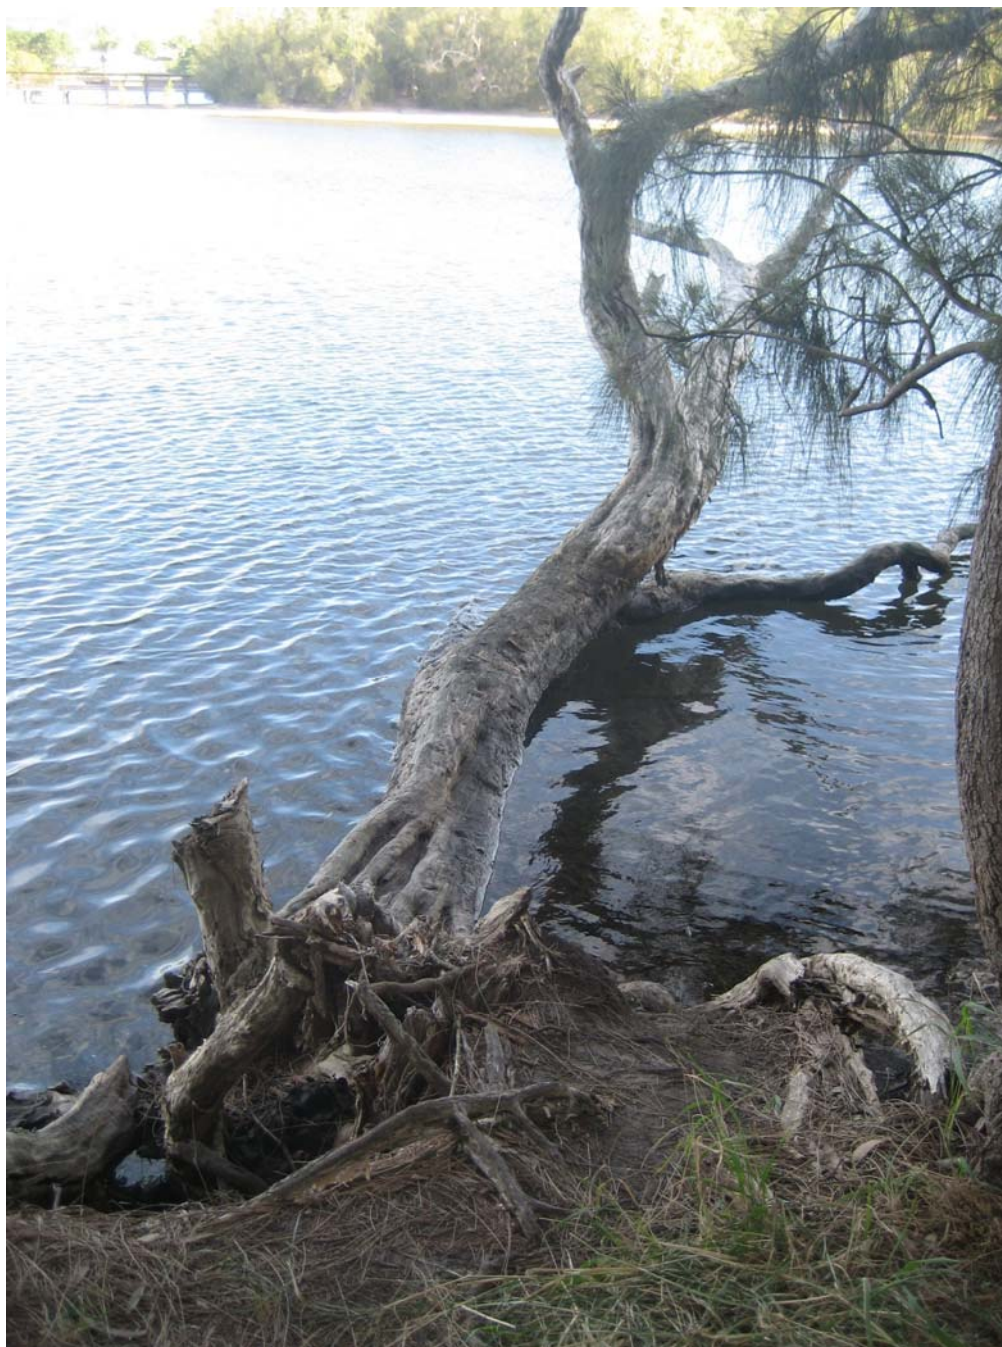
Erosion along the banks of Lake Currimundi and its adjoining creeks (Figures 8 and 9) is a serious problem and has been of major community concern (see Volume 2 - Appendix 6). The banks are a mixture of sand, silt, coffee rock and sandstone which are easily eroded by the action of tide and wave wash. Consequently the roots of trees have become exposed causing them to fall into the water and large sections of bank are lost from the parks and bushland bordering the lake. Although the community has accepted that bank erosion is a natural process many have questioned whether the current rate of erosion is occurring at its natural rate or is being sped up by yearly midge control operations, boat wash, increased use of walkways and the removal of fallen trees (Figure 10).

Figure 8: Bank erosion along Lake Currimundi

Figure 9: Fallen tree within Lake Currimundi

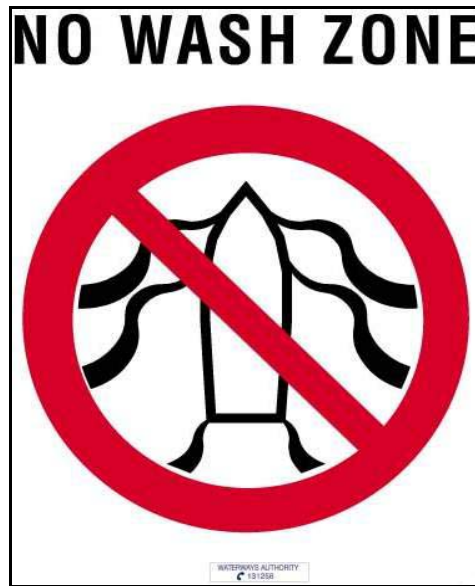
Figure 12: No wash speed signage

It is recommended that a newsletter be distributed to the Lake Currimundi community outlining the importance of obeying the speed limits within the creek. This will place some of the responsibility of the management of erosion back on to the community. The aim of the newsletter is to highlight the fragile nature of the environment in Lake Currimundi, discuss and explain the new "no wash" signs that are to be located along

the creek and to explain the importance of obeying these new signs when traversing the creek.

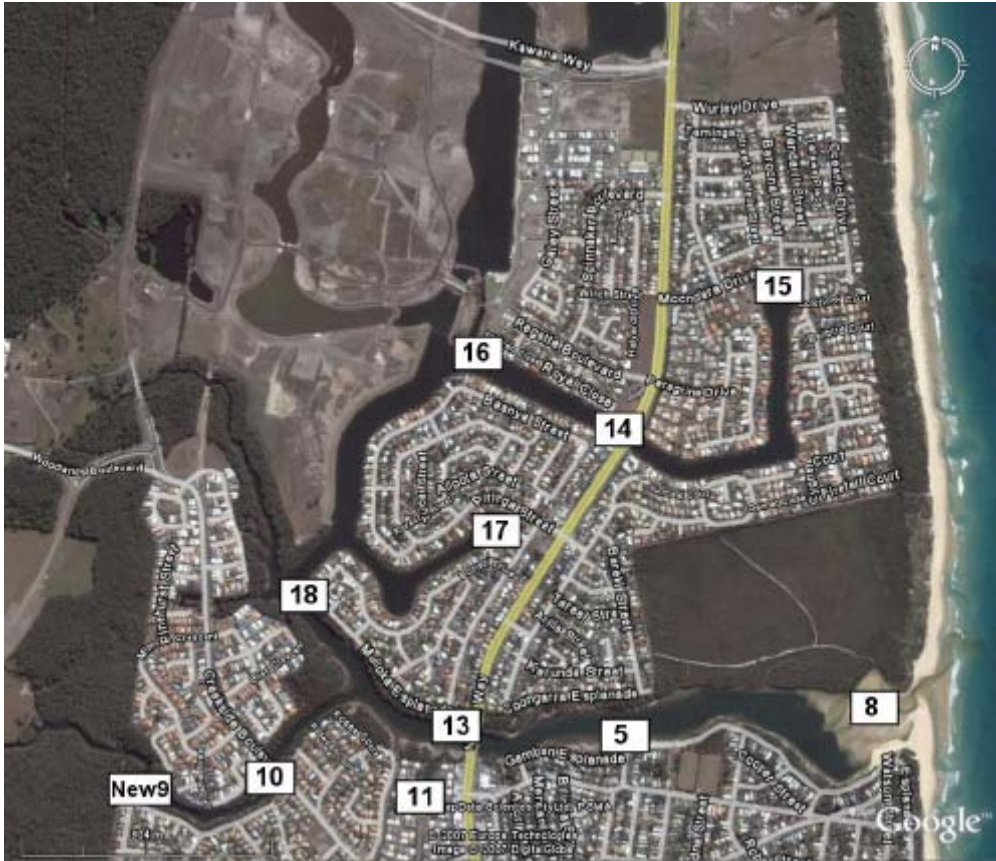
Figure 15: Locations of Council monitoring sites

The data were collected on an approximate monthly basis from early 2001 to mid 2007 at several monitoring locations, which are presented in Figure 15 and Table 2. Sampling was not standardized with respect to tides. Thus, varying strength of tidal flushing and/or dilution has the potential to confound the interpretation of small-scale spatial and temporal patterns in water quality.

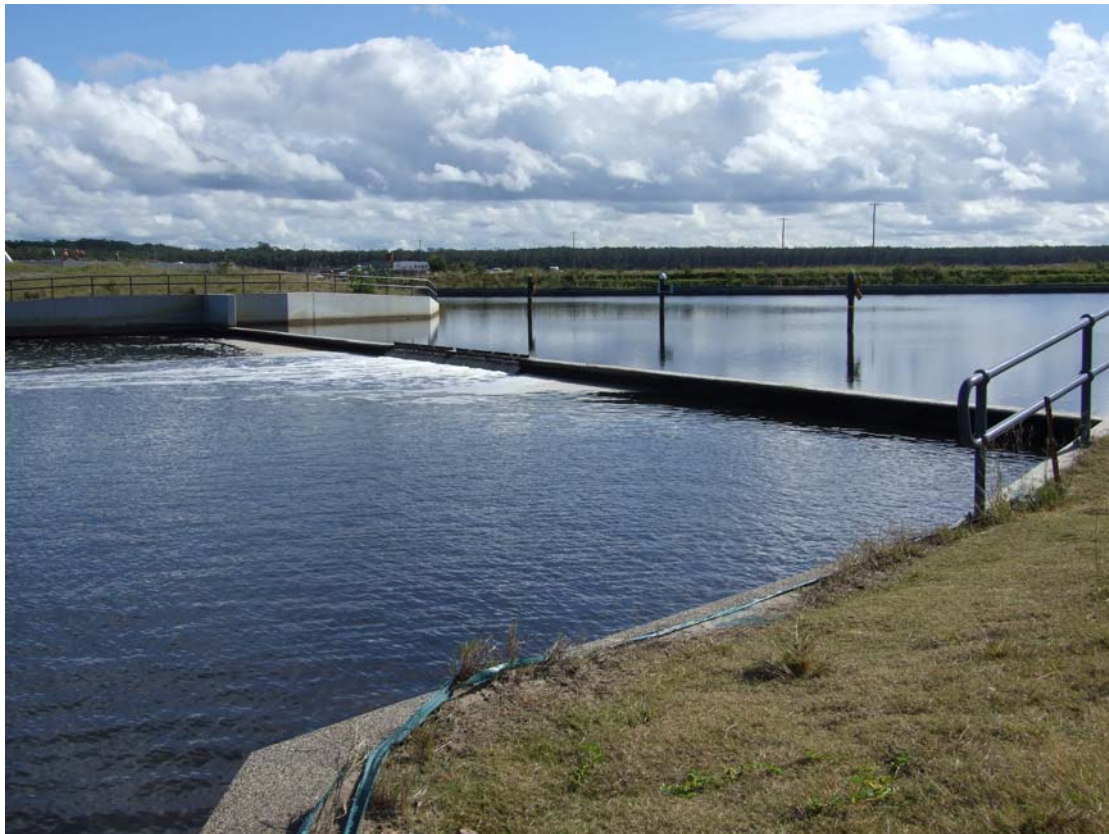
Figure 16: Weir between Lake Kawana (distant) and Lake Currimundi System (foreground)

As mentioned in the introduction, concerns have been raised that the connection of Lake Kawana to the Lake Currimundi system (Figure 16), combined with the natural closing of the Lake Currimundi mouth to the ocean, can have a detrimental impact on water quality indicators in the Lake Currimundi system.

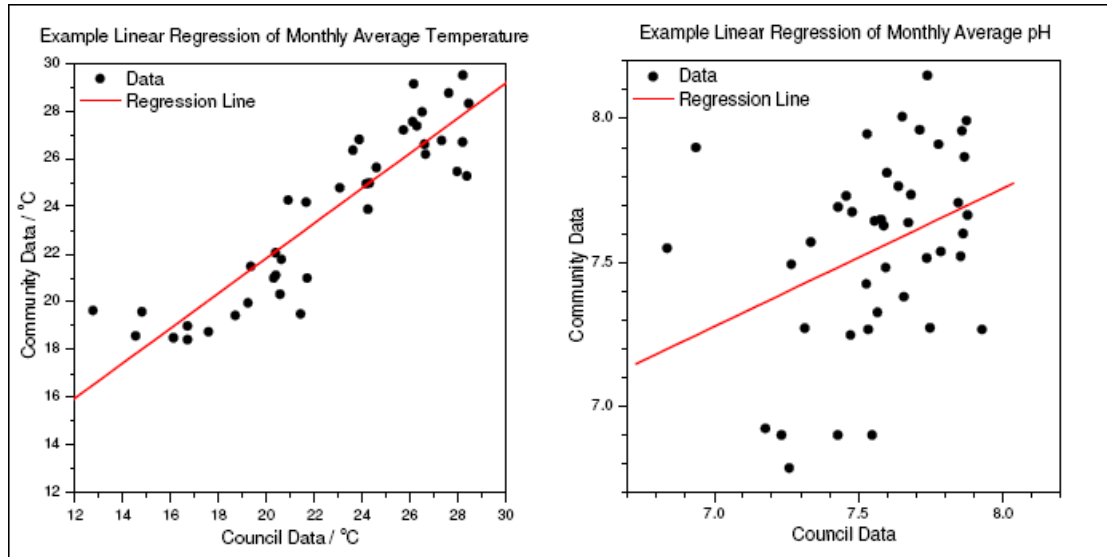
Figure 19: Example Scatterplots and Regression lines of Community Data vs Council Data

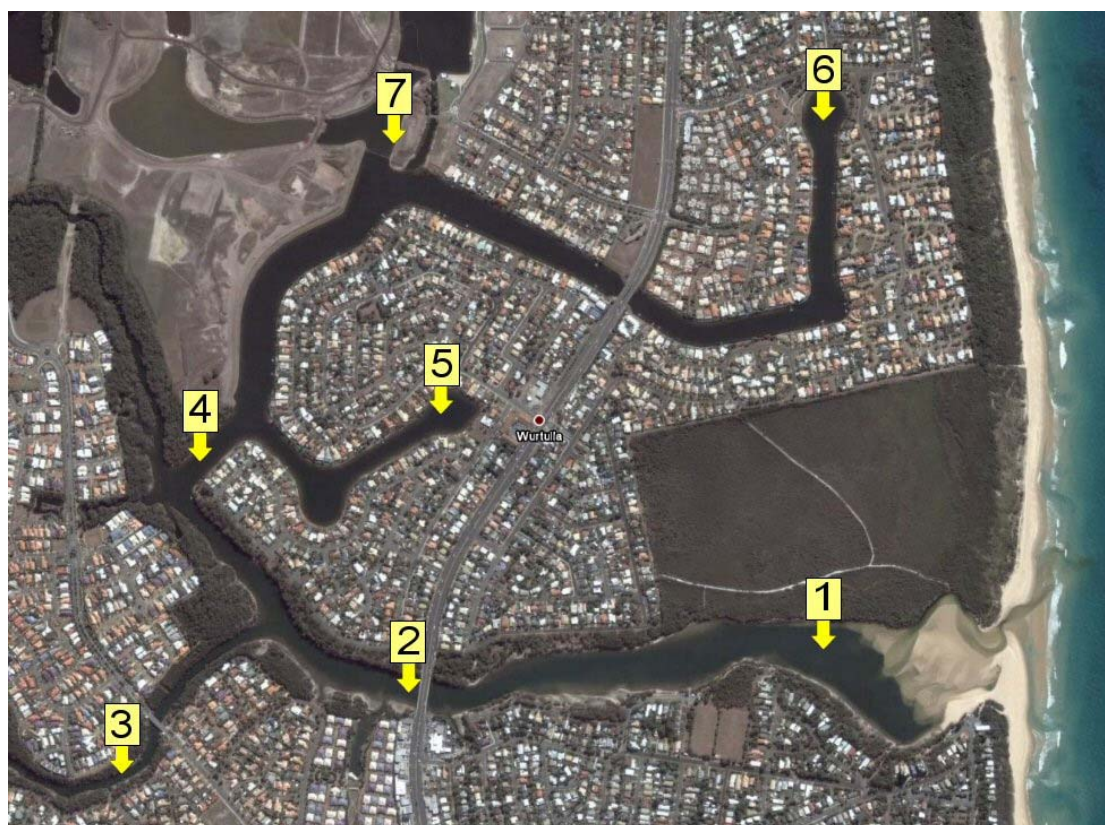
Figure 21: Locations of sampling sites (image courtesy of Google Earth™).

Between the 3rd June 2008 and 28th June 2008, twelve trips were made using a small boat to gain access to the sampling sites numbered 1 to 7 as provided in Tables 9 and 10, and illustrated in Figure 21. Sampling site 7 (see Figure 21) was located in Lake Kawana so that the impact of water flow from Lake Kawana into the Currimundi system, with respect to water quality indicators, could be evaluated if necessary.

Site 1: middle of sandy lagoon area.

Site 7: Lake Kawana, approx 15m from Weir.

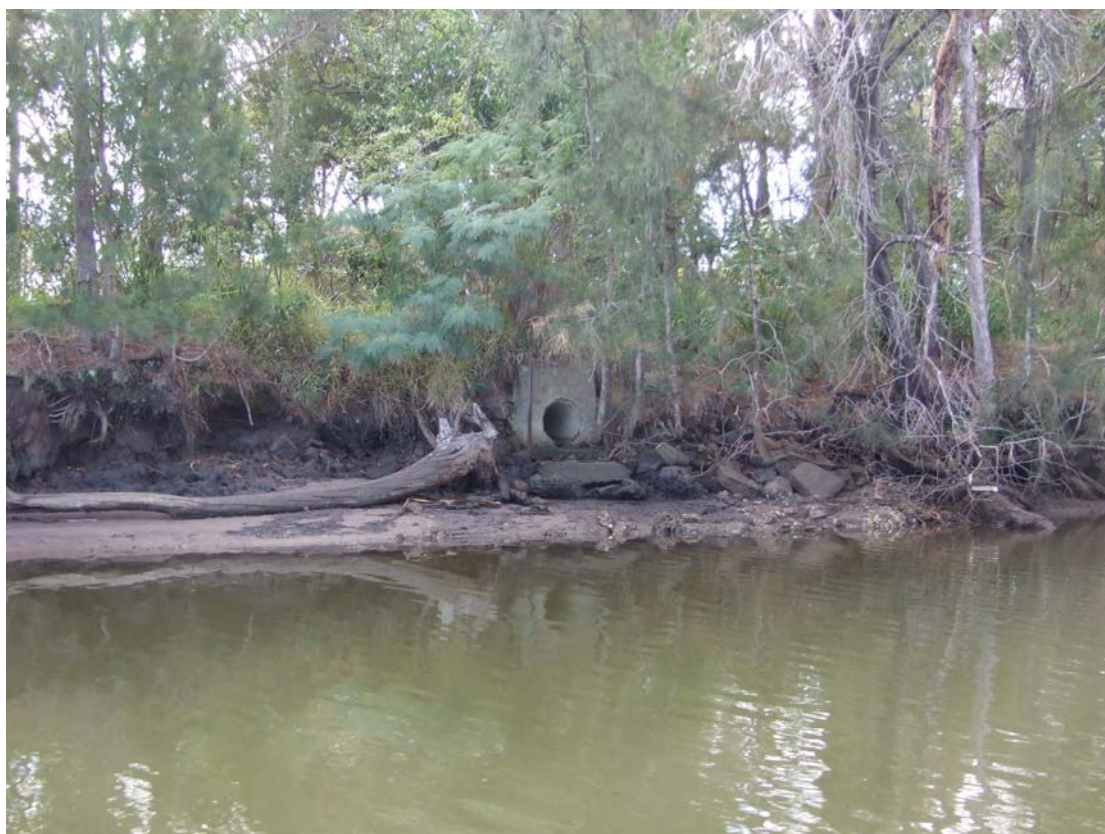
Figure 22: Stormwater drain near sampling site 3

Site 3: part way up a feeder creek. Water channel is narrow and deep, but is influenced by tides
(see Figure 22)

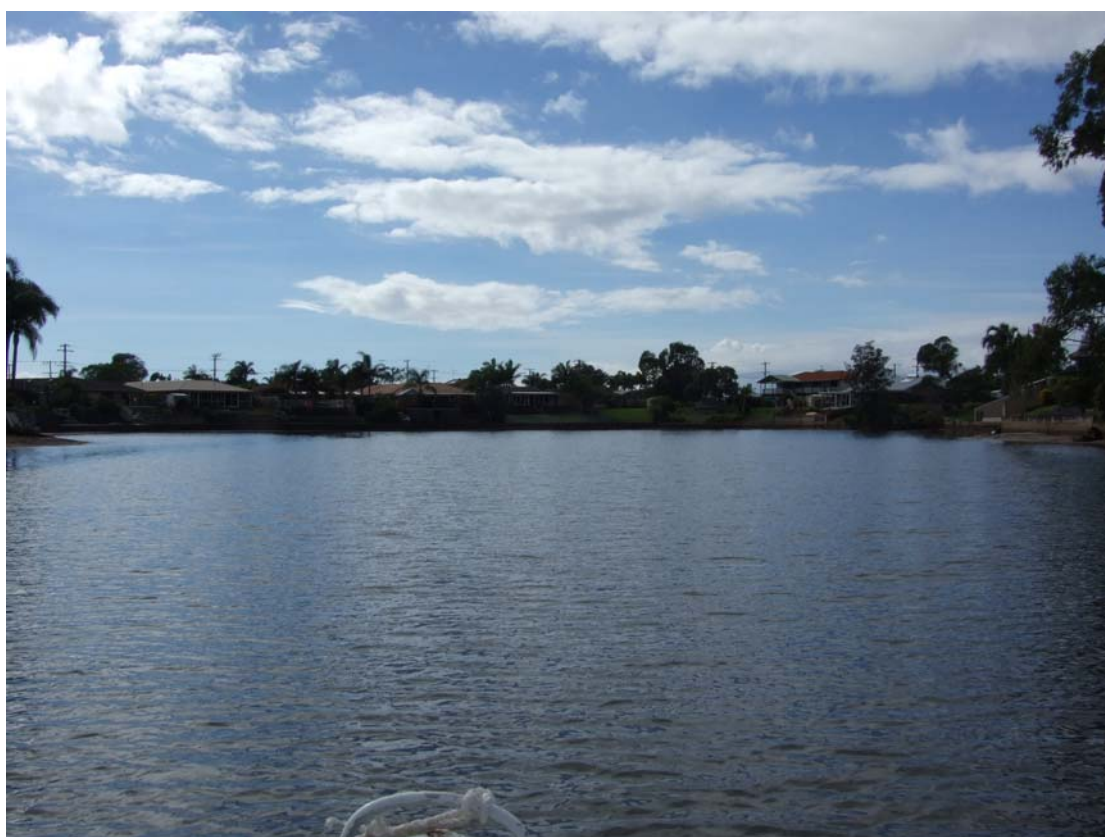
Figure 23: Approaching sample site 5 – Terminal point of Pangali Canal

Site 5: end of canal. Surrounded by concrete walls and houses (see Figure 23)

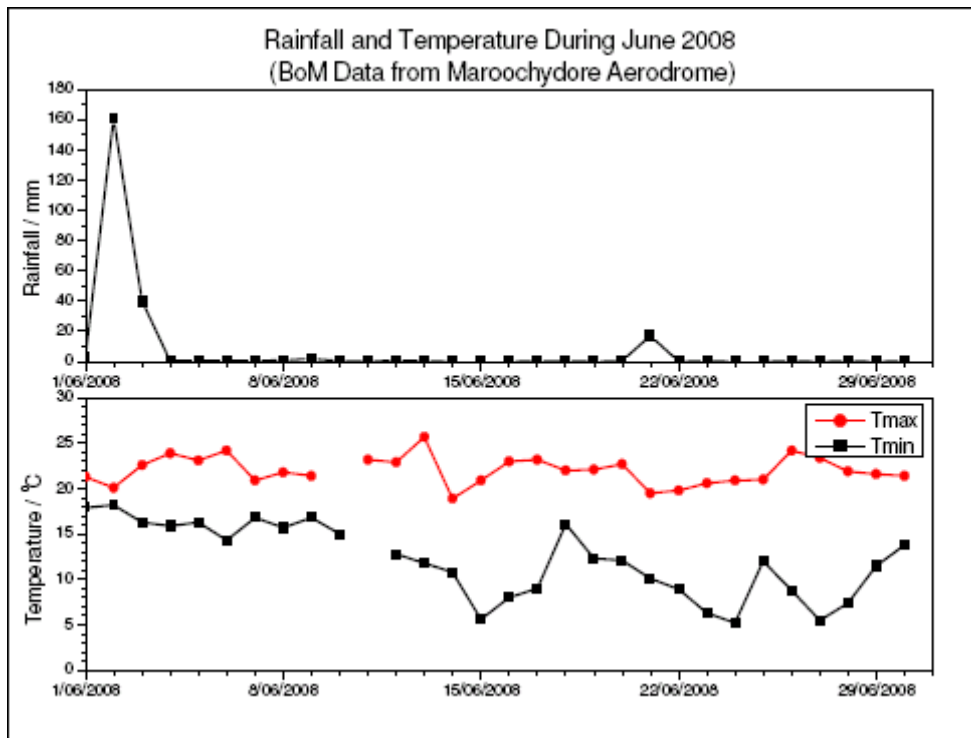
One day prior to the study commencing, a significant rain event occurred (Figure 24), which caused considerable freshwater flushing and dilution of the normally-saline system.

Figure 24: Daily Rainfall and Temperature During Study Period (BoM Maroochydore Data)

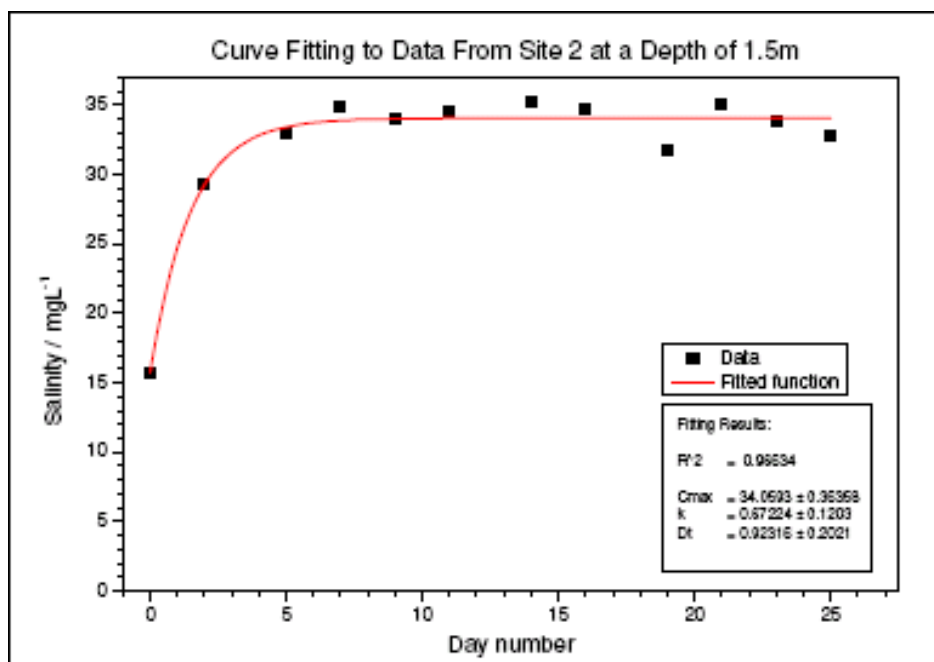
An example of a fitting run is provided in Figure 25 and the results from all fits are provided in Table 13. Note that site 7 is located in Lake Kawana and is unconnected to Currimundi, so has been excluded from this analysis.

Figure 25: Example of a fitted curve to time-series salinity data.

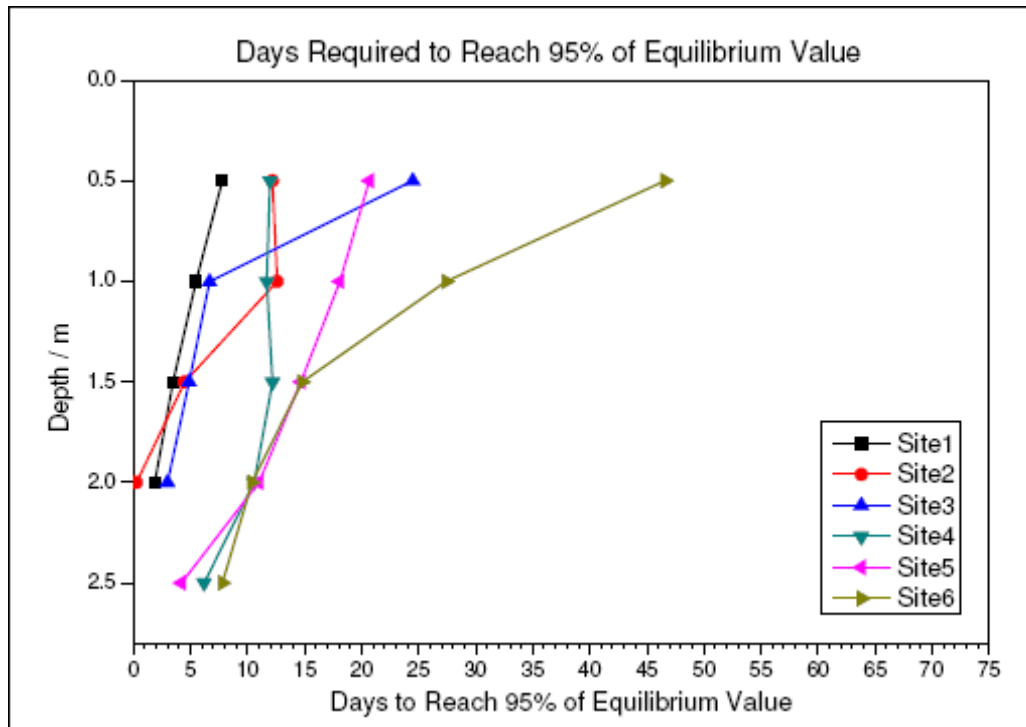
Figure 26: Time required to reach 95% of equilibrium values

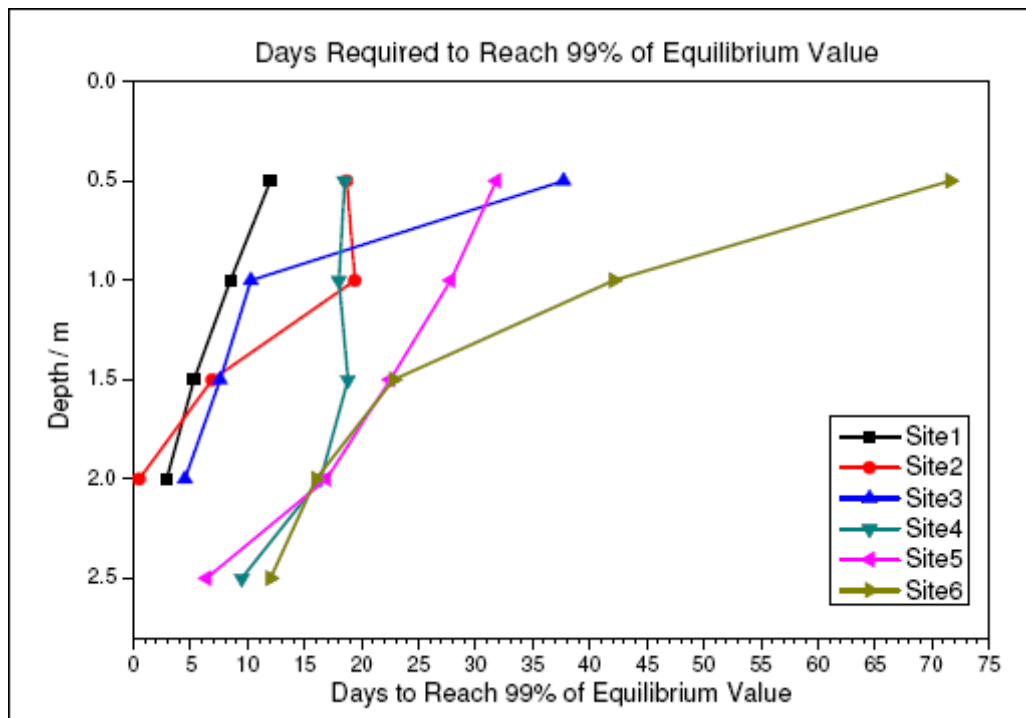
Figure 27: Time required to reach 99% of equilibrium values

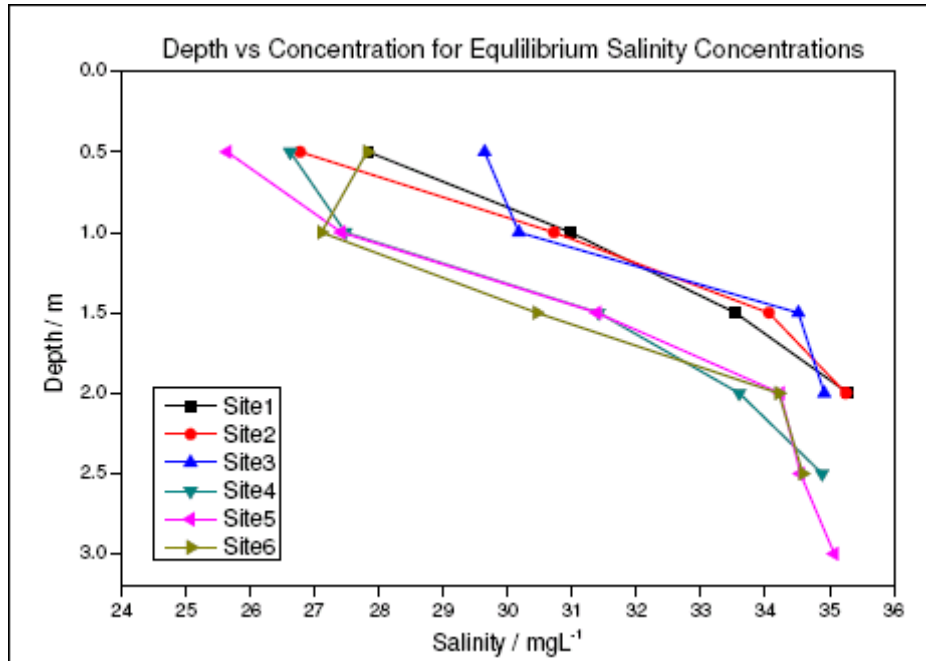
sites 4, 5 and 6 only show ocean-level salinity in the deepest layers. This again is evidence that the surface layers in the canals are more susceptible to freshwater inputs than those located closer to the mouth of the system.

Figure 28: Maximum (equilibrium) salinity at monitoring sites as a function of depth.
