Maroochy Beach Nourishment Feasibility Report

March 2012

Prepared For: Sunshine Coast Regional Council

Prepared By: BMT WBM Pty Ltd (Member of the BMT group of companies)

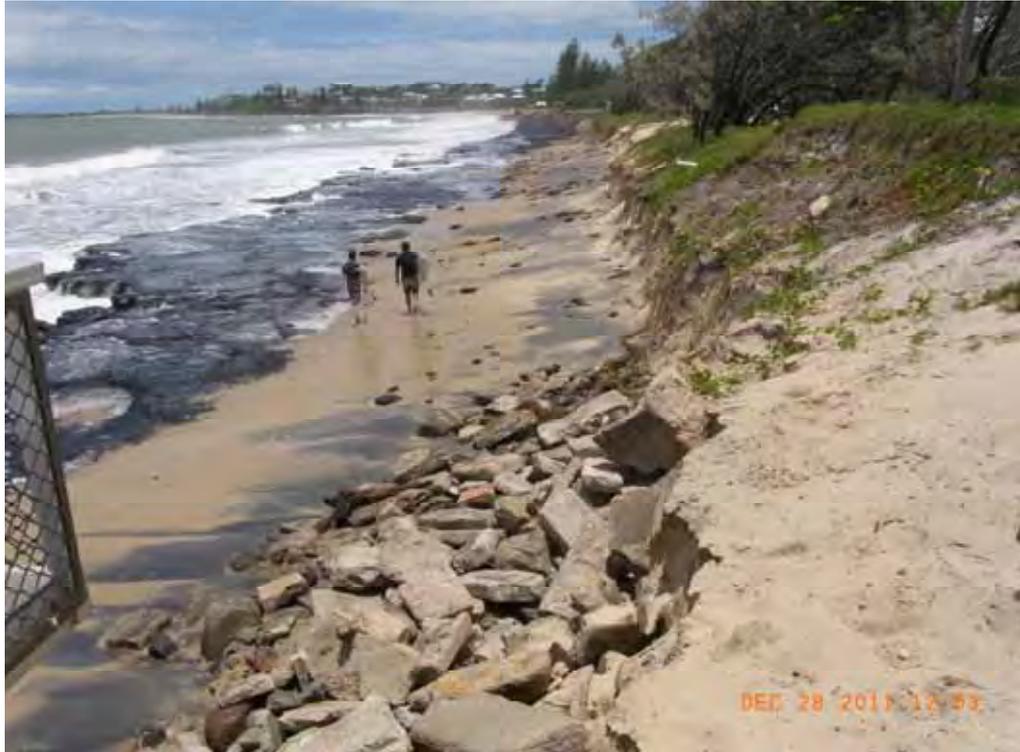
**Figure 1-2 Exposed Beach Fill and Coffee Rock Looking South toward Alex Heads Surf Club
(Photo Courtesy of SCRC)**

during the 2009, 2010 and 2011 summer periods have caused the beach to lower and much of the dune buffer has eroded. The erosion has also damaged beach access structures and exposed imported dune fill material (shown in Figure 1-2 and Figure 1-3), significantly impacting the 'values' or 'desirable features' of the area (refer Section 1.2). The fill material is likely to provide some stability to the shoreline however is not considered a suitable long-term shoreline protection measure.

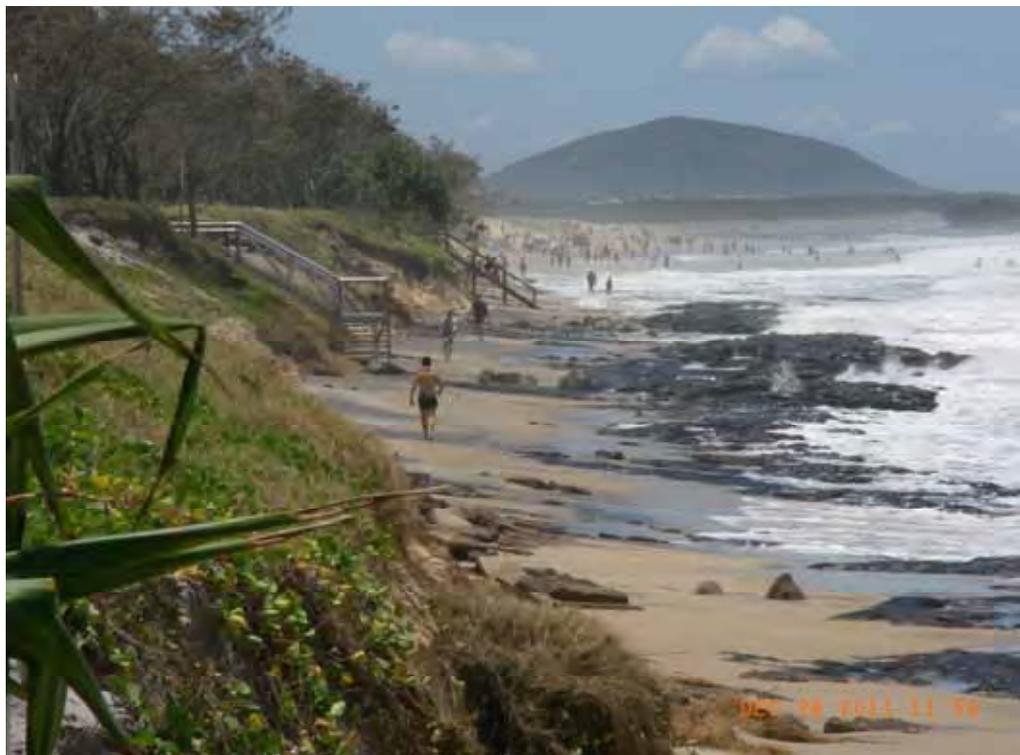
**Figure 1-3 Exposed Coffee Rock Looking North toward Maroochy Surf Club
(Photo Courtesy of SCRC)**

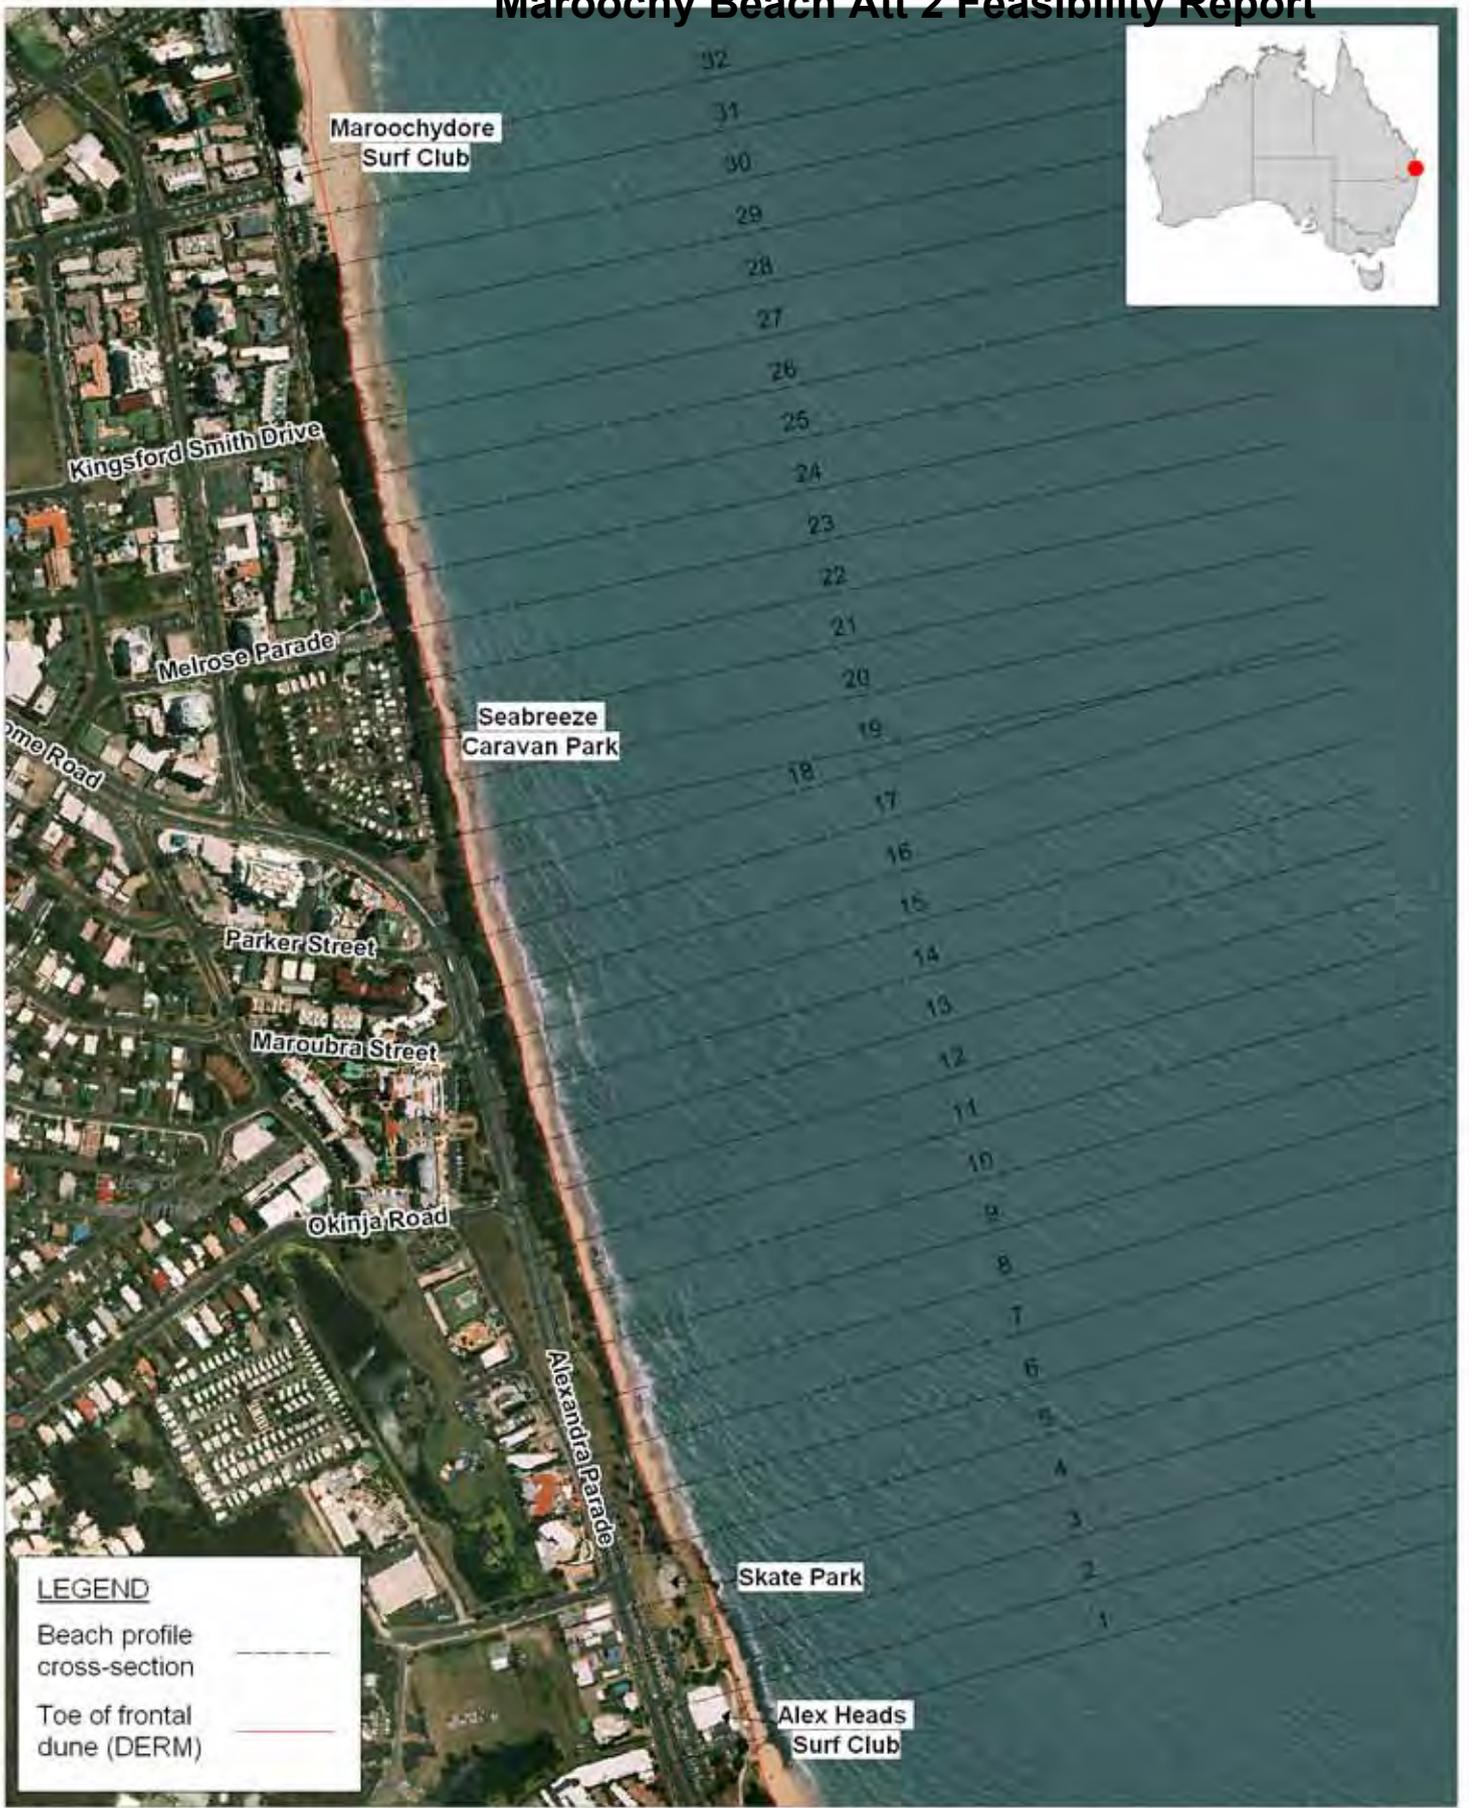
Figure:
2-1

Title:
**Beach Profile Cross-Section Locations
 Measured December 2010**

- 16 beach cross-sectional profile measurements obtained in December 2010 (odd numbered cross-sections indicated in Figure 2-1) and sediment characteristics;
- 50 year ARI wave conditions (obtained from BMT WBM 2011b);
- 100 year ARI storm surge conditions (obtained from Connell Wager, 2005); and
- Contribution of wave setup to the design water level (assumed to be 12.5% of the design wave height).

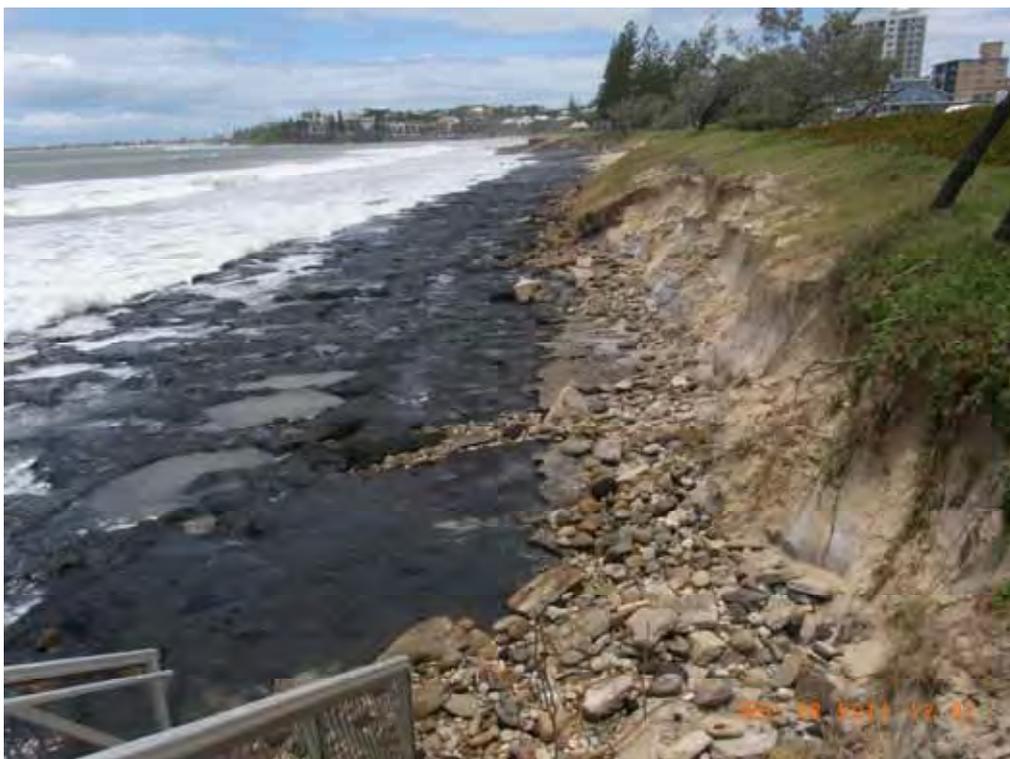
**Figure 2-4 Severe Erosion Observed between Alex Heads and Maroochyore Surf Clubs
(Photo Courtesy of SCRC)**

Beaches in a severely eroded condition might have little or no berm, a condition recently observed within the study area (refer Figure 2-4). A beach without a berm has low social value and a reduced capacity to dissipate wave energy, therefore providing little storm protection to adjacent assets. Enhancing and widening the beach berm within the study area, in order to improve the level of storm protection, is the primary objective of the proposed sand extraction and beach nourishment project.

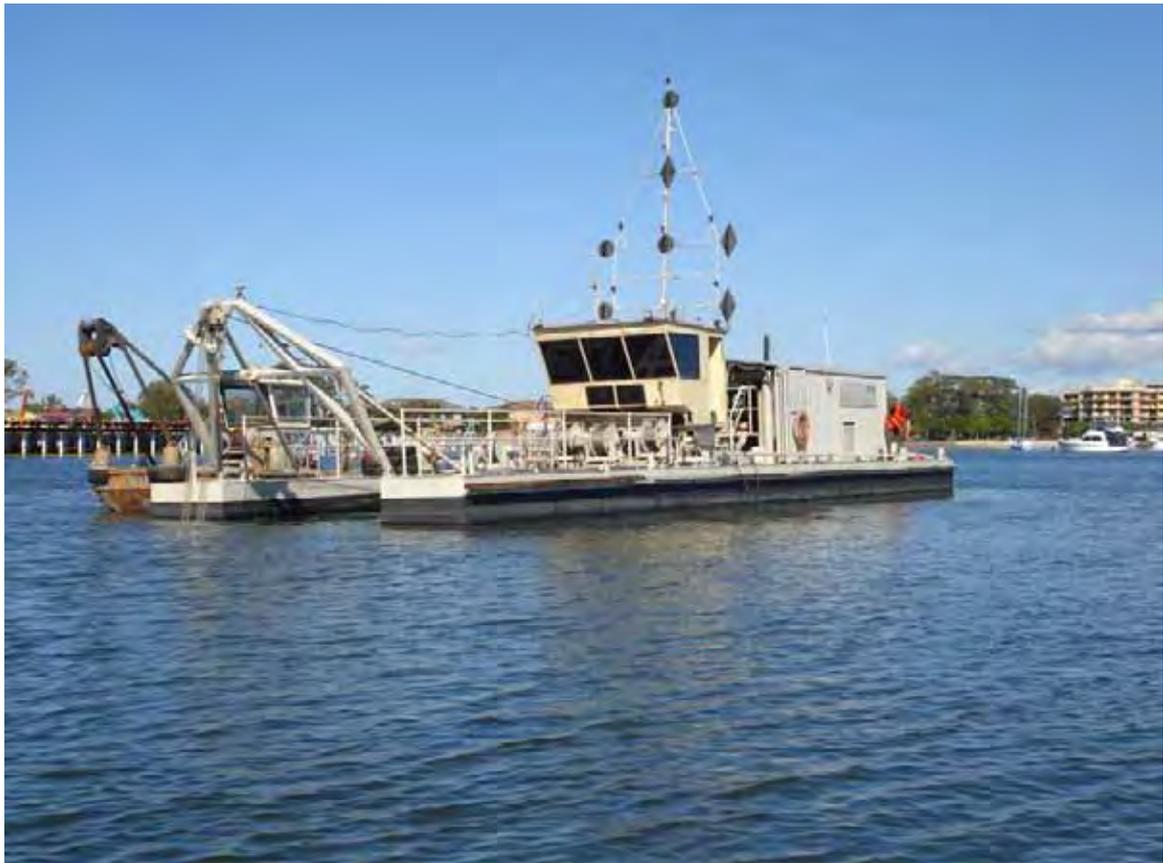
Figure 5-1 400mm Cutter Suction Dredge (Photo Courtesy of Hall Contracting Pty Ltd)

A CSD works most effectively in loose unconsolidated material which is pumped directly by pipeline to a disposal area. Such operations are an efficient means of delivering sand to a beach. The maximum distance of pumping depends on the dredge capacity. For the type of dredger that would have sufficient manoeuvrability to operate effectively in the lower Maroochy River a maximum pumping distance of 1.2km may apply. Delivery of sand beyond this distance would be achieved using booster pumps along the pipeline route. A CSD uses a combination of anchors and spuds to pull the dredge along so the footprint of the dredge is higher than for a TSHD. The submerged pipeline crossing from the dredge to the Cotton Tree shoreline may also hinder other vessel access during dredging. A pipeline would need to be permanently in place over the dredging period, as it cannot be easily dismantled and installed each day. A CSD may have a risk of pipeline breaking in heavy seas (although this is unlikely in the lower Maroochy River during the recommended dredge window). In general, a small CSD such as that shown in Figure 5-1 can only work in a swell of up to 0.6m.

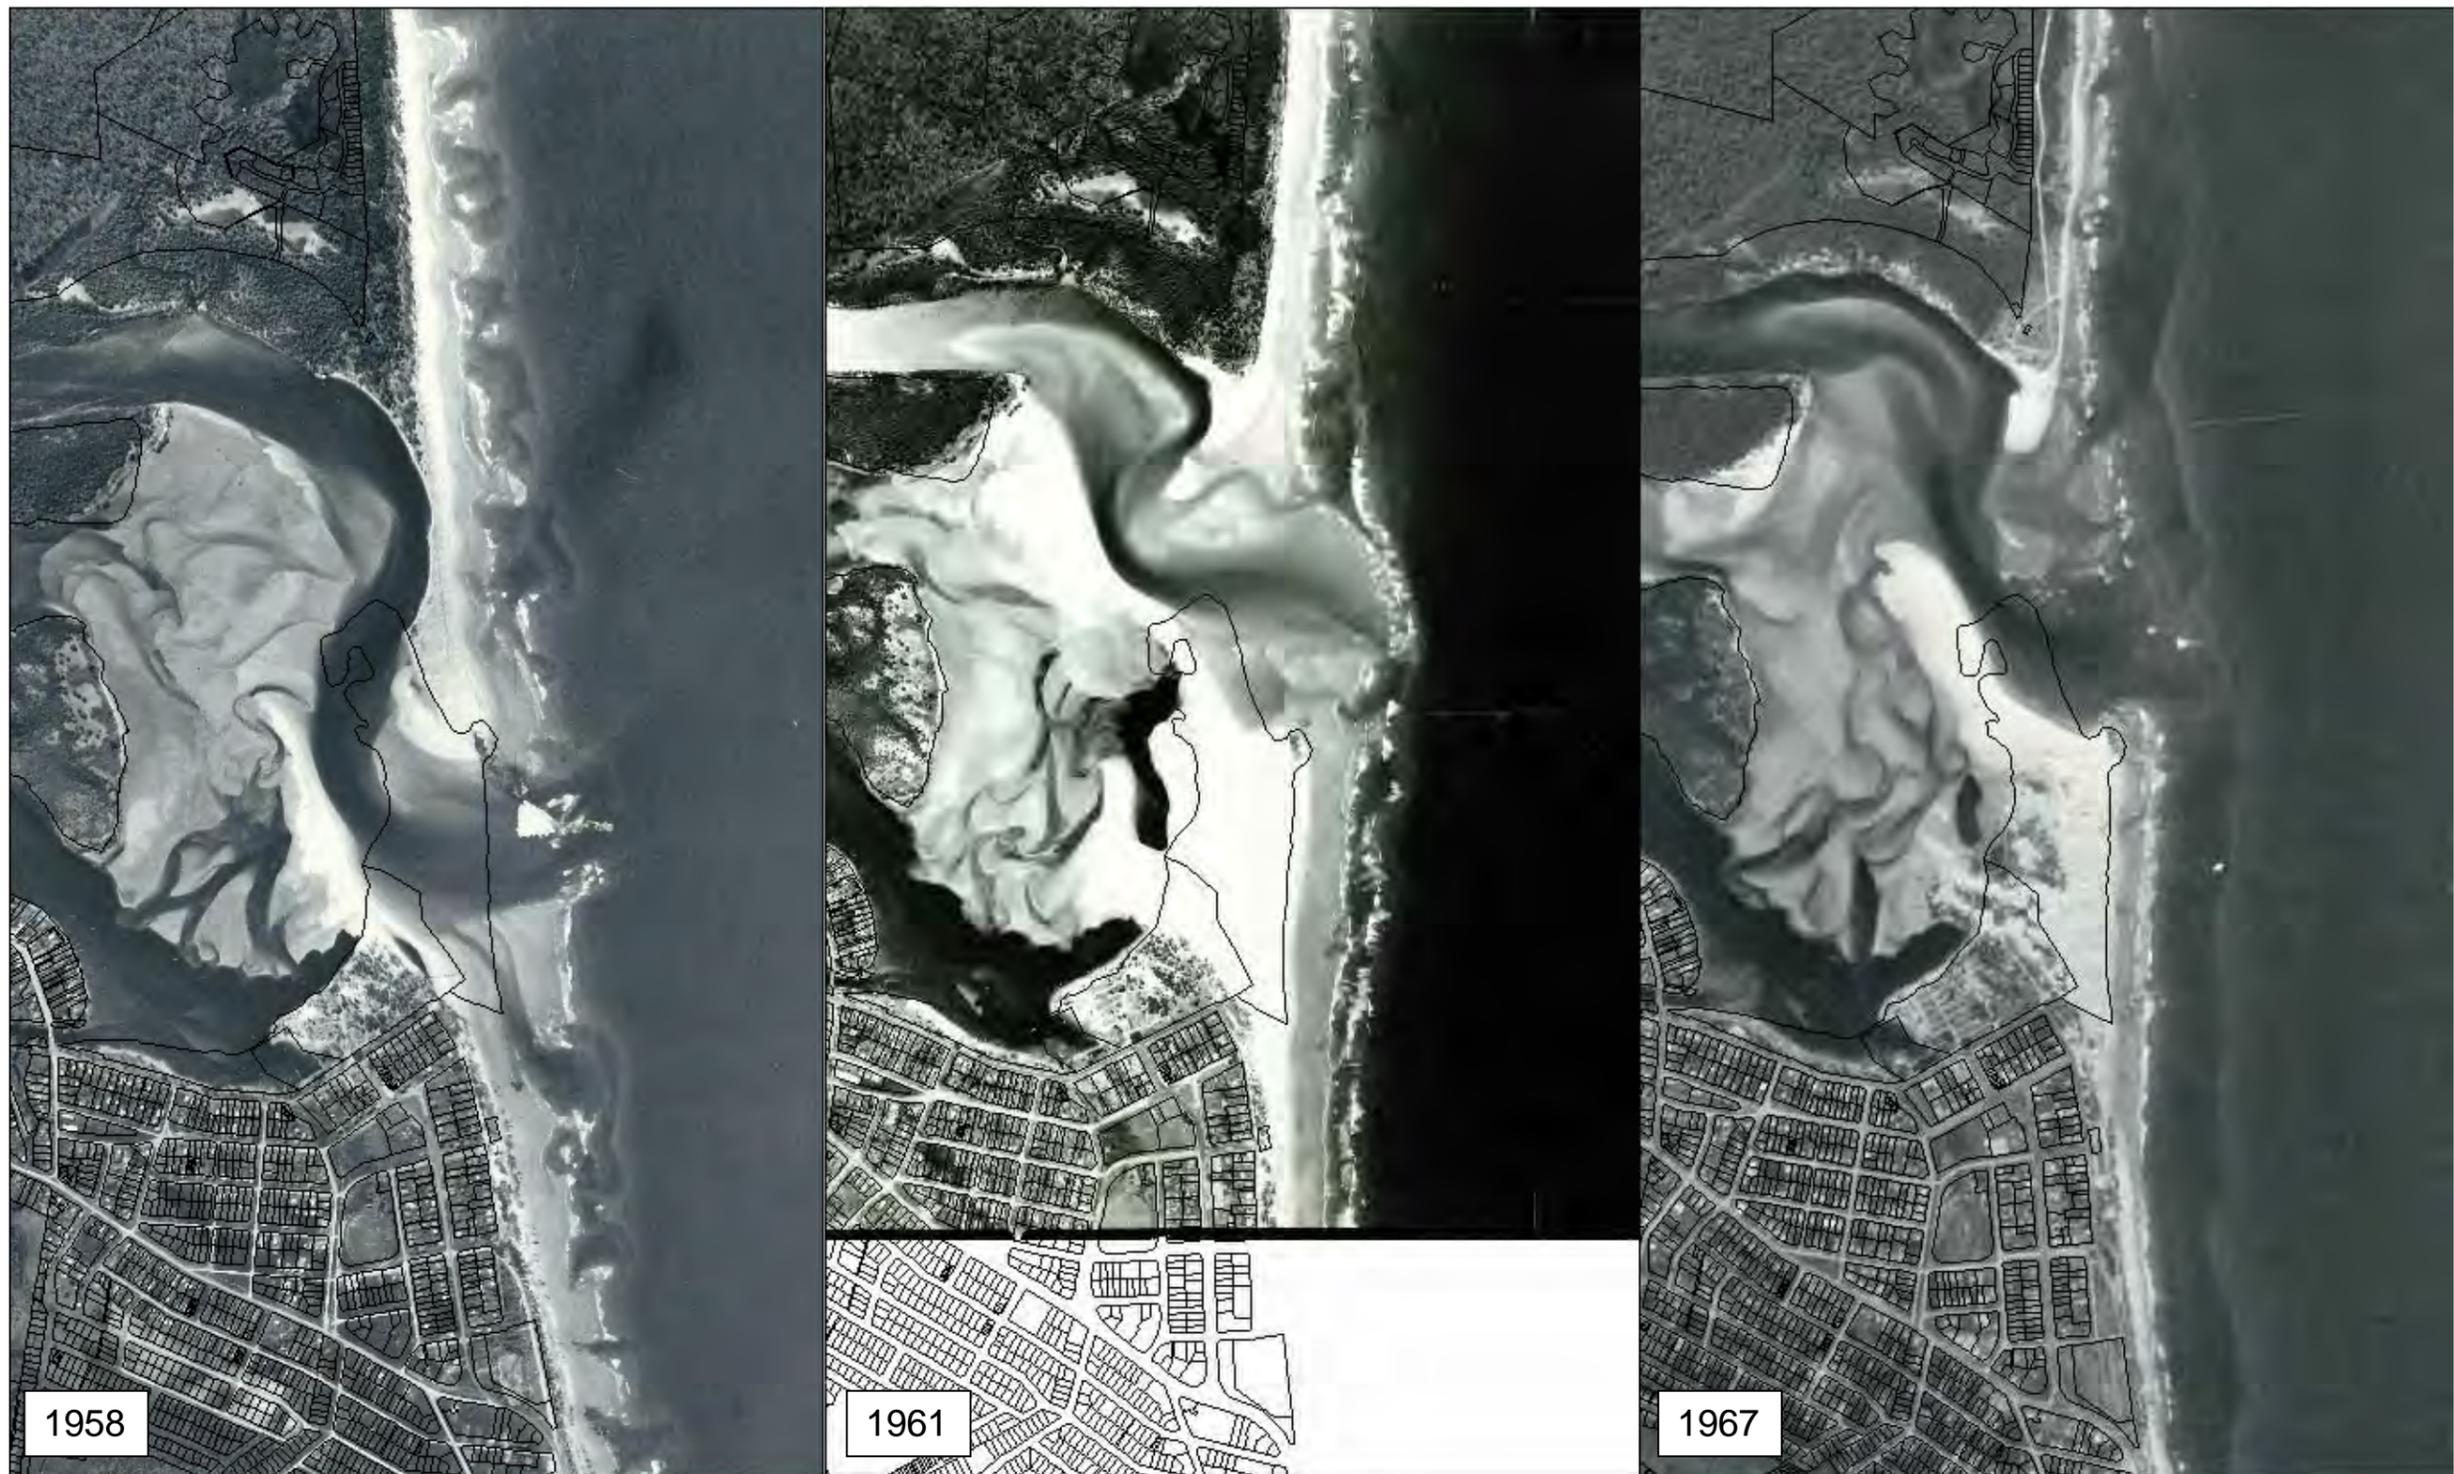
Figure D-1 Maroochy River Mouth Aerial Photography (1958 – 1967)

Currently the lower estuary, downstream of Channel and Goat Islands, contains a significant amount of sand that was eroded from the frontal dunes and beach that were once connected to Pincushion Island. In a similar cycle in the 1960-1970's, sand from the same location closed off the southern entrance of the Maroochy River forcing all flow through the northern channel and eroded the inside of the northern spit to such an extent that it caused the channel to eventually breakthrough just south of Twin Waters. Since this time the mouth has predominantly migrated in a southerly direction and is presently located between Cotton Tree and Pincushion Island. A collection of historical photos provided by DERM that show the entrance and lower estuary dynamics between 1958 and 2005 are included in Appendix D.

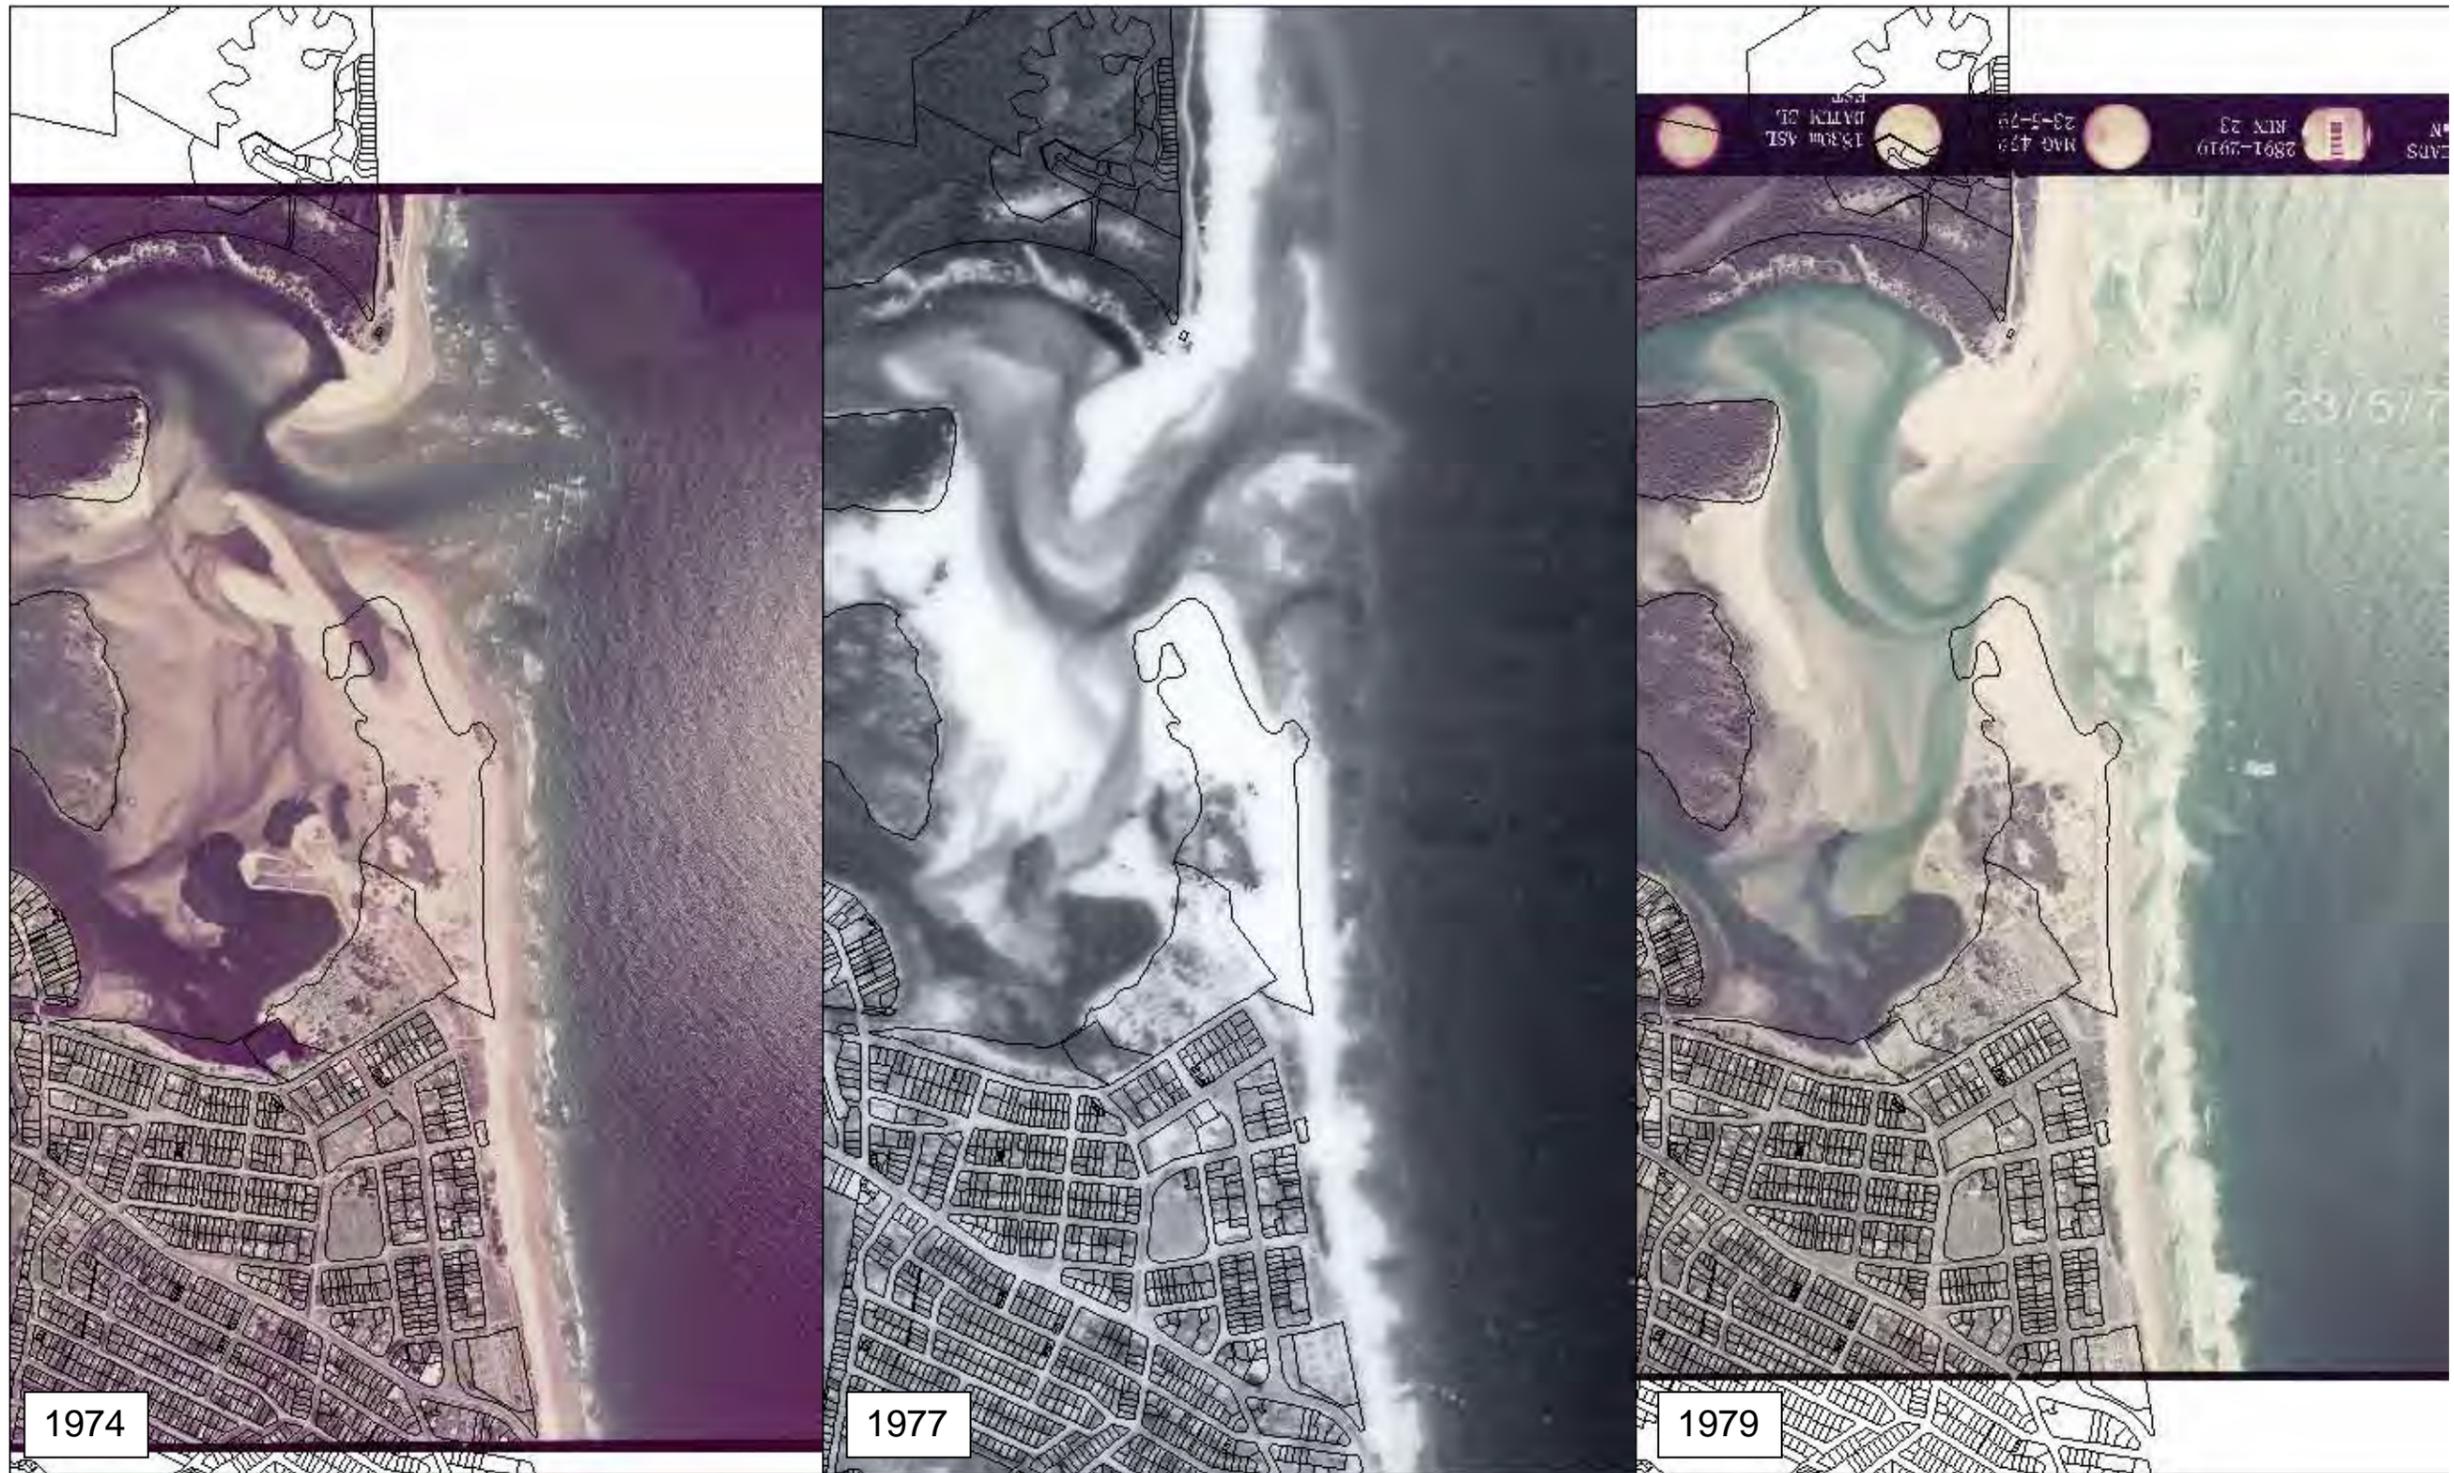
Figure D-2 Maroochy River Mouth Aerial Photography (1974 – 1979)

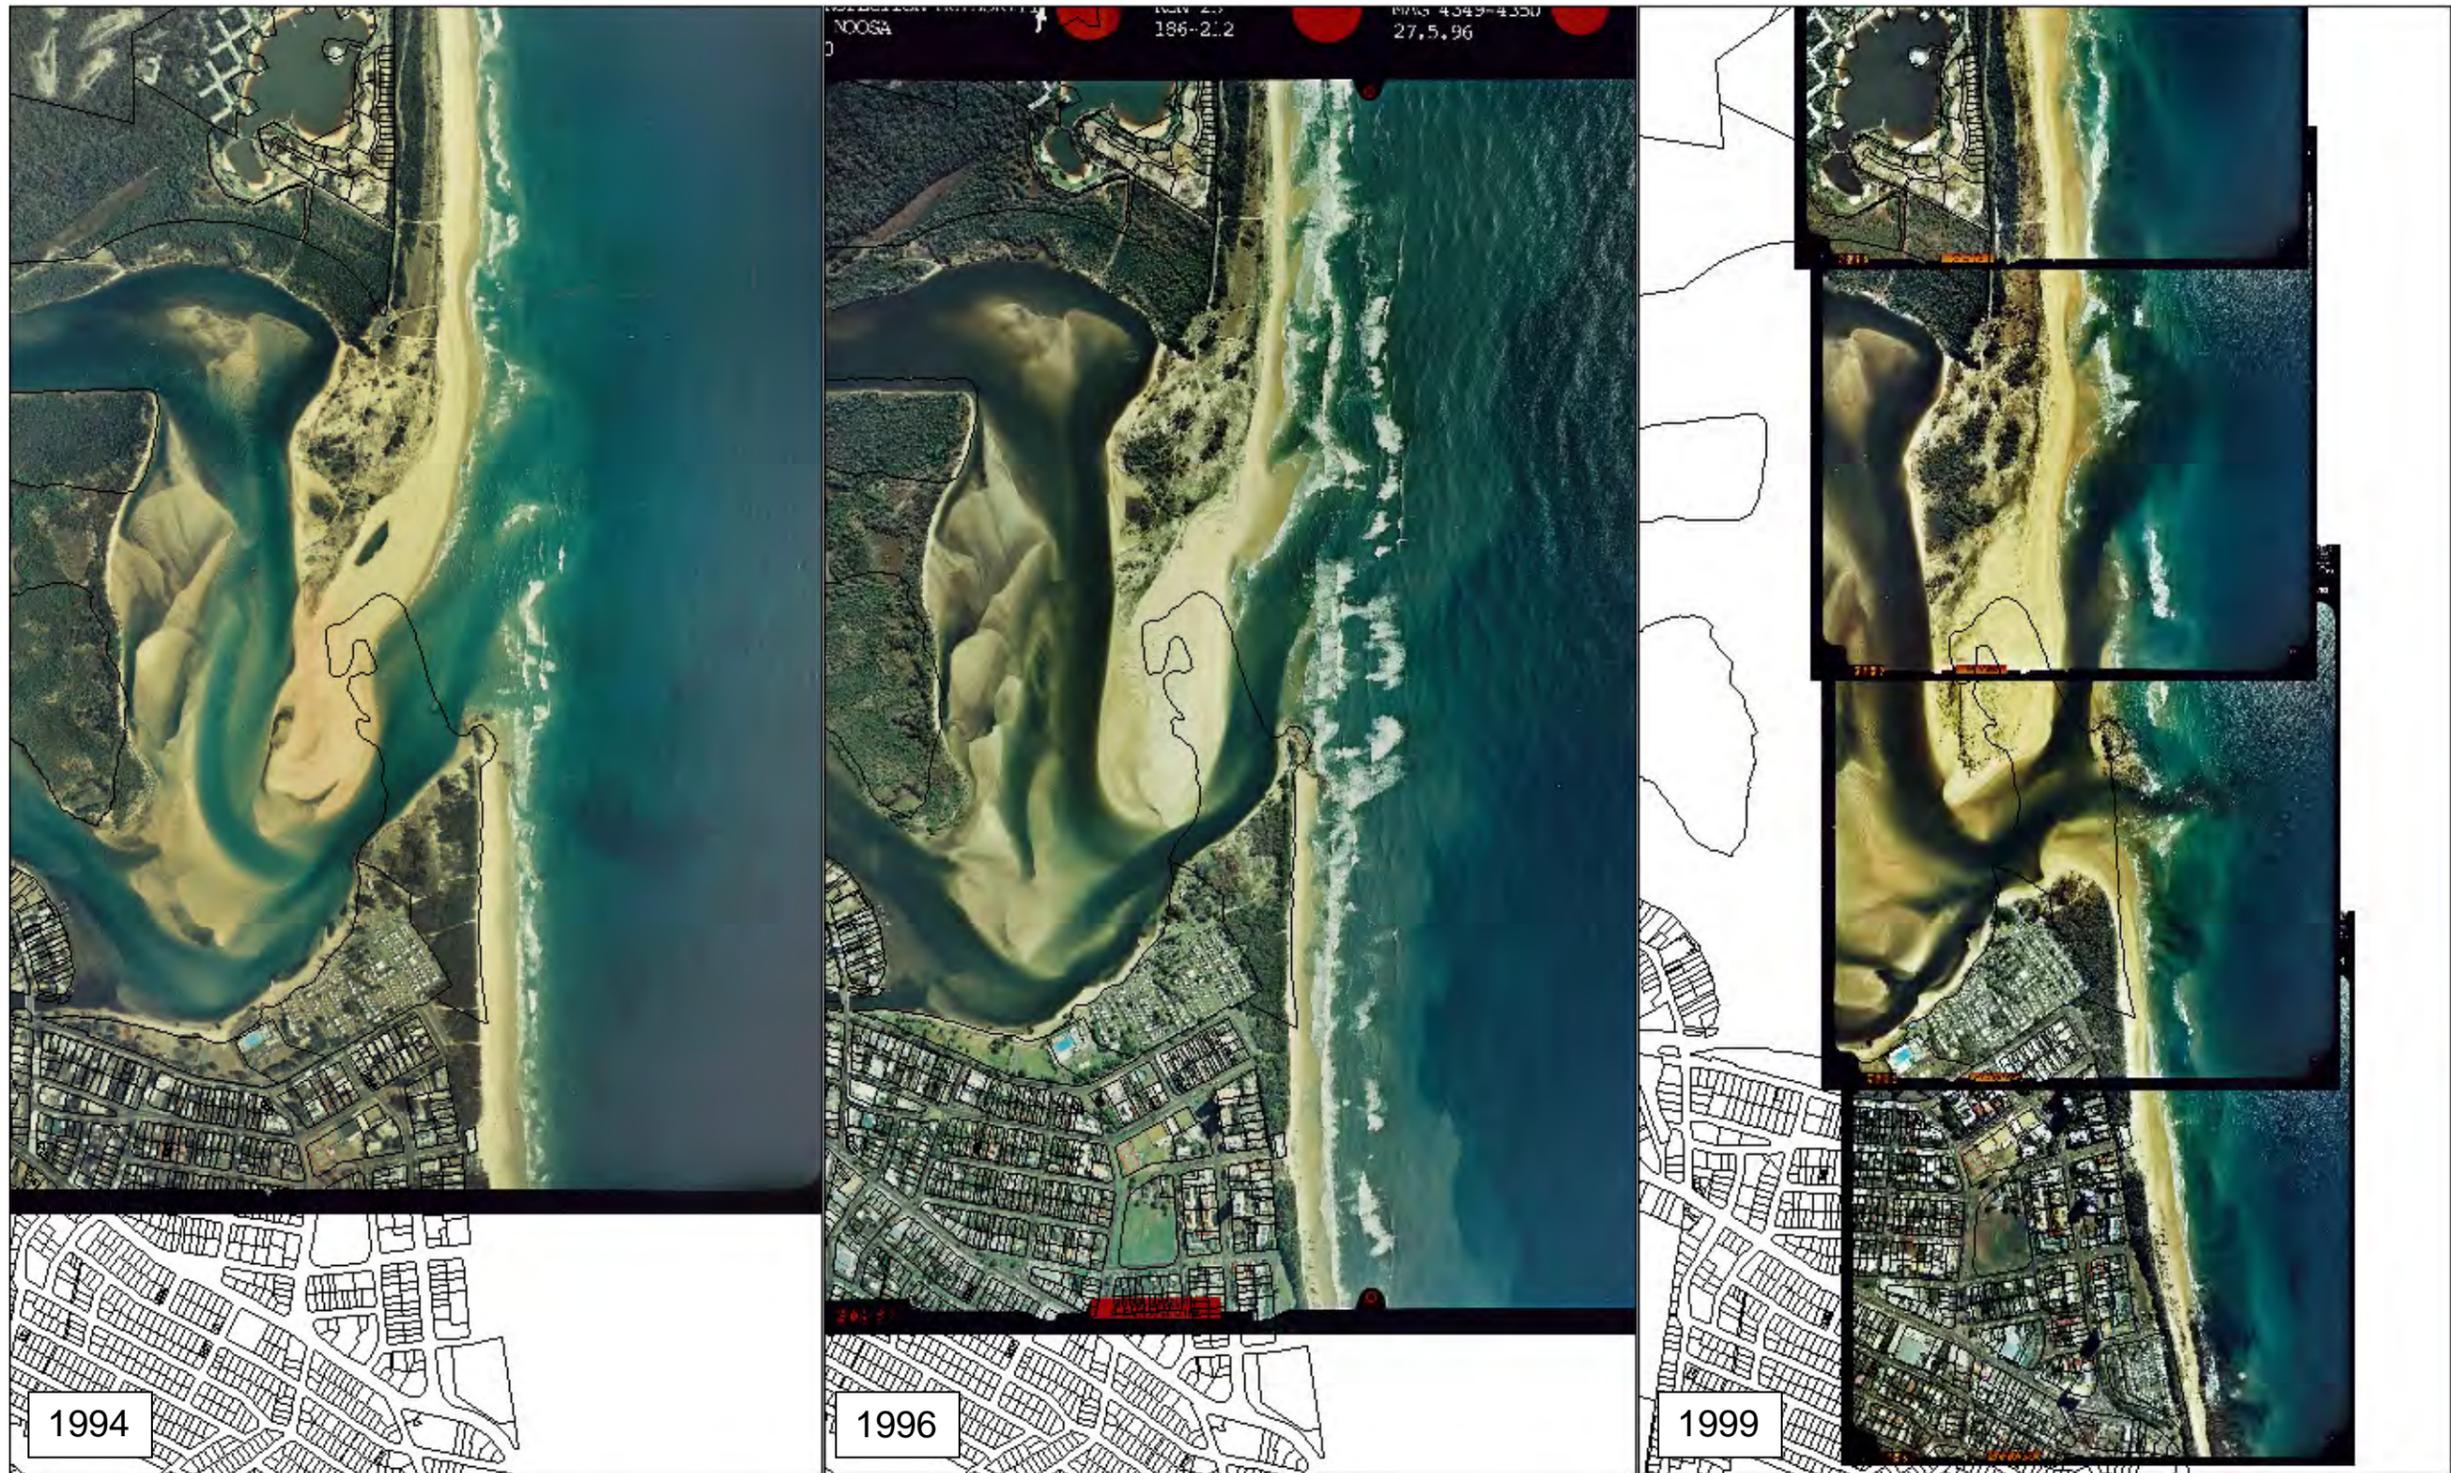
Figure D- 5 Maroochy River Mouth Aerial Photography (1994 – 1999)
