TEST EXCAVATION OF *S.S. DICKY*

17th APRIL 2015

S.S. Dicky

Cosmos Archaeology Job Number J14/18

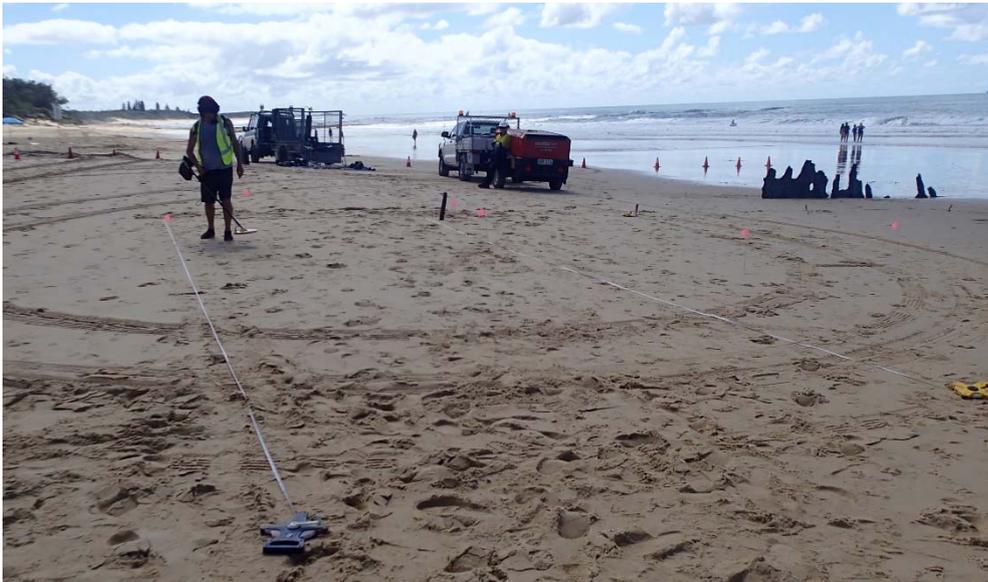
Figure 2. Conducting a metal detector transect, facing N. Note that this detector is re-inspecting the transect and that the transects were first surveyed in the opposite direction. (Cosmos Archaeology 17th April, 2015).

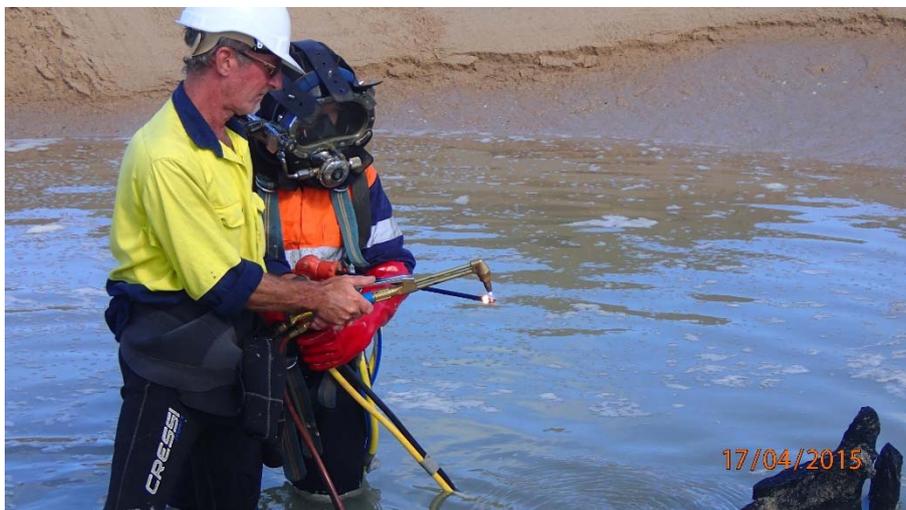
Cutting with the thermal lance was undertaken by experienced commercial divers contracted by SCC (Figure 9 and Figure 10). It was initially attempted on FR001 on the section of hull plating, however, it was quickly observed that the cutting procedure would take a considerable amount of time. After approximately 10 minutes only about 50 mm of the length of the plating had been cut through. It was decided that this process would take too long to cut the entire plate which was approximately 250 mm wide. Instead, this cut was abandoned and the cutting process was instead begun on the intact angle frame. The same problems were encountered and it took at least 20 minutes to successfully cut through and remove the top of this frame. The removed section is artefact FR001-001.

Figure 9. Lighting the thermal lance in preparation for cutting, facing S. (Cosmos Archaeology. 17th April, 2015).

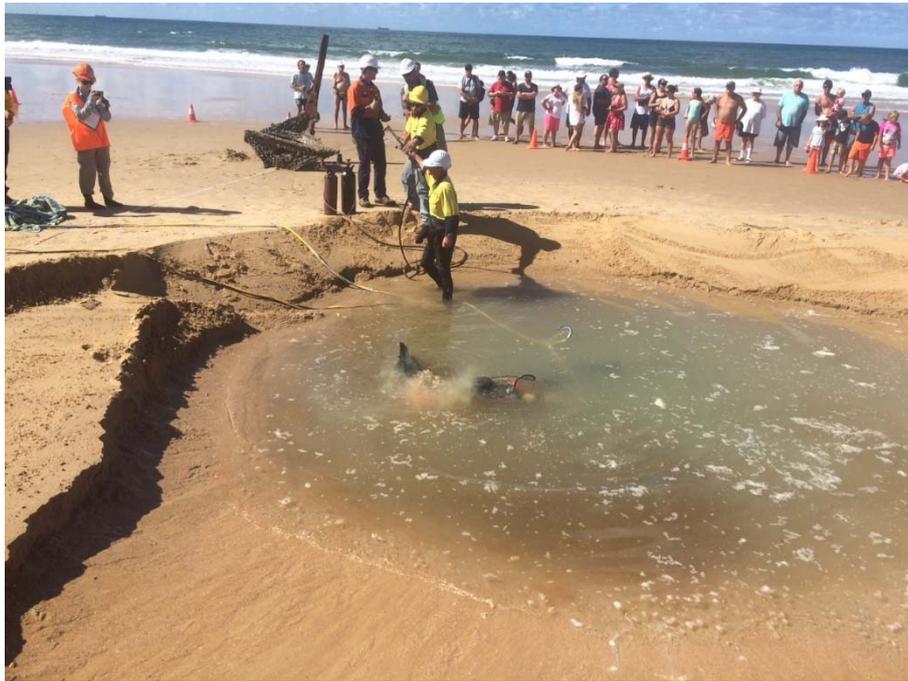
Figure 10. Diver undertaking the cutting, facing E. (Cosmos Archaeology, 17th April, 2015).

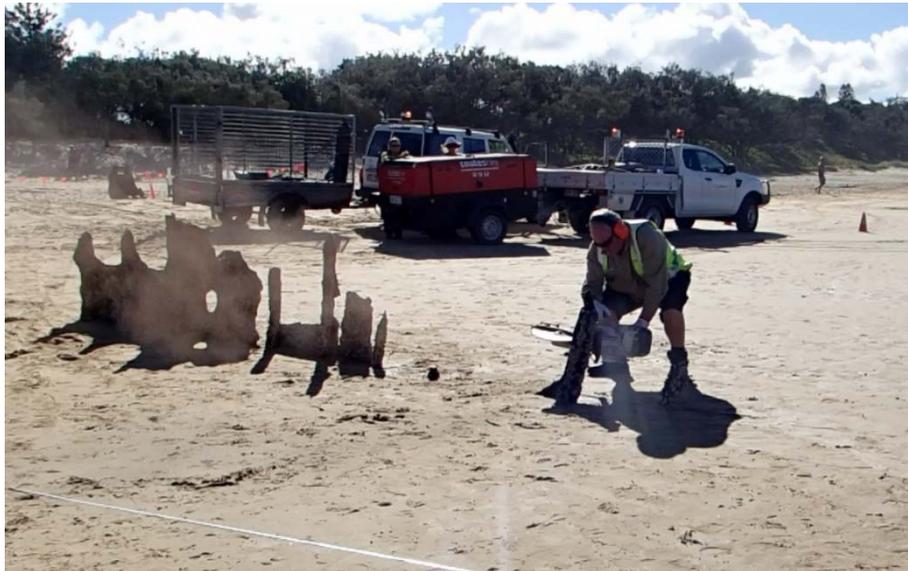
It was intended to test above water cutting equipment on the port side but, because no suitable wreck element was exposed in Test Pit Two, an exposed frame on the starboard side was used for testing instead. A hand held circular saw with a diamond blade was used and this was tested on frame FR002 on the starboard side (Figure 14). The initial cut with the circular saw took approximately two minutes and made significant progress through the western edge of the frame. The internal remains of the frame could be seen through this cut and it was obvious that a significant portion of metal remained, with a large amount of rust and concretion encasing it (Figure 15).

Figure 14. Cutting FR002 on the starboard side with hand held circular saw, facing NW. (Cosmos Archaeology, 17th April, 2015).

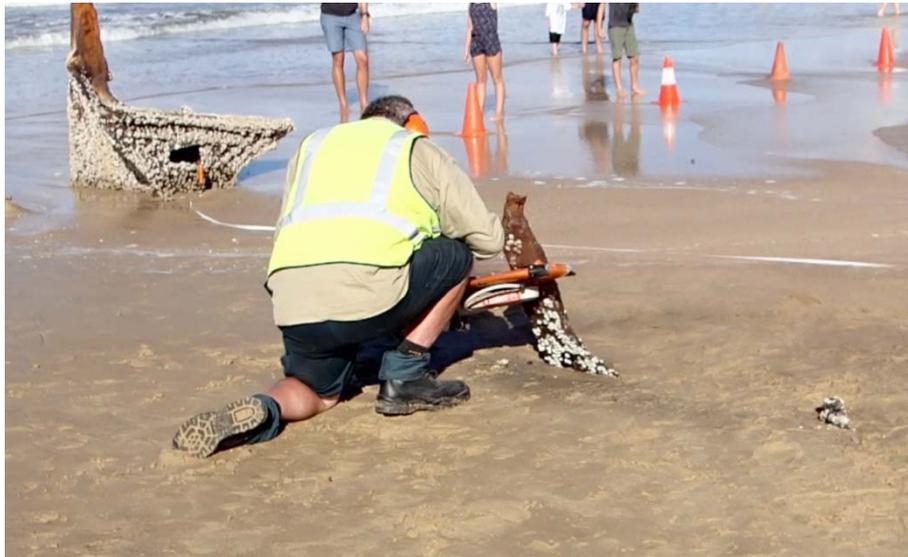
It took approximately another four minutes to cut through the remainder of the frame (Figure 16). The piece of frame that was removed is artefact FR002-001. The cross section of the frame as seen at the top of the remaining frame and base of the artefact clearly shows the frame structure and the amount of metal that survives within the concretion (Figure 17). The frame is shaped as a 'T' with two angle frames back to back and a spacer between as well as hull plating across the top of the 'T'. The thickest part of the surviving metal occurs at the inside corners of the angle frames and the centre of the hull plating, both being approximately 10 mm thick. The surviving metal then tapers down to points towards the edges of the frame.

Figure 16. Cutting through the remainder of frame FR002, facing SE.
(Cosmos Archaeology, 17th April, 2015).

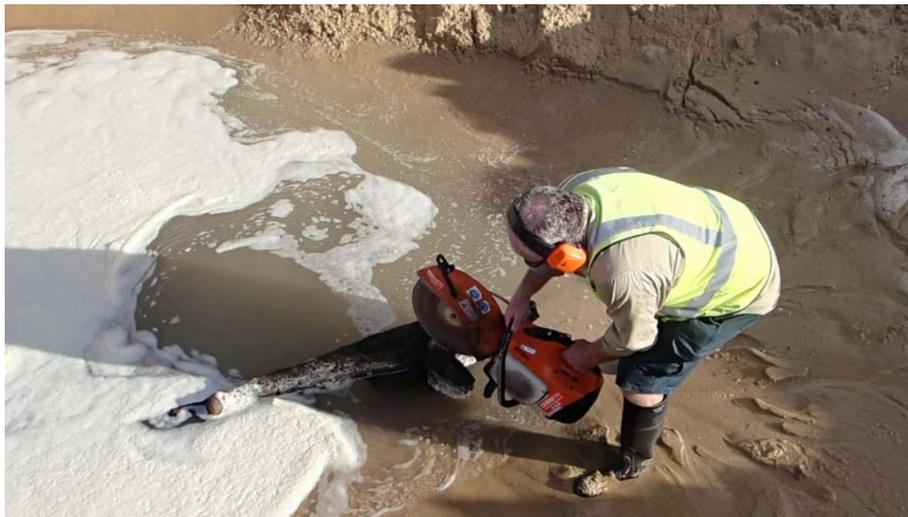
The hand held circular saw was again tested in this Pit. The piece of hull plating that had twisted to the side was removed, becoming artefact BW001-001. This cutting took considerable less time than with frame FR002, most likely due to the much thinner thickness of surviving metal and lack of concretion. It took approximately two minutes to complete the cut.

Figure 21. Cutting of the bow section with hand held circular saw, facing S. (Cosmos Archaeology, 17th April, 2015).

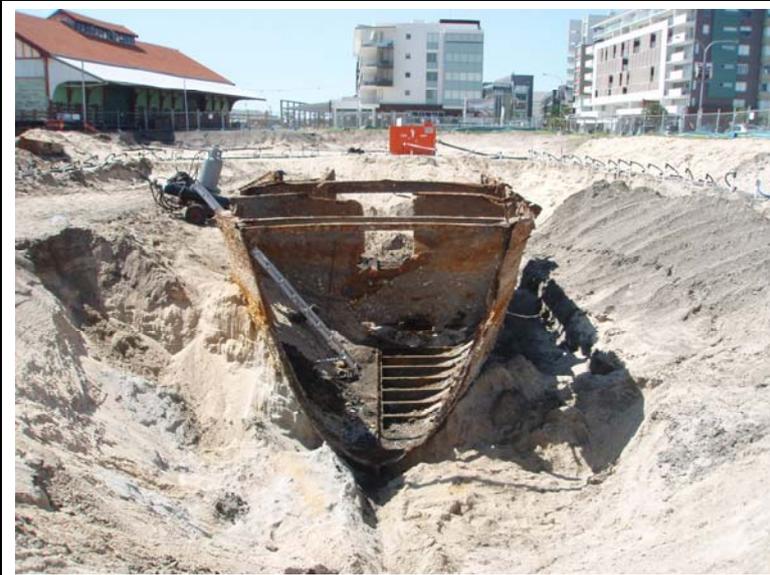
The *Leo*. Iron hull. Was affected by tide but were able to de-water to record and do the cutting. Examples provided of cutting tools used – above water.

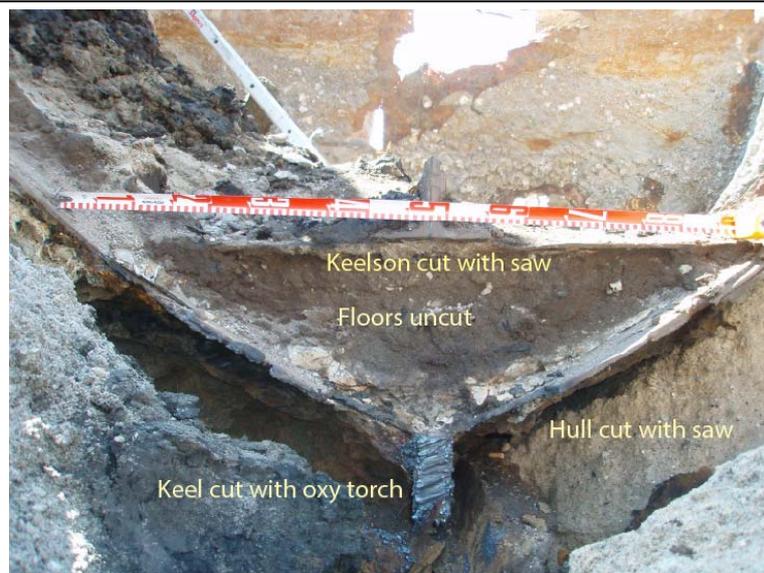
Forward part of the *Leo* after bow removed. All cutting done with circular saw and oxy torch.

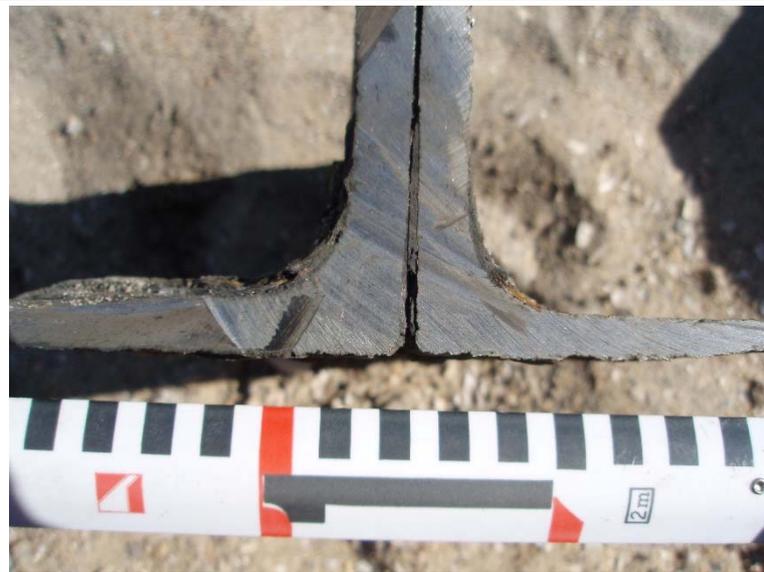
Keelson cut with circular saw

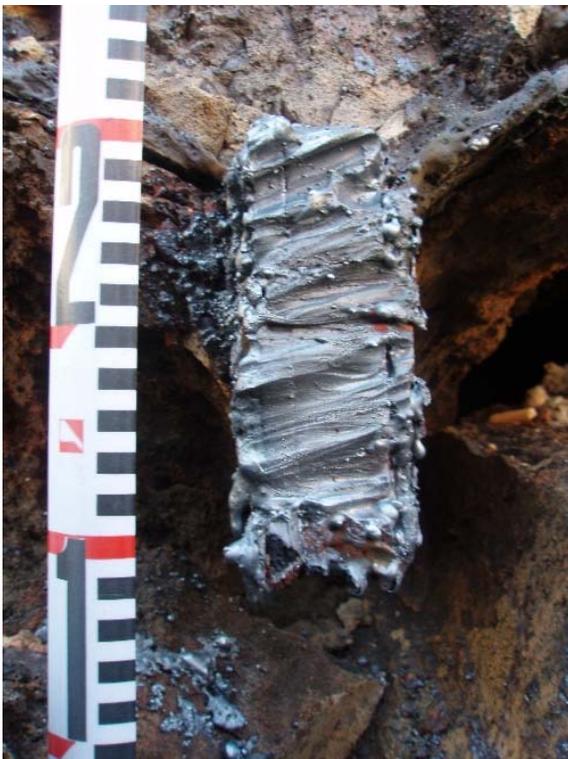
Keel cut with oxy torch.
Thickest iron element on vessel. The iron connecting the rudder post to the stern on the *Dicky* maybe thicker.

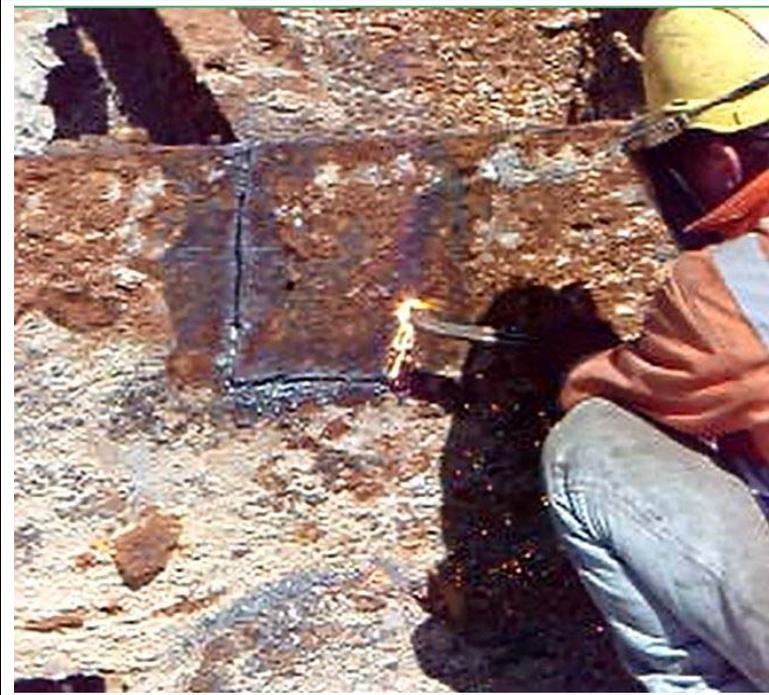
Oxy cutter used to cut hull plate.

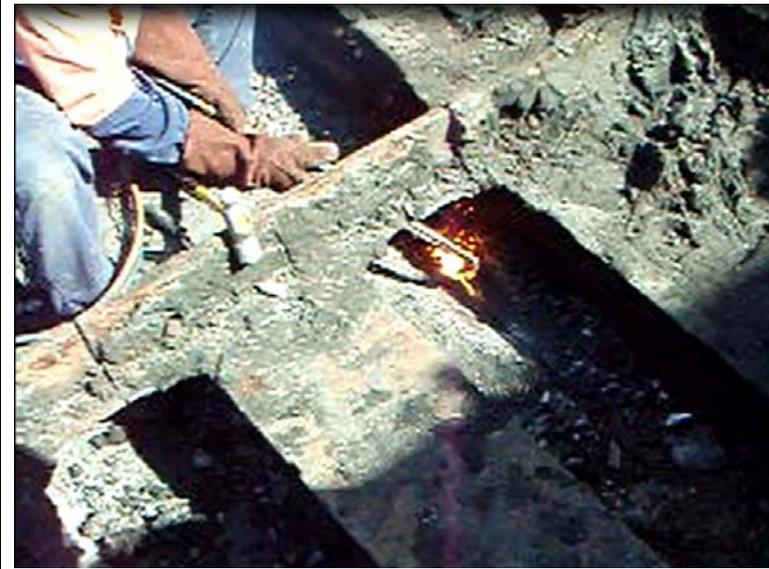
Oxy cutter used to cut keel
