The Kings Beach Surf Life Saving Club building is a brick and hardiplank two storey structure approximately 25 years old on the beach front at Kings Beach, Caloundra. It is currently actively used as a life guard look out, lifeguard equipment storage facility and Nippers club house.

Following the request from Darren Lee from Sunshine Coast Regional Council, GHD were engaged to undertake a dilapidation review of the Kings Beach Surf Life Saving building located on the beach at Kings Beach, Caloundra. The 25 year old building is situated in a severe corrosive environment, which has had an obvious effect on the structure.

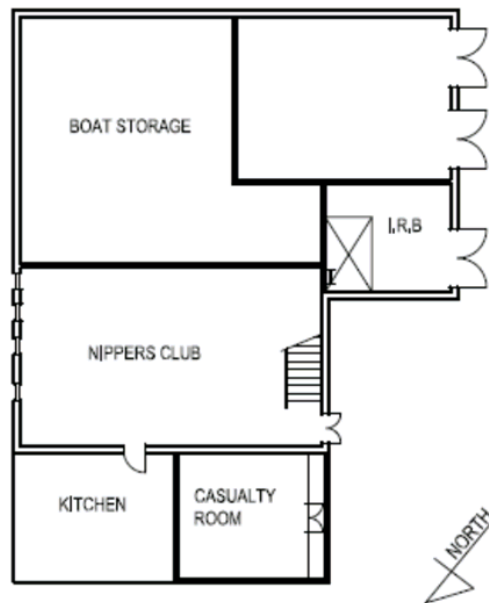
Figure 4 Ground Floor Plan

Based on the information obtained from Sunshine Coast City Council, the below Figure was developed to illustrate the ground floor layout. The upper floor consisting of the lookout room and balcony has not been illustrated but is located above the boathouse.
