**Sunshine Coast Regional Council**  
**Noosa Waters Revetment Walls**  
**Condition Assessment & Concept Report**

May 2013

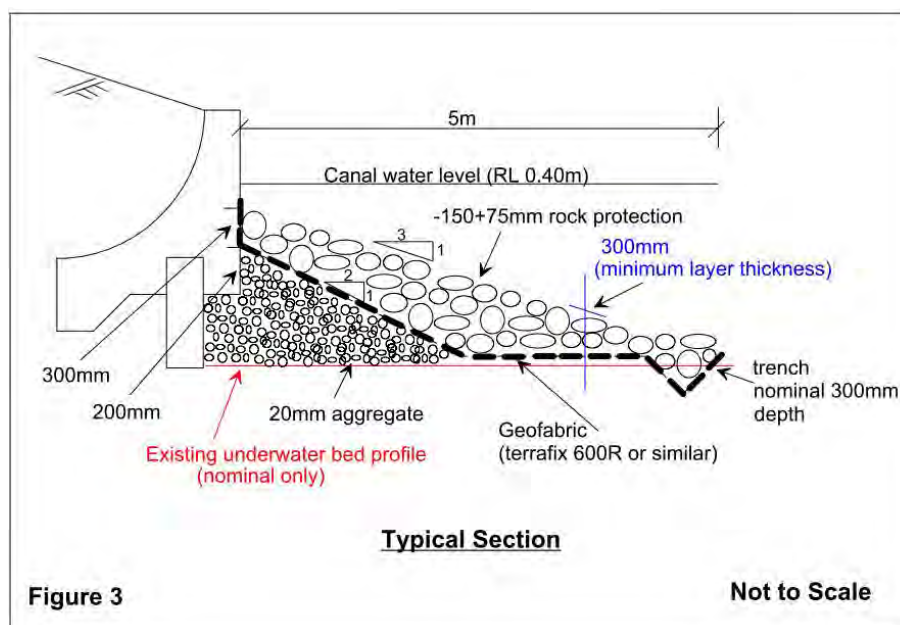
(Soil Surveys 2013)

Subsequent to the GHD Condition Assessment and Concept Report prepared December 2012 (contained herein) Soil Surveys (2013) undertook a geotechnical investigation of the Noosa Waters estate. The GHD proposed concepts (Appendix A) have been reviewed against Soil Survey investigation and remediation options are generally in accordance with those recommended by Soil Surveys. Both Soil Surveys and GHD recommend revetment rock at the toe of revetment walls where the bed level is below that of the original design. The revetment rock will provide an overburden pressure and increase stability.

Soil Surveys remediation recommendations are illustrated in Figure 3 which *indicates a diagrammatic recommended Typical Section of rock scour protection. The use of 20 mm aggregate, without geofabric underlay, is suggested to fill voids and re-establish ground support at the toe of the revetment wall where slumping has exposed or undermined the revetment wall base. Where the lake has not slumped below RL0.0m immediately adjacent to the wall a -150+75mm rock protection layer, with geofabric undelay, is recommended'*(Soil Surveys 2013)
